## **Stage 1/2 Road Safety Audit**

**Housing Development at Pairc na hAbhainn, Athenry**

**On behalf of Galway County Council**

**November 2025**

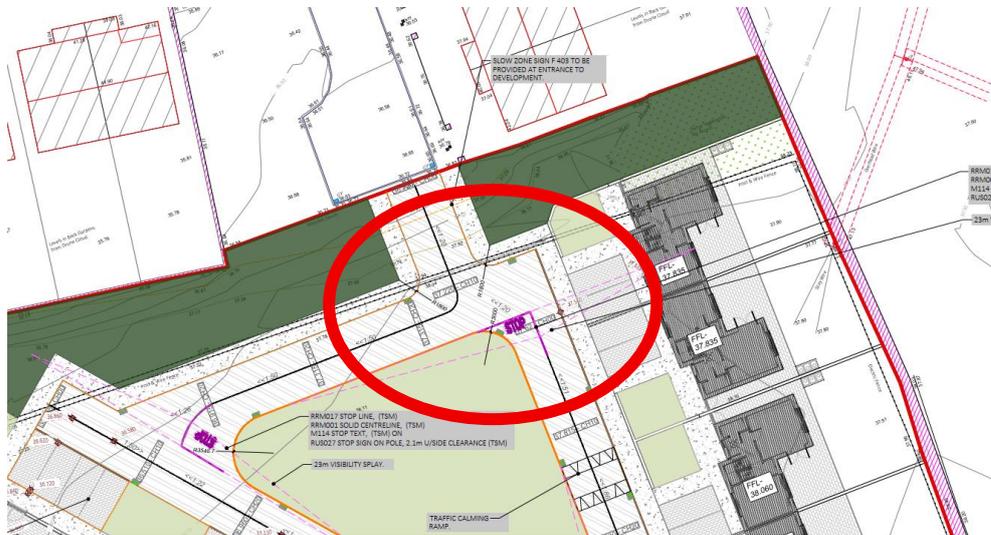
#### 4.1.1 Entrance to proposed development

**Problem:** The entrance to the proposed housing development is confusing, whereby the priority is offered to motorists who are undertaking a sharp right-hand turn. It is likely users exiting from the eastern road will not stop at the indicated road junction.

**Hazard:** Impacts within the junction may result.

**Recommendation:** The Design Team should redesign the junction such that the use is intuitive.

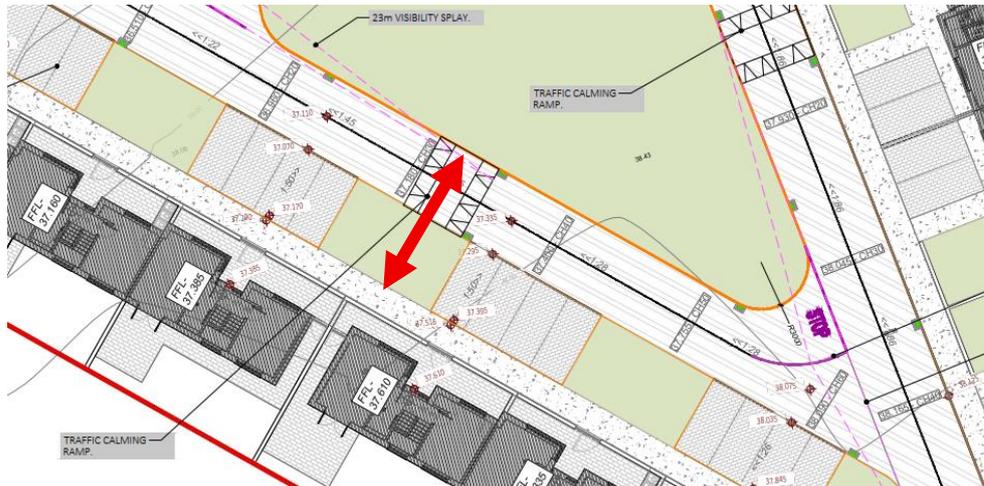
#### 4.1.2 Pedestrian Access to Public Open Space

**Problem:** There is no direct pedestrian access to the public open space from the road to the south. Pedestrians are likely to walk in between parked vehicles and cross the road unsighted to approaching drivers.

**Hazard:** Pedestrian / vehicle impacts may result.

**Recommendation:** The Design Team should provide a footpath to link with the proposed raised table on this road.

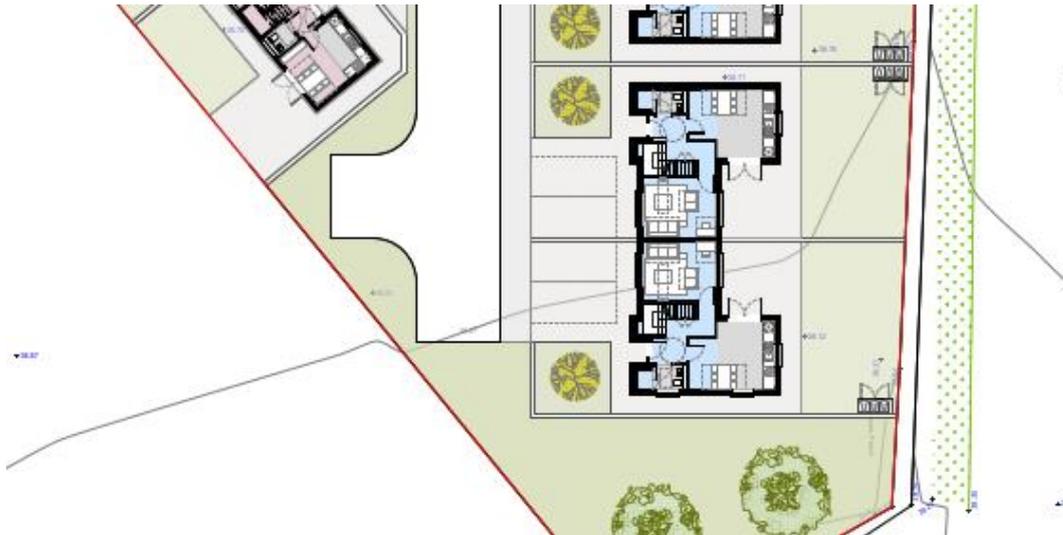
### 4.2.1 Turning Head

**Problem:** The turning head appears small. Large vehicles including the refuse collection vehicle may have difficulty in turning within the space provided. The vehicle may be required to reverse back to the nearest road junction.

**Hazard:** Impact with other road users or crossing pedestrians may result.

**Recommendation:** The Design Team should ensure the turning head is of sufficient size for turning of all anticipated vehicles.

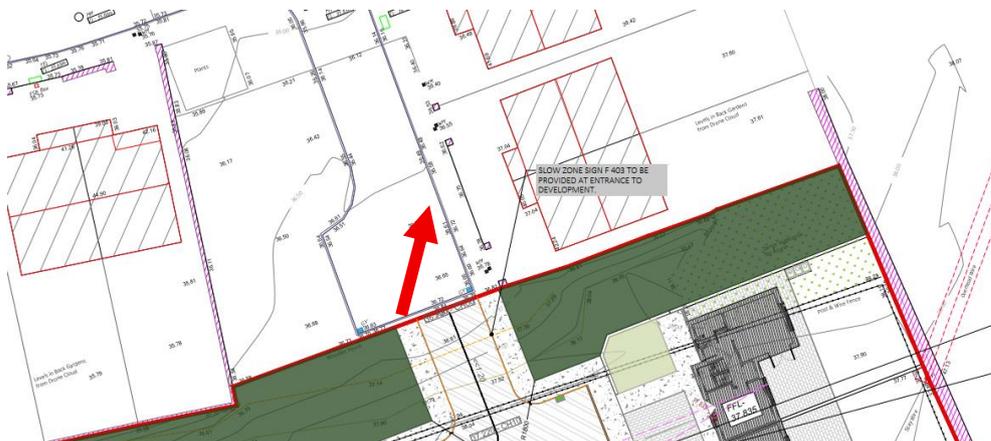
### 4.2.2 Existing Turning Head / Footpath Connectivity

**Problem:** The proposed development extends where the existing turning head is located. There is no footpath to the western side of the existing estate road for the proposed new footpath to connect with. Pedestrians exiting the proposed development are likely to cross the road diagonally, with their back to development exiting traffic in this area.

**Hazard:** Pedestrians may be struck by vehicles.

**Recommendation:** The Design Team should interconnect the footpaths to the southern side of the existing housing development road.

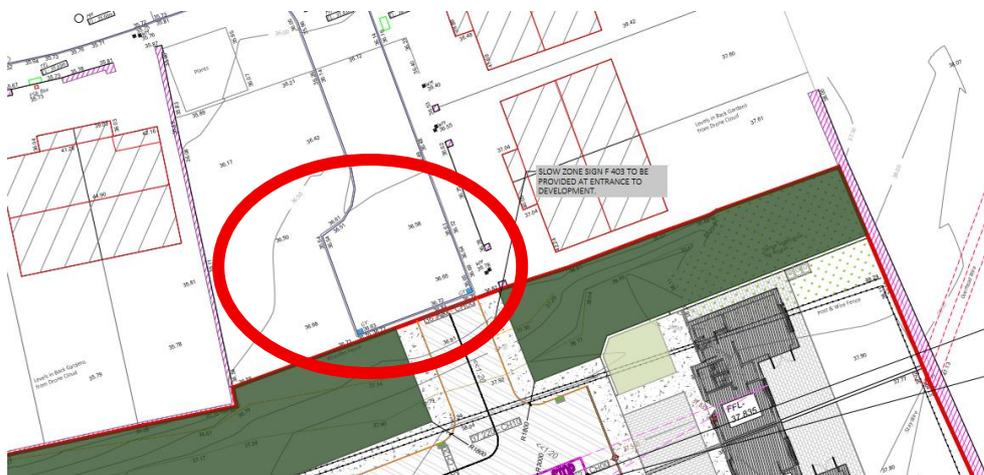
#### 4.2.3 Existing Turning Head

**Problem:** It was observed during the site visit the existing turning head is being used for long term car parking. Upon opening of the proposed development, there is concern these parked cars will protrude into the path of vehicles exiting the development.

**Hazard:** Development traffic may collide with parked vehicles.

**Recommendation:** The Design Team should remove the existing turning head.
