## DEMOLITION & REPLACEMENT OF EXISTING COTTAGE AT: CHURCH STREET, LOUGHREA, CO. GALWAY

Architectural Heritage Impact Assessment 30/07/2026

**aughey o' flaherty architects**

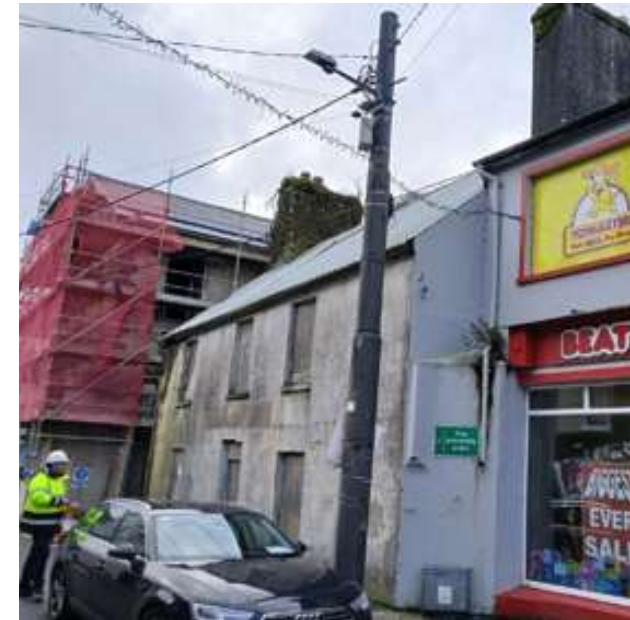
Fig.17: View from Church Street

The structural cross walls and chimney breasts are intact and are contributing to stability of the structure. The external plaster to the Church street facade appears in poor but stable condition, while all architectural features and external joinery are missing. Established wild ivy and creepers have taken over the side and rear facades in a number of locations.

- 'Bellying' of the front masonry wall as structural elements have decayed and failed.
- First floor structural timber joists and internal masonry 'tie walls' have separated from the external walls.
- Leaning of the southern gable and chimney towards the town hall.
- Collapse of first floor timbers.
- Collapse of the timber staircase and landings.
- Decay and collapse of timber lintels.
- Failure and collapse of roof structure of both the cottage and lean-to extension.
- Deterioration of timber roof trusses has resulted in decay of roof covering fixings.

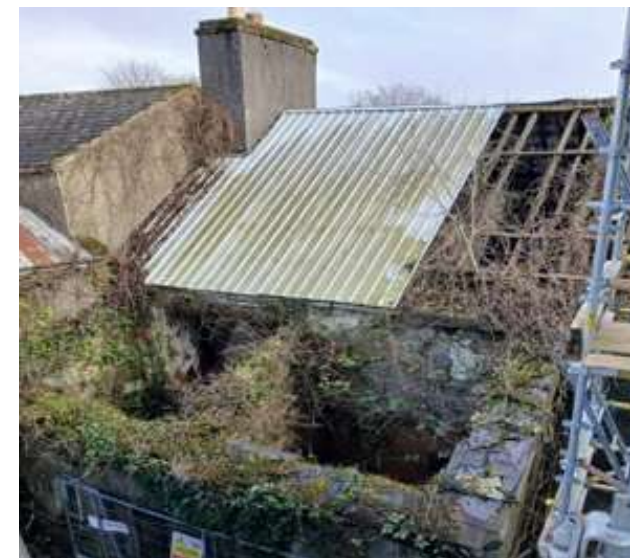
It is not clear when the roof has collapsed, but the current condition is partly due to extensive water ingress to all parts of the interior through the missing roof. The entirety of the slates are missing from the roof and the condition of the primary roof timbers is beyond repair.

Fig.19: View of collapsed Roof

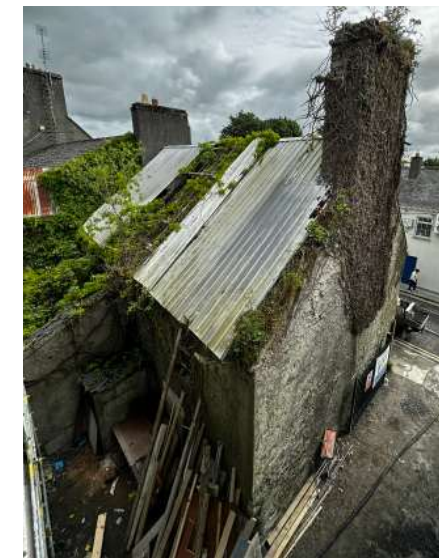
Fig.20: View of overgrowth on roof and chimney

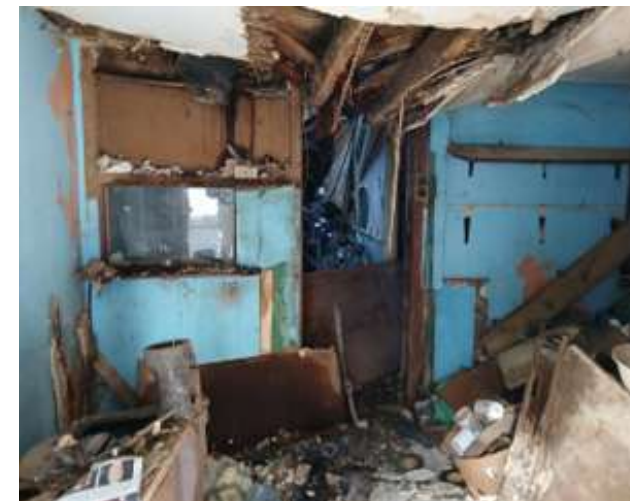
Fig.21: Interior View

The interior of the building is heavily saturated and floor joists on the upper floors are partially extant and partially collapsed, and likely to be significantly weakened through rot. Most of the floorboards at first floor level appear to have been removed. The plaster and lath ceilings at both first floor and ground floor level have, for the most part, collapsed into the ground floor rooms. The timber floorboards at ground floor level are saturated and soft through rot, with gaps where the floorboards have collapsed into the floor void below.

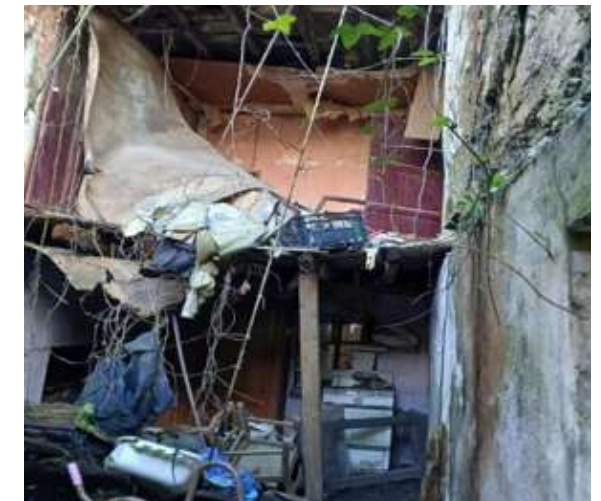
The timber staircase appears to be collapsed also.

Fig.22: Interior View of Collapse
