**Structural Condition  
and  
Remedial Intervention Report  
to  
Church Street, Loughrea**

Report Ref: CORA-26110-RP-01

Date: 27th April, 2026

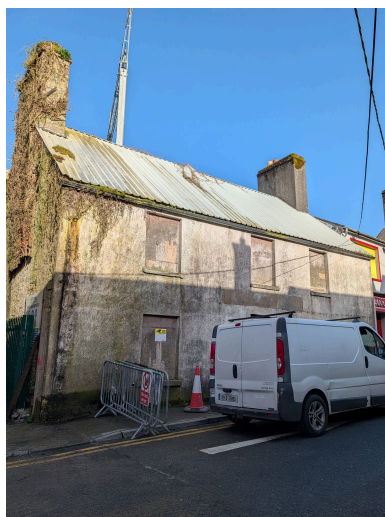
Image 1

- **Image 1:** Tailte Éireann Historic Maps Dashboard showing six map panes of the site.
- **Image 2:** The front elevation on Church Street. It shows the rendered facade, metal roof, and boarded openings behind temporary fencing. An outward deflection is visible at the mid-height of the wall.

The load-bearing structure consists of random rubble stone walls. The front elevation on Church Street bows outward at the first-floor level. A survey using a 4-foot manual spirit level recorded an outward deviation of 25mm to 40mm over the 4-foot span. A digital inclinometer recorded angles between 88.1 and 89.6 degrees.

To address the recorded deviations (25-40mm and 20-45mm over a 4-foot level), a system of raking shores must be installed against the front elevation and southern gable to counteract the outward movement. Internal flying shores or wall ties may also be required between the front and rear elevations. The final design will follow the internal clearance.

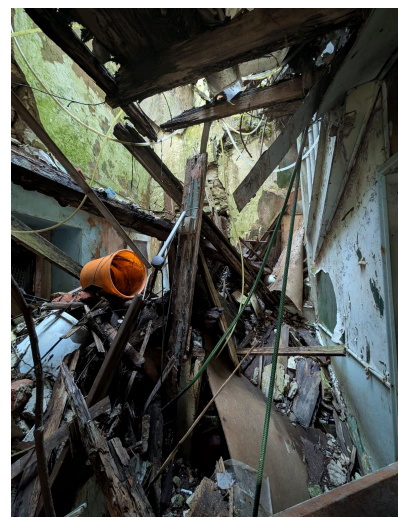
Image 2

- **Image 3:** The ground-floor interior, containing collapsed timber joists, lath, plaster, and masonry debris. An orange bucket is present, and green algae and moss are visible on the exposed stone walls.

The collapsed first-floor materials must be removed to reduce loads on the lower structures and to expose the internal masonry for the design of a temporary propping system. Mechanical extraction from the exterior is advised to limit personnel access to the interior.

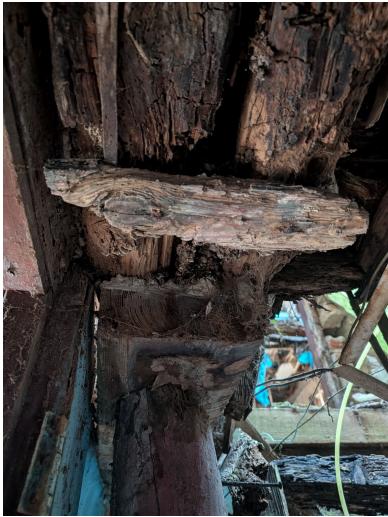
Image 3

- **Image 4:** A horizontal timber member resting on a vertical post. The timber displays longitudinal cracking and fungal decay.
- **Image 5:** An internal view showing an exposed rubble wall, failing upper timber structure, and vegetation entering the building.

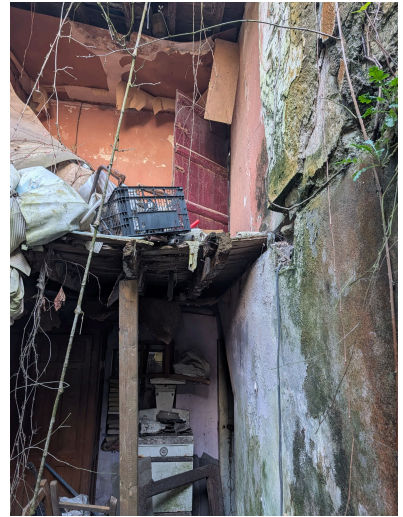
Image 5

- **Image 6:** A ground-floor room with a displaced timber door.
- **Image 7:** An elevated view of the masonry structure covered in moss and ivy, with scattered roofing slates.

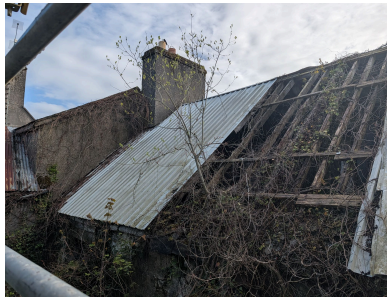
Image 7

- **Image 8:** The main roof structure from the exterior. A central section of the profiled metal cladding is missing, exposing the timber rafters and internal vegetation. A rendered chimney stack is visible.

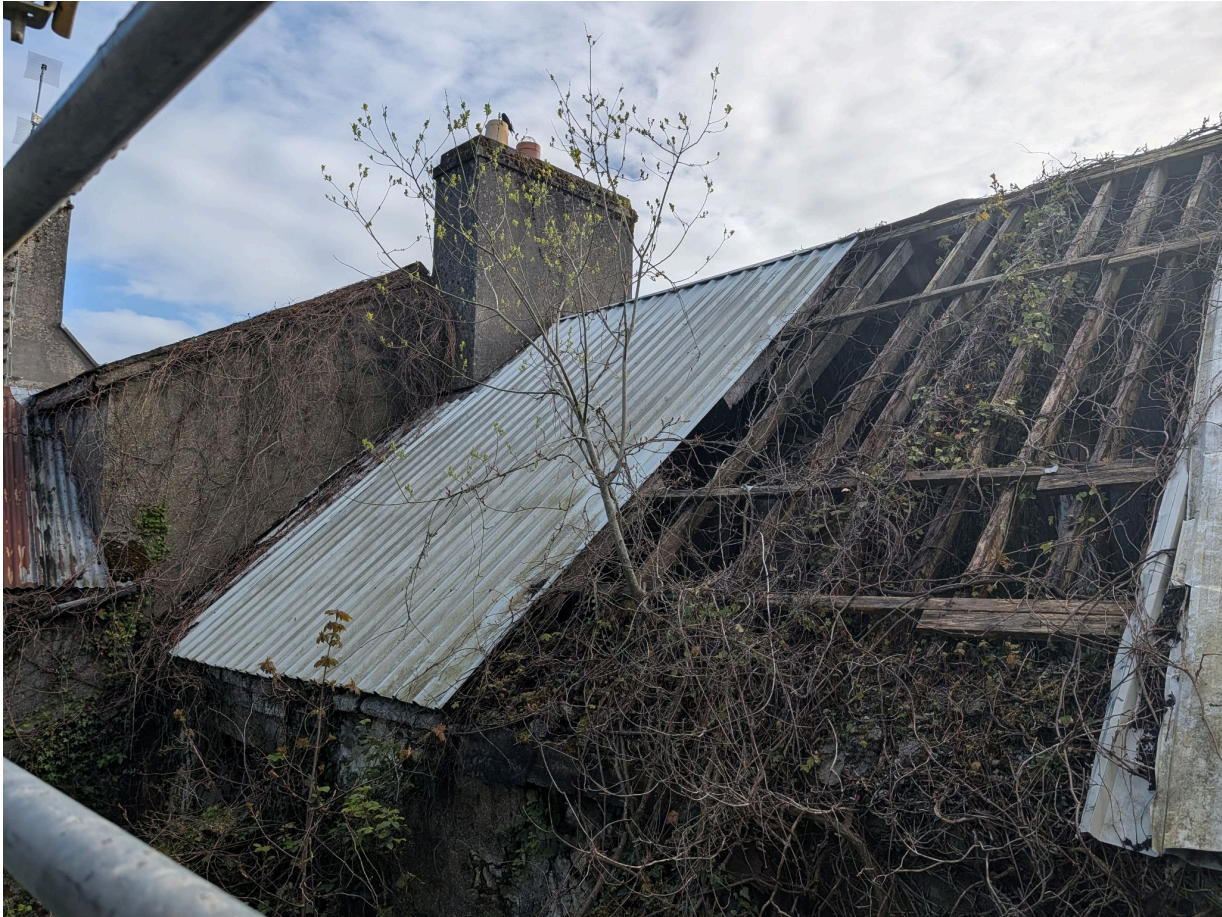
Image 8

The central ridge capping and a large section of the profiled metal sheeting on the rear elevation are missing (Image 8). This permits water to enter the building. The exposed timber rafters show signs of decay. The roof over the rear single-storey extension has collapsed completely. Suspected asbestos-containing materials (ACMs) were noted at the roof level.

The structural defects are primarily the result of water ingress through the compromised roof. This water exposure has increased the moisture content of the internal timber elements, leading to fungal decay. The loss of structural integrity in the timber joists and lintels caused the first floor to collapse.

The remaining roof cladding and timber structure must be removed to eliminate uneven vertical loads and reduce the wind load on the unrestrained facades. This work must be executed from the exterior using mobile elevating work platforms (MEWPs) or cranes.

A Refurbishment and Demolition (R&D) Asbestos Survey must be conducted before roof removal. Any confirmed ACMs must be removed under controlled conditions by a licensed contractor.

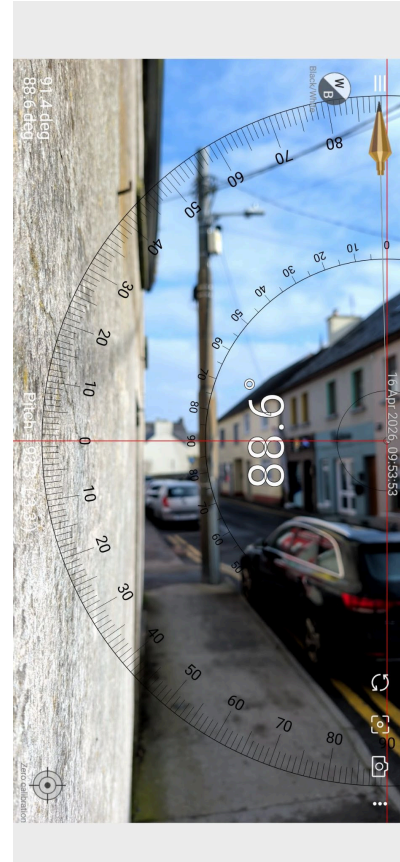
Elevation Survey 3

Measurements of the rear facade were hindered by the uneven stone surface, but readings

taken at the southern gable showed deviations of 20mm to 45mm over the 4-foot level. The southern gable exhibits a lean to the south.

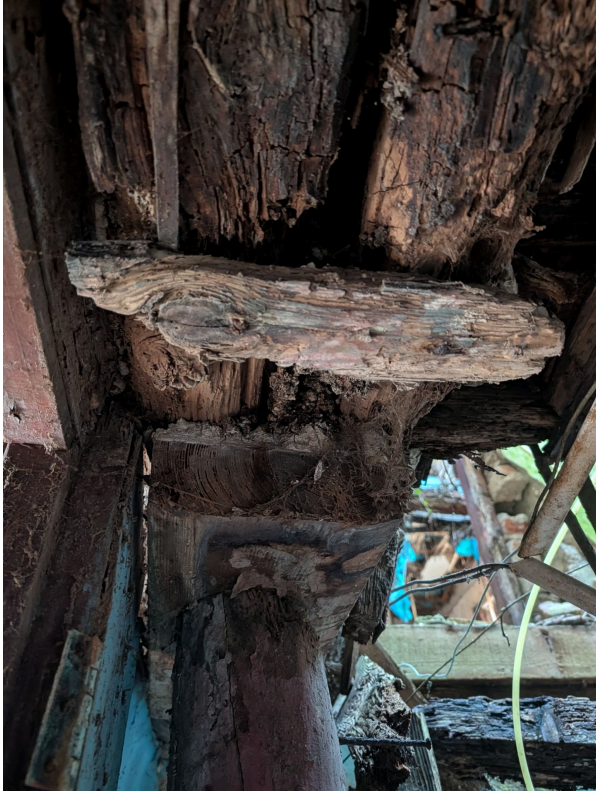
Image 4

Timber lintels over the door and window openings are decayed where exposed (Image 4).

Timber or steel cross-bracing must be installed within the window and door reveals to support the masonry above the decayed timber lintels.

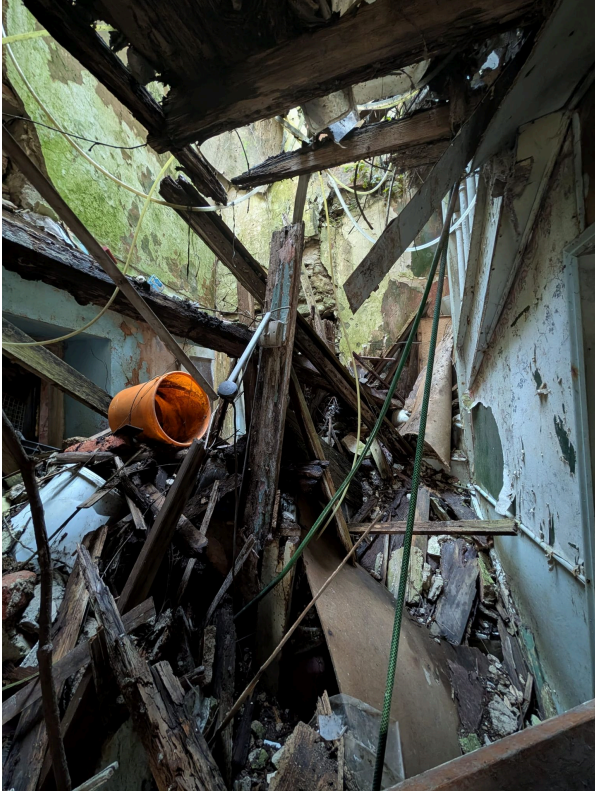
Image 3

The internal timber floor joists are decayed. The timber support structure between the front and back rooms has failed, resulting in the collapse of the first floor into the ground-floor rooms (Image 3). This collapsed material has displaced the polystyrene ceiling tiles in the southern front room (Image 6). The rear staircase has also collapsed.

The unreinforced masonry walls rely on the internal floor joists for lateral restraint. The collapse of these joists removed this restraint. Combined with potential mortar degradation from the water ingress, the loss of lateral support has resulted in the outward bowing of the front elevation and the leaning of the southern gable. The walls are currently unrestrained.

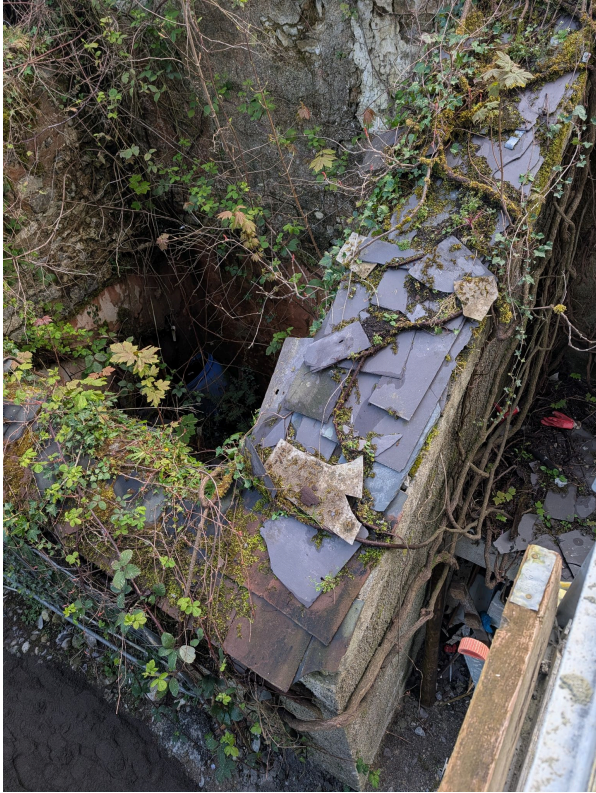
Image 7

The building is structurally unsafe. The collapsed first floor exerts loads on the ground-floor structures, and the unrestrained external walls pose a risk to the adjacent public street. Access must remain restricted. The suspected ACMs at roof level (Image 7) require a formal survey and removal by licensed specialists prior to other works.
