TREE SURVEY

**Mountain Road,
Maigh Cuilinn,
Co Galway.**

December 2020

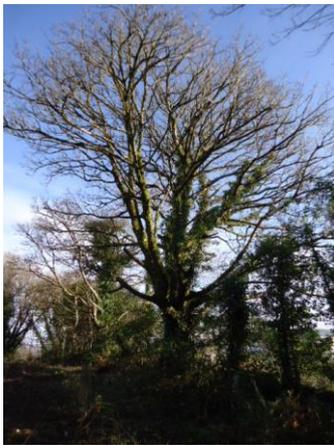
T555 – this tree appears to be in direct conflict with proposed new development.

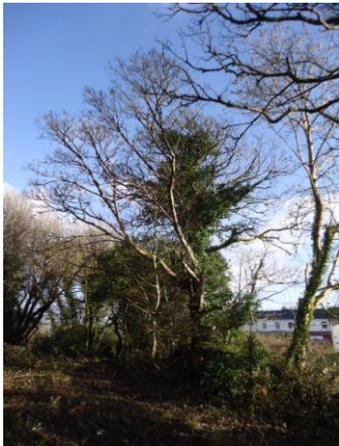
T557 – this tree appears to be in direct conflict with proposed new development.

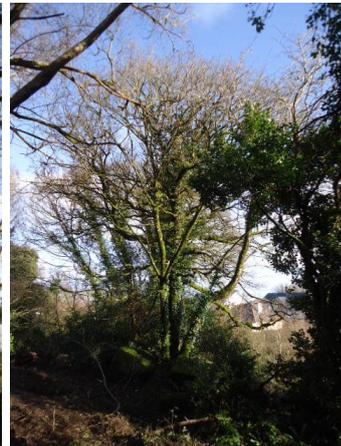
T558 – this tree appears to be in direct conflict with proposed new development.

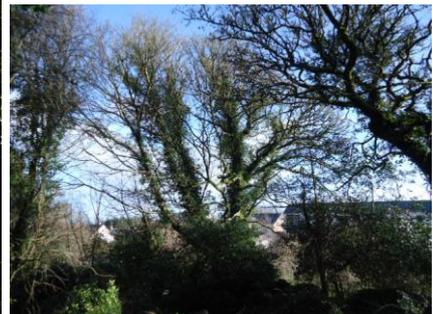
Particular care will be required around T559 the RPA of which extends into the site but area, however its retention is deemed possible as the majority will be within a planned greenspace. It is essential however that the area be protected as indicated on Tree Protection Dwg No 18401/T/103 Rev A.

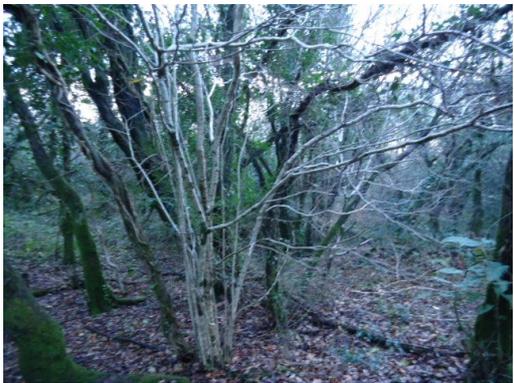
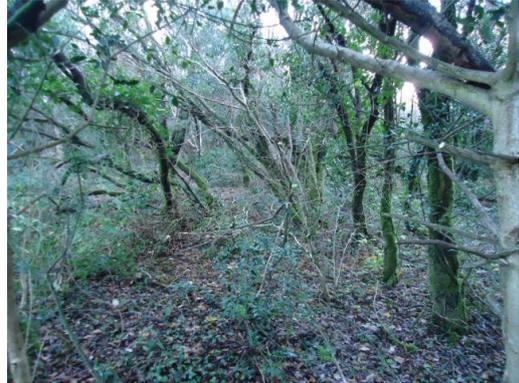
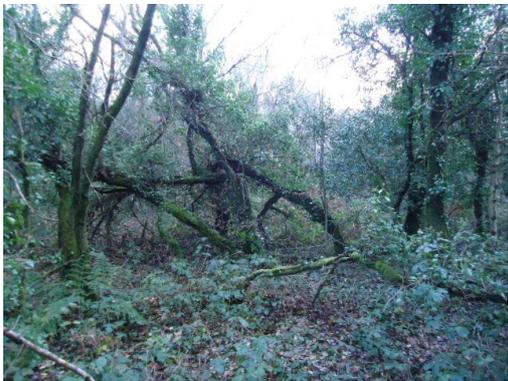
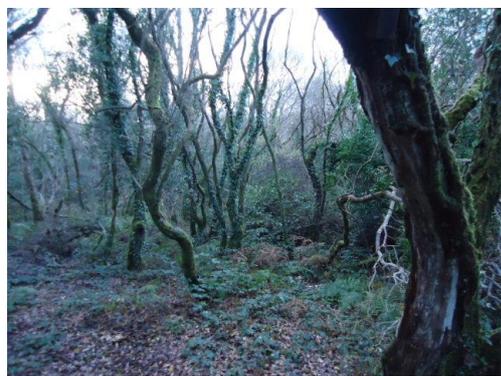
TG1 typical

Tree Group 1 – this group appears to be in direct conflict with proposed new development.

563	Acer platanoides	9	5/5/5/5	600	7.20	2m all	MA	40+	Good	Fair		B1	
564	Sorbus aucuparia	5	3/3/3/3	350	4.20	2m all	MA	20+	Good	Fair		B1	
565	Salix sp.	8	5/4/4/4	300x2/400	7.00	0m all	MA	20+	Fair	Fair		B2	Some decay present
566	Betula pendula	13	3/3/3/3	350	4.20	2m all	MA	40+	Good	Fair	Remove Ivy	B1	
567	Acer pseudoplatanus	12	4/2/3/4	400	4.80	1.5m w	MA	40+	Good	Fair	Remove Ivy	B1	
568	Acer pseudoplatanus	14	5/5/5/5	900	10.80	4m all	MA	10<	Fair	Poor	Monolith	U	Significant basal decay
569	Acer pseudoplatanus	14	2/4/2/4	400	4.80	5m w	MA	40+	Good	Fair	Remove Ivy	B2	
570	Acer pseudoplatanus	13	4/6/5/5	570	6.84	2m s	MA	40+	Good	Fair		B1	
571	Acer pseudoplatanus	12	3/3/3/3	400	4.80	5m all	MA	40+	Good	Fair	Remove Ivy	B1	
572	Acer pseudoplatanus	15	5/5/5/5	820	9.84	2m all	MA	40+	Good	Fair	Remove Ivy	B1	
573	Salix sp.	11	4/4/6/4	500	6.00	2m e	MA	40+	Good	Fair	Remove Ivy	B2	
TG1	Mixed Broadleaf	6 to 12			0.00		MA	40+	Good	Fair	Remove Ivy & Crown Clean	B2
