Building Conservation Assessment Report.

Tuam Town Hall
The Square
Tuam
Co. Galway
H54 XD61

Client:
Galway County Council

Date: 30th September 2021 (Revised on the 7th December 2021)

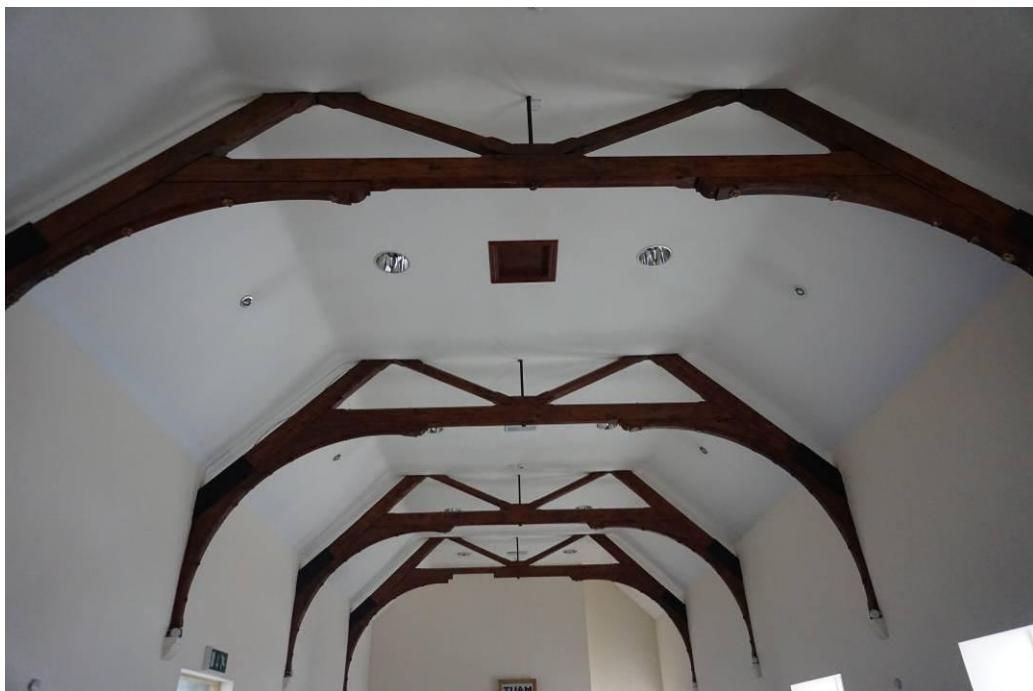
Opening up works have been requested in order to determine the condition of the structural trusses. The main concern with the trusses is at the juncture with the walls, where the internal plaster work may be concealing potential defective timber, possible latent defects here may be timber affected by wet rot, as there is evidence of water ingress to these walls.

Photograph 1 View of the trusses within the meeting room.

The other area of potential concern is the upper level of the trusses in the main roof, which were simply not accessible on the day of inspection. These can be accessed through the high level attic hatches within the meeting room and have been identified as items for further inspection when access has been provided.

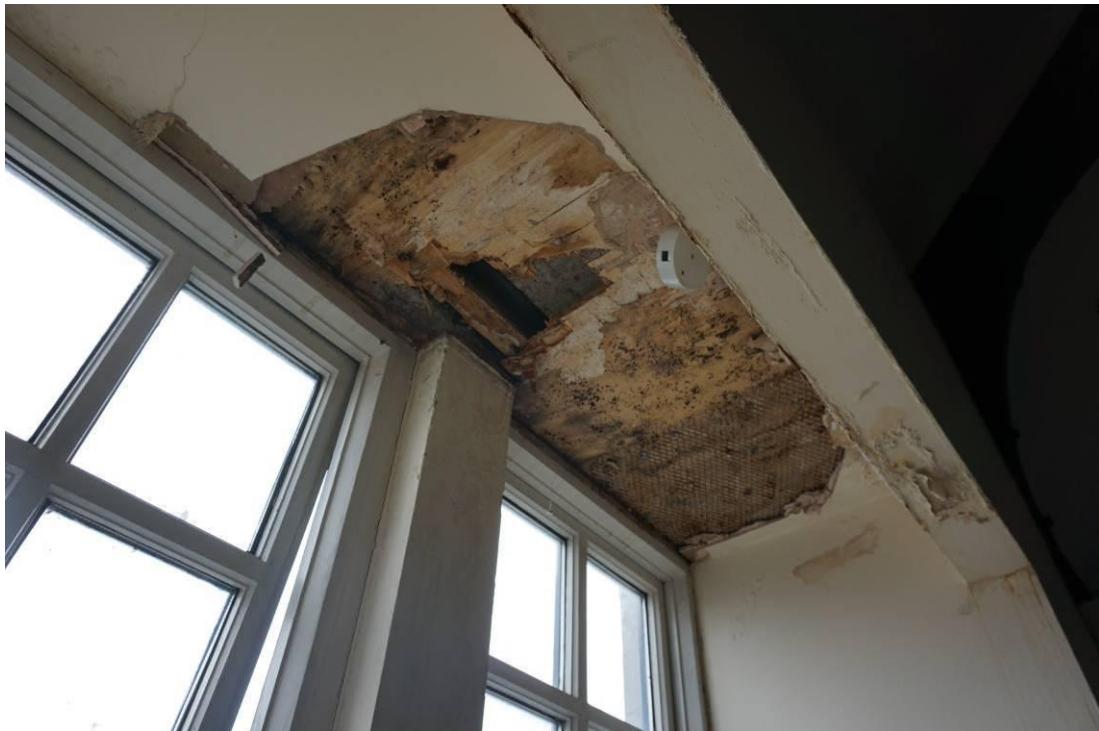
The window head soffits plaster work of one of the front facing windows of the meeting room on the first floor has failed, exposing the works detailing underneath.

Photograph 2 Window head soffit with water ingress damage. Note DPC detail, poorly installed.

The soffits is made up of what appears to be OSB boards, skimmed over with a DPC also on view, installed flat with no upstand. Where an actual need for a DPC in the first instance is questionable?

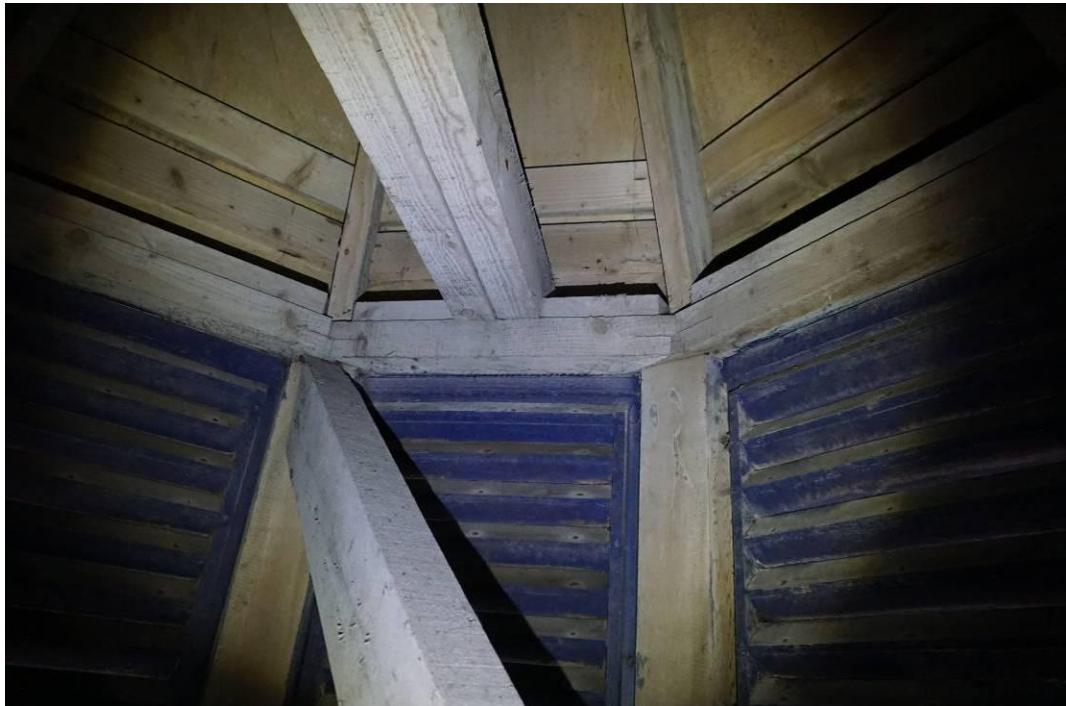
Photograph 3 Internal view of the Louvre panels.

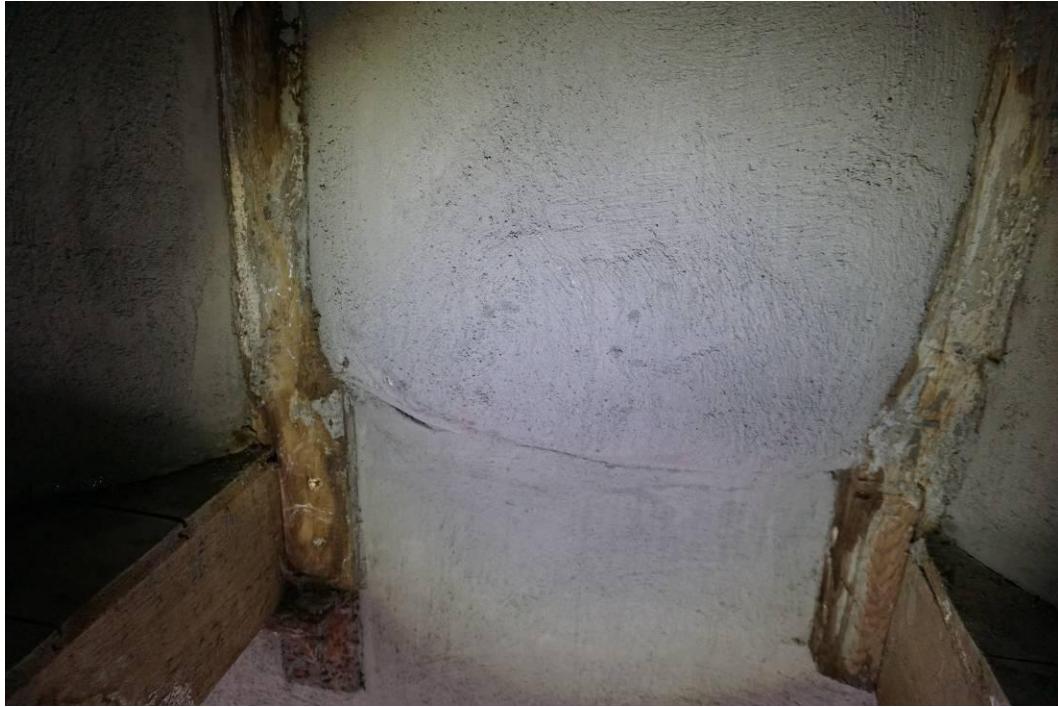
Photograph 4 Example of cementitious rendered panel with crack clearly visible.

Recommended works here are the removal of the cementitious render and application of a more appropriate Natural Hydraulic Lime based render in its place. In the mean time, it is recommended to also remove the cementitious render from around the cast iron corbels and inspect the condition of them.

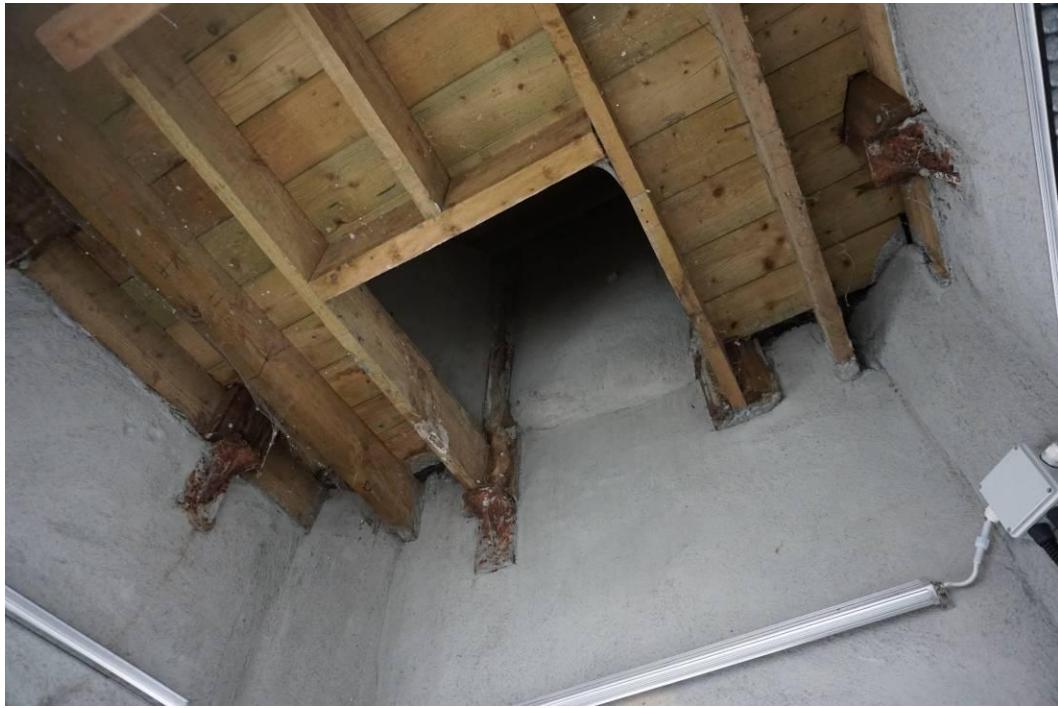
The floor supports, which are cast iron and embedded in the masonry, have also been mostly rendered over, the condition of the metal underneath this render is of concern, given the structural support function of the corbels.

Photograph 5 View of underside of upper floor deck. Note supports with cementitious render applied around them. These supports are either mechanically fixed or built into the fabric.

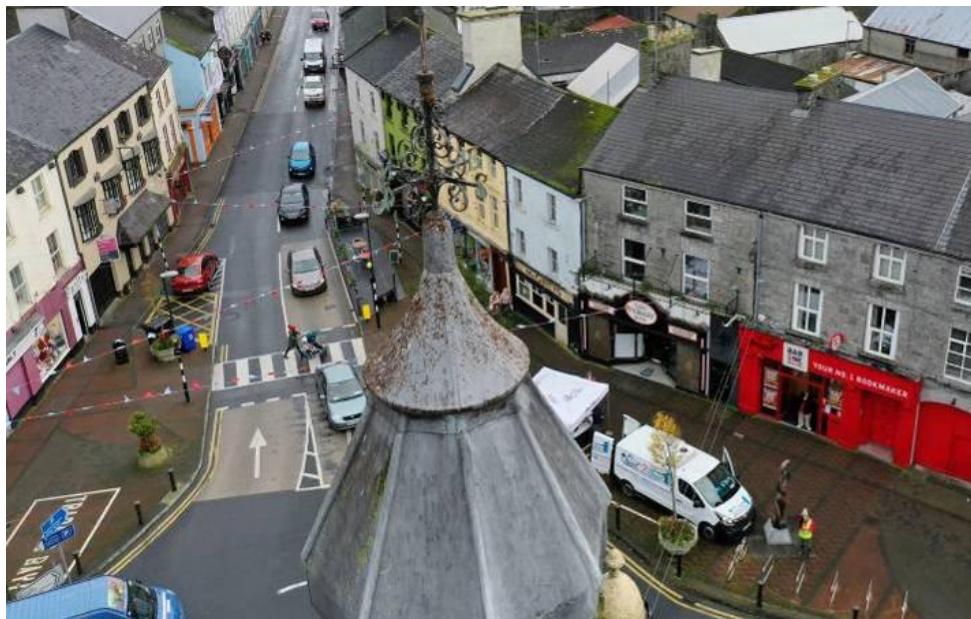
The lead lined roof above the louvers of the tower appear in reasonably good repair. The lead is heavily stained on one side with bird guana however, the fixtures appeared intact. The lower Rolled Lead Sheet sections appeared in good order, the fixtures for these sheets was visible. There was noted corrosion to the nail heads, although not completely wasted.

Photograph 6 Top section of the tower, covered in Rolled Lead Sheet.

It is recommended that all of this Rolled Lead Sheet work be renewed if works are to be undertaken to the masonry of the tower in the near future.

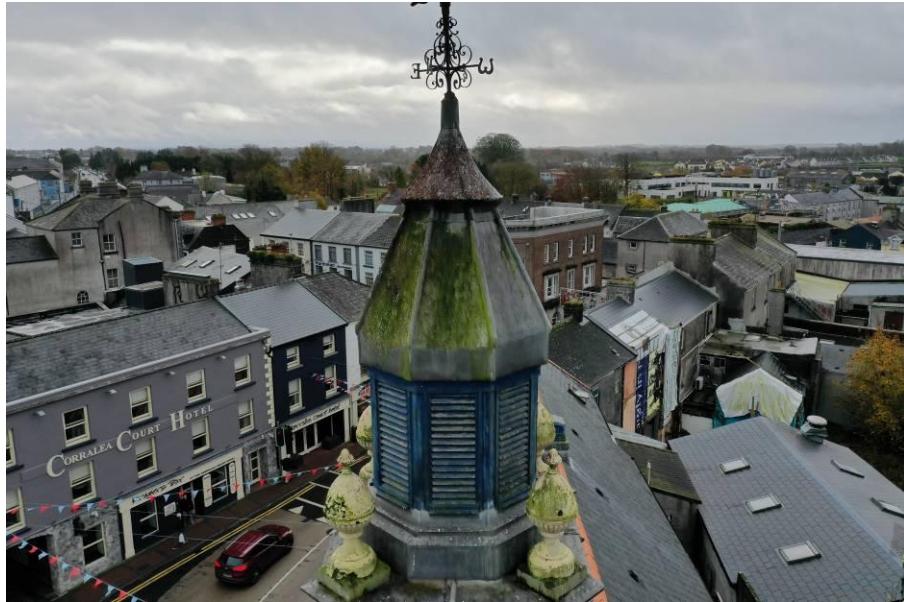
Photograph 7 Section of the RLS roof, heavily stained in bird guana.

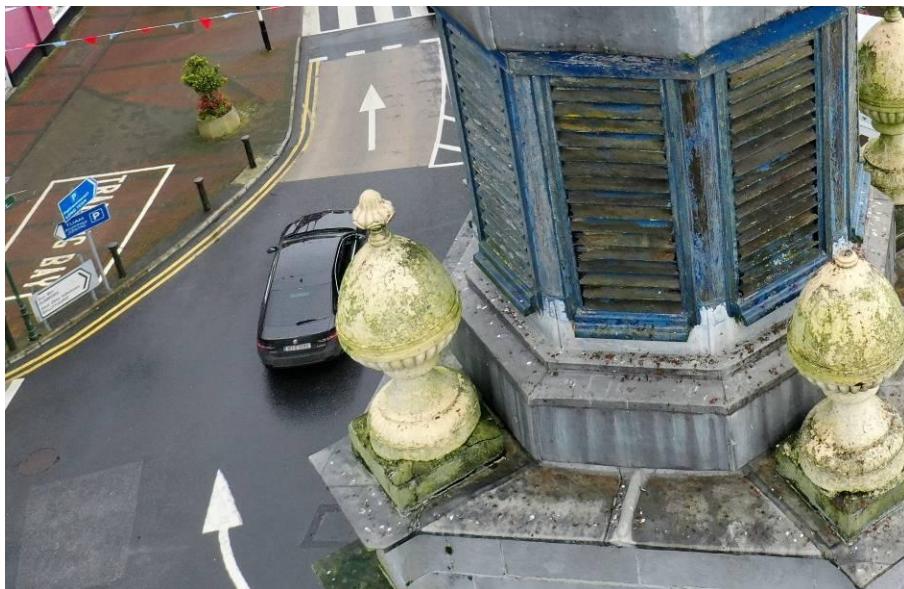
All of the louvers require re painting. There is visible cracking to the concrete base surround of at least one of the urns located on the ledge beneath the louvers.

Photograph 8 Detail of “Urn” on the upper ledges. Note cracking to concrete surround.

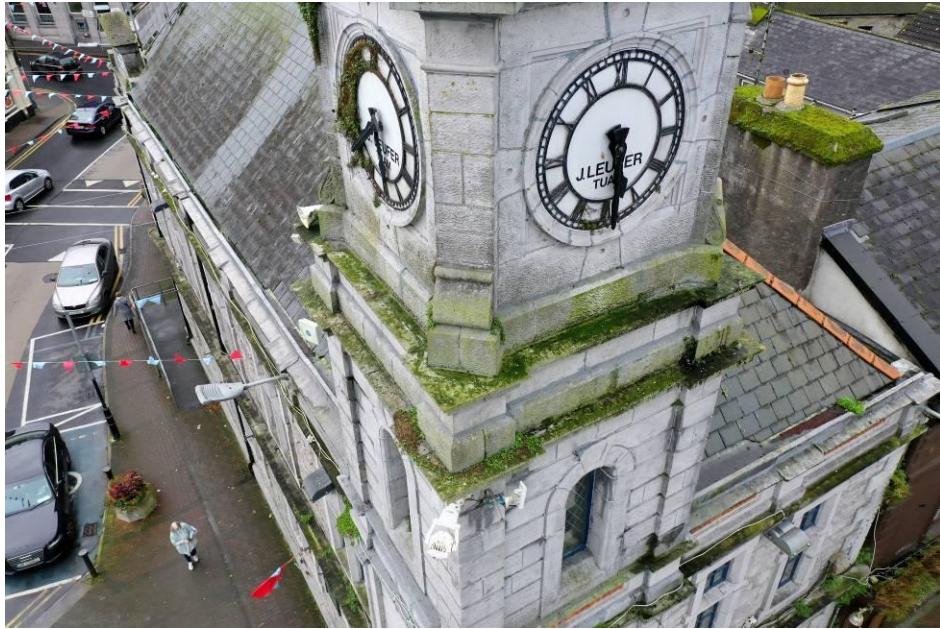
The stonework of the remainder of the tower has been pointed, crudely, using silicones and mastics instead of Natural Hydraulic Lime based mortars. This is most worrying and may explain some of the noted ingress to the fabric in the lower tower.

Photograph 9 Mid section of the tower. Masonry pointed with mastic. Heavy vegetation growth and staining.

This will require complete removal and replacement with a Natural Hydraulic Lime based mortar.

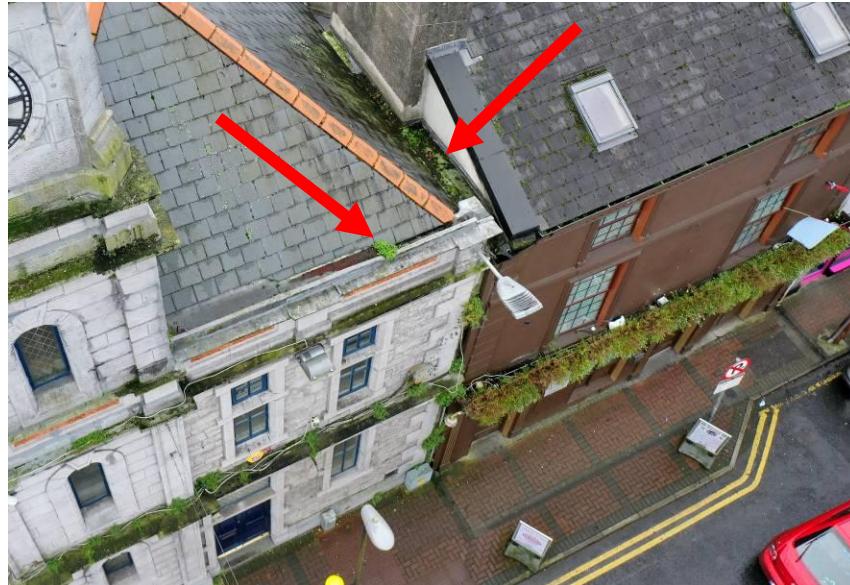
The roof, when inspected from the Small Unmanned Serial Vehicle (SUAS) was generally noted to be in a good state of repair. There are a small number of slipped slates noted to the front roof plane however, and the missing slate vent covers to the rear roof plane as previously noted.

Photograph 10 View to end elevation of Tuam Town hall. Note block parapet gutter and heavy vegetation to abutment gutter of neighbouring property (Highlighted).

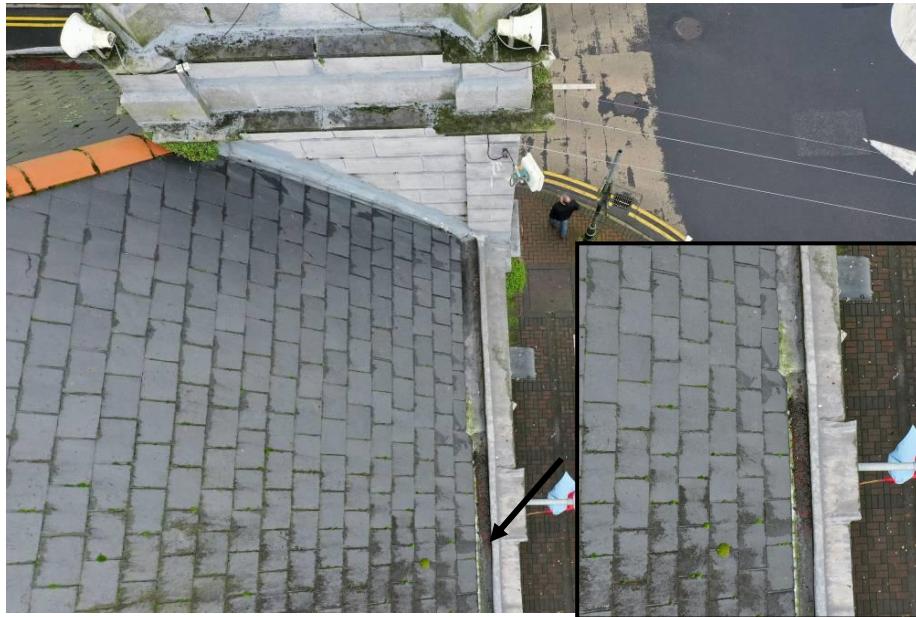
While there was no obvious obstruction on view when inspected, the fall of the gutter above the problematic section could not be accurately determined. The area did show some signs of water pooling however, highlighted in “*Photograph 11* View of problematic area of the parapet gutter (North, by tower). Note signs of poor fall and water pooling (Highlighted). This area requires attention. “ below.

Photograph 11 View of problematic area of the parapet gutter (North, by tower). Note signs of poor fall and water pooling (Highlighted). This area requires attention.

The recommendation here is the relining of this gutter with correctly specified Rolled Lead Sheet installed by competent trades' men with a proven record of working with Rolled Lead Sheet on historic buildings, with the works undertaken within the overall works packages to the tower and roof.

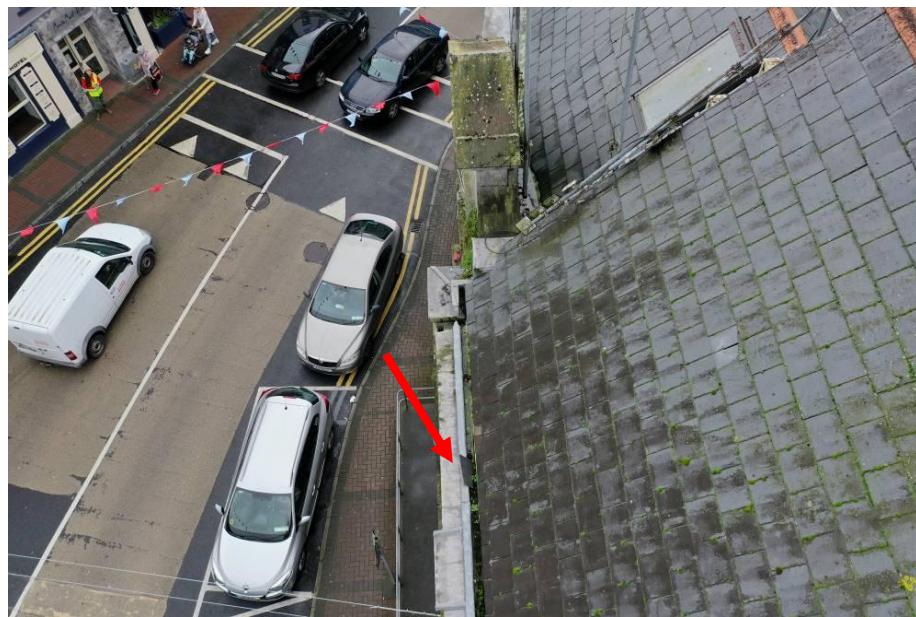
Photograph 12 View of continuation of the Parapet Gutter to south, note slipped slate in gutter.

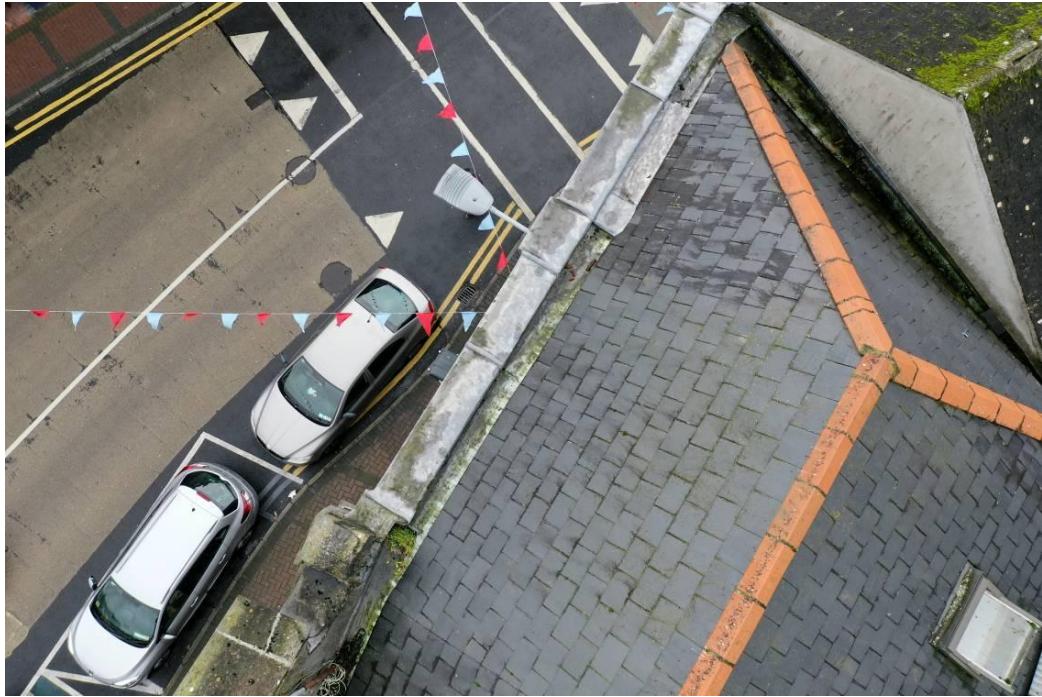
Photograph 13 View of Parapet Gutter, southern roof section.

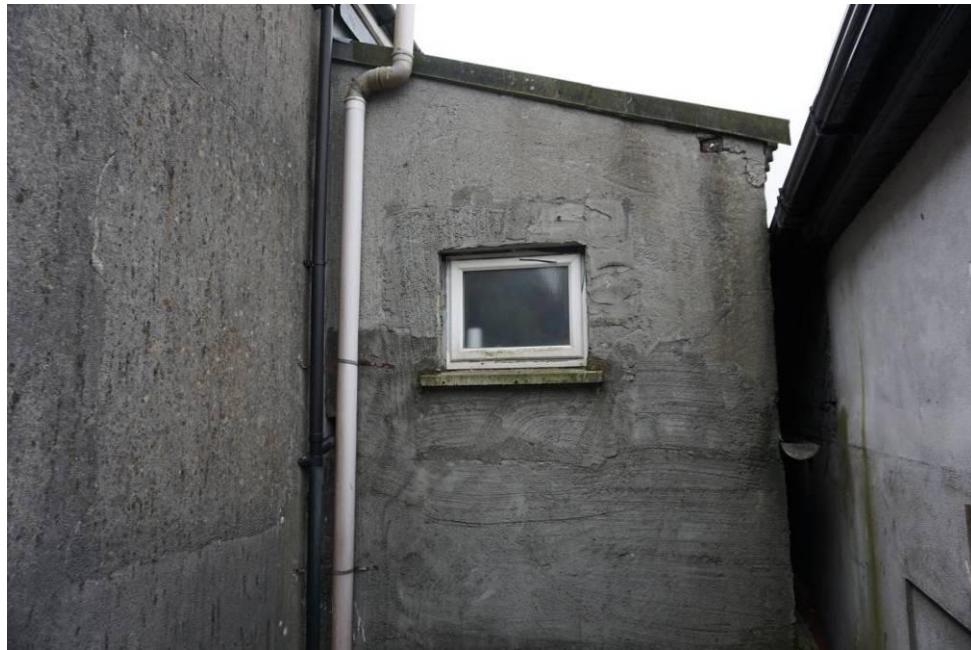
It is noted that the rear elevation externally is rendered with an inappropriate cementitious render. This render type is unsuitable for a building of this construction type. It is noted that there is a small section of a harling dash type lime render surviving beneath the alley way, this may be the original type of render applied to this building.

Photograph 14 Patchy render applied to the rear annex.

The general scope of recommended works to the rear external walls is the removal of this render and replacement of same with a Natural Hydraulic based render (possibly a harling dash finish).

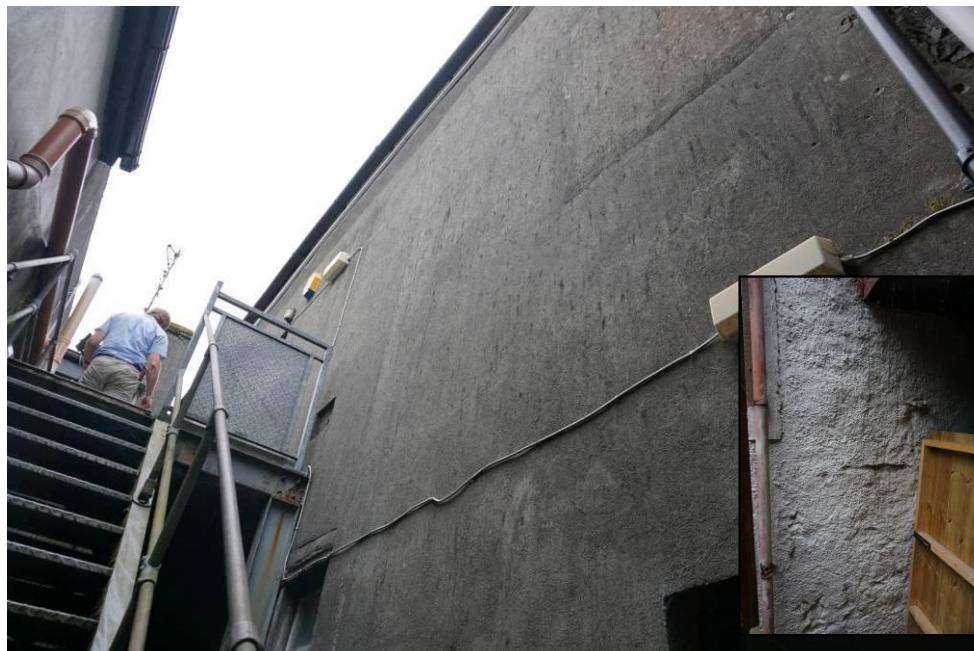
Photograph 15 General view of rear external wall with cementitious render applied. Inset: NHL render to wall beneath annex in alleyway.

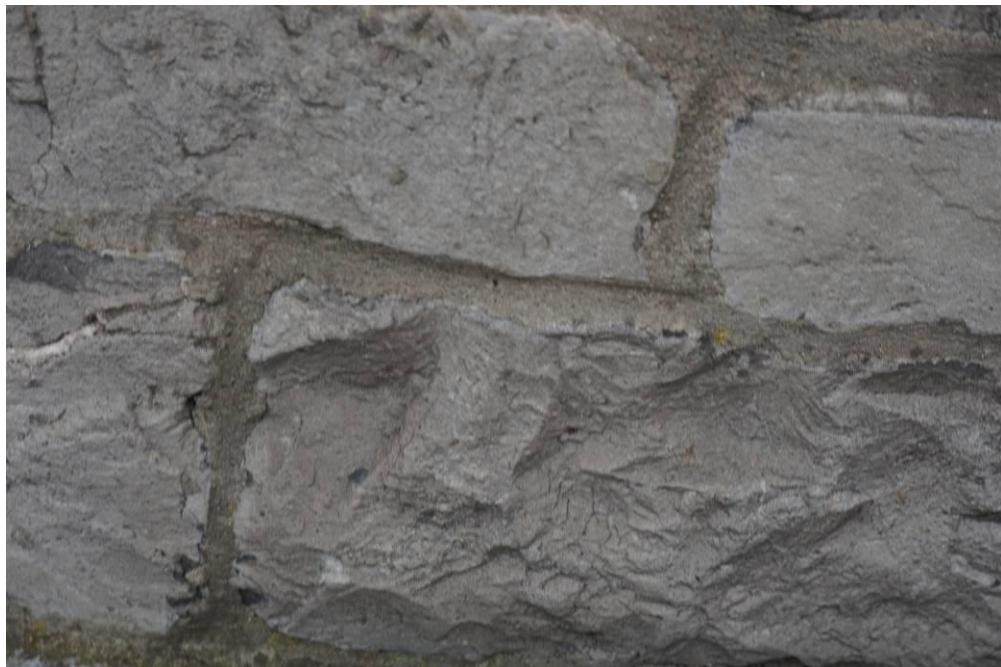
There are no major patent defects, from a structural perspective, noted on the day of inspection. The stone work has however been re pointed with an inappropriate cementitious mortar. There was also what appears to be a silicone or mastic used to point some of the stone work to the tower. The lead counter flashing to the tower is also sealed with this mastic, the lead itself incorrectly installed across the masonry rather than stepped, which should have been the case given the uniformity of the masonry units to the tower.

The use of cementitious mortar is problematic and completely inappropriate with this structure type and stone work in general. The use of a mastic type sealant to replace failed mortar joints in masonry is always inappropriate with any building type.

Photograph 16 Detail of the cementitious mortar pointing.

Generally, the recommended scope of works will entail the removal of the cementitious mortar pointing and the mastic pointing where present, carefully using hand held tools. On completion of the removal of the inappropriate materials the application of a Natural Hydraulic Lime based mortar pointing throughout the external stone masonry walls and the tower.

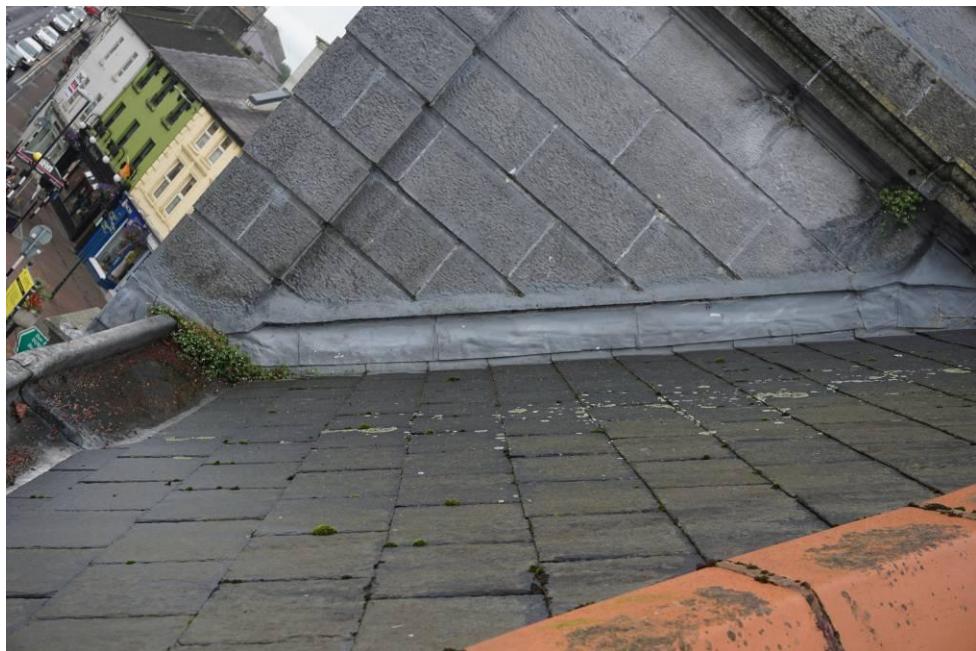
Photograph 17 View of flashing detail to the tower.

On the tower, the Rolled Lead Sheet Counter flashing should be removed and new counter flashing installed to the correct specification. The lead is currently installed across the masonry units.

These units are laid in even coursing, so the correct detailing here would be stepped Rolled Lead Sheet counter flashing.

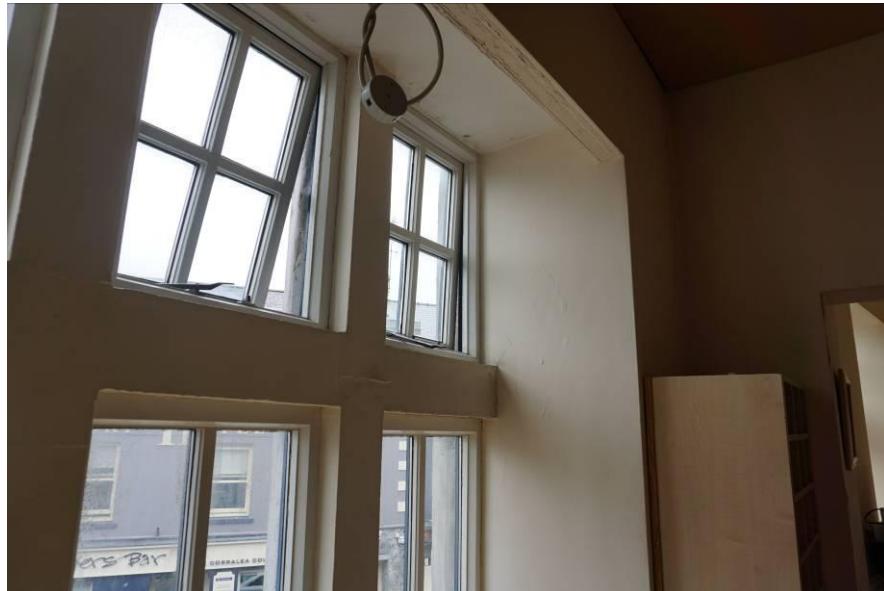
The main concern with the window assemblies mainly lies with the condition of the timber frames behind the inappropriate render applied internally and of course the poor DPC detailing mentioned earlier in this report.

Photograph 18 View of a First Floor Window assembly.

The recommended scope of works to the window assemblies is, generally, undertake the opening up works around the window frames, locally.

Carry out the careful removal of the paint finishes and putty to the glazing prior to the above. Undertake any necessary repairs to the timber in these locations, the areas that are usually most affected are around the timber cills, lower rails, meeting rails and lower sections of the timber frames.

Consideration as to the replacement of the glazing units (the units may be effective for a number of years to come, there was no sign of failure to the units on the day of inspection), application of new putty and draught stripping of the window opening leafs and painting to finish.

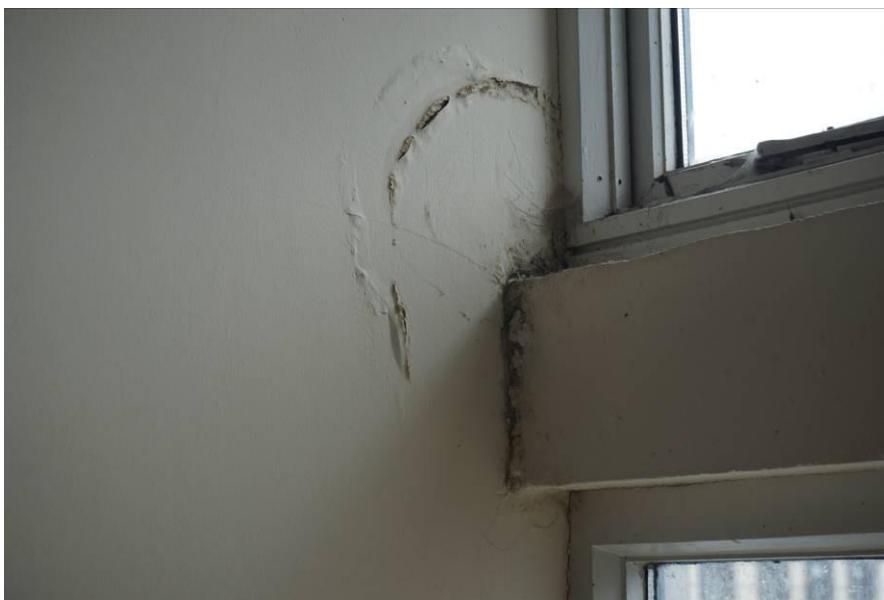
Photograph 19 Detail of centre mullion. Note signs of water ingress on window jamb.

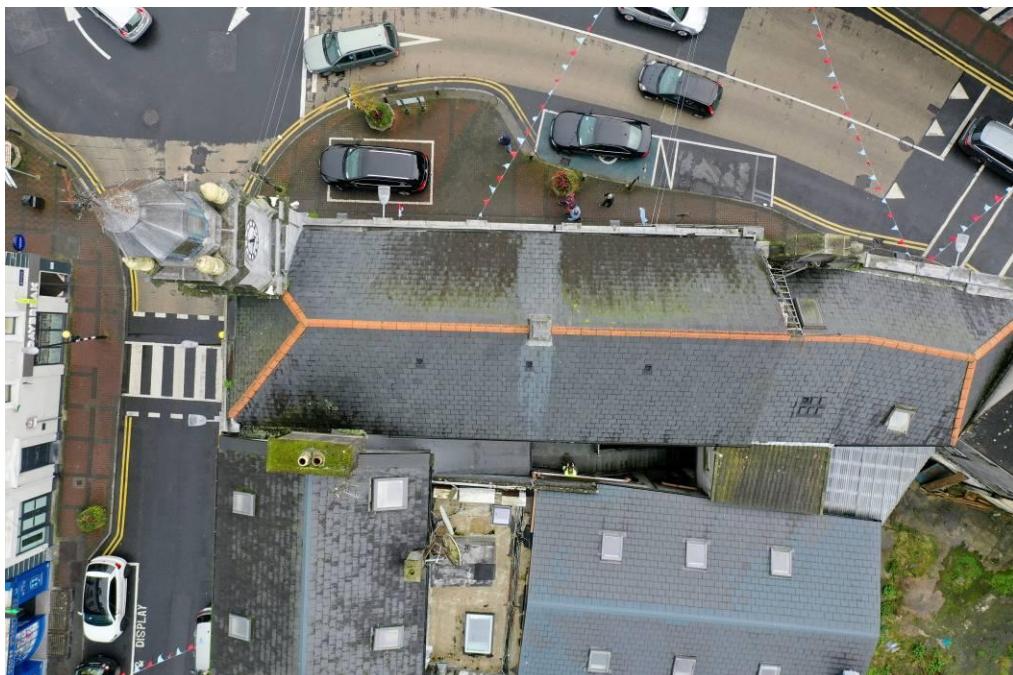
The slate covering to the roof, inspected in further detail by Small Unmanned Aerial Vehicle on the 19th of November 2021, was noted to be in a fair state of repair. There was 2 noted slate slippages to the Front Roof plane and the missing slate vents covers to the rear roof plane.

Photograph 20 Aerial view of the roof planes of Tuam Town Hall.

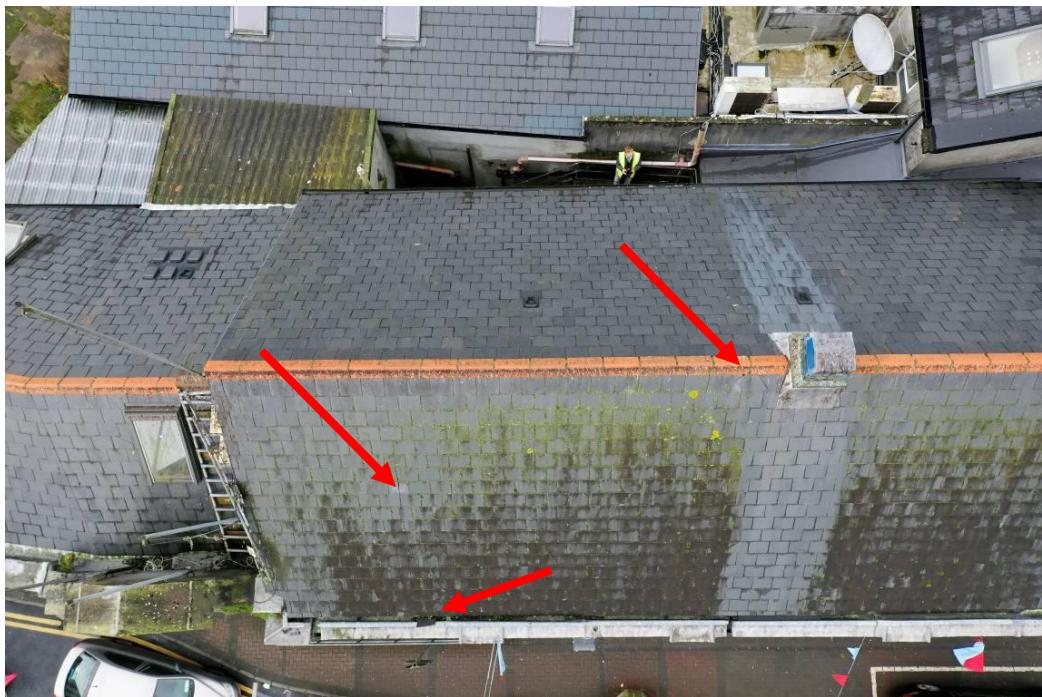
Photograph 21 View of a section of the front roof plane, slipped/failed slates highlighted.

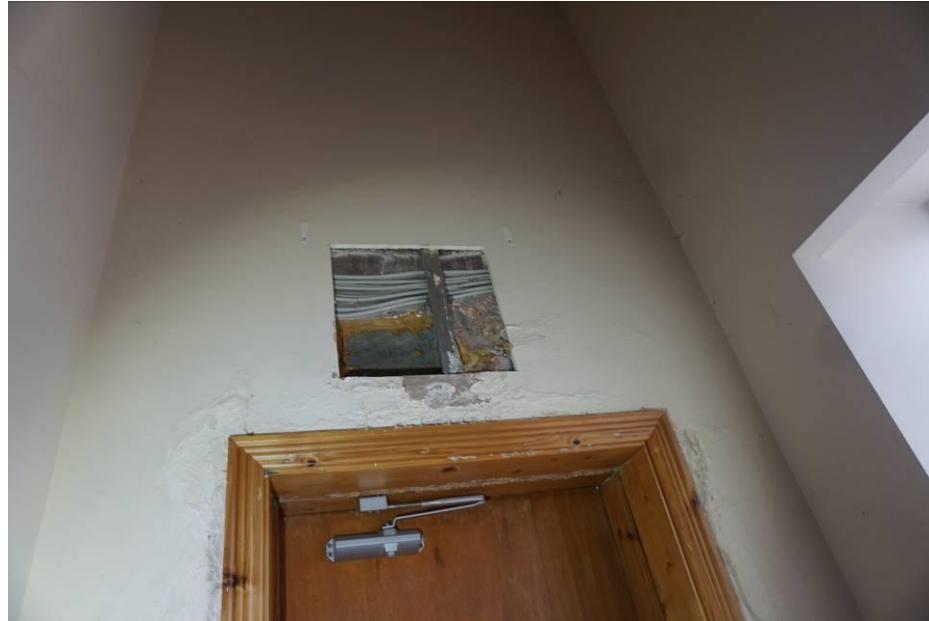
The opening found the fabric build up to be skimmed plaster slab onto metal stud wall system onto rendered internal masonry wall with fibreglass roll insulation between the metal partition sections. There were electrical services noted running across the opening location.

Photograph 22 View of investigative opening up panel. Note cable run.

Recommendation: Replace the defective sections of plasterboard around the door opening on a like for like basis and re skim the wall. Keep under observation thereafter.

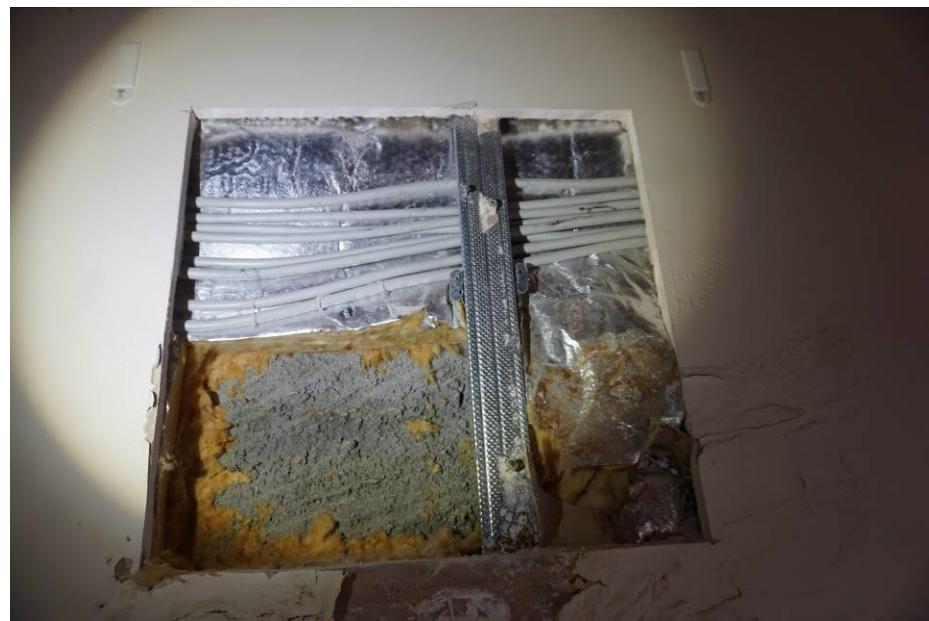
Photograph 23 Detail of the panel. Note adherence of the fiberglass to the render.

While the wall and external wall surface did show the results of past water ingress, there was no sign of active water ingress. The fibre glass was noted to have adhered to the wall, a sign that water ingress was prevalent in this location.

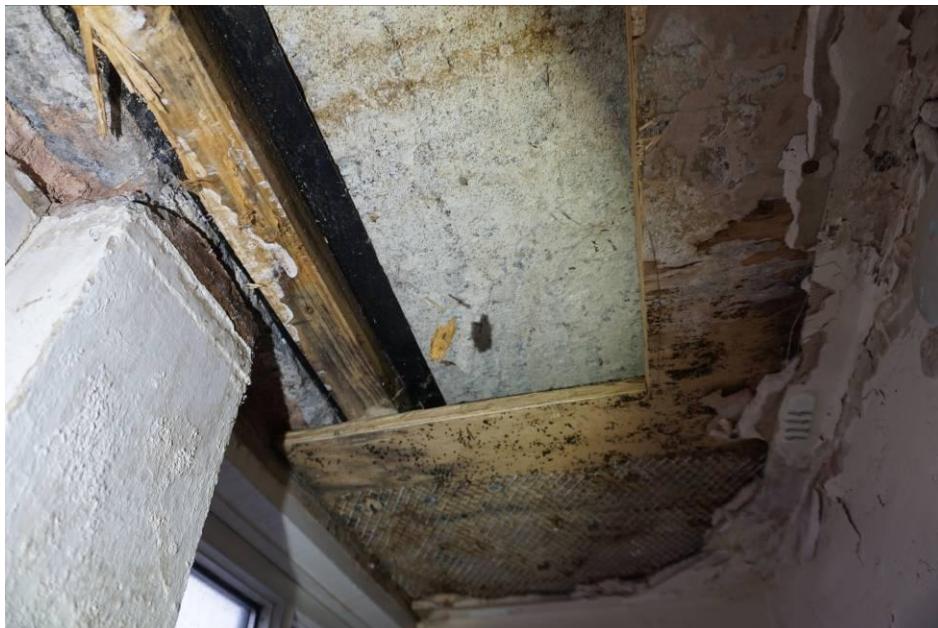
The fabric build up here was noted to be: Plasterboard with plaster skim finish on stainless steel mesh on plywood on timber battens on DPC fitted directly onto cast insitu concrete lintel.

The work here is noted to be completely modern, with the use of DPC questionable. The original lintels here were most likely a hard wood lintel such as oak or a durable soft wood such as Scandinavian slow grown pitch pine, with the main structural feature in the wall being a relieving arch spanning the opening.

Photograph 24 Detail of the opening up works to the window head.

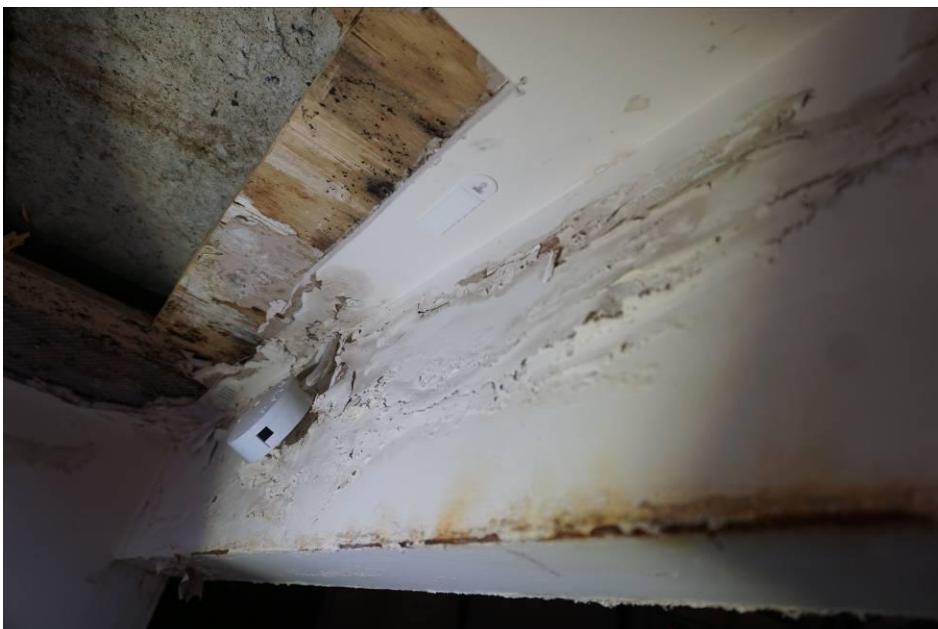
Photograph 25 Fabric damage from water ingress.

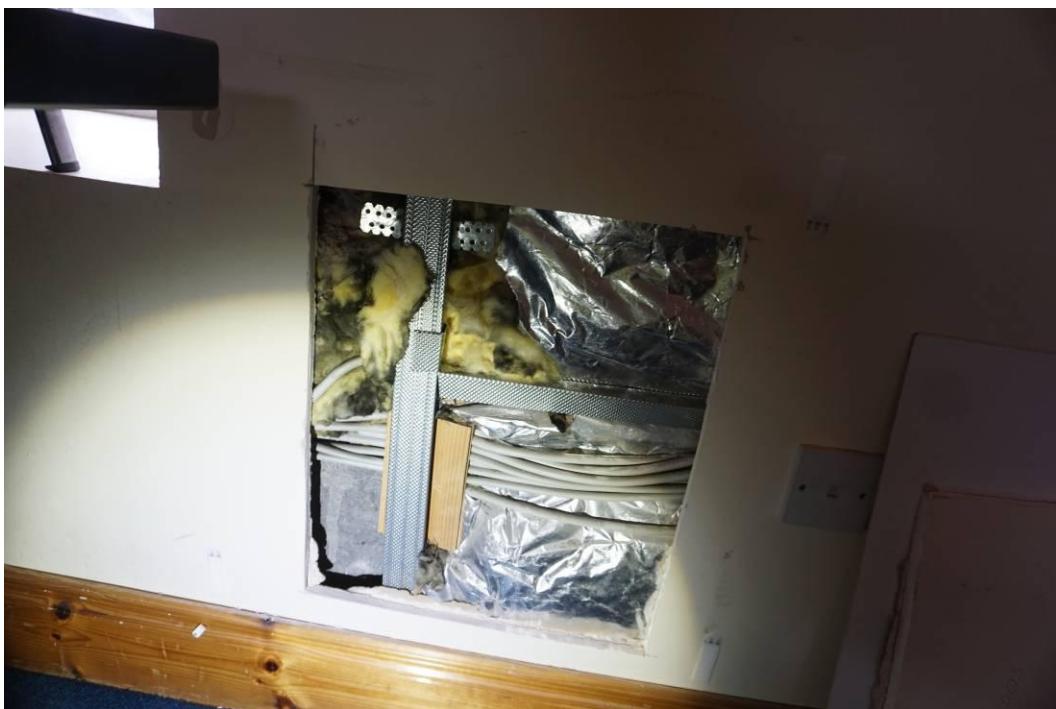
The fabric buildup here was noted to be Plasterboard with skim plaster finish on metal stud wall on rendered internal masonry wall with fibreglass roll insulation between the metal partition sections. There were electrical services noted running across the opening location.

Photograph 26 View of the investigate opening up to the wall surface.

The render applied to the internal surface of the external wall was noted to be a hard well set cementitious render. There were no noted condensation or water ingress issues here.

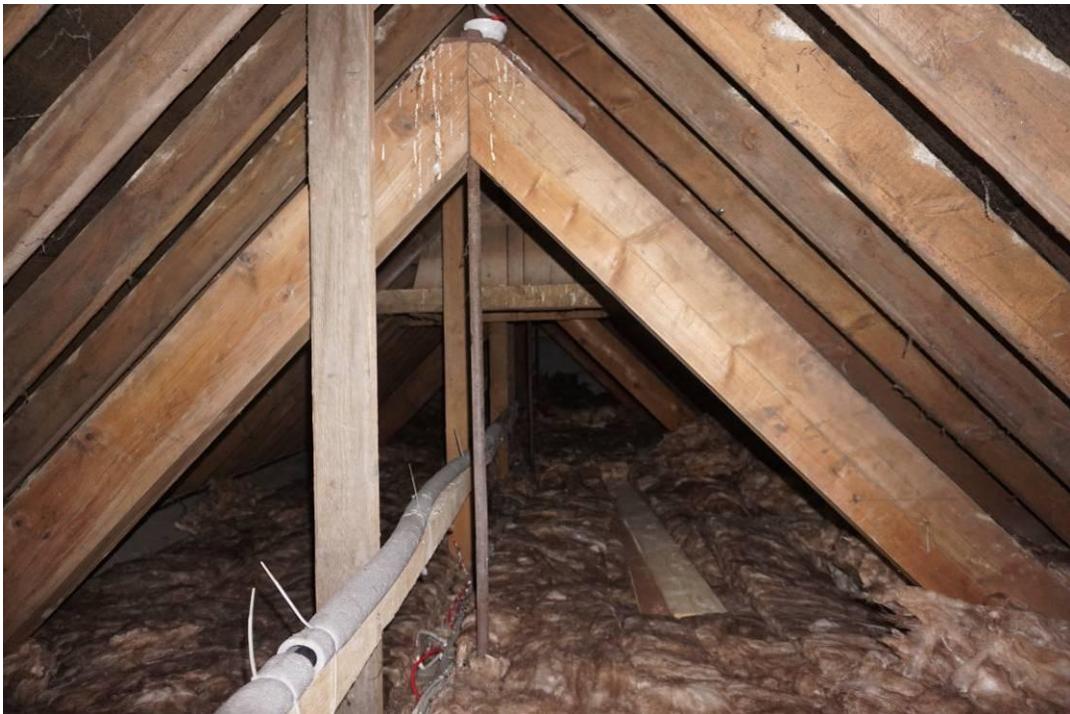
The roof space above the high ceiling was accessed by scaffold. The roof structure was noted to be in good repair. This is most likely the original replacement roof constructed around 1924 (evidenced by historic graffiti on the trusses and the known dates of the burning of the building).

Photograph 27 View of the roof structure above the high ceiling.

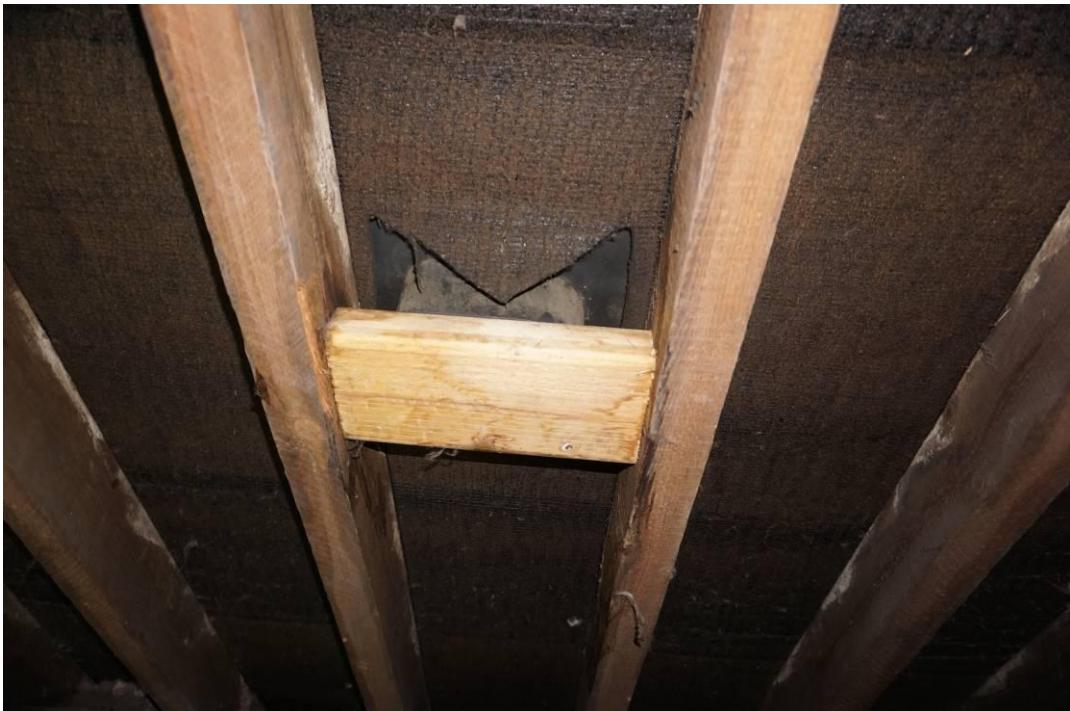
Photograph 28 Attempt to stop water ingress at a slate vent.

The only notable issue to the roof at present is the absent vent tile covers noted in an earlier section of this report.

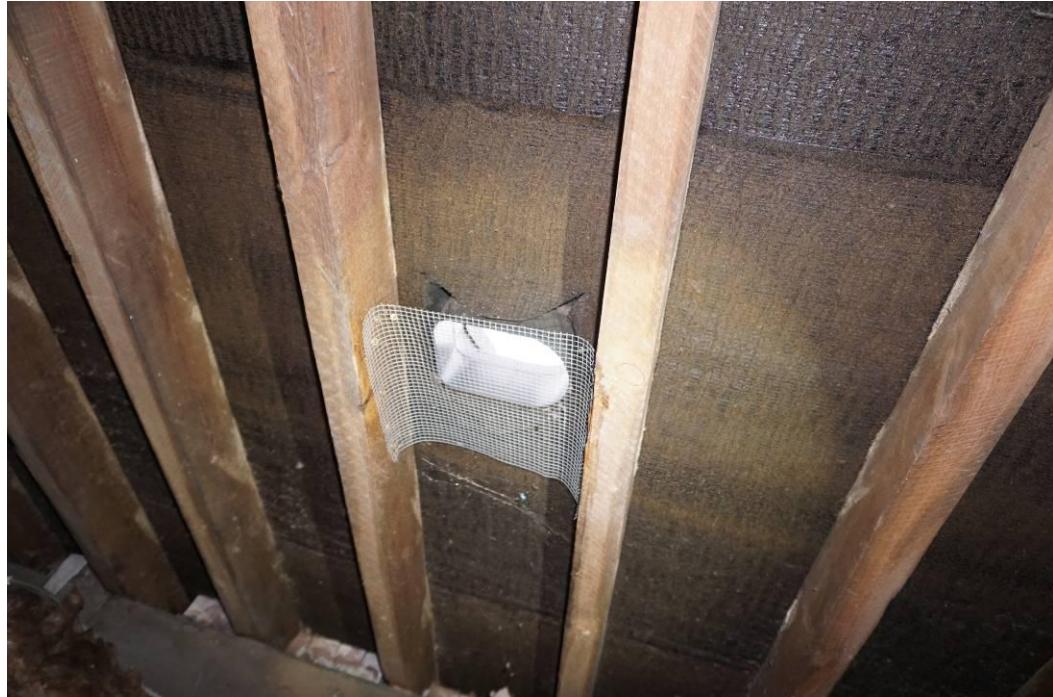
Photograph 29 Mesh applied across one of the vents.

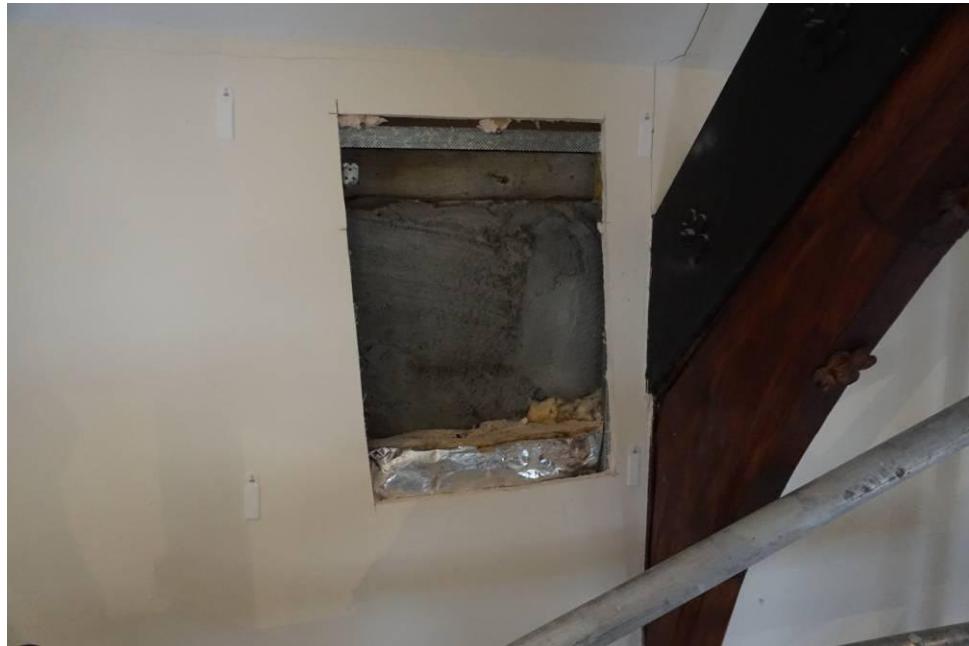
The fabric buildup was noted to be plasterboard with skim plaster finish on metal stud on cementitious render applied to the masonry wall. The location of the opening was at eaves, it was noted that the infill works undertaken were a mix and match of available materials e.g. an off cut of a window sill was recorded here.

Photograph 31 View of the investigative opening at eaves, by the truss.
