Building Conservation Assessment Report.

Tuam Town Hall
The Square
Tuam
Co. Galway
H54 XD61

Client:
Galway County Council

Date: 30th September 2021 (Revised on the 7th December 2021)

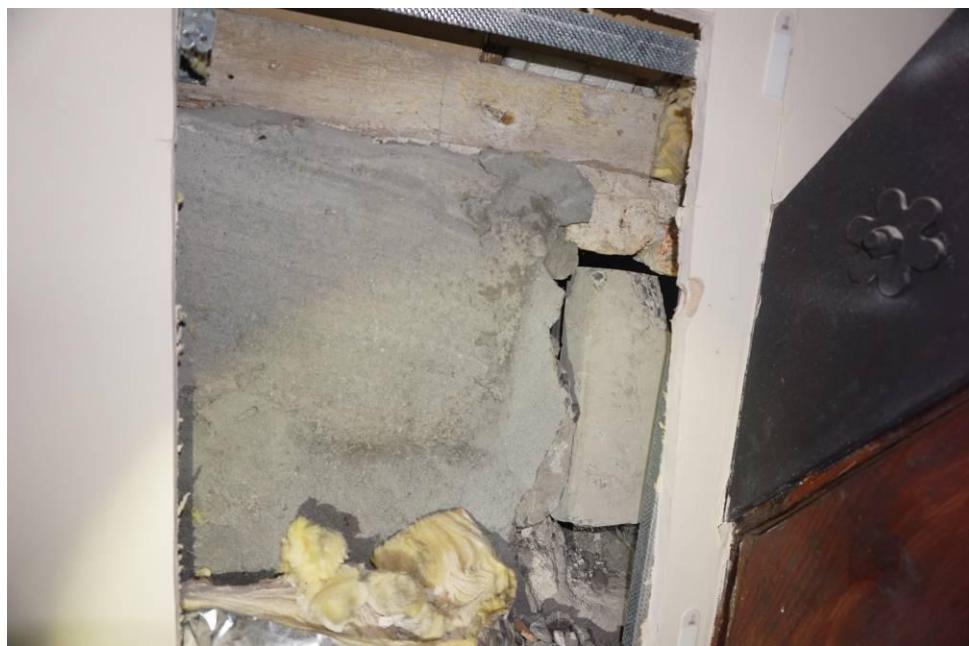
Photograph 32 View of mismatch of materials (off cut of a window sill).

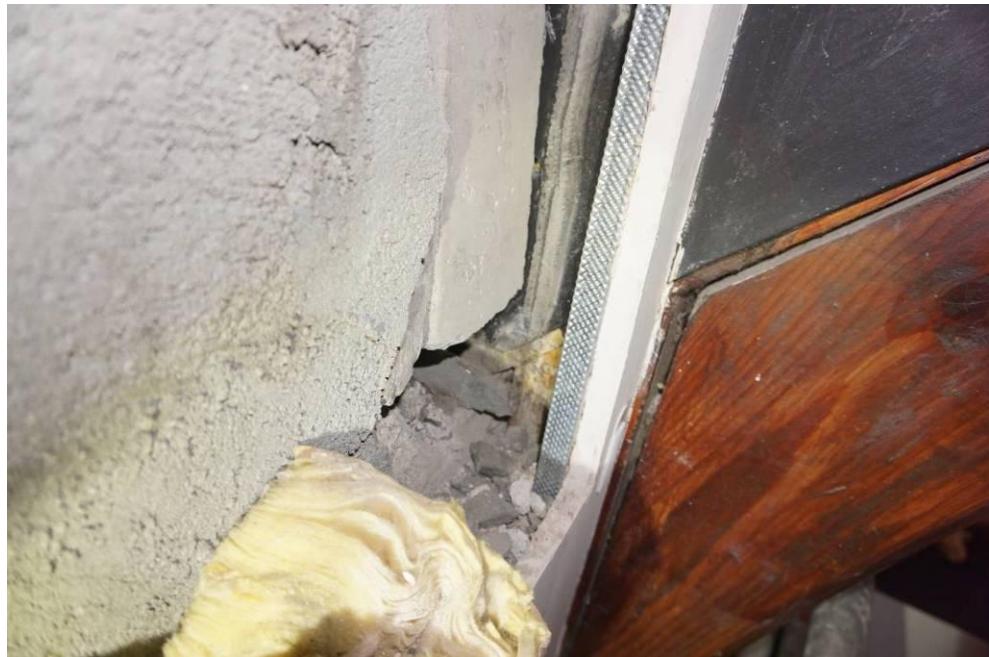
Photograph 33 View of the truss where fitted against the masonry.

The truss it self finished at the wall, there was no sign of any patent defect, with the wood passing the penetration tests.

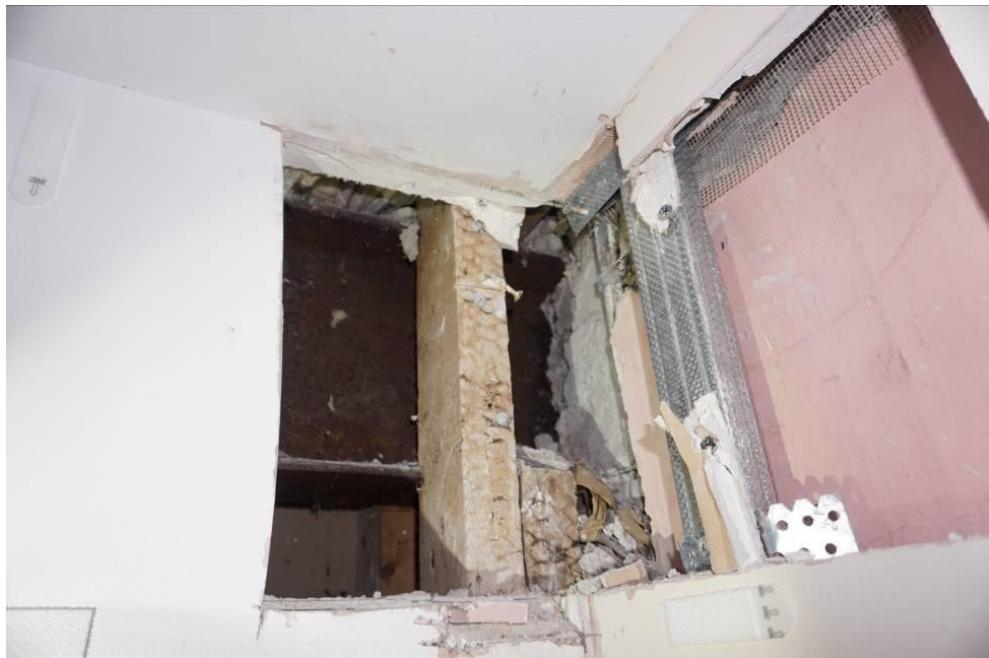
Photograph 34 View of the opening up investigative works to the ground floor ceiling.

The fabric build up was noted to be plasterboard slabs (double slabs) with plaster skim finish on timber batten formwork on Rolled Steel Joist beam. The fabric build up of the wall was plasterboard with plaster skim finish on metal stud partition on rendered masonry wall (original render and plaster intact, probably from the rebuild).

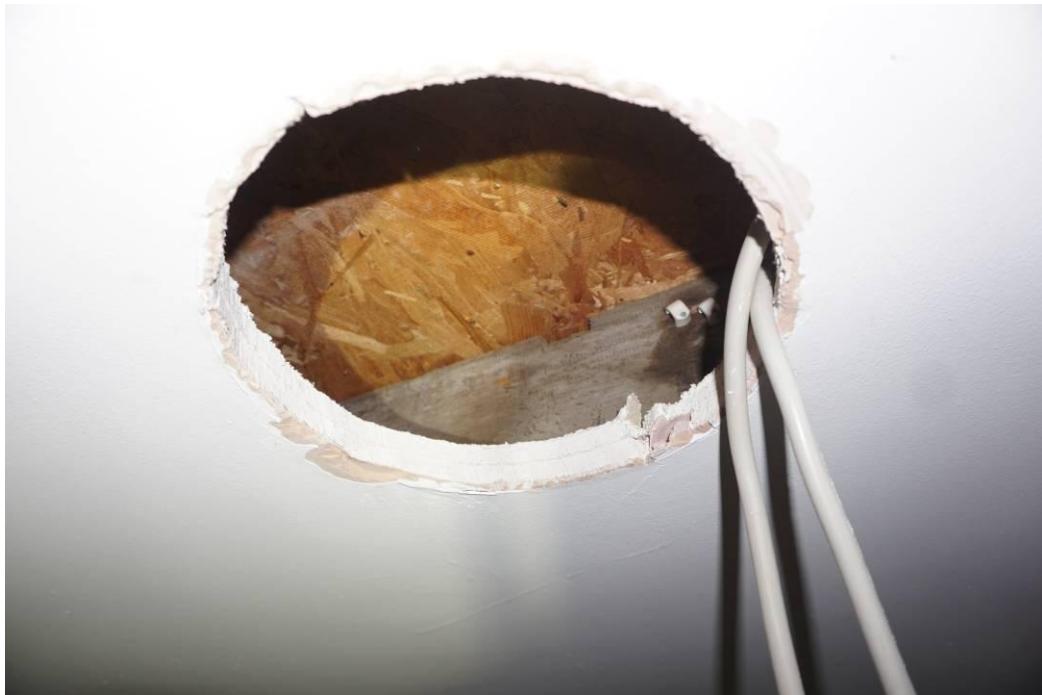
Photograph 35 Penetration for the light fitting.

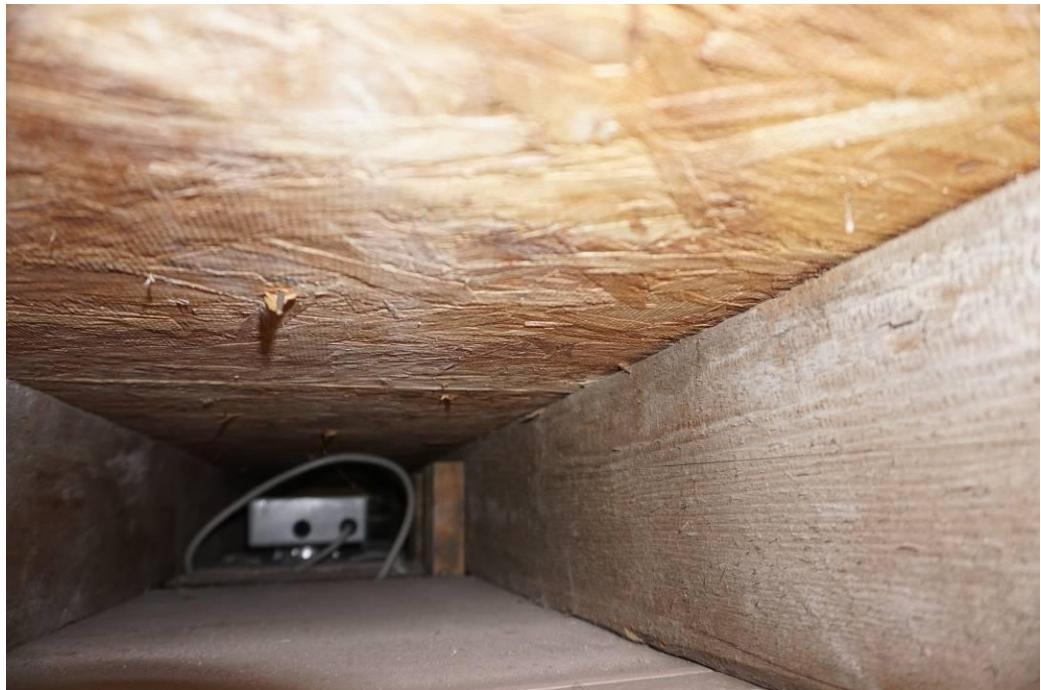
Photograph 36 View of junction box within ceiling void.

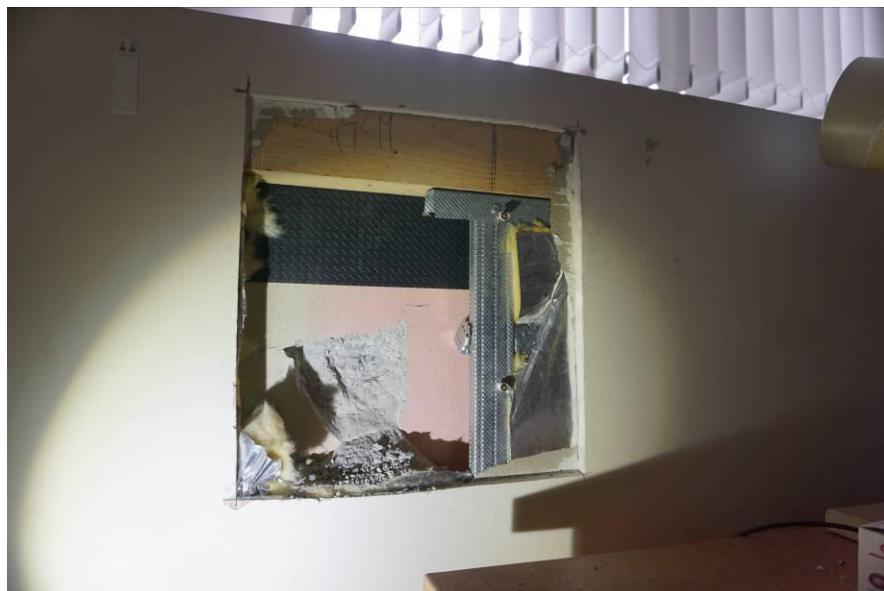
The buildup of the fabric for this investigative opening up location was: Plasterboard Slab on metal stud with foil back fibreglass insulation infill on rendered masonry wall (the render here was noted to be older than that observed on the first floor, a cementitious render with heavy lime content dating it from anytime after the mid twentieth century, or earlier, but certainly post the fire of 1920). At the meeting point of the wall and splay to the window, a timber member is installed with a DPC underneath.

Photograph 37 Investigative opening on the ground floor.

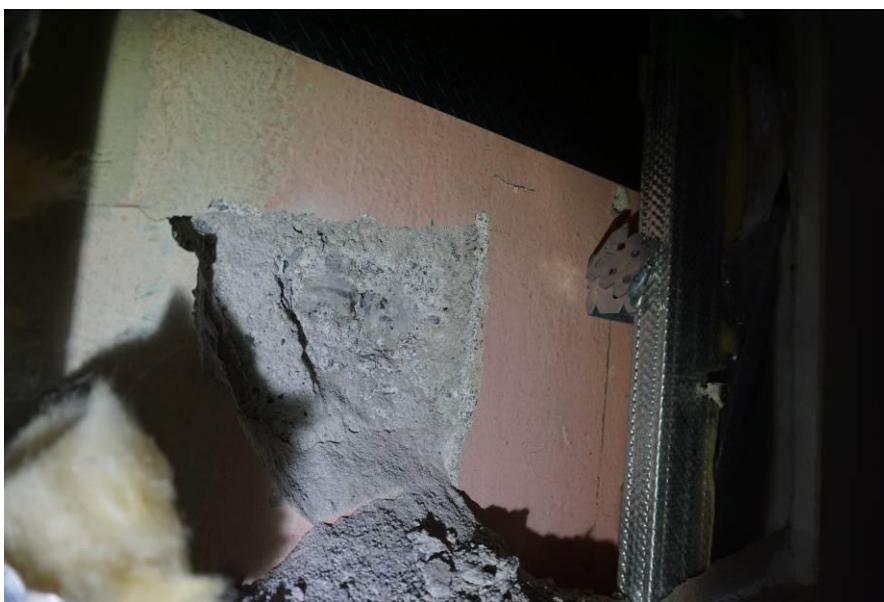
Photograph 38 Opening made to the render, a lime rich cementitious render.

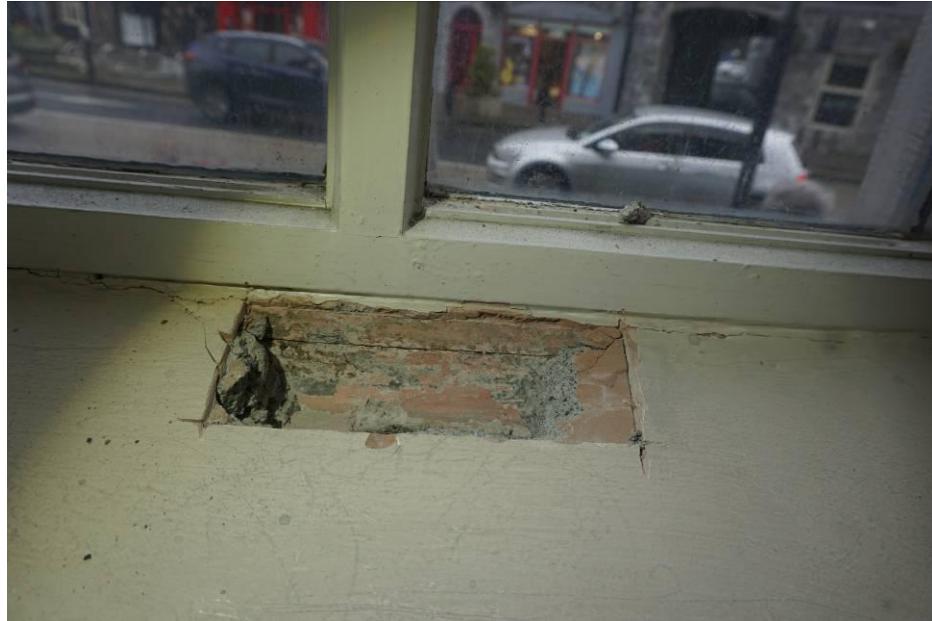
Photograph 39 View of investigative opening up at the window frame, top of window sill splay.

A further opening was made by the window frame to the top of the splay, the same type render was observed here. The frame looked to be in good repair.
