**BAT AND SWIFT SURVEYS AT DUNLO HILL
TERRACE, DOOLEY'S PUB AND ADJOINING
PROPERTY, BALLINASLOE, CO. GALWAY**

Structure: Dunlo Hill Terrace, Dooley's Pub + Adjoining 3 storey house

Proposed Works: Renovation to residential units

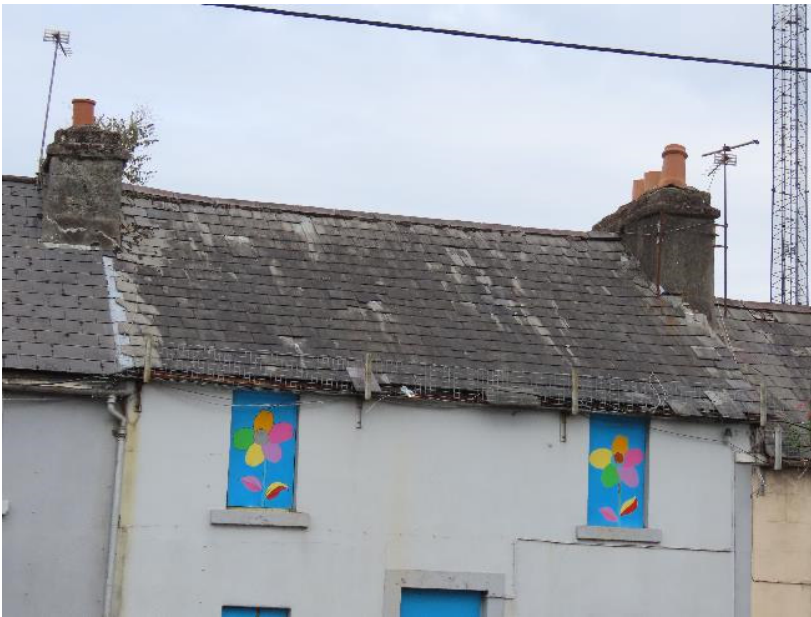
Many of the roofs of the cottages in the terrace are in poor structural repair with numerous missing slates. Holes in the roofs have allowed the ingress of water, leaving ceilings below in poor condition. The roof of P. Dooley's pub and the adjoining building are in good structural repair.

Photo 4 - Property 4 – showing poor condition of roof. Wire slate guard in place to catch falling slates

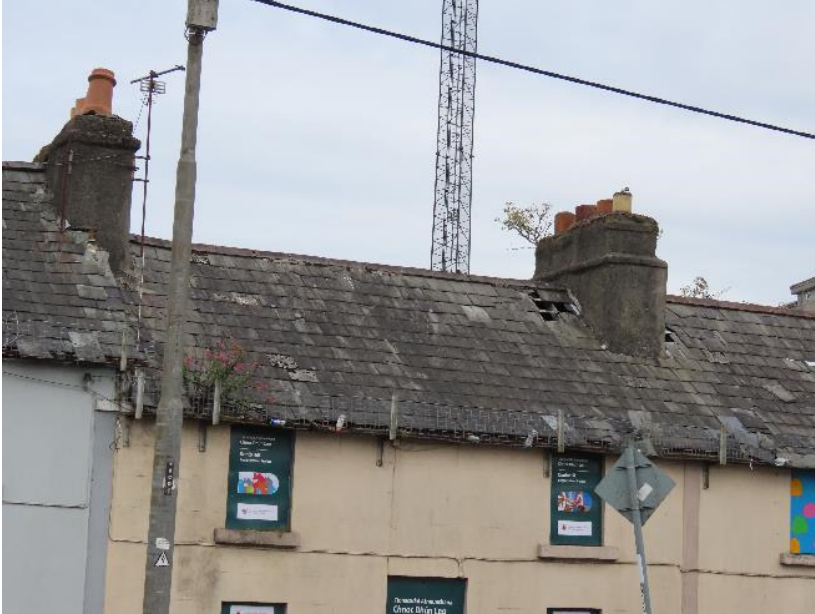
Photo 5 - Roof of Property 5 with hole around chimney stack

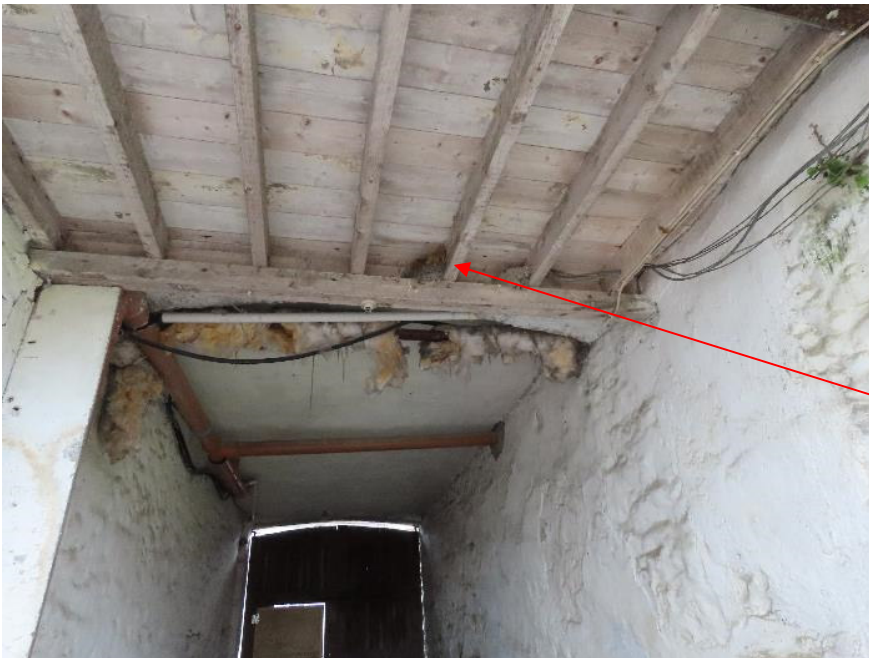
Photo 9 – access to rear of building via archway between Dooley's pub and Dunlo Hill terrace. Several swallows' nests were recorded on roof timbers

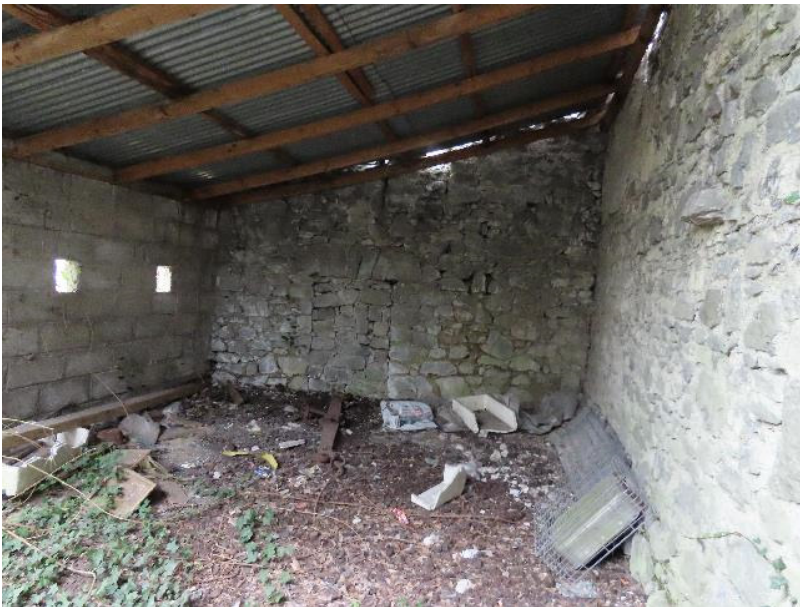
Photo 15 – Lean-to stone shed to rear of westernmost property in Dunlo Terrace. This building was considered to have potential as a bat roosting site

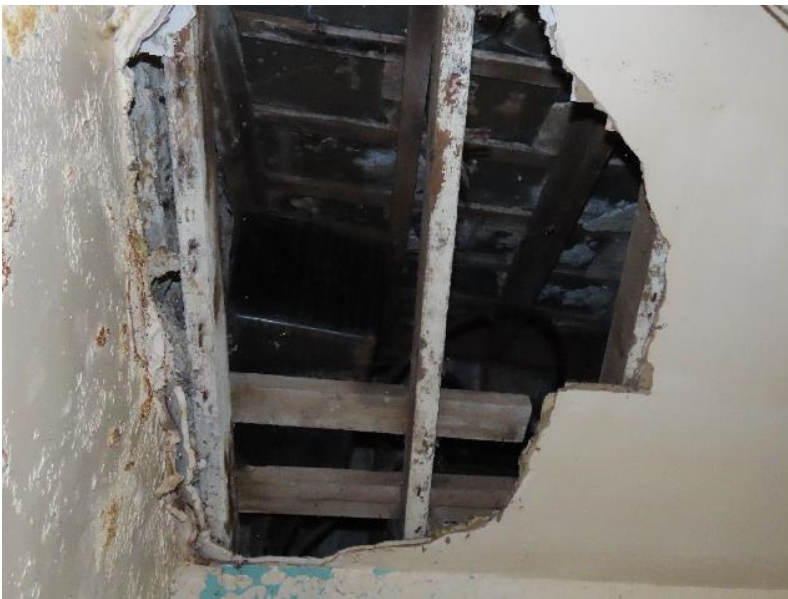
Photo 21 - Hole in upstairs ceiling of Property 1 in Dunlo Terrace

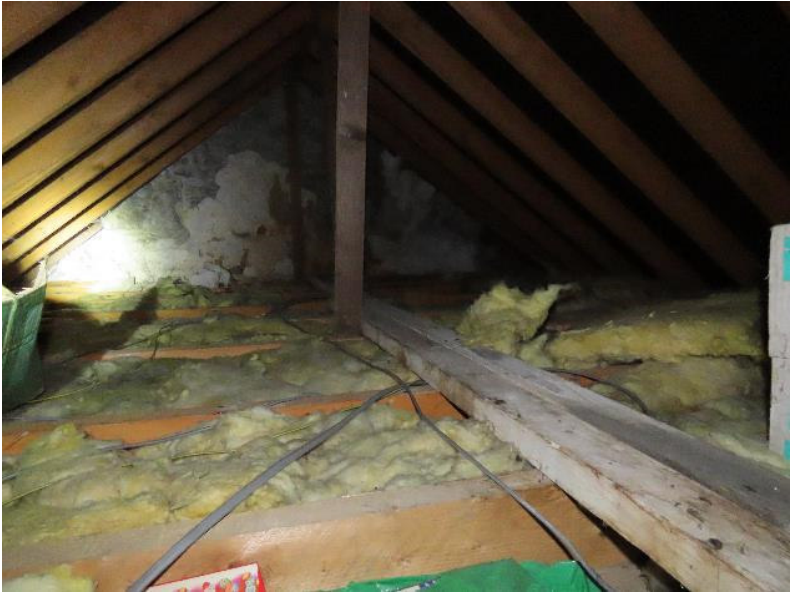
Photo 27 - Attic space of Property 3. No evidence of usage by bats

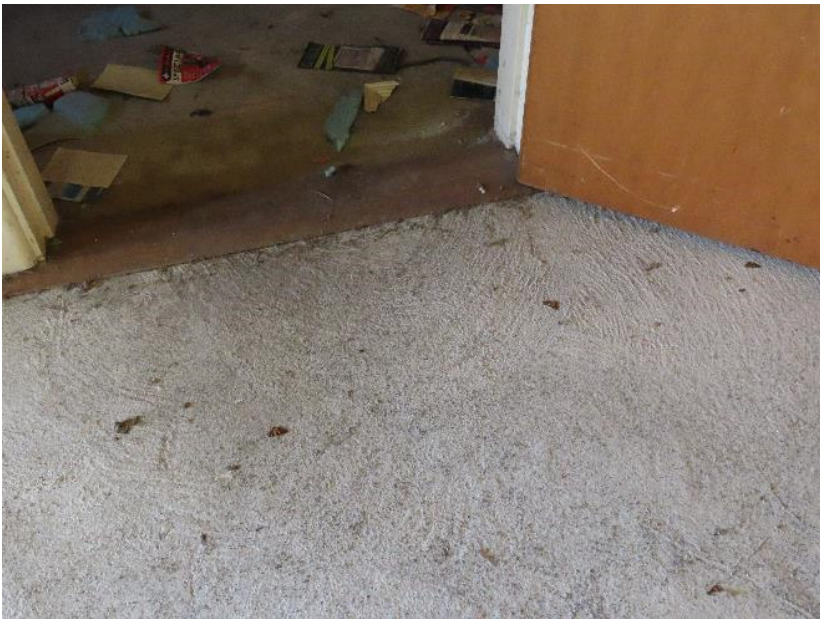
No bats or signs of bats were recorded in any of the nine buildings or in any of the outbuildings to the rear. A small number of butterfly wings were recorded on the floor of Property 3 which may be the feeding remains of a single Long-eared bat. No bat droppings were recorded. It was possible to access the attic spaces of all nine buildings. There were no accumulations of droppings anywhere in the buildings or outbuildings.

Photo 29 - Floor of Property 3 with some butterfly wings and a few droppings of Brown long-eared bat. Used as a feeding perch by a single bat

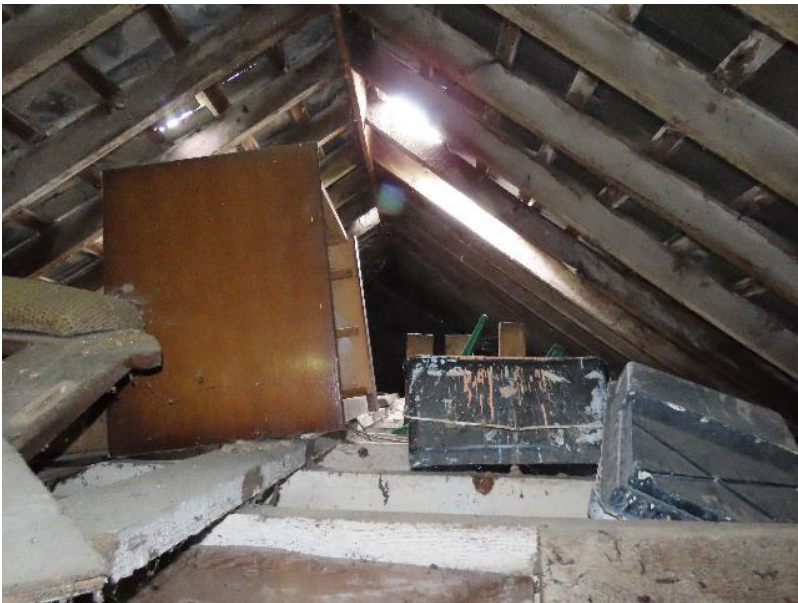
Photo 33 - Attic of Property 4 with void in roof

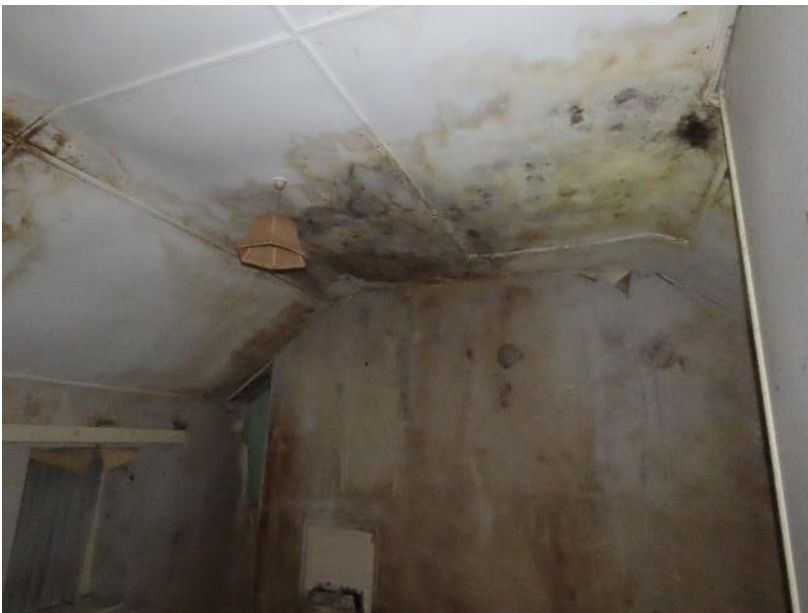
Photo 36 – damage caused by water egress in property No 6

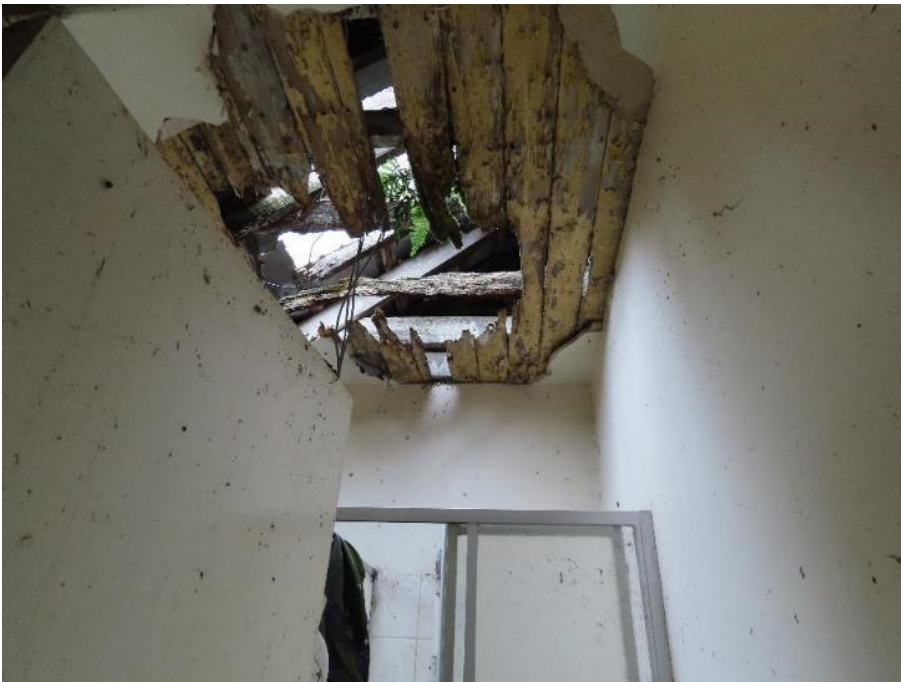
Photo 38 – damage to ceiling in Property 6

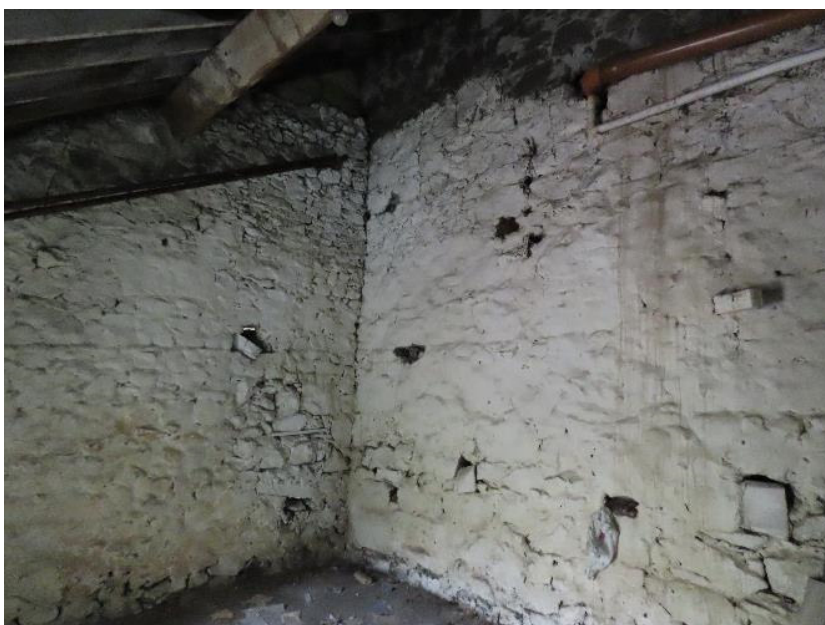
Photo 44 - stone shed to rear of Dooley’s pub. This shed was considered to have potential as a roosting site for bats

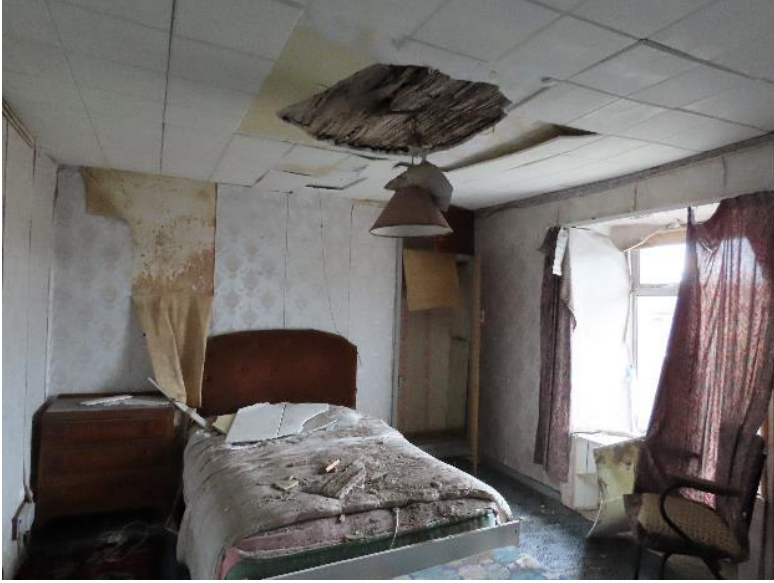
Photo 57 – bedroom with damaged ceiling

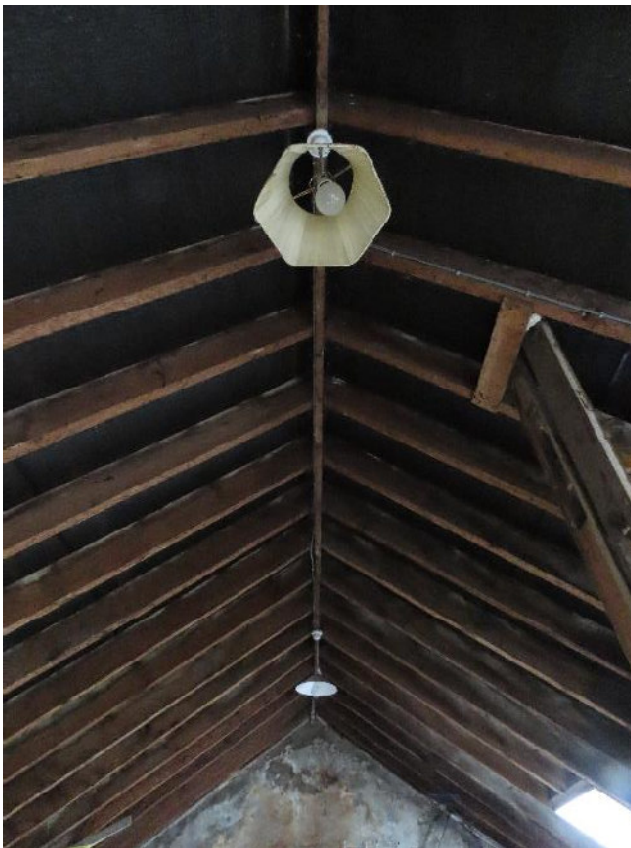
Photo 60 – exposed timbers in attic space – no evidence of bats

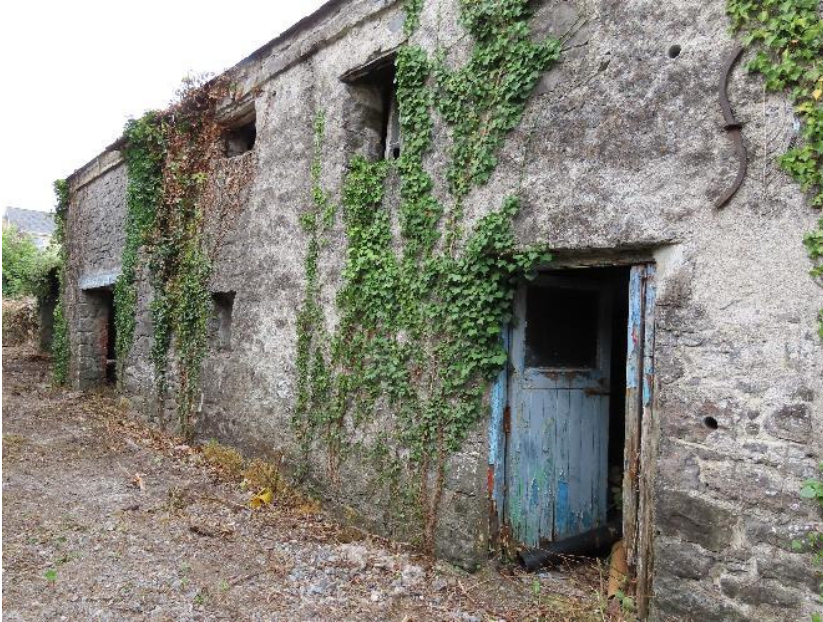
Photo 61 – stone outbuildings to rear of Property 9. These buildings were considered to have the greatest potential for roosting bats but no bats were recorded
