Asbestos Survey Report

(Refurbishment / Demolition Survey)

Ref No: HI15576

Location: Dunlo Hill, Townparks, Ballinasloe, Co. Galway

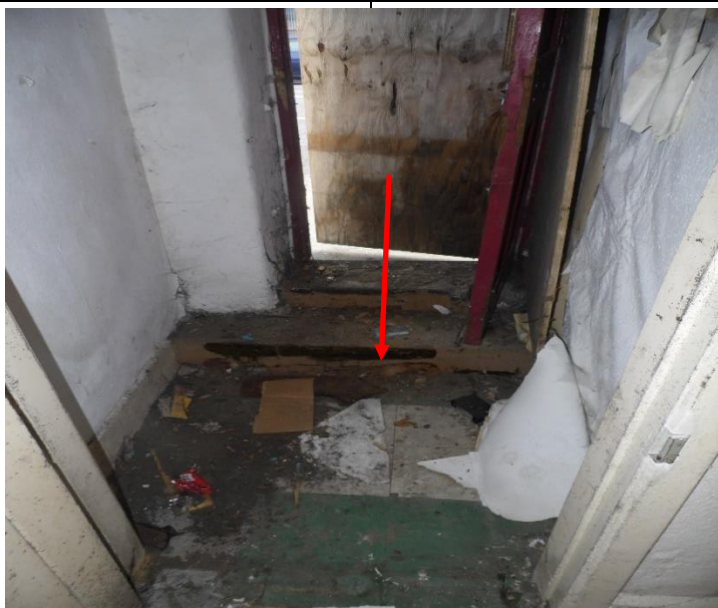
Room/Section: Terraced House #2
 Description: Vinyl Floor tiles and adhesive
 Sample Location: Small hallway inside front door entrance
 and around fire place in living area

Sample no(s): BS196143
 Amount: approx. 1 sq.m
 Access: Access to sample

Asbestos Type: **Chrysotile**
 Surface Treatment: **Reinforced composite and well bound material**
 Product Type: **Vinyl Floor tiles**
 Condition: **Poor**
 Material Assessment Score: **5(Low Risk)**

Recommendation: Removal Prior to demolition/Refurbishment taking place.

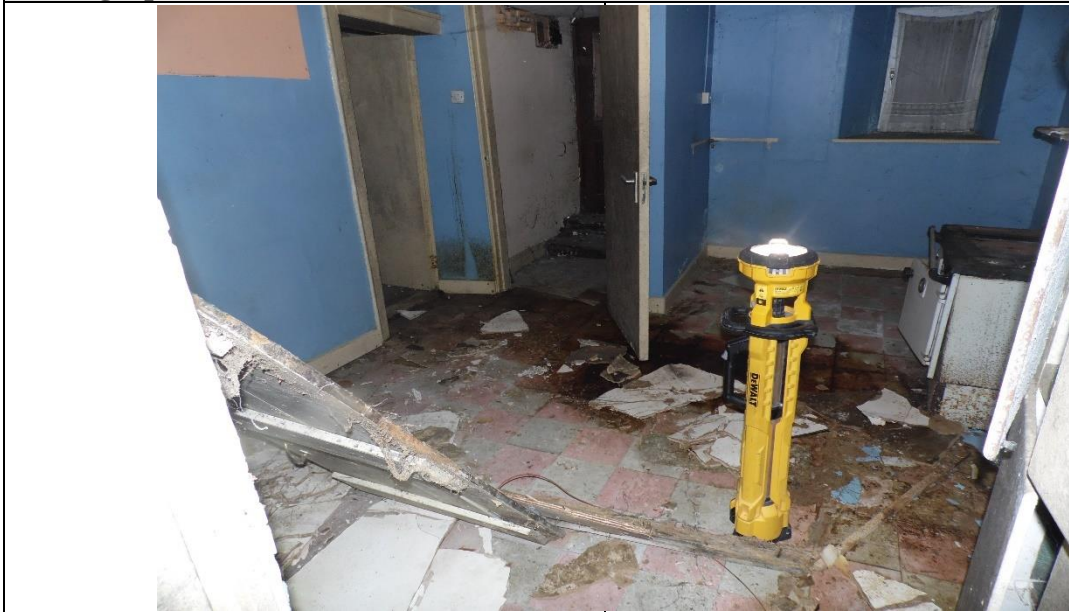
Room/Section: Terraced House #6
Description: Vinyl Floor tiles
Sample Location: Downstairs living area

Sample no(s): BS196147
Amount: approx. 16 sq.m
Access: Access to sample

Asbestos Type: **Chrysotile**
Surface Treatment: **Reinforced composite**
Product Type: **Vinyl Floor tiles**
Condition: **Poor**

Material Assessment Score: **5 (Low Risk)**

Recommendation: **Removal Prior to demolition/Refurbishment taking place.**

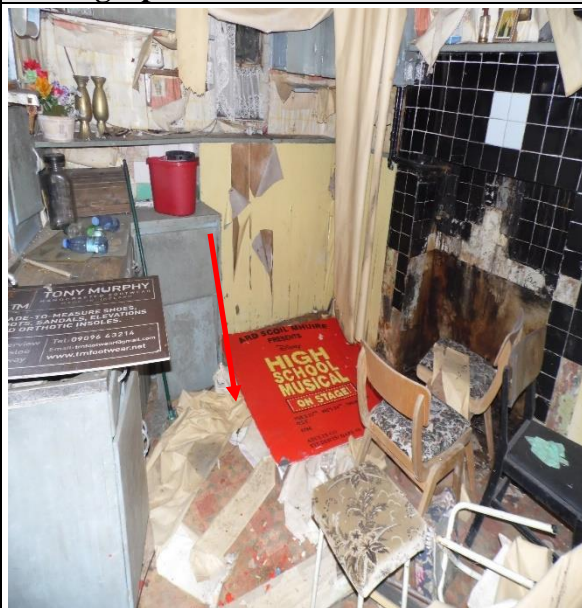
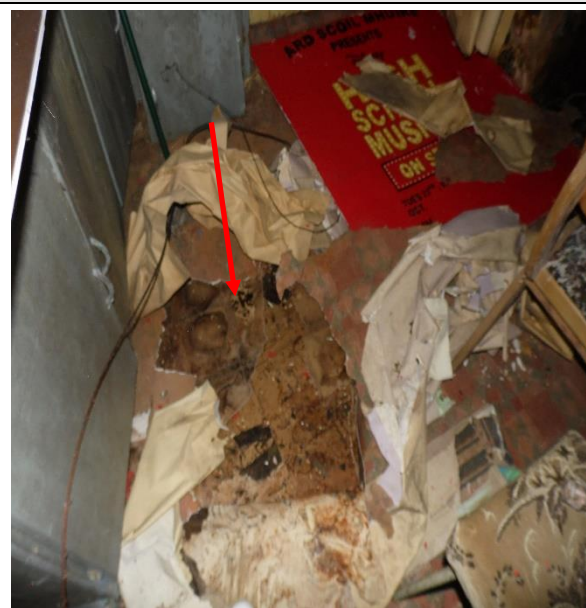
Room/Section: Townhouse (beside Dooleys) single storey extension to rear
Description: Vinyl Floor tiles
Sample Location: Kitchen

Sample no(s): BS196138
Amount: approx. 10 sq.m
Access: Access to sample

Asbestos Type: Chrysotile
Surface Treatment: Reinforced composite
Product Type: Vinyl Floor tiles
Condition: Poor
Material Assessment Score: 5 (Low Risk)

Recommendation: Removal Prior to demolition/Refurbishment taking place.

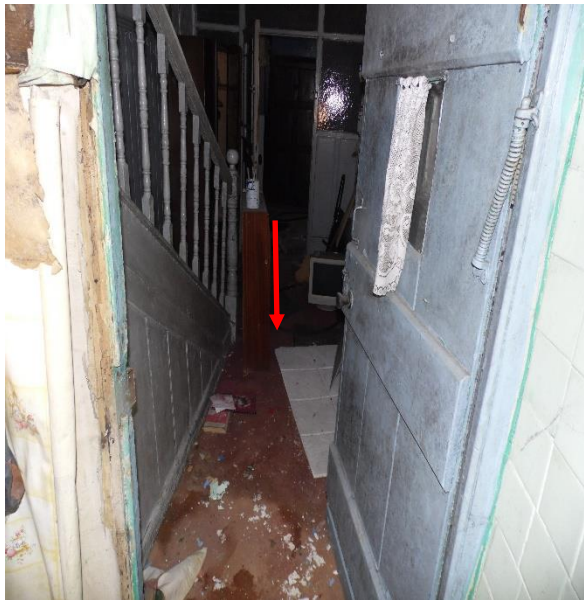
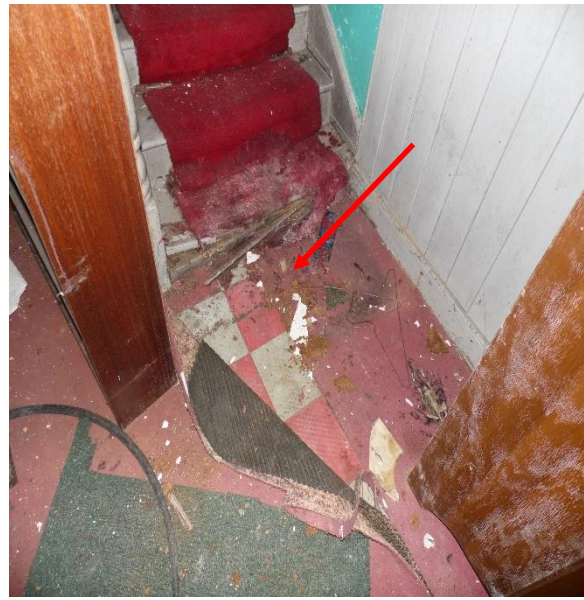
Asbestos Type: Chrysotile
Surface Treatment: Reinforced composite
Product Type: Vinyl Floor tiles
Condition: Good condition
Material Assessment Score: 3 (Low Risk)

Recommendation: Removal Prior to demolition/Refurbishment taking place.

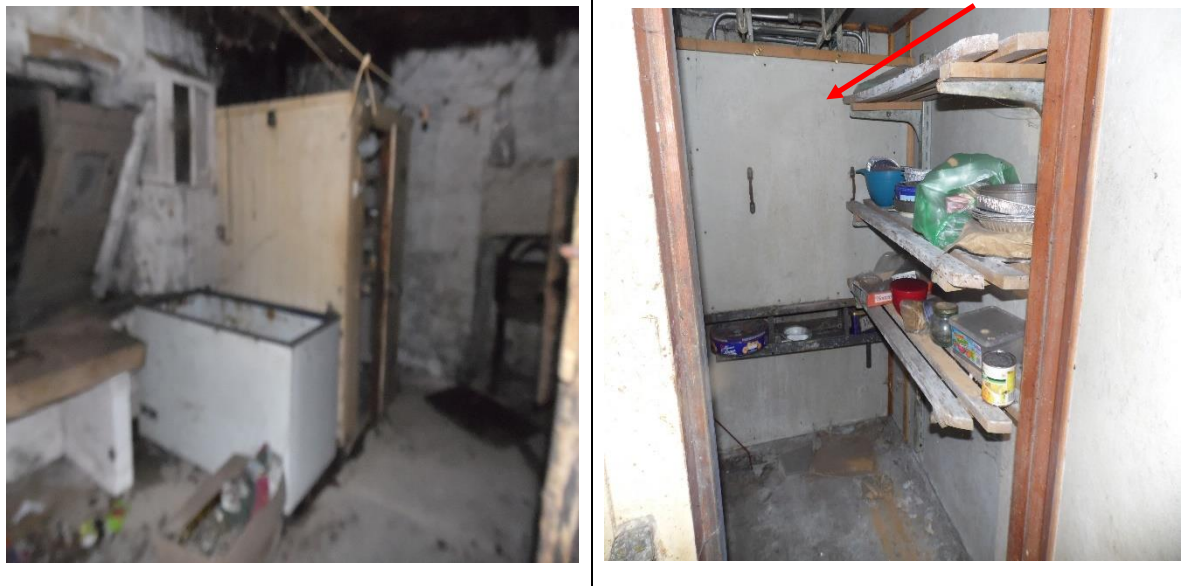
| Material Assessment | Score: |
|--|---|
| Condition: Good condition | 0 |

| Material Assessment | Score: |
|--|---|
| Recommendation: Removal Prior to demolition/Refurbishment taking place. | |

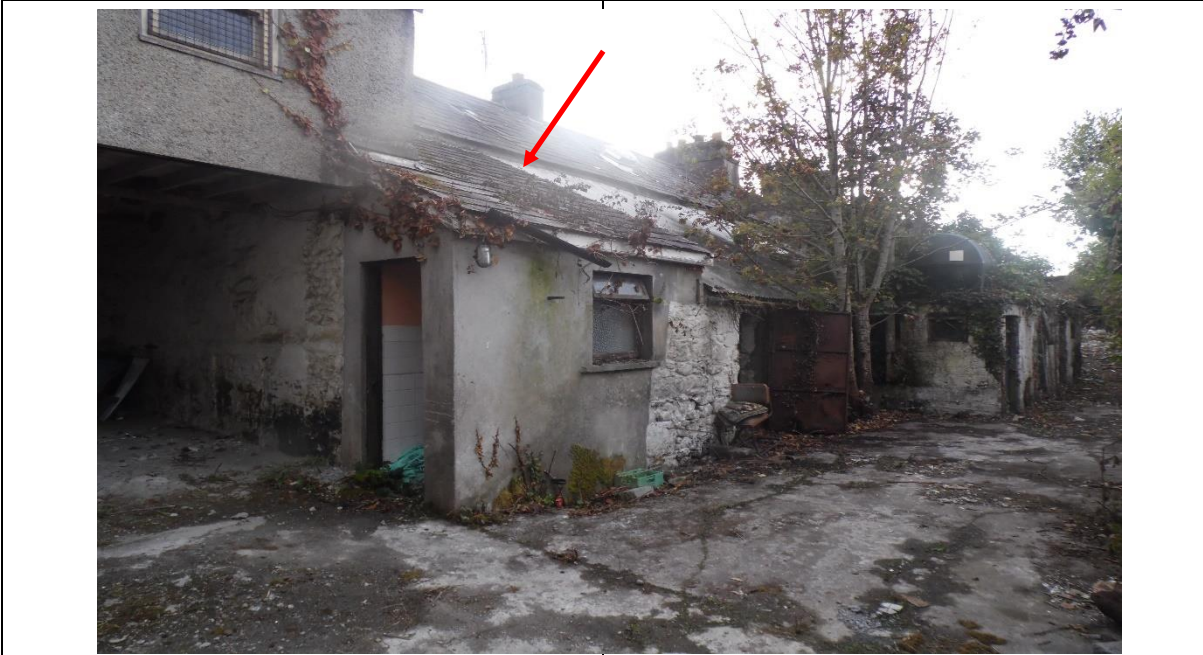
| Material Assessment | Score: |
|--|---|
| Condition: Good condition | 0 |

| Material Assessment | Score: |
|--|---|
| Recommendation: Removal Prior to demolition/Refurbishment taking place. | |

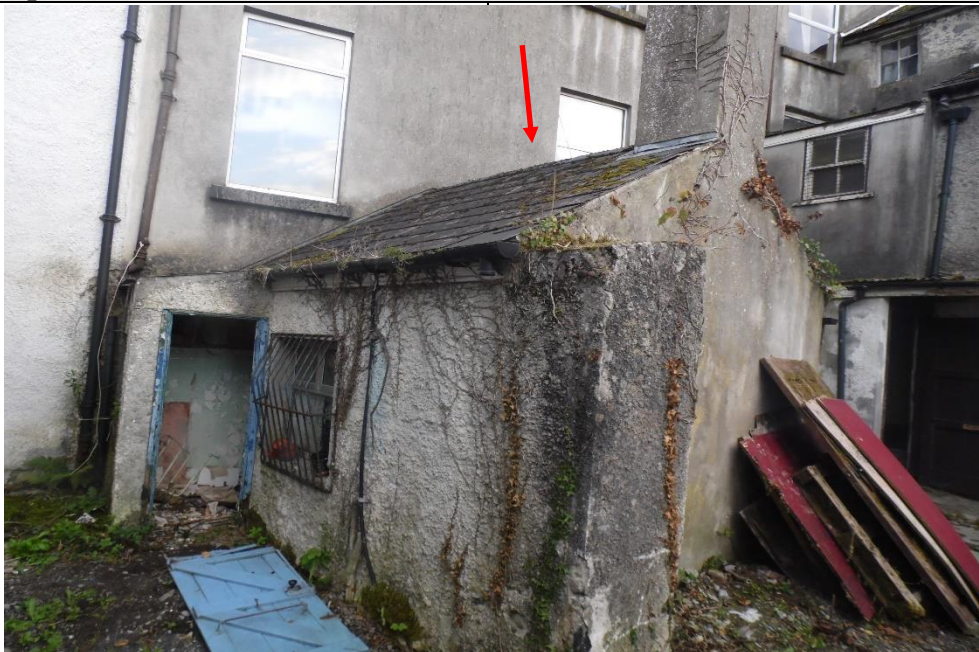
Asbestos Type: **Chrysotile**
Surface Treatment: **Asbestos Cement**
Product Type: **Roof Slates**
Condition: **Good condition**

Recommendation: Removal Prior to demolition/Refurbishment taking place.

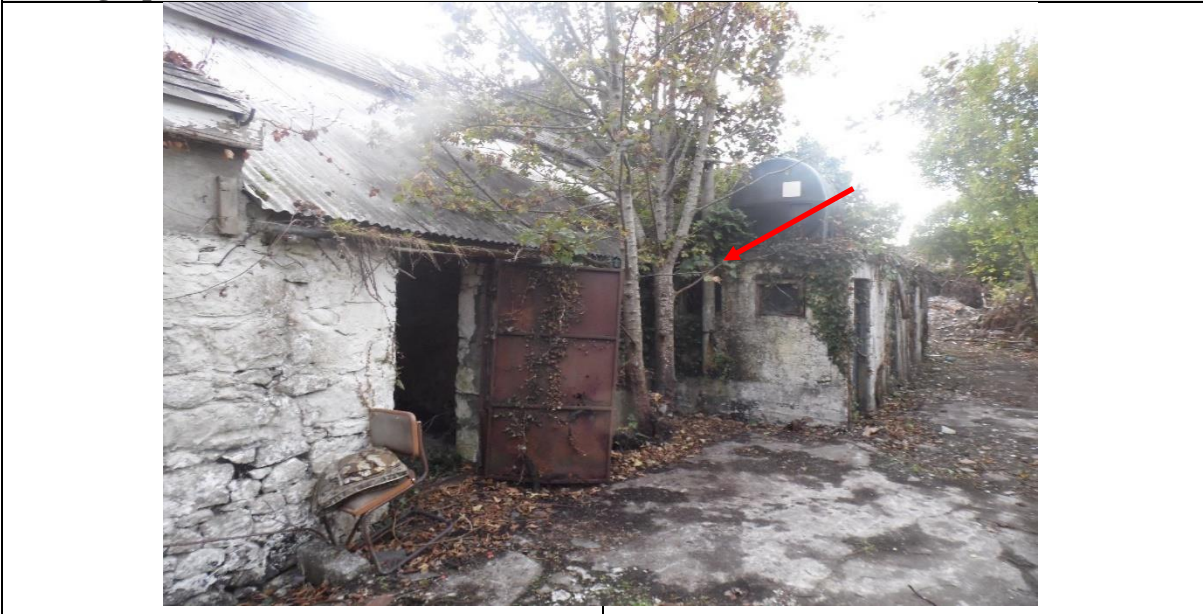
| Material Assessment | Score: |
|--|---|
| Condition: Good condition | 0 |

| Material Assessment | Score: |
|--|---|
| Recommendation: Removal Prior to demolition/Refurbishment taking place. | |

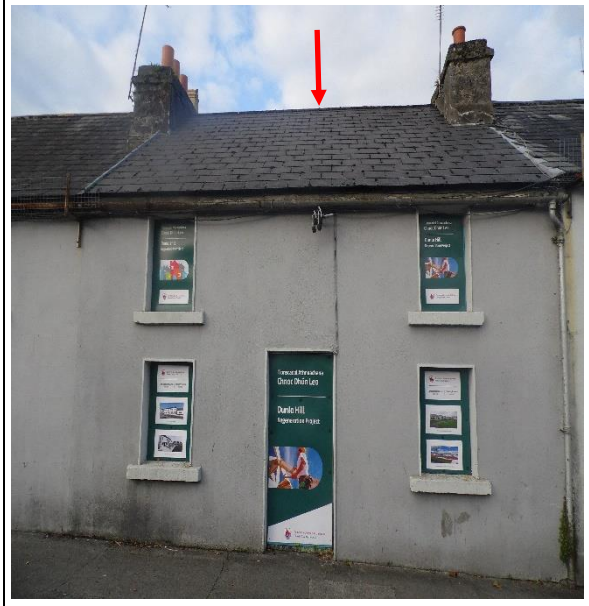
Slates to Roof of Terraced House #5 are strongly presumed ACM's

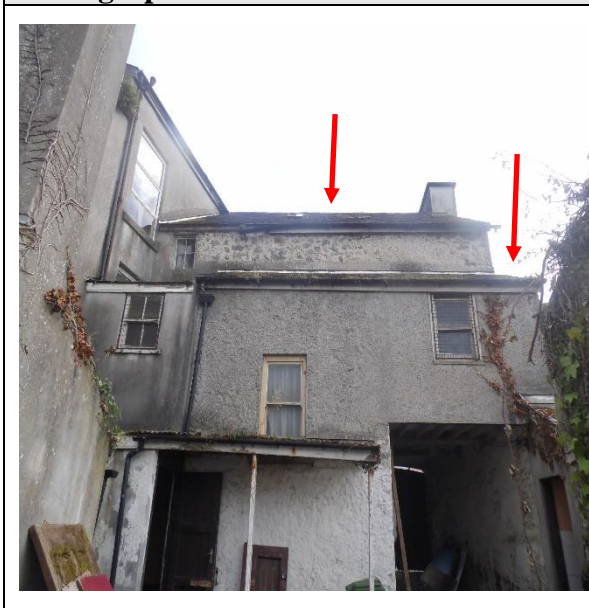
Slates to Roof of extension to rear of (Dooleys)Townhouse strongly presumed ACM's

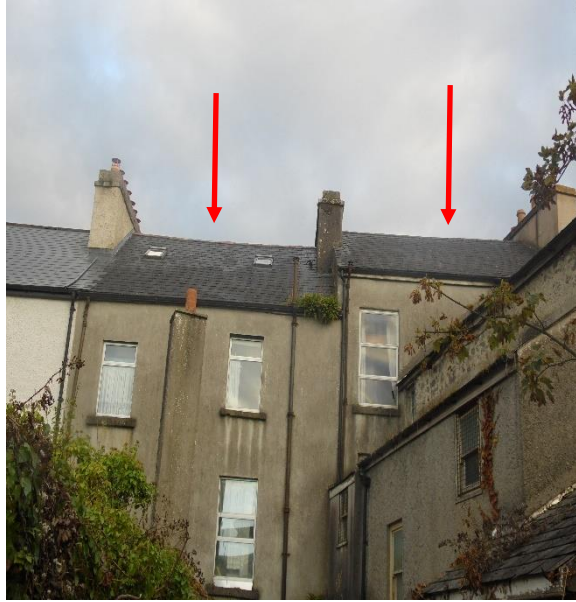
Slates to Roof of two Townhouses strongly presumed ACM's

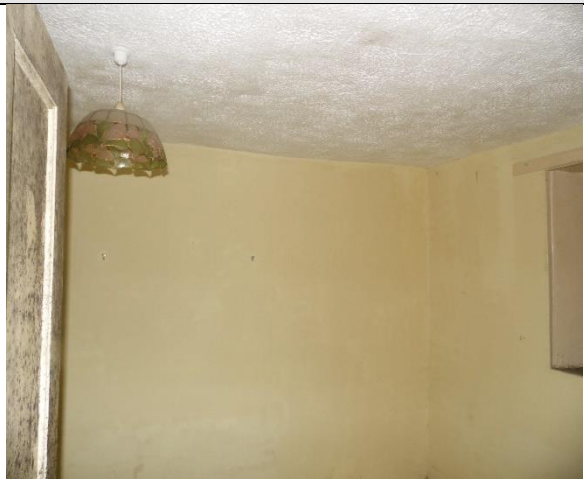
Floor: Ground
Room/Section: Terraced House #2
Description : No Asbestos Detected in sample taken of Textured coating
Sample Reference: BS196144

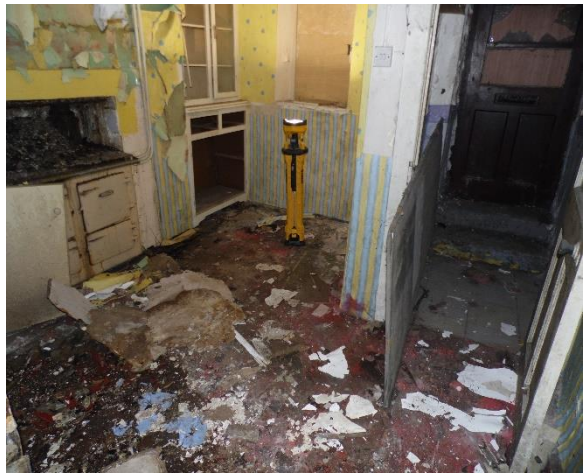
Floor: Ground
Room/Section: Terraced Houses #3 and #4
Description : No Asbestos Detected in samples taken of Floor Tiles
Sample References: BS196145 and BS196146
