Received: 19/05/23

Dunlo Hill, Ballinasloe, Co. Galway

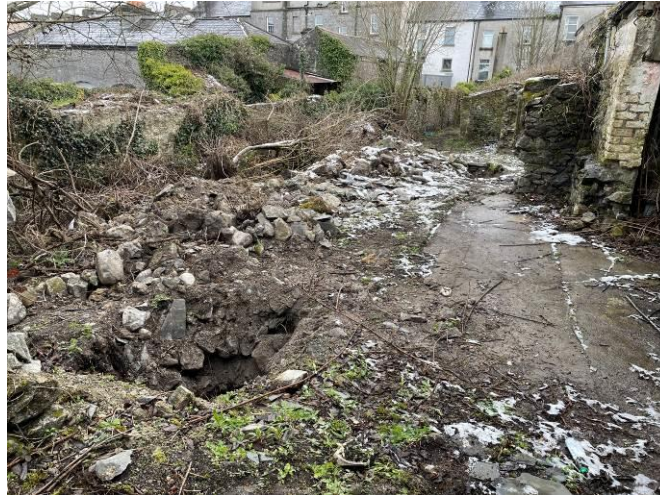
Photograph 1: Locations of trial holes at rear right side of the site

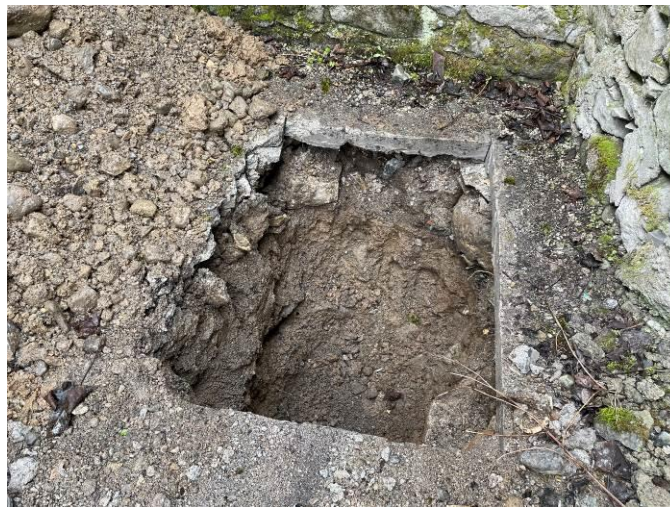
Photograph 2: Typical external ground conditions with good ground encountered at 1m to 1.5m below existing ground level. Note the shallow depth of the bearing pad stones under the stone wall

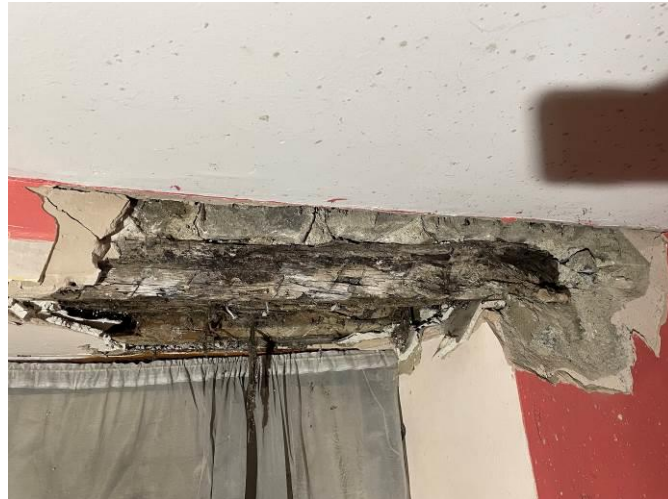
Photograph 8: Condition of Timber Lintels in Unit 01

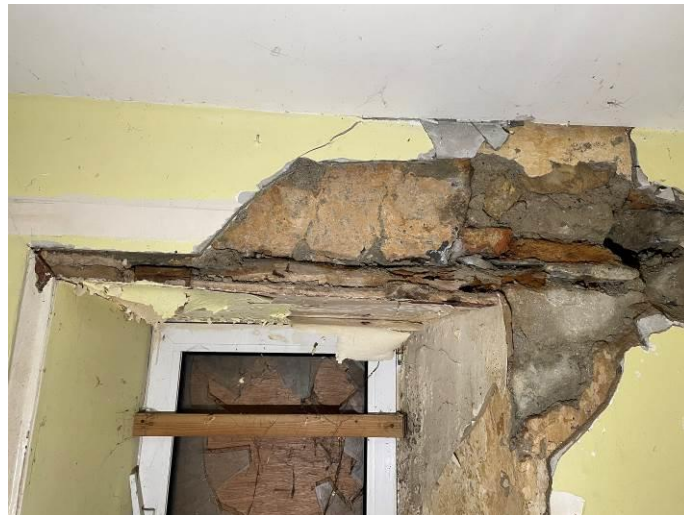
Photograph 9: Condition of Timber Lintels in Unit 03

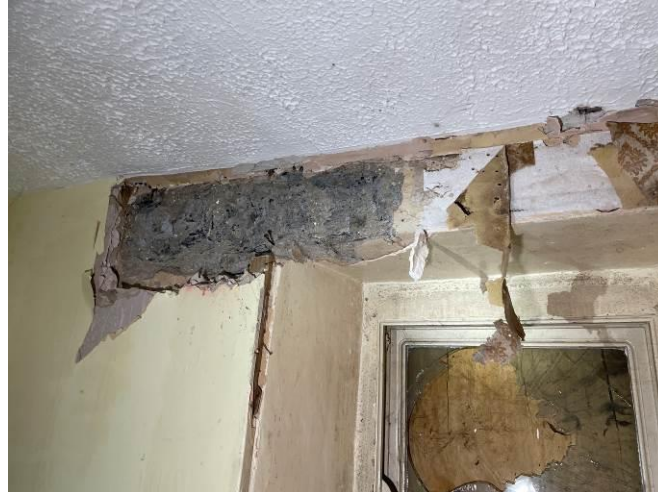
Photograph 10: Concrete & stone lintels were also noted in places within the residential properties

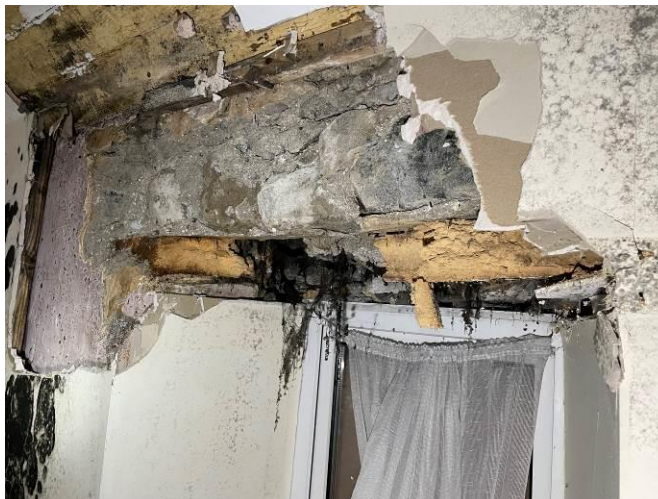
Photograph 11: Example of rotted and dilapidated timber lintel

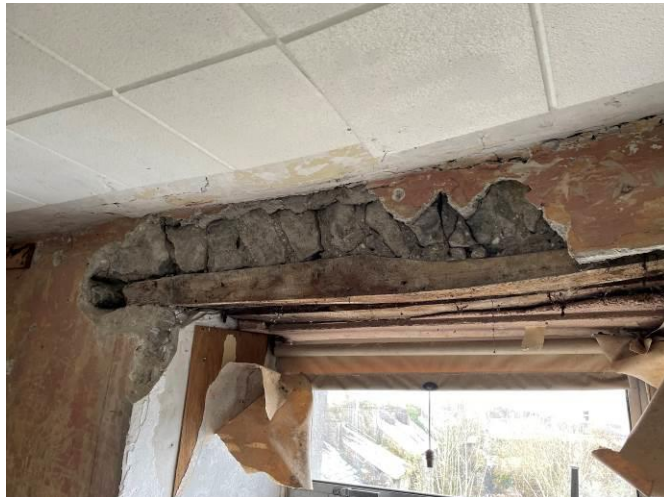
Photograph 14: Woodworm noted in timber lintels within the public house part of the property

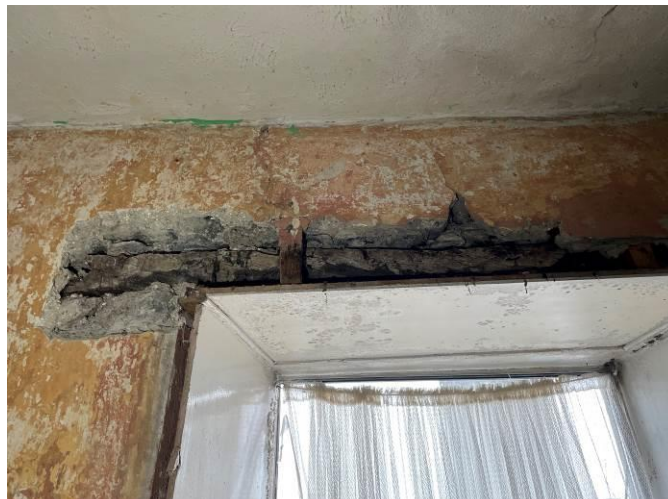
Photograph 15: Typical example of the dilapidated nature of the timber lintels

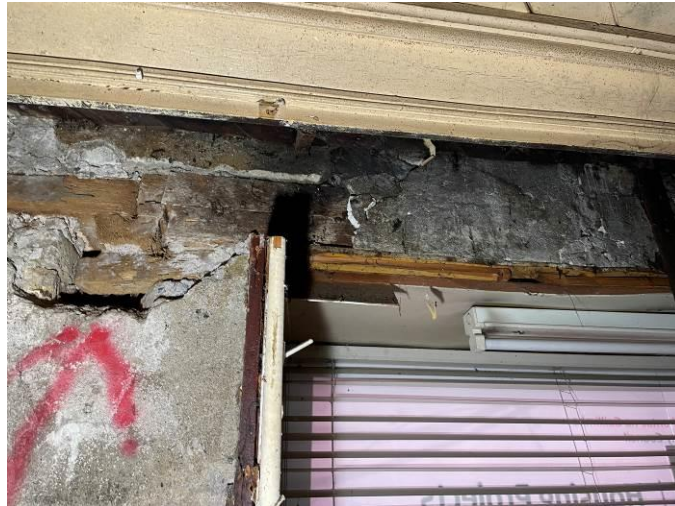
Photograph 16: Typical example of the nature and condition of the timber lintels and beams in the public house area

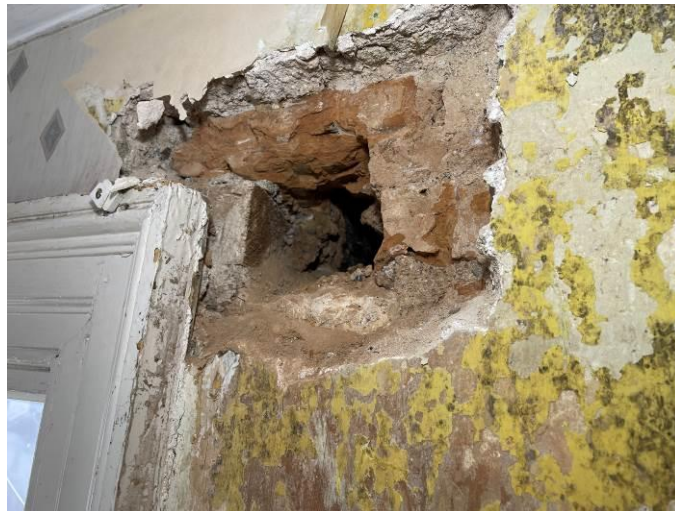
Photograph 17: Typical example of the nature and condition of the timber lintels in the public house area, 1st floor

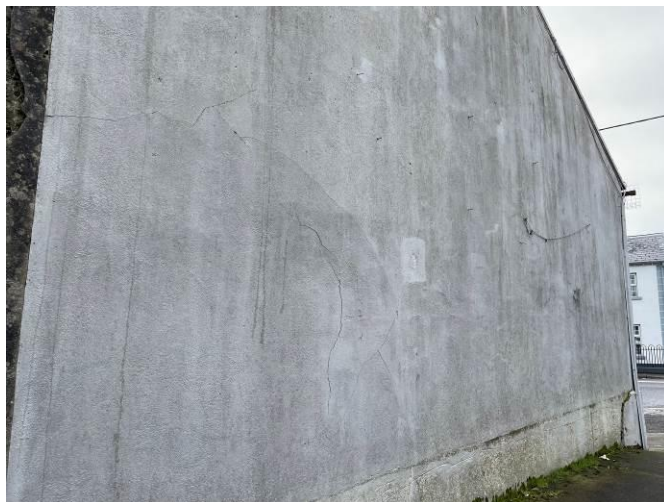
Photograph 18: Cracked and hollow sounding render noted on the left side gable end of the residential properties

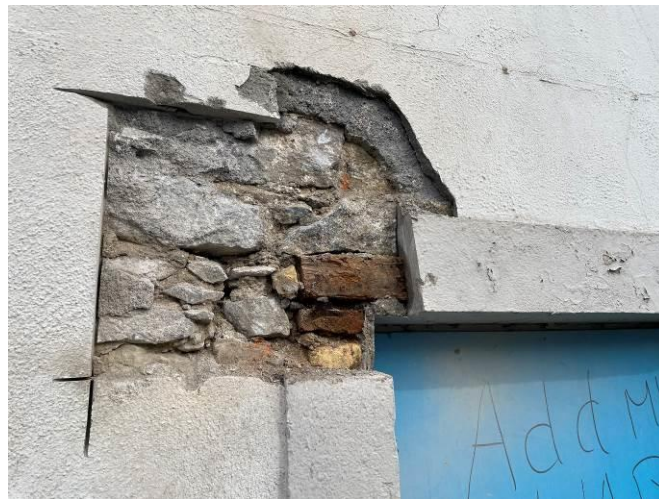
Photograph 20: Note the water damaged timber lintel on the front elevation

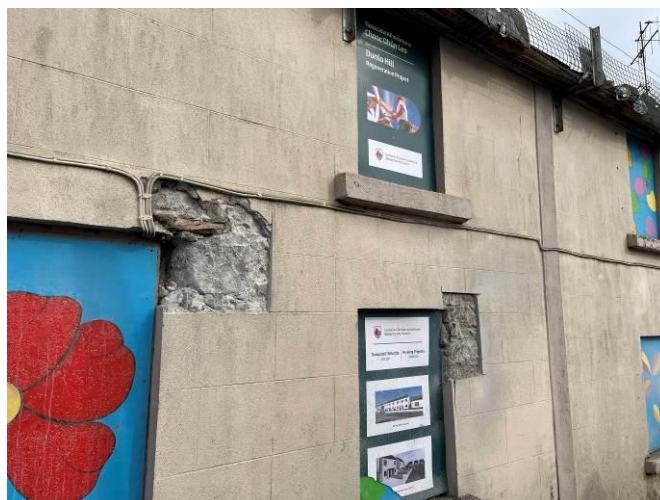
Photograph 21: Examples of the explorative holes in the render on the front elevations of the residential properties

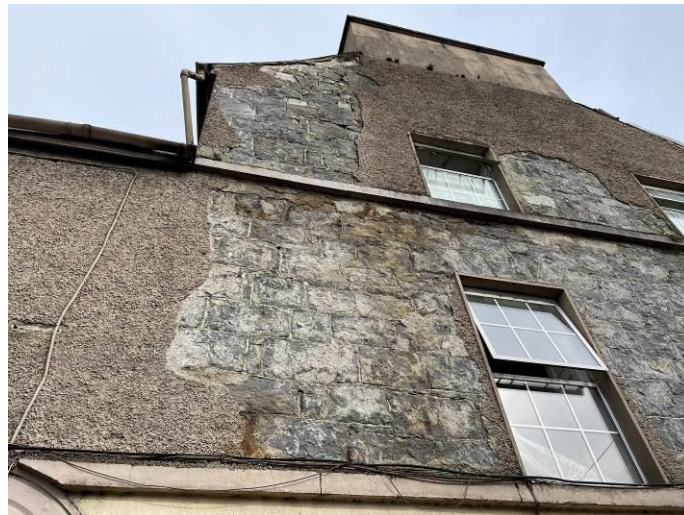
Photograph 23: Spalled render from public house section

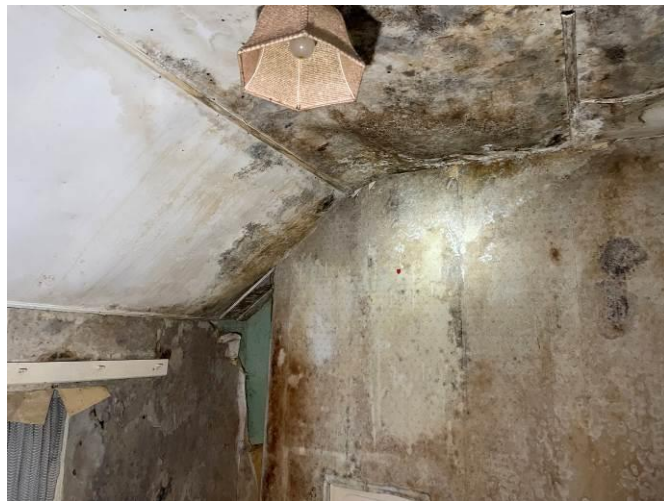
Photograph 25: Typical condition of the internal walls and ceilings within the residential properties

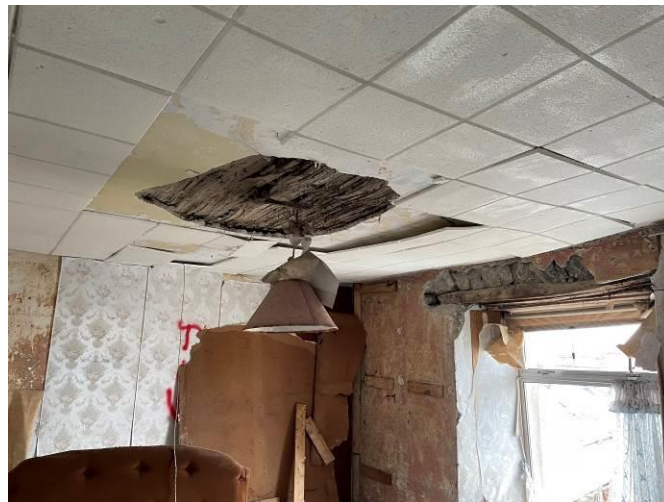
Photograph 27: Dilapidated nature of the walls and ceilings within the public house area

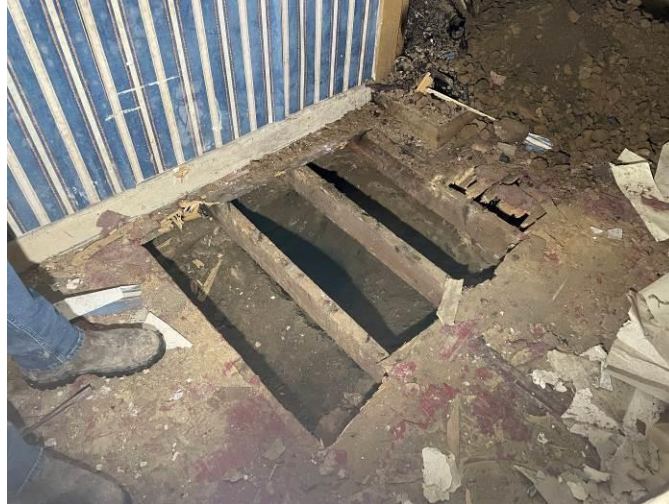
Photograph 30: Example of suspended timber floor within one of the residential units

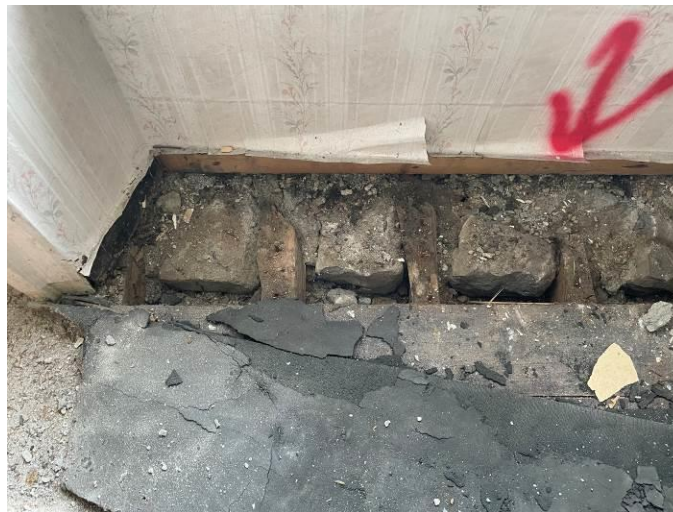
Photograph 31: Example of first floor timber joists abutting a stone wall.
The joists were found to be in good condition

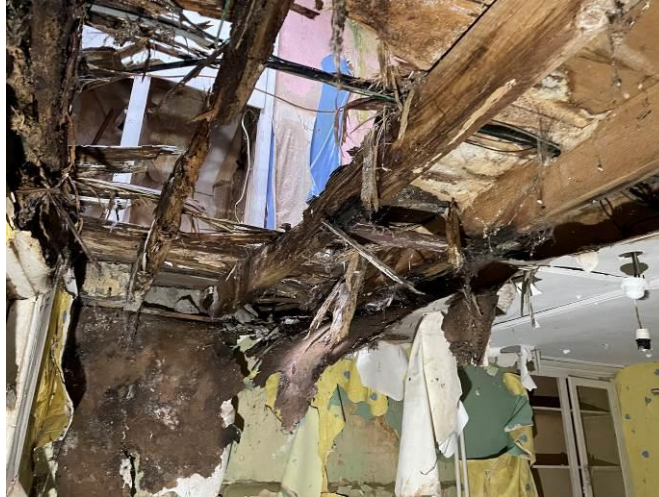
Photograph 32: First floor joists were found to be in this dilapidated condition within a number of the residential units

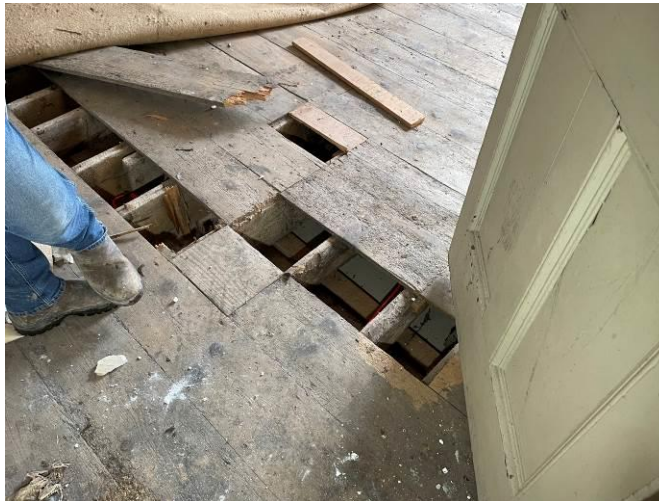
Photograph 33: Brittle condition of the floorboards and floor joists in the property adjacent to the archway

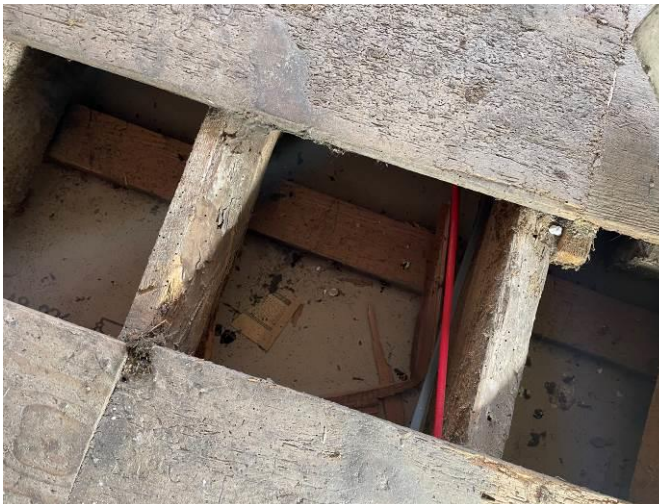
Photograph 34: Woodworm attack noted in the floor joists at the location above

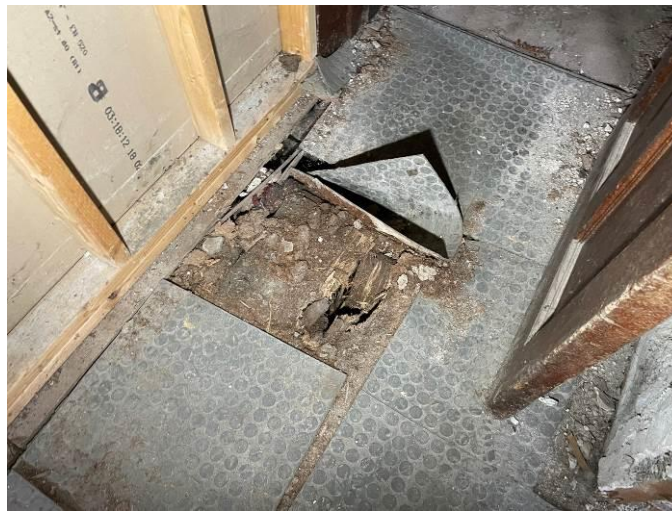
Photograph 36: Close up of the defects noted above

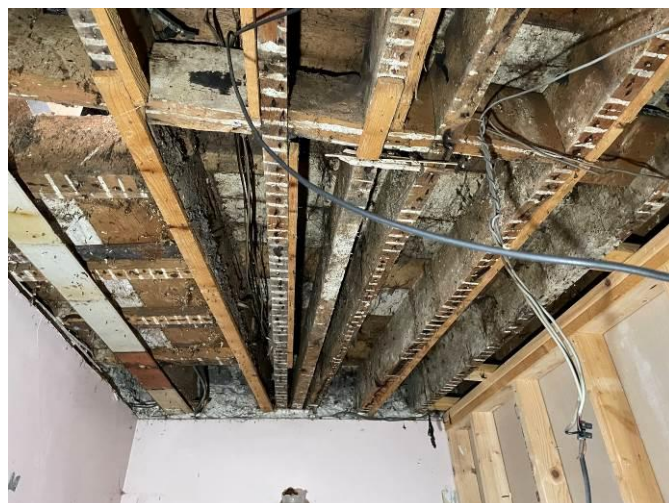
Photograph 37: Condition of the timber first floor joists in the public house area

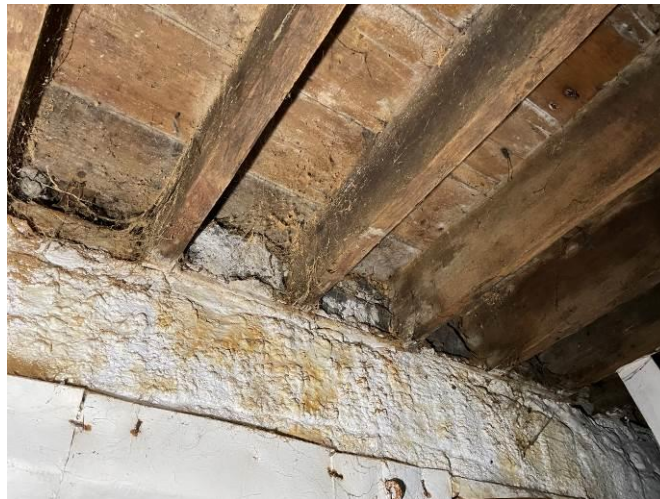
Photograph 39: Dilapidated condition of the timber floors and floor joists on the ground floor of the public house area

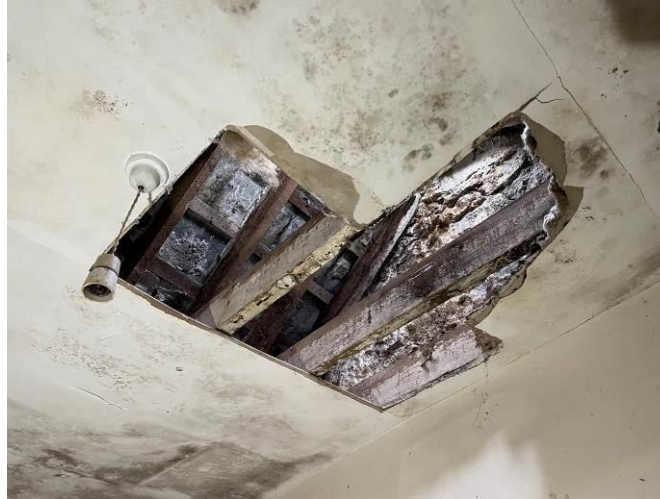
Photograph 40: Dilapidated condition of the roof and attic spaces in the residential properties

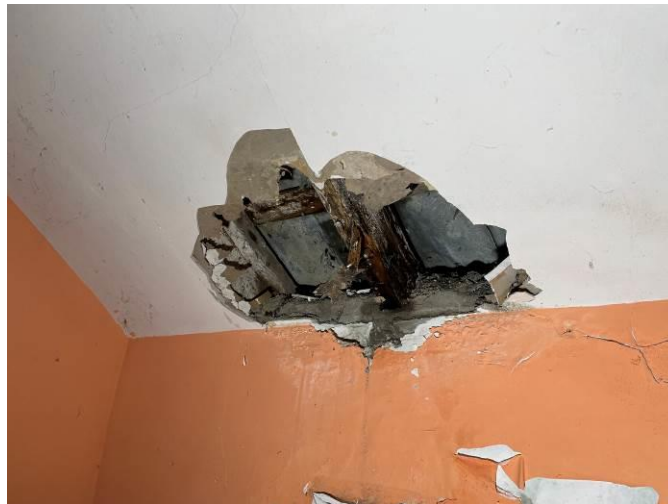
Photograph 41: Example of water damaged ends of rafters in the residential properties and where same abut the external walls

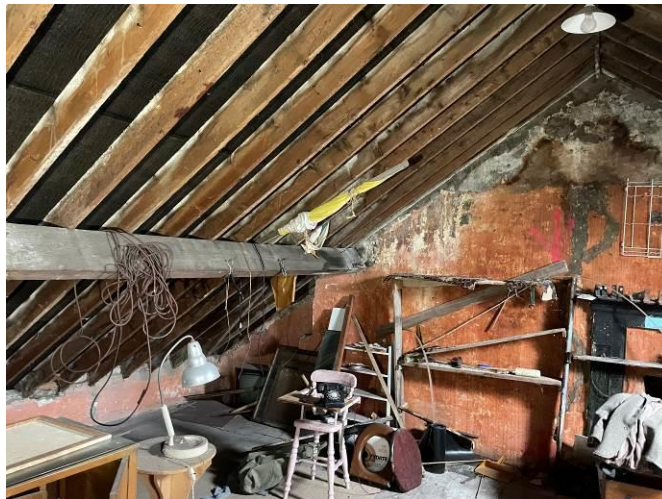
Photograph 43: Good condition of the attic space and timbers in the property adjacent to the public house

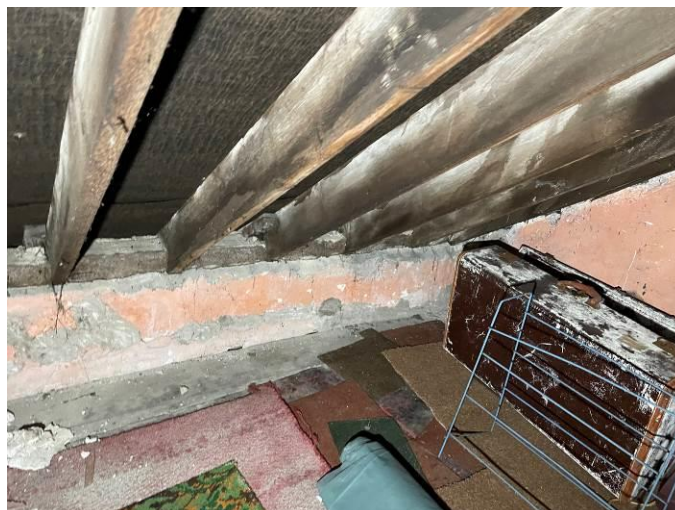
Photograph 44: Good condition of the attic space and timbers in the property adjacent to the public house

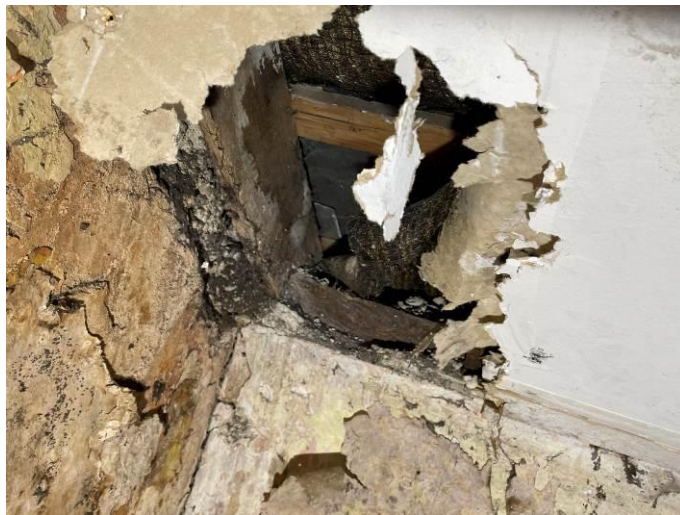
Photograph 46: Dilapidated and water damaged timber rafters in the residential property adjacent to the public house, left side

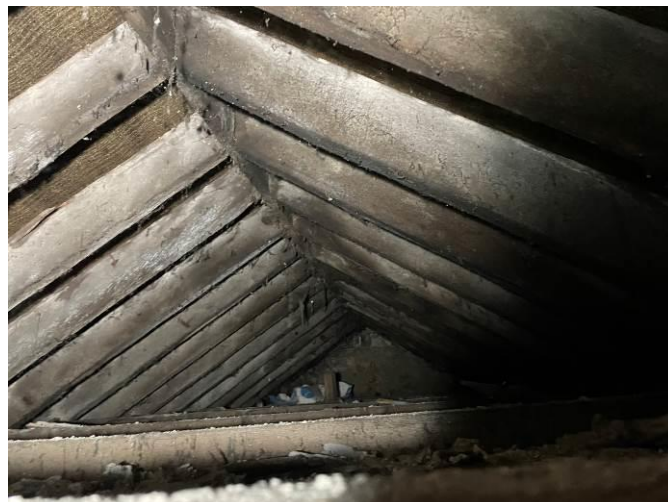
Photograph 47: Good condition of the rafters in the roof over the public house area

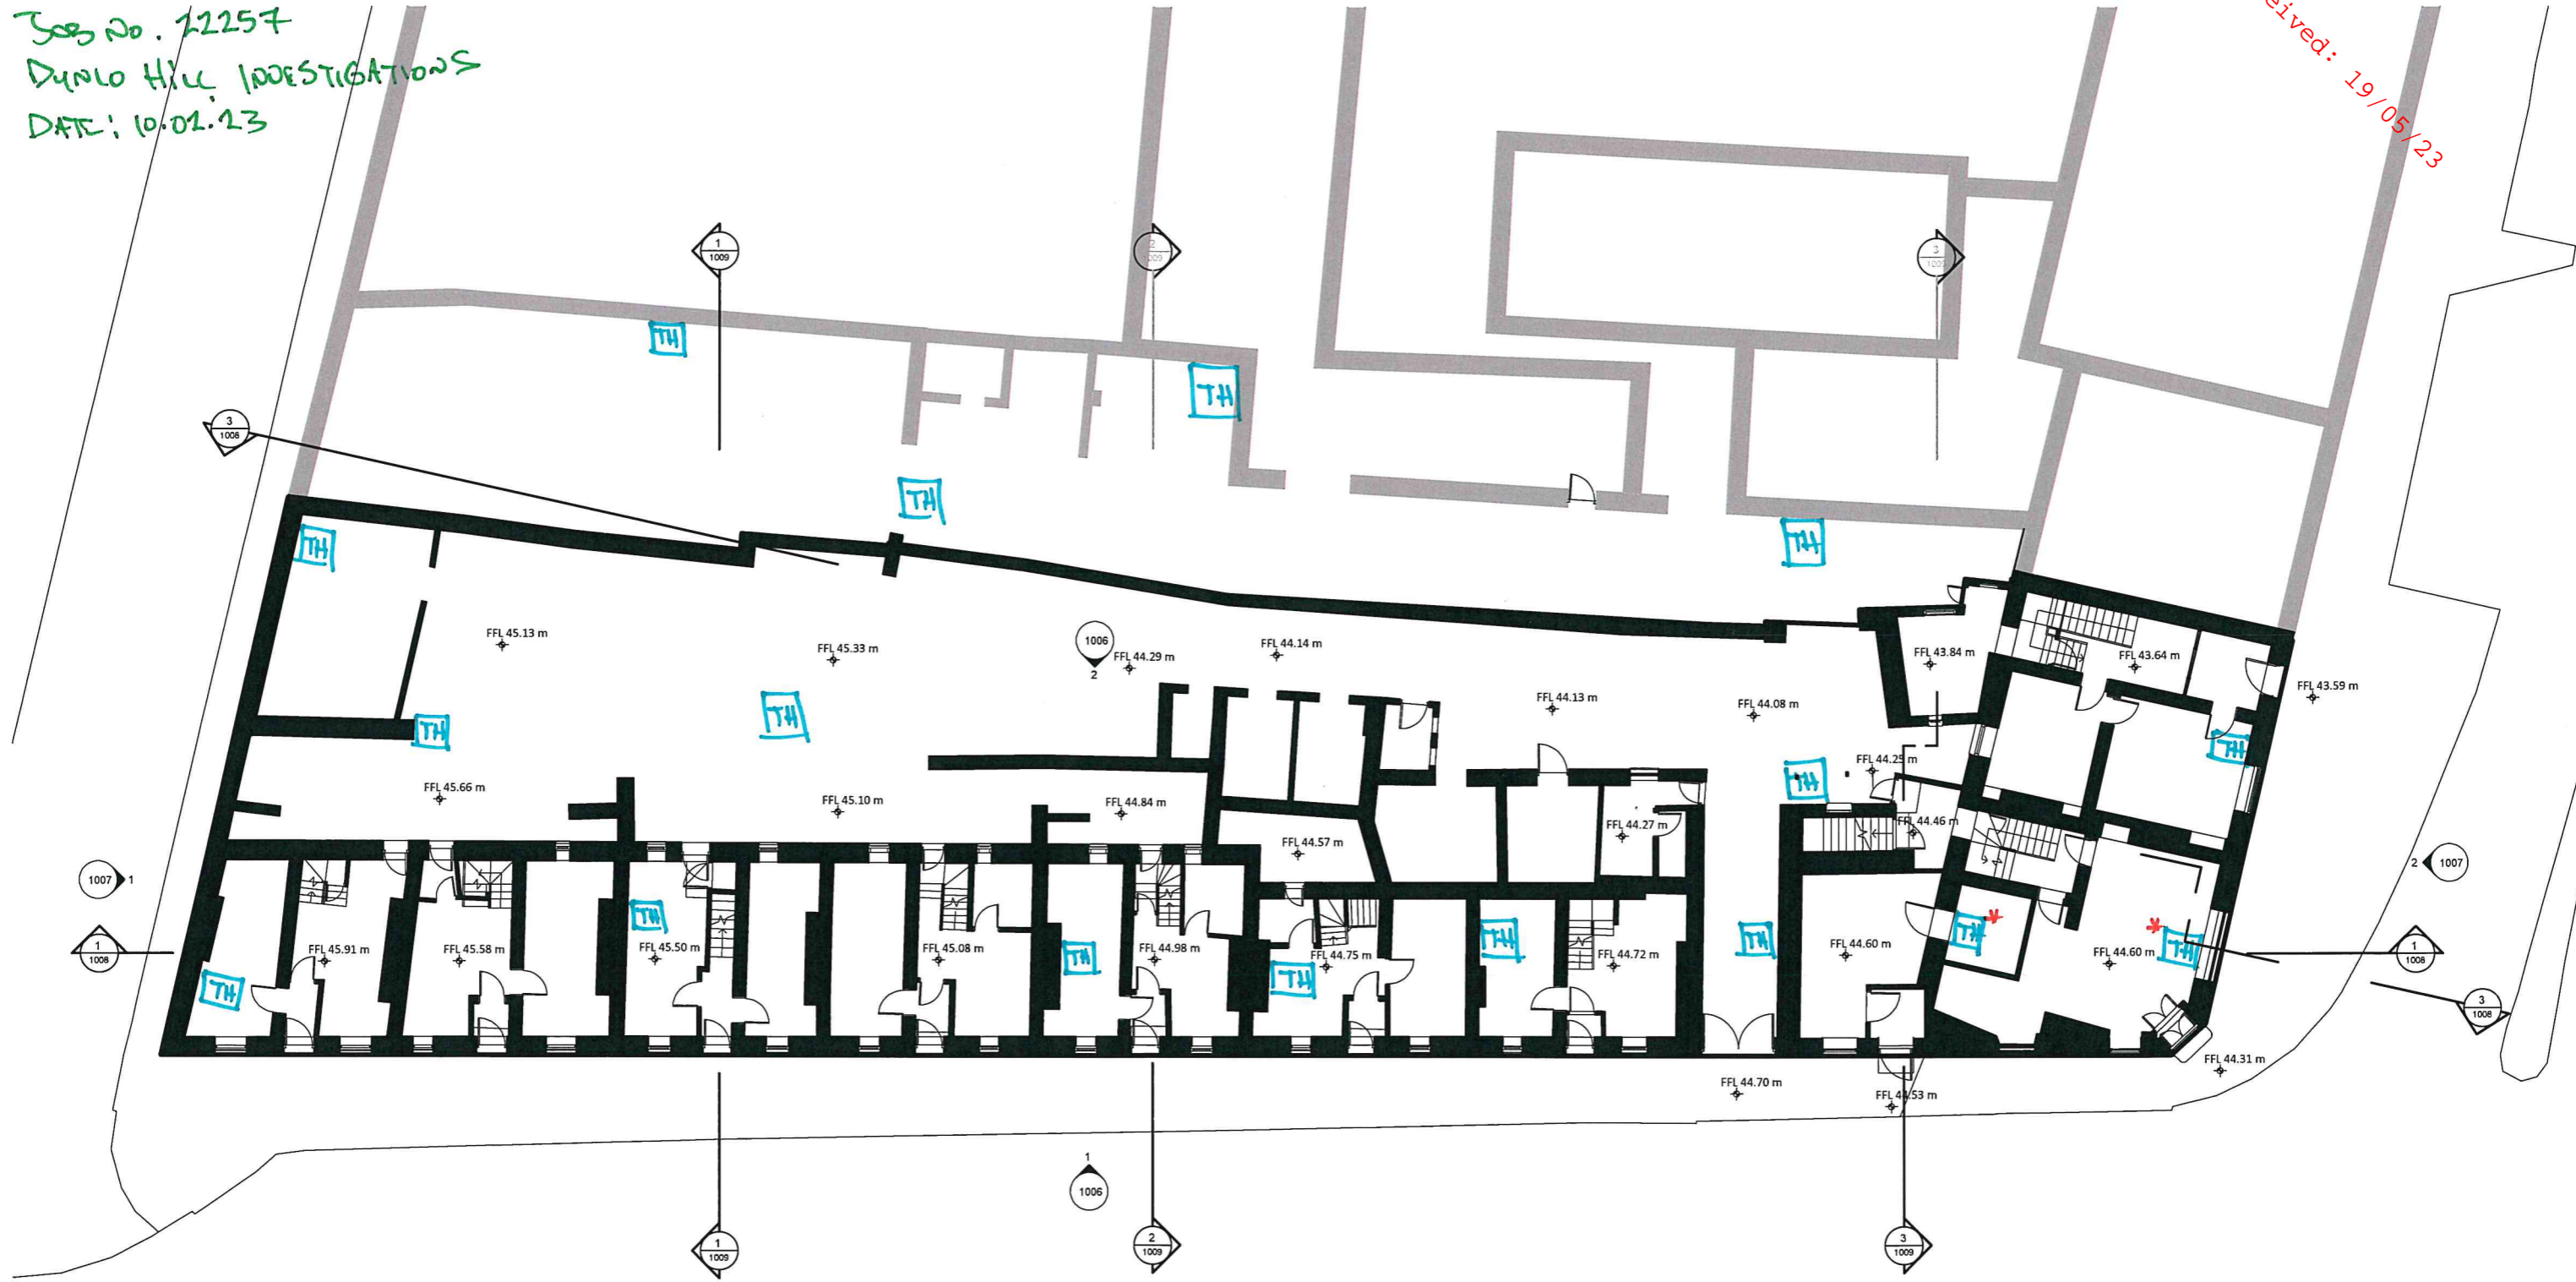
TH DENOTES TRIAL HOLE TO EXPOSE DEPTH OF EXISTING 'PAD STONE' FOUNDATIONS + DEPTH REQUIRED TO GOOD GROUND.
