Title: **Stage 1&2 ROAD SAFETY AUDIT**
For;
Dunlo Hill Development, Ballinasloe, Co. Galway.

Client: **Galway Co. Co.**

Date: **May 2023**

Report reference: **1846R01**

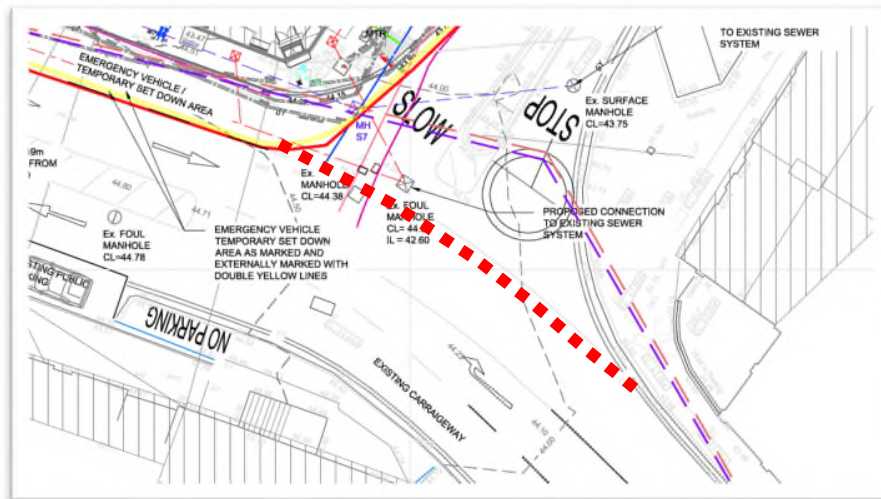
Drawing 2257/CE/002/PL, Dunlo Street Junction.

The stop line is set very far behind the edge of the R446 through route. This makes the visibility to the left for drivers exiting Dunlo Street appear worse than it actually is. The stop line may be ignored by drivers who are familiar with the area leading to a less formal yield control junction.

It is recommended that the stop line be brought forward to close top the edge of the through carriageway/new double yellow line.

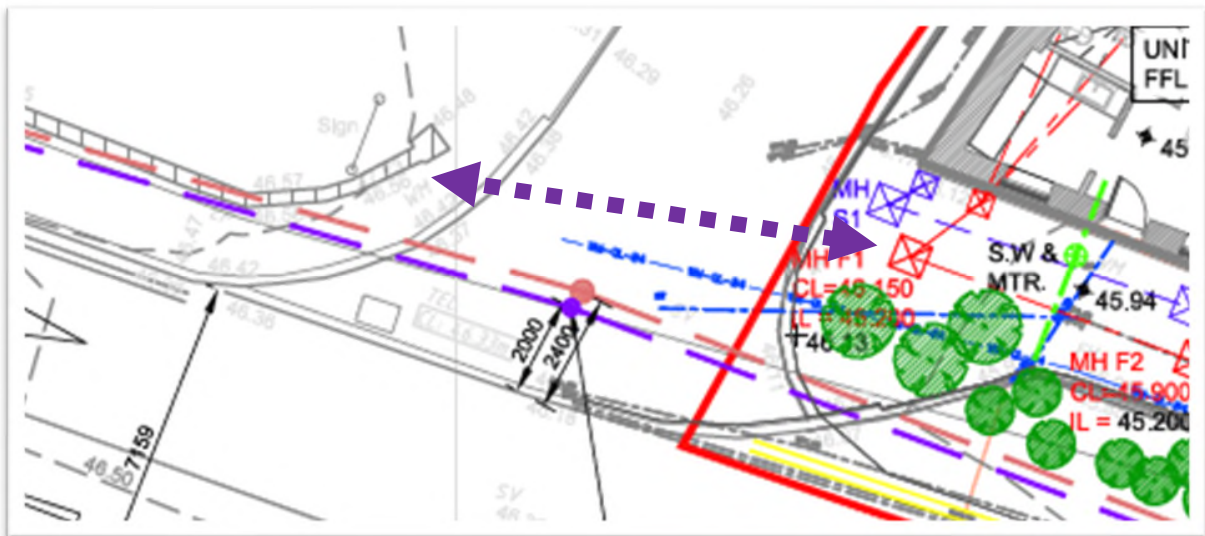
Drawing 2257/CE/002/PL, Dunlo Hill.

Pedestrians crossing the Dunlo Hill access road to the west of the site may not have suitable crossing facilities which could lead to trips and falls.

Ensure that suitable dropped kerbs and tactile paving is provided.
