## PRELIMINARY DAMP & TIMBER DECAY REPORT

**Re: Renovation & Alterations at Dunlo Hill/Dunlo Street, Ballinasloe, Co. Galway.**

**The Buildings Inspected:** A set of seven workers' cottages. A two-bay by two bay three-storey end-of-terrace building (former pub which is a Protected Structure RPS 2730) with a two bay two-storey addition. A two-bay, three-storey terraced building (townhouse).

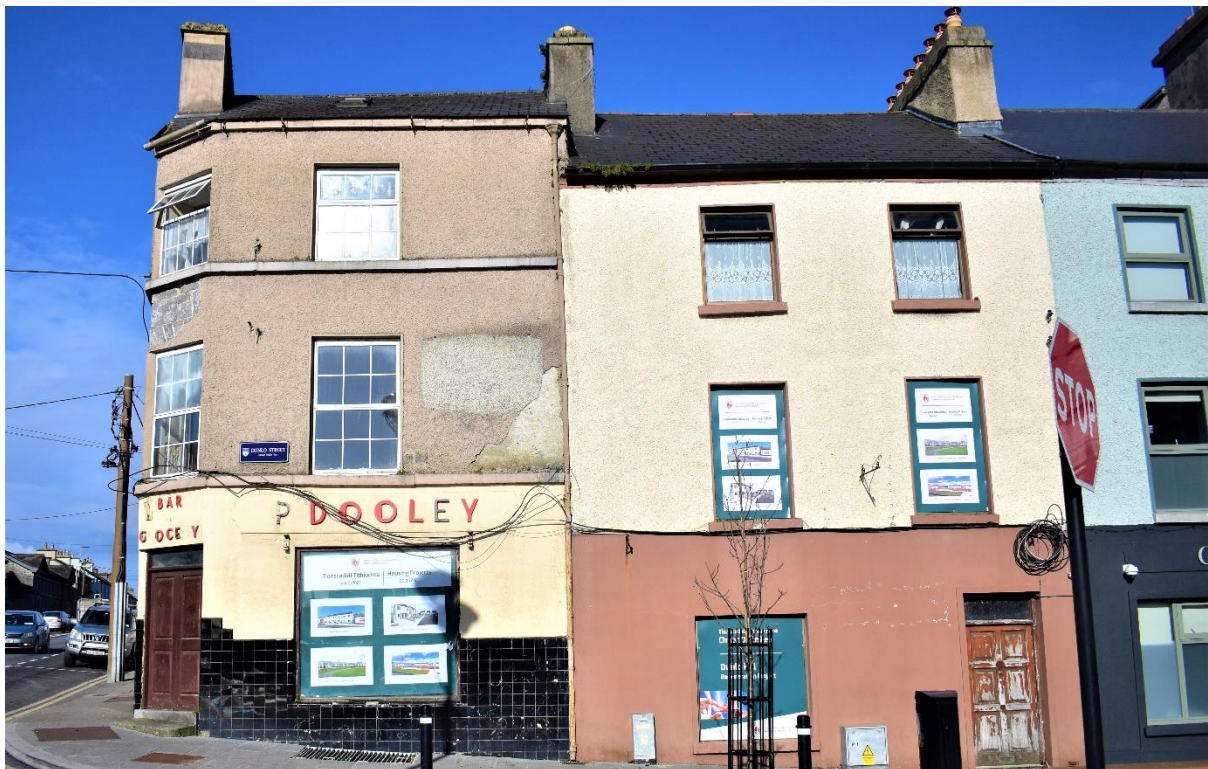
*Figure 1. Shows the elevation facing Dunlo Street.*

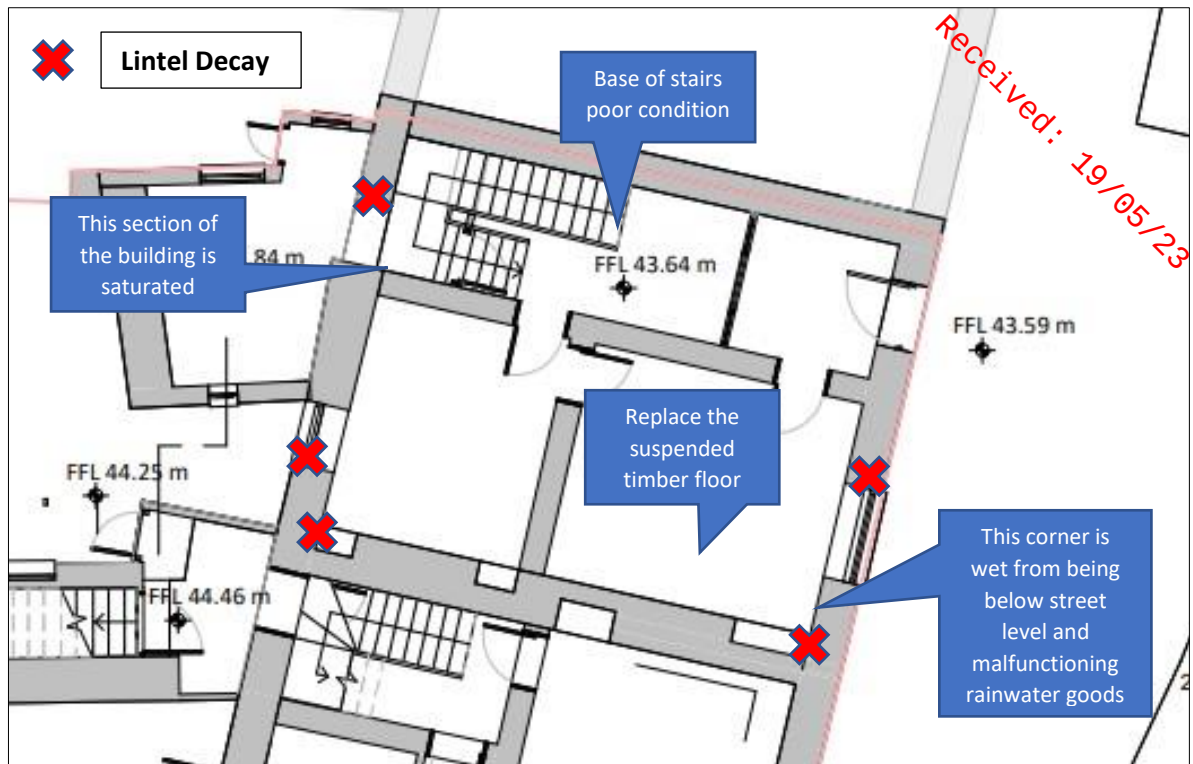
The ground floor is a suspended timber floor at the front, with long-term decay from a high moisture content and poor subfloor ventilation. The remaining floors are solid, presumably without any form of DPM present based on the high moisture content.

Figure 2. Shows the ground floor of the Three Storey Townhouse.

The following proposal is subject to further review when the masonry is fully accessible. We recommend that all floors be removed in full. We recommend that a Geocell/Glapur foam glass aggregate is installed as per the engineers' detail. Allow for additional depth adjacent to all external walls; this detail reduces capillary action against the external walls.

Provide to hack off all internal plaster and install a scud and scratch coat of NHL 3.5 lime-based mortar to the exterior walls and all walls abutting an external wall. Ensure all timbers embedded in the masonry are removed as part of this process.

Fit a Wykamol CM8 cavity drain membrane to the inside of the exterior walls at the full height of the room and against all walls abutting an external wall. Install a Wykamol CM20 membrane to the underside of the new floor slab and tape it to the C20 membrane to give a complete seal. Install the appropriate breathable drylining system in front on completion.

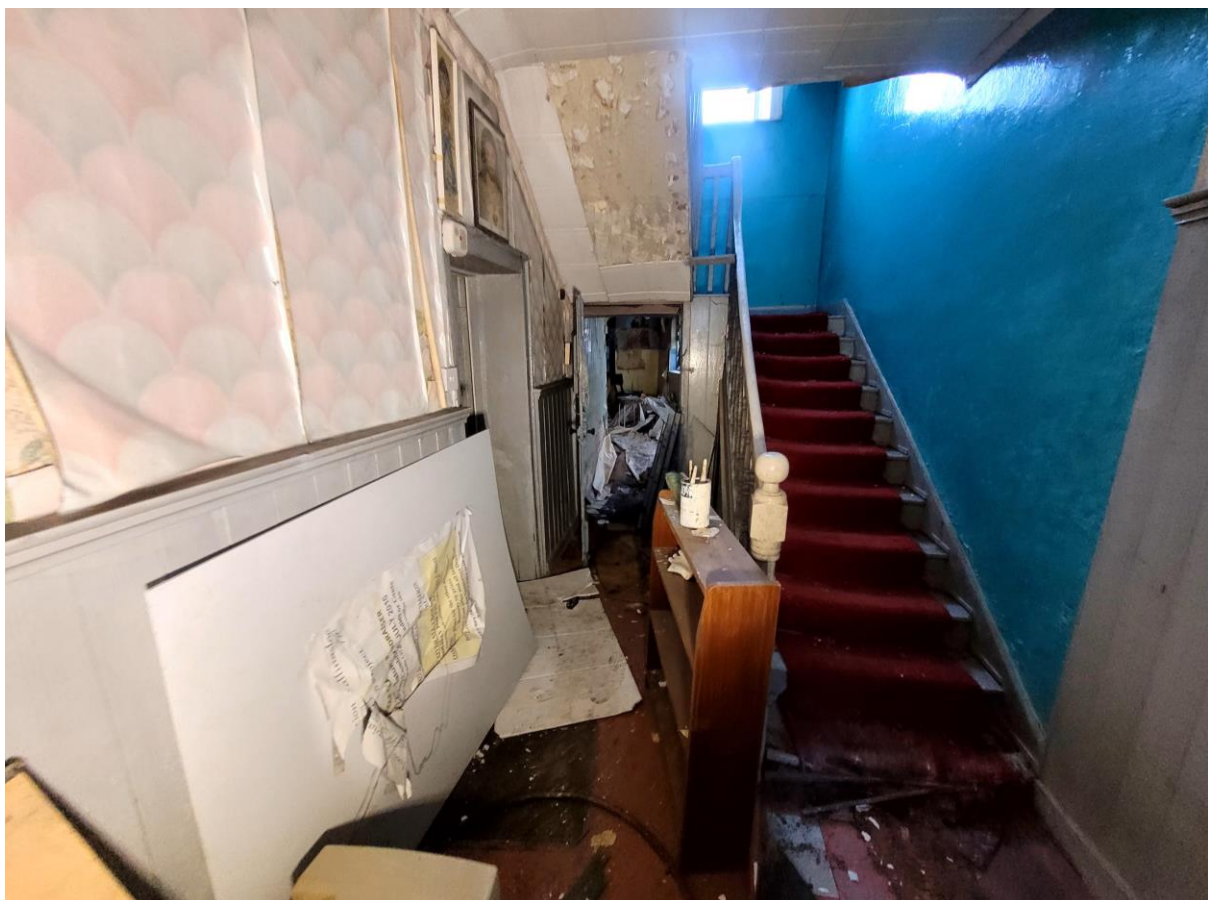
The base of the stairs is in poor condition, and there is solid masonry on the underside of the stairs adding to the issue. Most lintels at this level have decay present and should be replaced in full as per the engineers' detail.

Figure 3. Shows the ground floor of the Three Storey Townhouse. Note the base of the stairs is in poor condition.

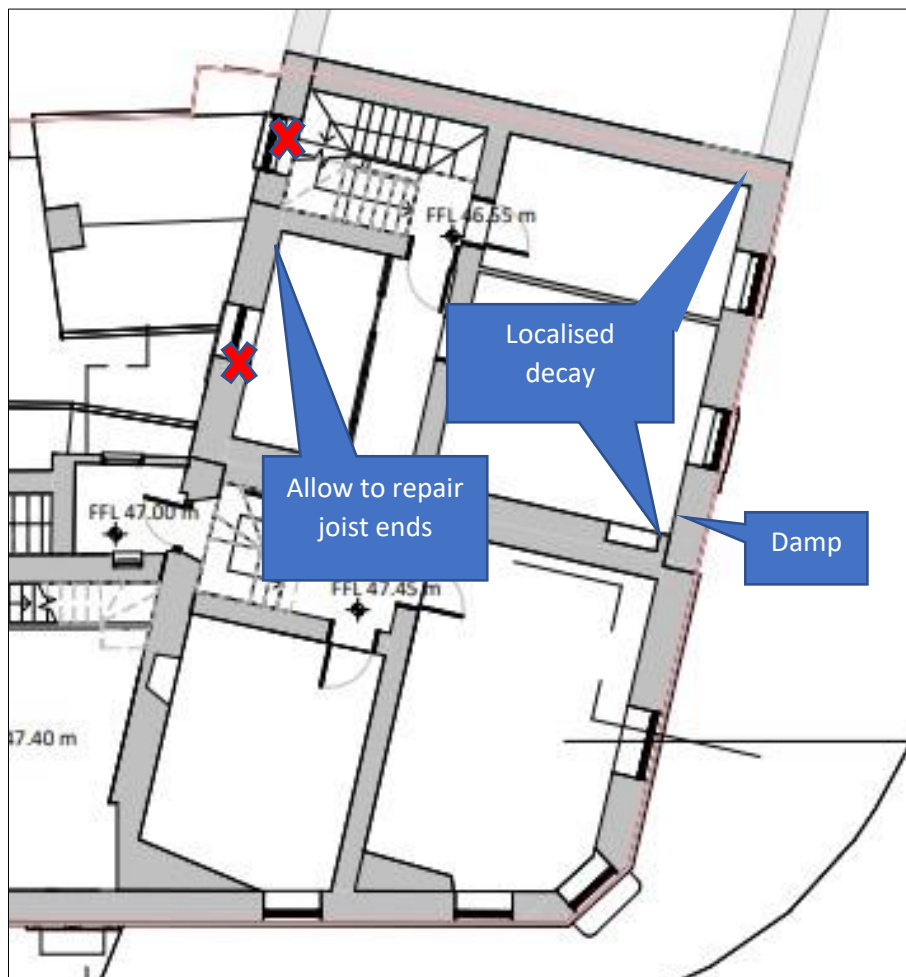
The first-floor joists are parallel to the front wall at the front of the building. The bearing end of the joist closest to the wall has some decay present on both sides of the building. The floor joists in the main bedroom have some deflection due to the room's span but are generally reasonable.

The floor joists at the rear were inaccessible during our inspection. We have noted that the masonry at the rear was damp, which is likely to cause the decay of the bearing ends.

The lintel in the rear bedroom has signs of decay and should be replaced in full as per the engineers' detail.

Figure 4. Shows the first floor of the Three Storey Townhouse

We recommend that you allow for repairing 25% of all floor joists at this level, subject to further review when they are fully accessible. Allow for reviewing all chimney and stair trimming timbers when fully accessible.

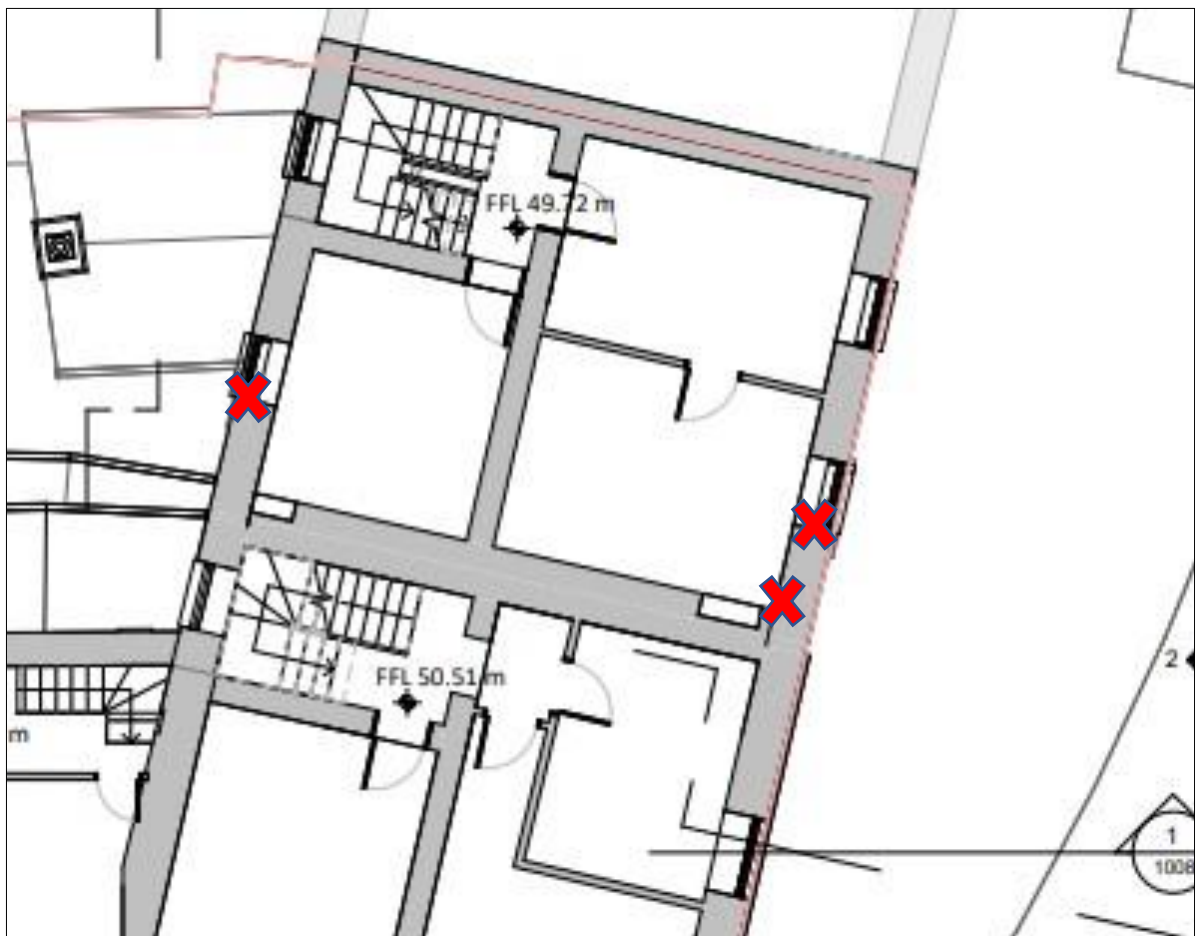
The lintel in the front bedroom has signs of decay and should be replaced in full as per the engineers' detail. Allow for replacing the adjacent window lintel, subject to further investigation. The rear lintel shows signs of deterioration and should be further reviewed when accessible.

Figure 5. Highlights areas of damaged lintels on the second floor.

We recommend that you allow for repairing 25% of all floor joists, subject to further review when they are fully accessible. Allow for reviewing all chimney and stair trimming timbers when fully accessible.

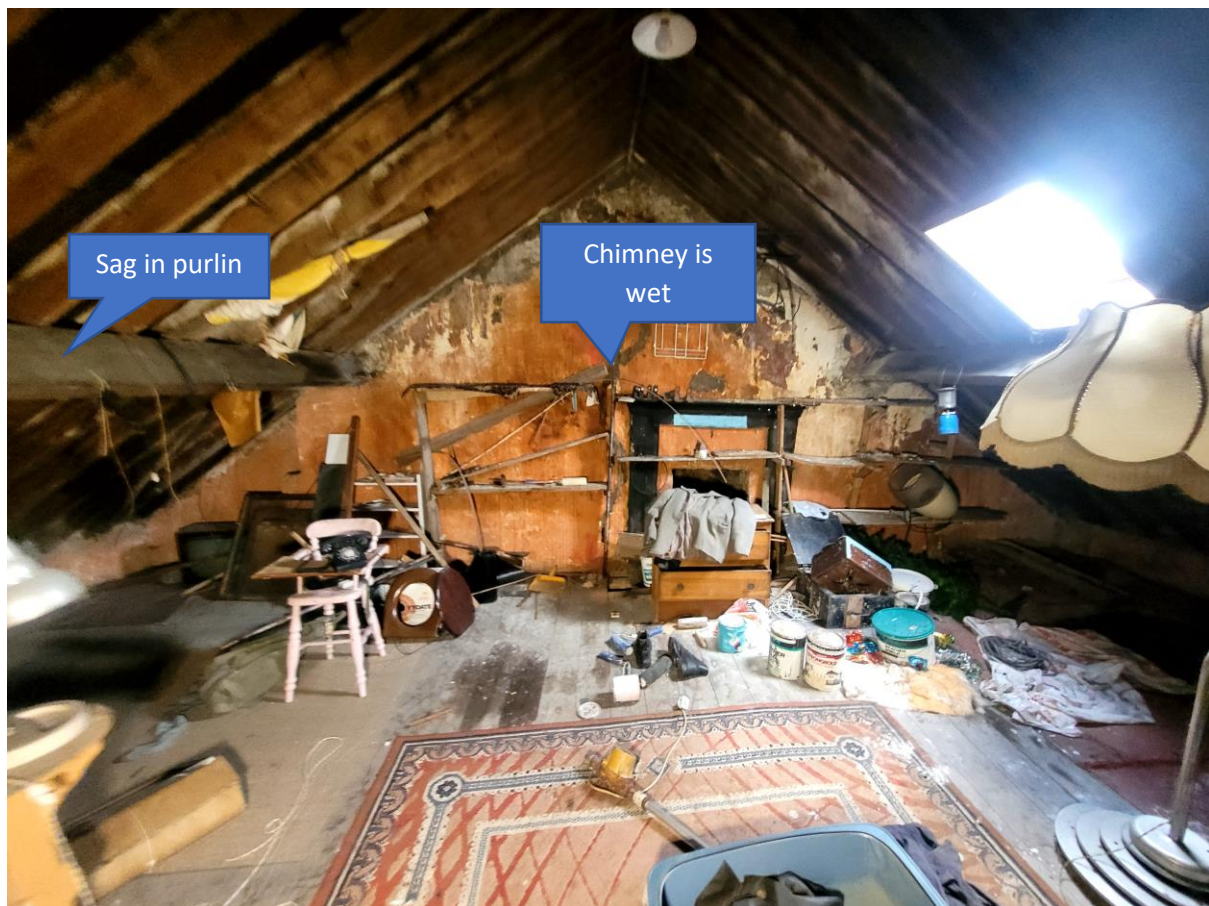
The roof consists of a traditional cut timber roof as the primary structure which rest on a long purlin. The floor joists in the attic are light and have deflected considerably as a result. We recommend that the entire floor is reviewed. The roof is slate covered and underdrawn with a non-breathable sarking felt, presumably installed in the 1970s. The attic void has little ventilation cross ventilation but vents through the chimney. The roof structure is generally reasonably maintained, with localised decay noted primarily at both gables, which requires local repair

We have recorded that there is evidence of light scattered common furniture beetle (*Anobium punctatum*) within the roof space. The floorboards and joists have heavy damage in some areas.

The span of the purlin at the front of the building is long and has deflected in the centre. We recommend that the purlin is strengthened/supported as per the engineers' detail. The purlin at the rear is cut to allow headroom into the attic. The bearing ends of the purlins show signs of decay where they are embedded in the wall/chimney. We recommend that all decayed timber be cut back and a steel splice/shoe detail installed per the engineers' detail.

Figure 6. Shows a broad view of the attic space.

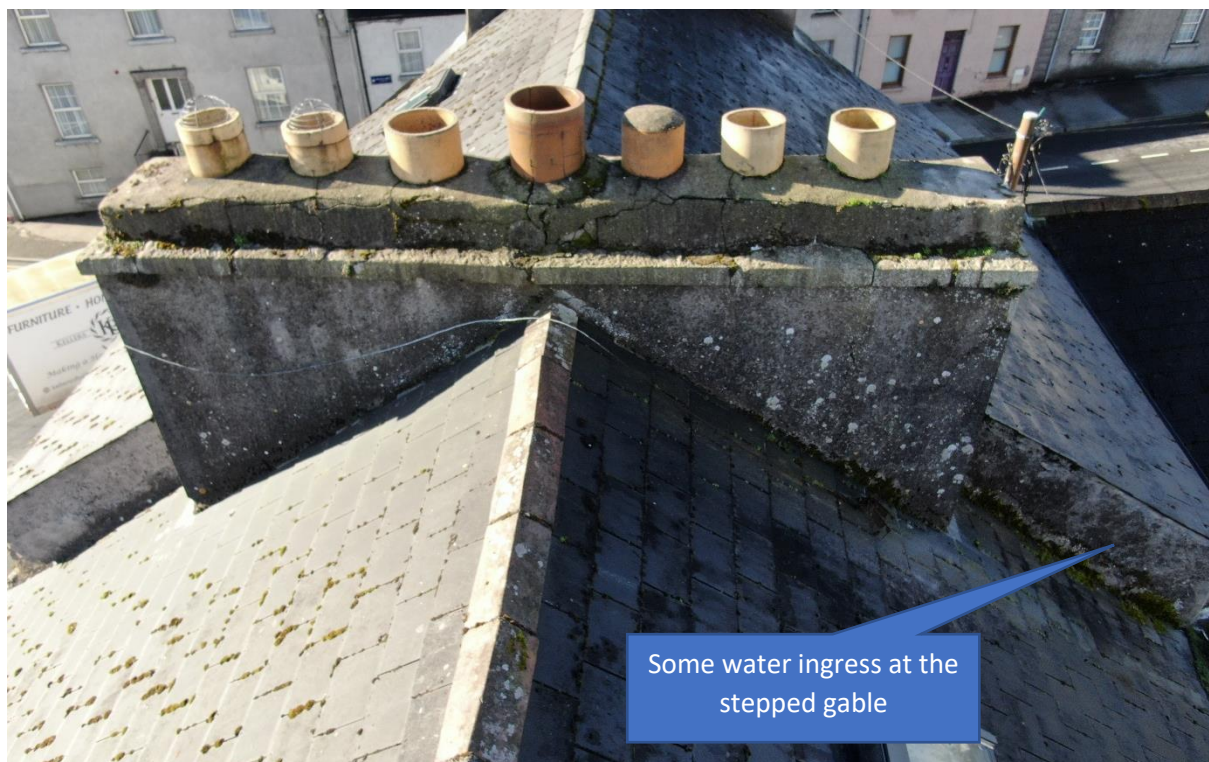
Both chimneys allow water ingress, and the shared chimney with Dooley's pub is in poor condition. The stepped section of the gable (where the roof abuts Dooleys) requires specific attention.

*Figure 7. Shows an aerial view of the shared chimney.*

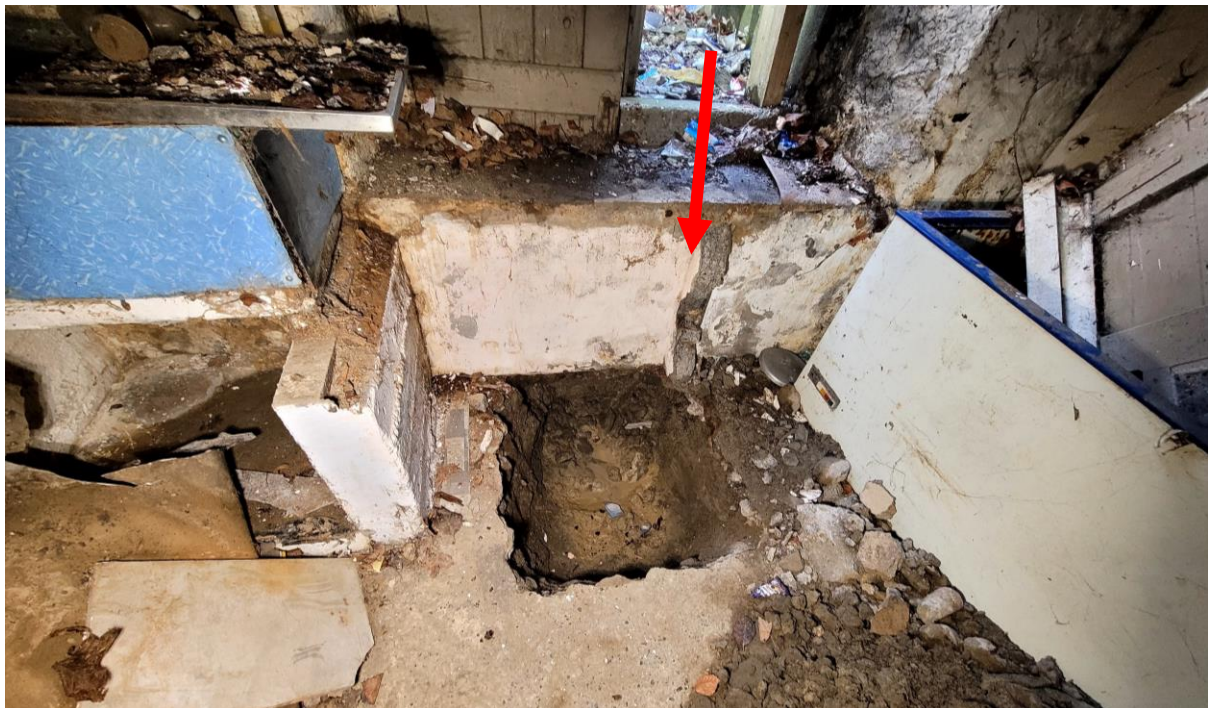
All timbers within the basement have decayed from wet rot and woodboring beetle. This includes the lightwell window lintels and rear lintels, the bottom of the stairs and supporting timbers.

The chimney/fireplace in the basement was particularly wet during our inspection.

*Figure 8. Shows the area exposed in the basement. Note the water ingress through the light well.*

We recommend that all timbers in the basement are entirely replaced as per the engineers' detail.

We recommend that the basement is fully waterproofed using the following membrane. We do not recommend cementitious tanking as it can have knock-on effects and is generally irreversible for use in a protected structure.

We recommend that a Vapourflow basement ventilation system is installed as part of crossflow ventilation.

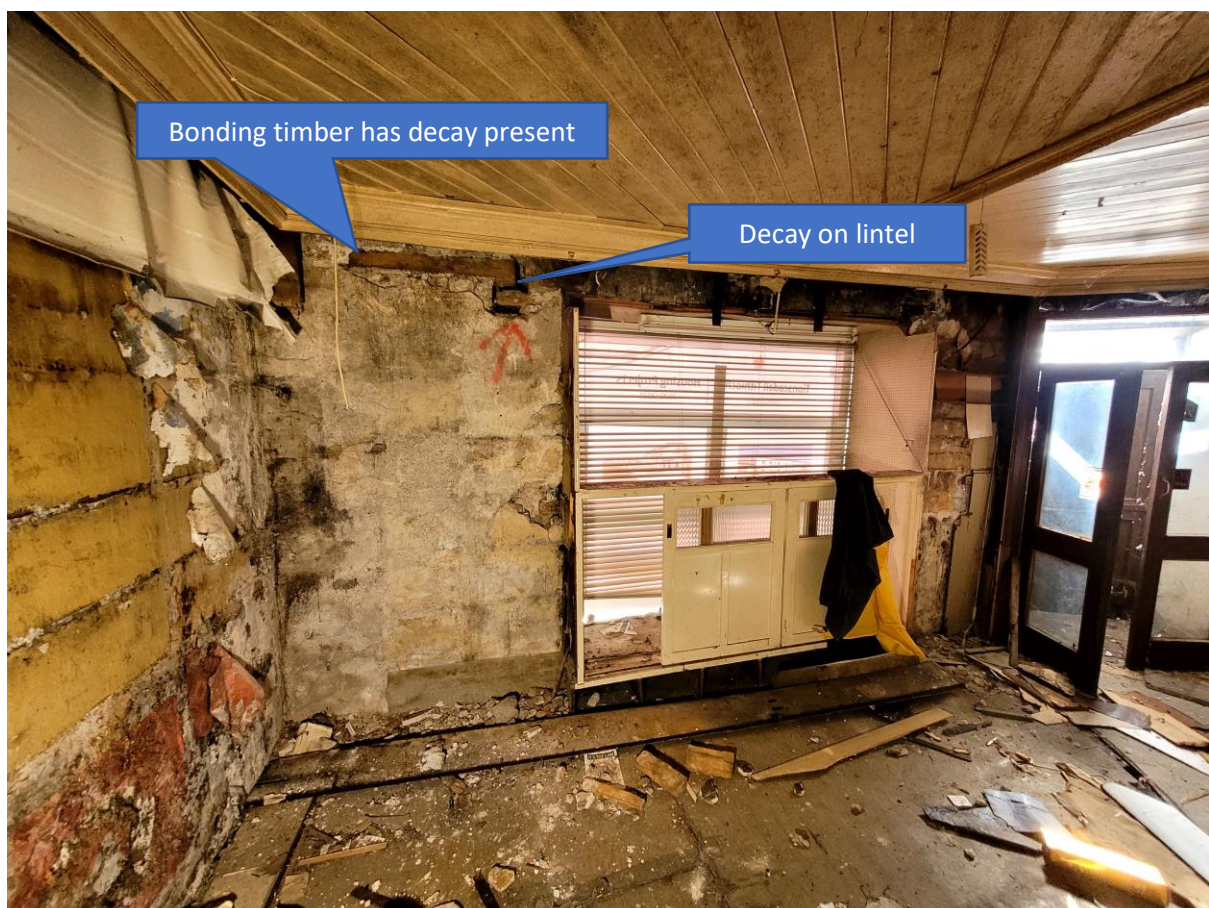
The ground floor of the pub area is in poor overall condition. The joist ends in the walls are heavily decayed, and there is a deterioration of the main floor joists as a result of being damp for an extended period of time. There have been supporting timbers installed at some point which are sagging. We recommend that the floor is replaced in full as per the engineers' detail. We recommend that all new timbers installed are certified pressure treated and that they rest on steel rather than becoming embedded in a damp wall on completion.

*Figure 9. Shows a broad view of the ground floor of Dooleys Pub.*

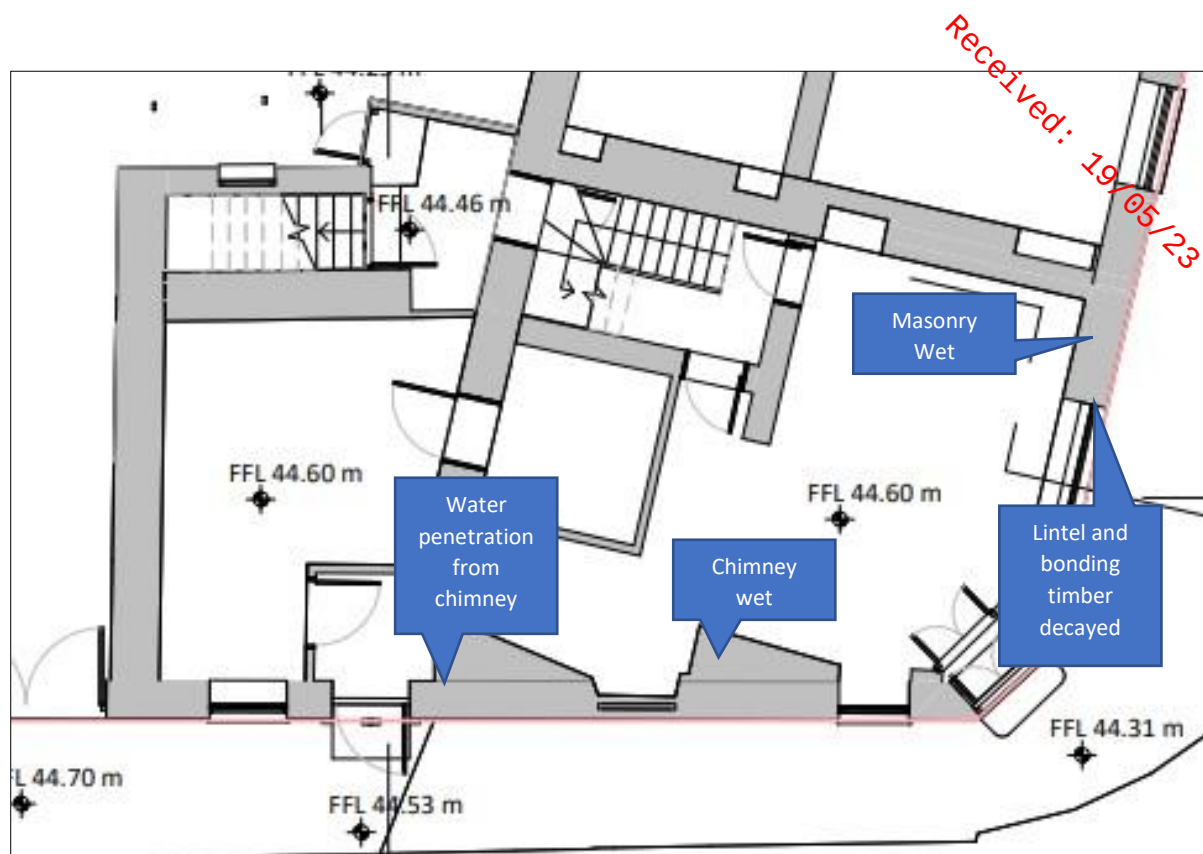
The timber lintel over the main shopfront has decay present on the east side where it was exposed. We recommend that the lintel be exposed for further review during the project and that, from a quantity point of view, it is replaced in full as per the engineers' detail.

There is an embedded bonding timber adjacent to the lintels that has heavy decay and should be removed, and the socket is infilled with masonry and lime mortar.

Figure 10. Shows a marked-up section of the ground floor in Dooley's Pub

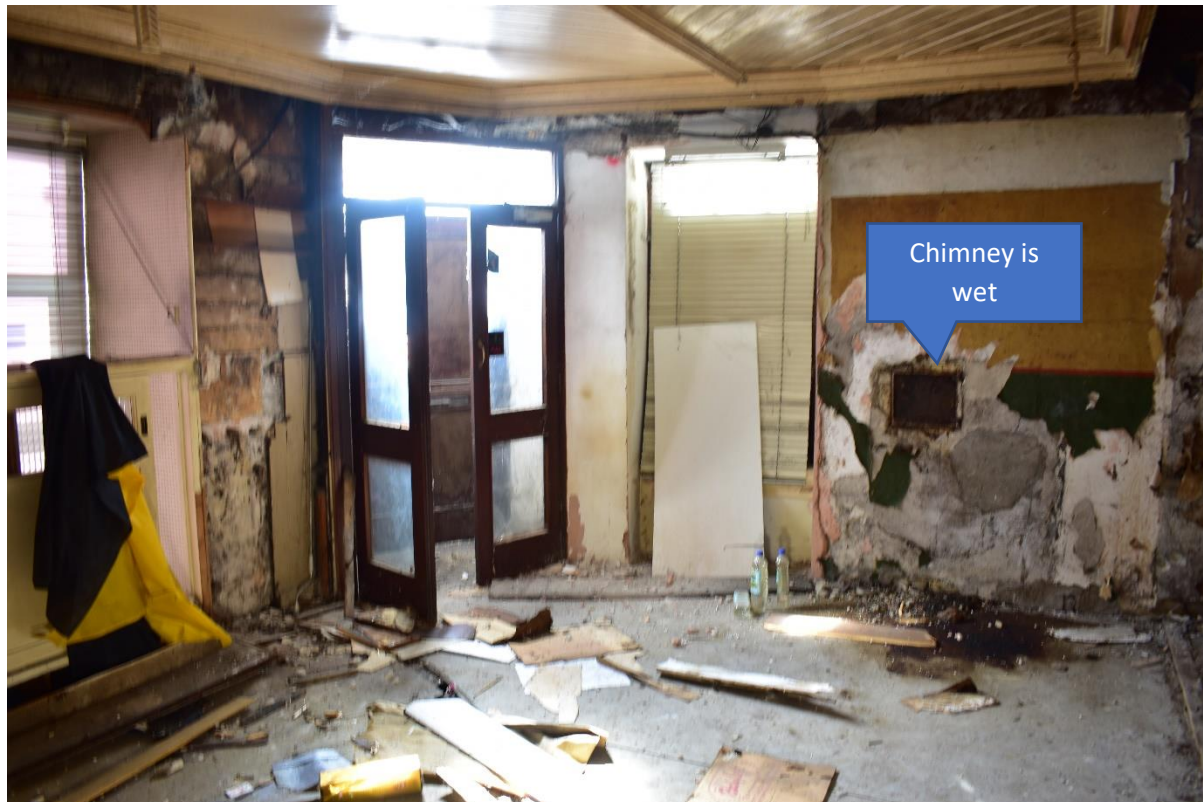
The fireplace/chimney was wet in this location during our inspection and heavily contaminated with salts.

Figure 11. Shows a broad view of the ground floor, including a section of the chimney that is currently wet.

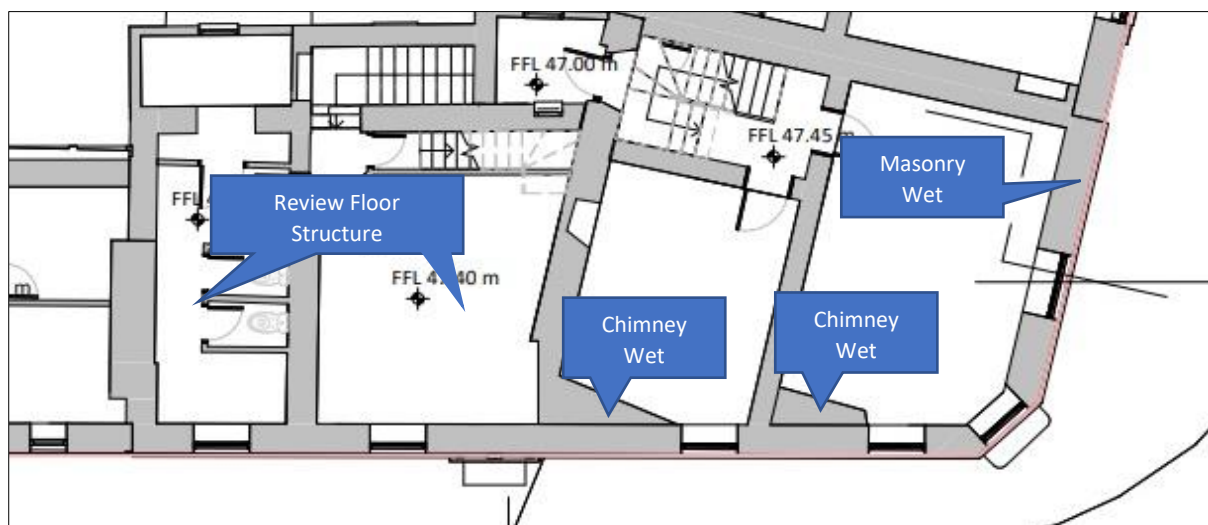
The first floor in the two-story section has heavy damage from the common furniture beetle, and the joists in the main room are supported on a steel midway. This section should be treated and strengthened or replaced per the engineers' detail. Review the joist ends when accessible. The joists over the carriageway have some damage from common furniture beetle. Similarly, they should be treated and strengthened/replaced as per the engineers' direction.

Figure 12. Shows a marked section of the first floor of Dooley's Pub.

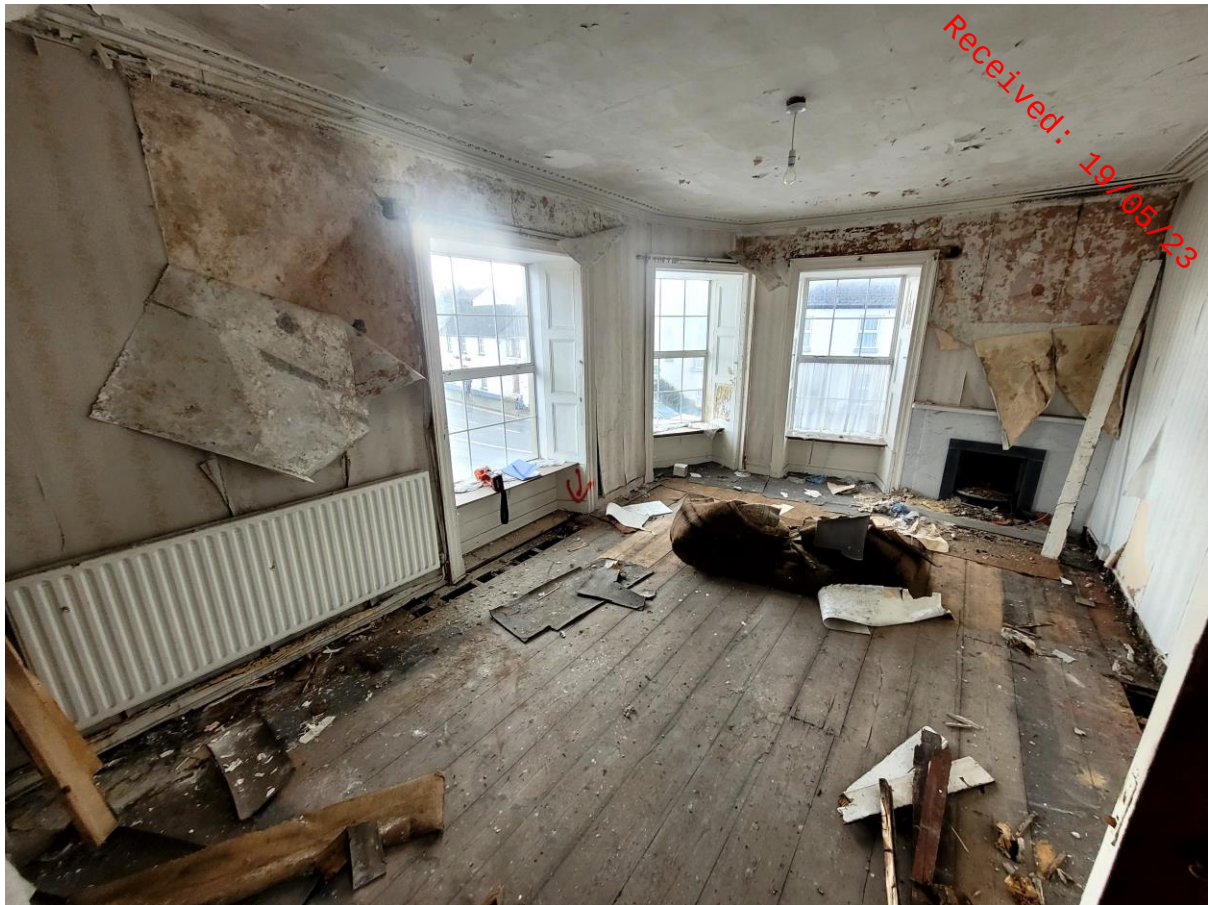
*Figure 13. Shows a broad view of the first-floor front room.*

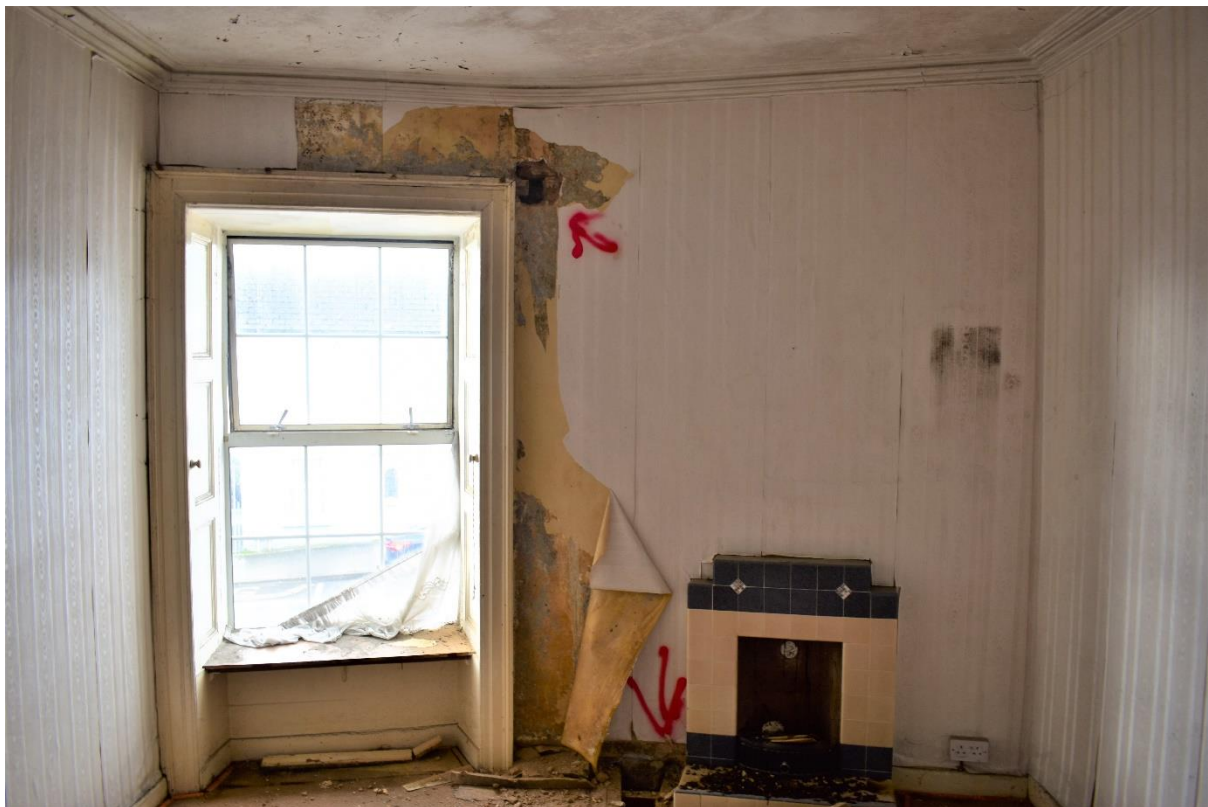
*Figure 14. Shows pockets exposed on the Dunlo Hill elevation.*

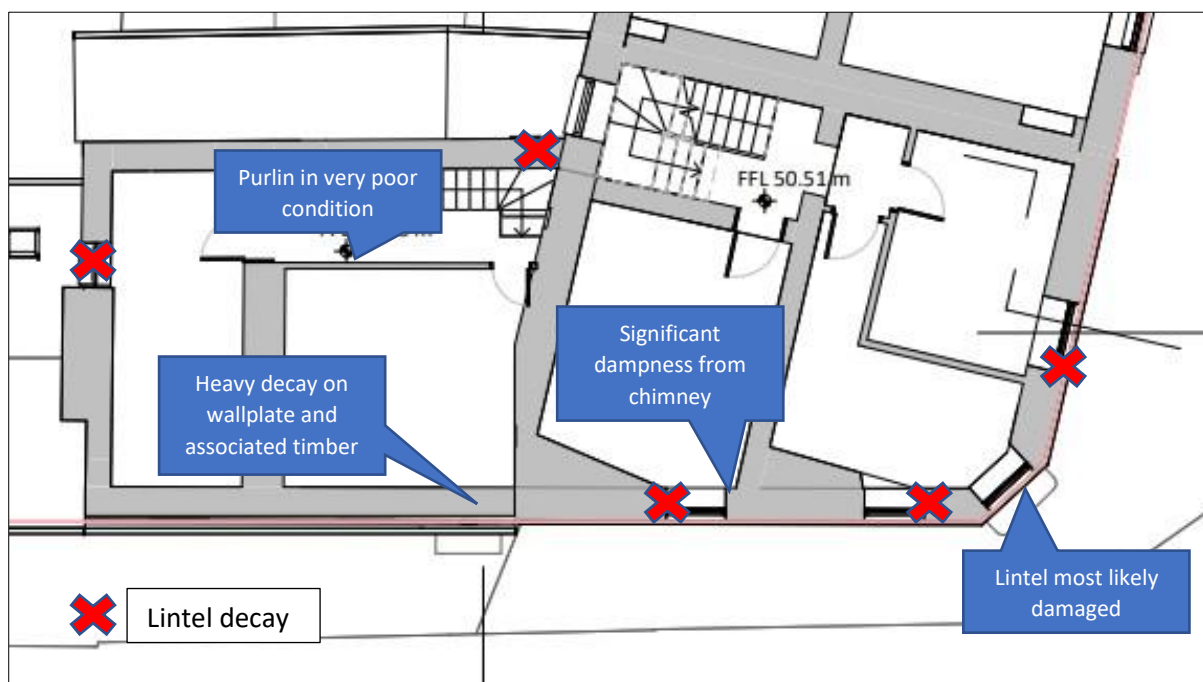
We have noted that all three lintels exposed at the front of the building have decay present, and the remaining two are likely to be in a similar condition. Allow for replacing all lintels at this level, subject to further review.

The wall plaster is in very poor condition at this level and contaminated with salts from water ingress. There is foil-backed lining paper used at this level, suggesting an ongoing issue with dampness at this level.

Figure 15. Shows marked-up areas of decay at the second floor level.

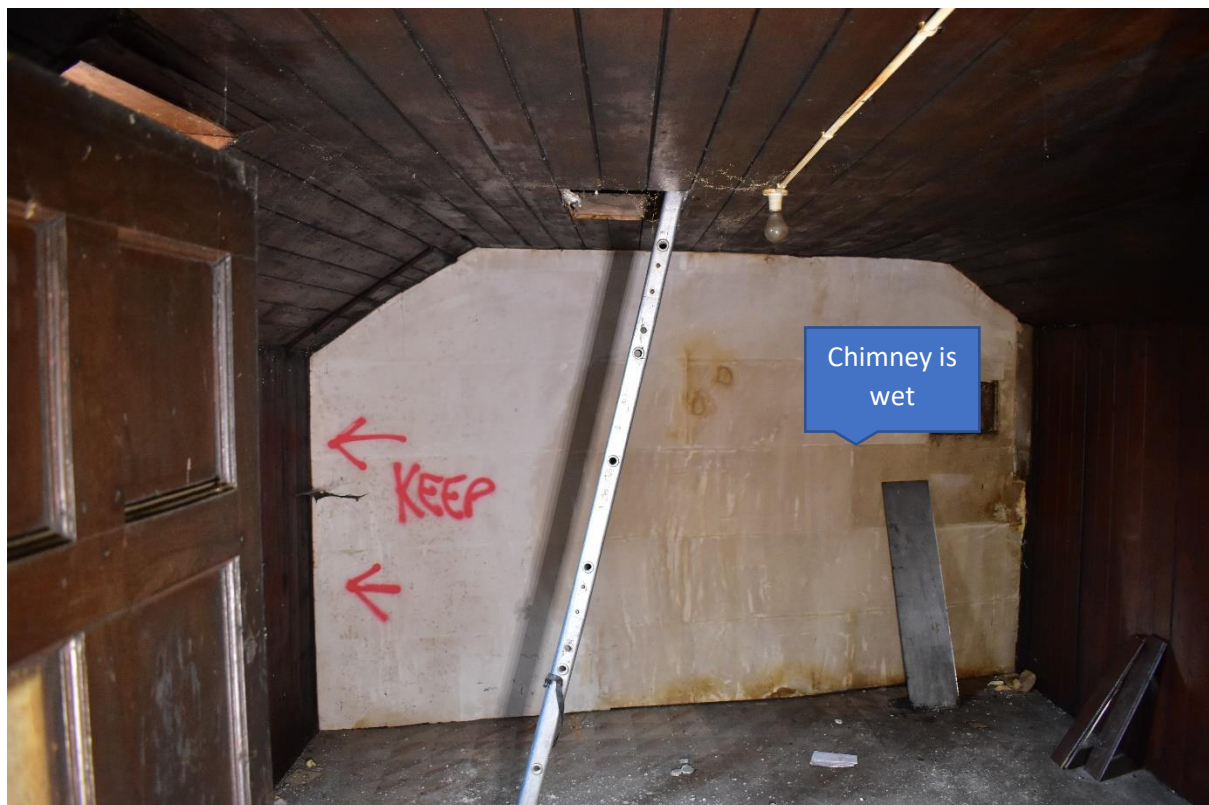
The main roof consists of a traditional cut timber roof as the primary structure. The roof structure is generally reasonably maintained, with localised decay noted primarily at the gable and chimney, which requires local repair. The roof is slate covered and underpinned with a non-breathable sarking felt, presumably installed in the 1970s. We have noted that the purlin ends embedded in the common chimney have decay present and require repair as per the engineers' detail.

The old lime parging/torthing is left on the flooring since the roof was stripped. We have not accessed the floor joists at this level. We have recorded that there is evidence of light scattered common furniture beetle (*Anobium punctatum*) within the roof space. The floorboards and joists have heavy damage in some areas.

The chimney is again consistently damp in this location due to water penetration.

Figure 16. Shows the broad view of the attic room in Dooley's Pub.

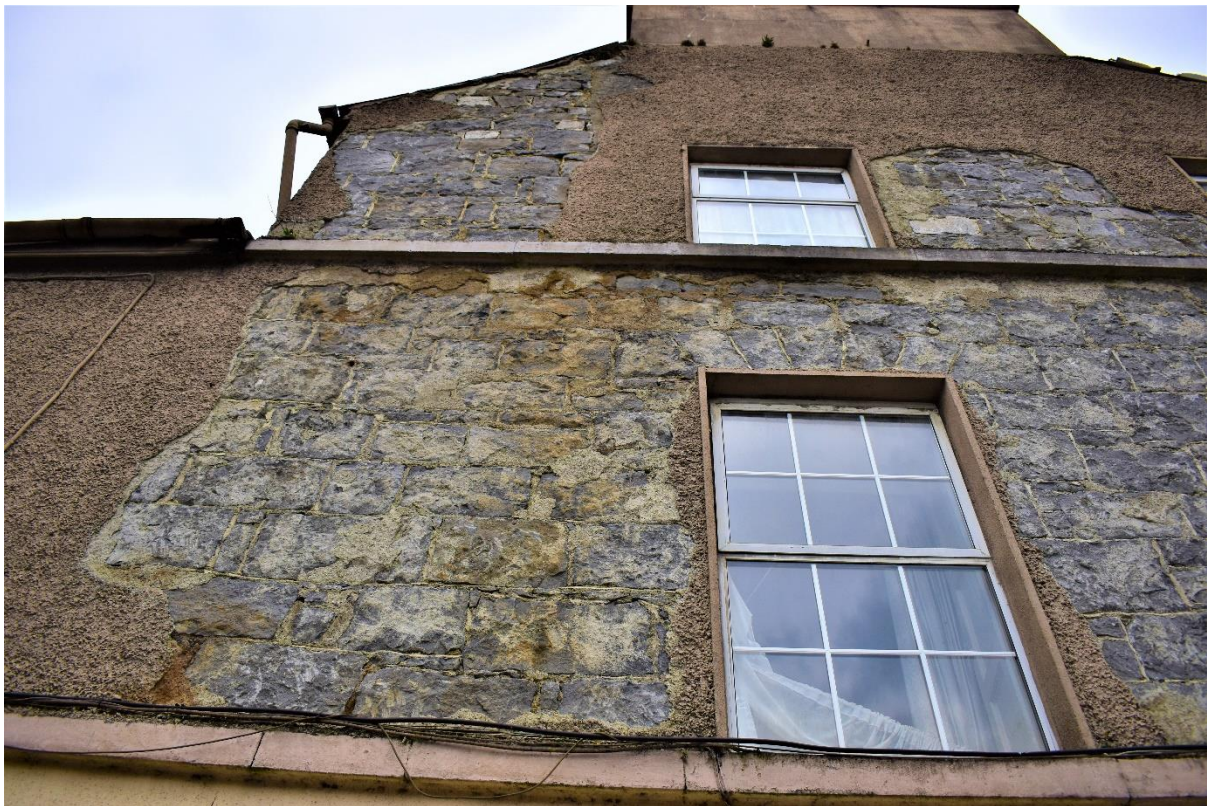
The render, which has blown in areas, appears to be sand and cement based, which contributes to the dampness within the building. There is a crack at a high level on the Dunlo Hill elevation, which allows water penetration into the building. We recommend that all render is removed and replaced with a lime-based harling-smooth render on completion. Note that a harling coat provides good water-shedding qualities and can dry out masonry faster than a smooth render.

The chimneys allow considerable water ingress into the building, which is causing notable staining both internally and externally. A poultice or additional action may be required at the Dunlo Hill elevation to address the salt contamination from 'bleeding' through the new render.

*Figure 17. Shows the external of Dooley's Pub where the render has blown. Note the staining from the chimneys.*

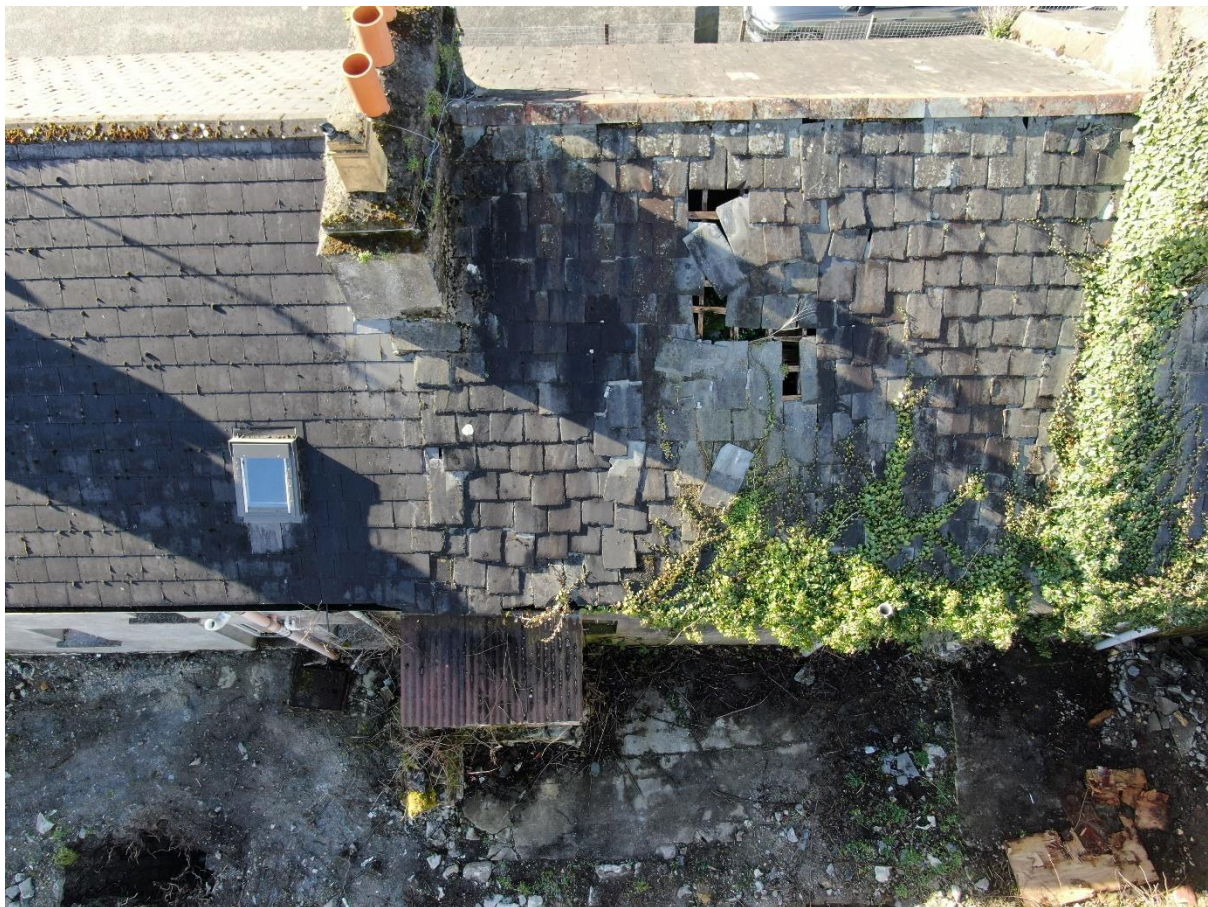
Apart from Unit 3, all roofs are in inferior condition, and some have failed allowing a significant amount of water into the buildings.

Figure 18. Shows an aerial view over a typical cottage that is in poor condition.

In our view, based on the level of decay present, we suggest that the entire timber structure – Roof, First floors, Suspended timber floors and Timber lintels are replaced in full as per the engineers' detail.

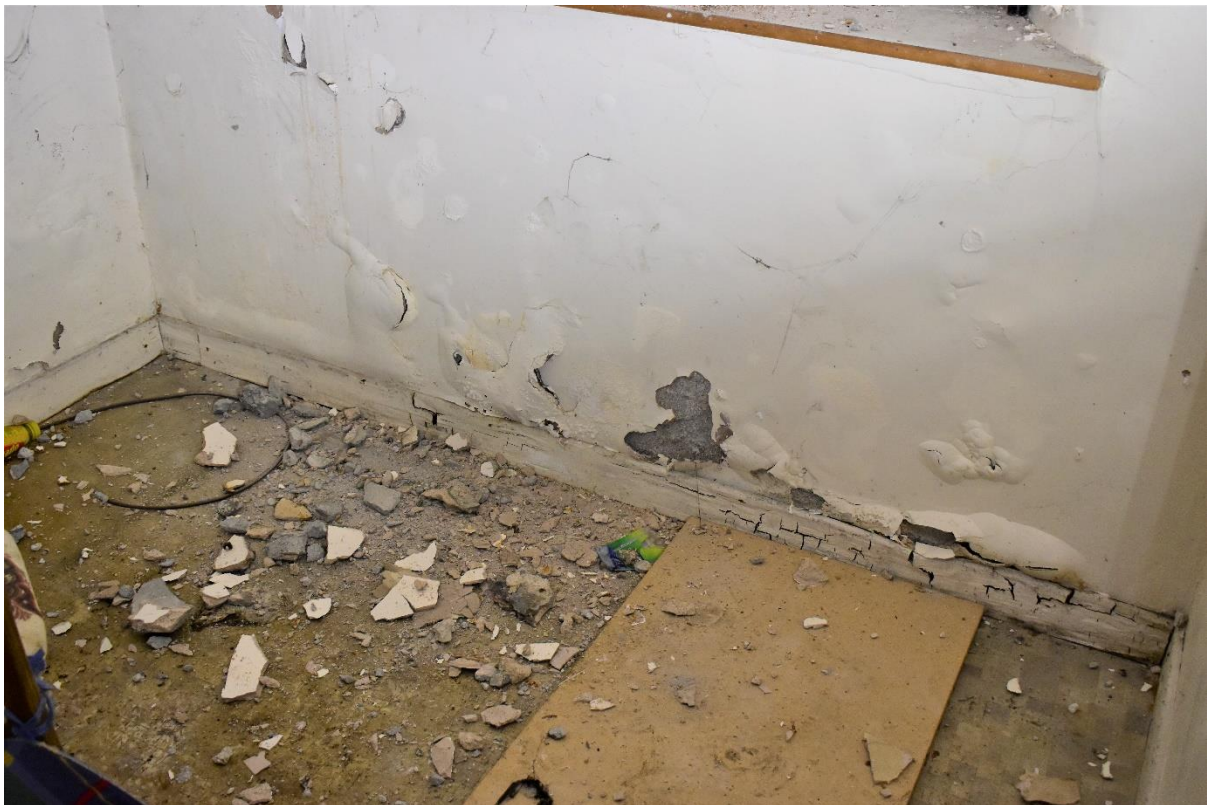
No physical DPC was located during our inspection of the building as expected. As highlighted above, the internal FFL is lower than the road level along with the gable of Unit 1. This is the significant contributing factor to the rising dampness noted. As the floor is low in relation to the external footpath/road, the moisture rises to approximately 1500mm above floor level in the buildings.

*Figure 19. Shows a typical section at the base of the masonry in a cottage from rising dampness.*

The following proposal is subject to further review when the masonry is fully accessible. We recommend that all floors be removed in full. We recommend that a Geocell/Glapur foam glass gravel is installed as per the engineers' detail. Allow for additional depth adjacent to all external walls; this detail reduces capillary action against the external walls. This should also be considered externally below the footpath.

Externally, reduce ground levels. At the rear of the buildings, install a French Drain detail as per the engineers' detail, and ideally, the drain should be 1 meter out from the external wall. Install Geocell/Glapur foam glass gravel to the trench to prevent capillary action against the wall. Install a decorative stone to finish top if required.

On the street side, ideally, additional drainage is introduced against the wall. Install an appropriate stone drainage channel along the face of the building to guide water away.

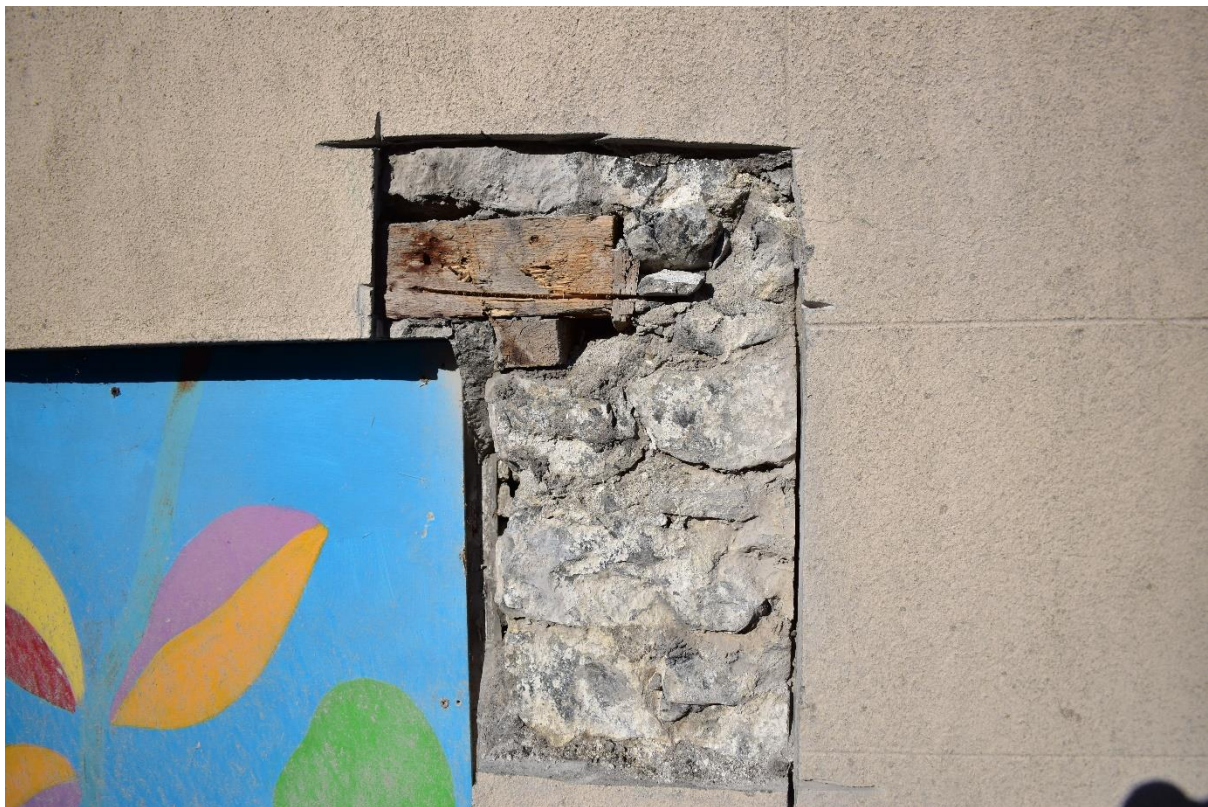
*Figure 20. Shows a section of removed render that has exposed an external timber.*
