## PRELIMINARY DAMP & TIMBER DECAY REPORT

**Re: Renovation & Alterations at Dunlo Hill/Dunlo Street, Ballinasloe, Co. Galway.**

**The Buildings Inspected:** A set of seven workers' cottages. A two-bay by two bay three-storey end-of-terrace building (former pub which is a Protected Structure RPS 2730) with a two bay two-storey addition. A two-bay, three-storey terraced building (townhouse).

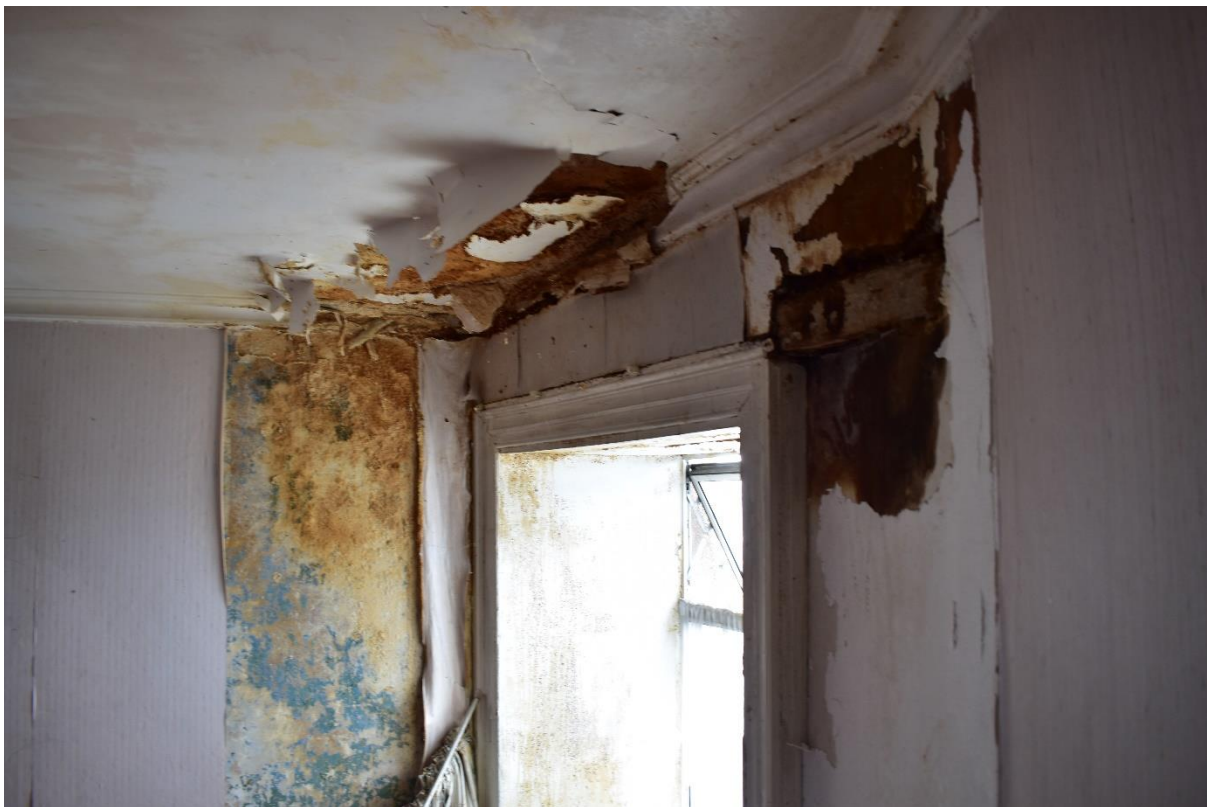
As discussed in this document, all chimneys appear to be causing issues from decades of burning solid fuel which has been exacerbated by water ingress. There is significant staining 'bleeding' through the masonry in practically all buildings. The salt-contaminated mortar can continue to 'bleed' through the fabric on completion, and in our view, it should be isolated. There are specific mortar mixes that can help control the salt contamination that could be considered.

*Figure 21. Shows a section of deterioration from salts bleeding through from the chimney at the second floor level in Dooley's Pub.*

We recommend that a robust repair is carried out on all chimneys. Ideally, this work would be carried out early in the project to start the drying-out process.

In our experience, hygroscopic salts can lead to dampness issues exacerbated by internal humidity. Provide to strip all decayed internal plaster on any chimney.

Provide to clean out all chimneys, install an anti-rain/bird cowl on completion, and ideally; all flues vent from each room.
