Bat Survey & Mitigation Measures
For the Demolition of a Disused Dwelling
& Replacement with 2 no. Dwellings
at
Woodford, Co. Galway

Doherty Environmental Consultants Ltd.

March 2024

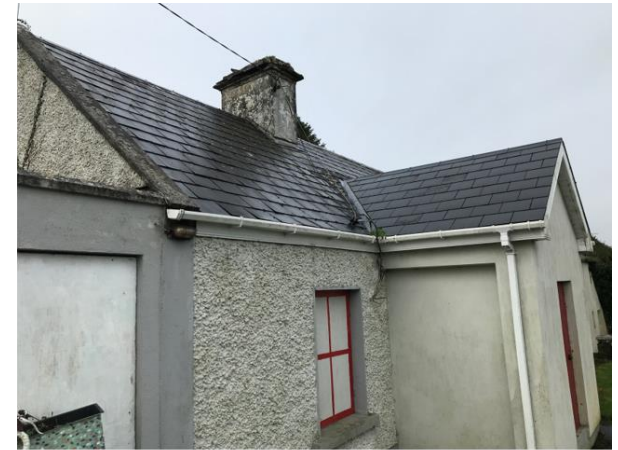
Plate 3: View of slate roof in good condition with no obvious access points to the interior

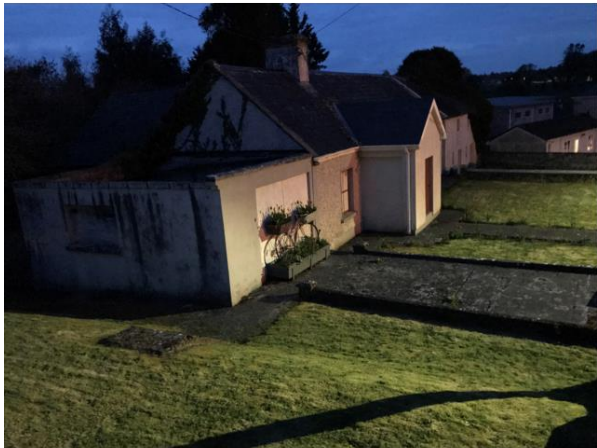
During the inspection survey positions were taken up to the south of the dwelling (see Appendix 1: Plate 4) that provided a vantage view over the structure and the roof.

Plate 4: Night view of dwelling during bat surveys

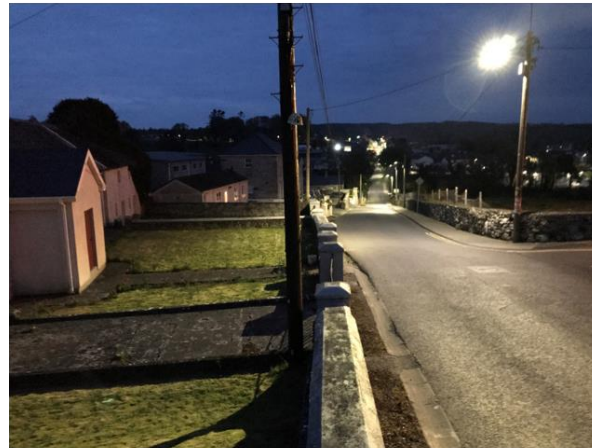
Plate 5: Night view of dwelling and adjacent street lighting during bat survey

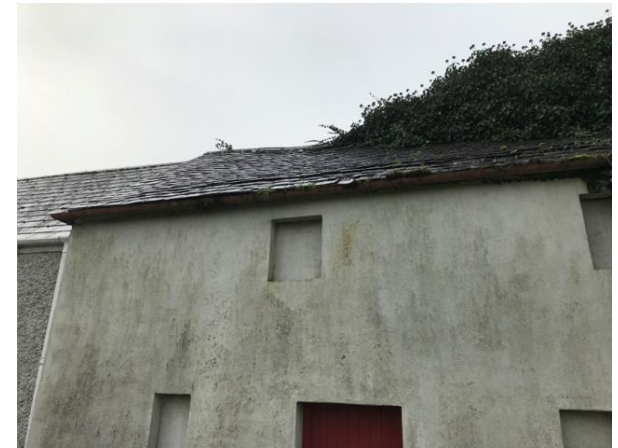
Plate 6: View of adjoining shed area with uneven slates but no obvious access points on the front elevation.

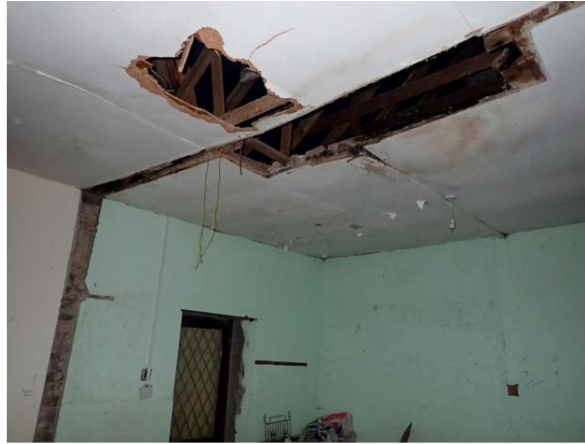
Plate 8: View of degraded ceiling during March 2024 survey

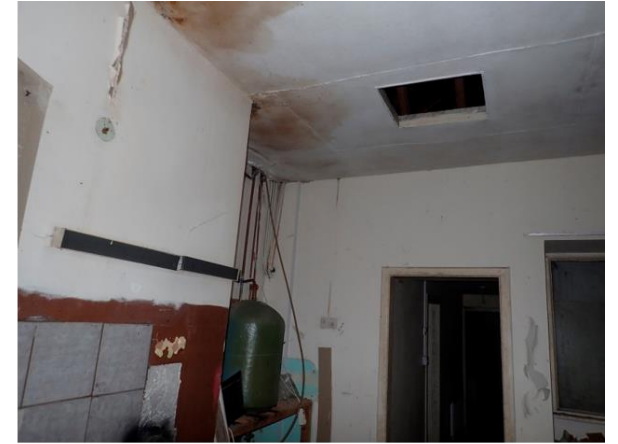
Plate 7: View of loft hatch during March 2024 survey
