## **Building Conservation Assessment**

Barkhill, Woodford, Co. Galway (**Planning Ref: Part 8 LA01/24**)

**Client:** Galway County Council

**Date:** 28<sup>th</sup> of June 2024

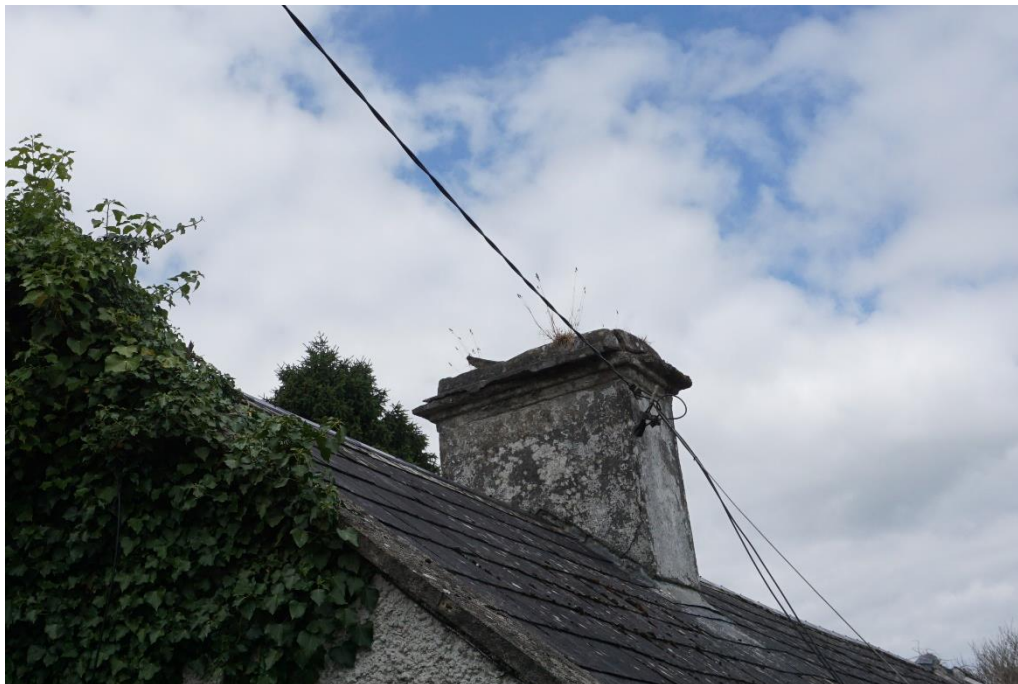
**Photograph 2 - Chimney from Southern Side**

The stone chimney stack on the original cottage is rendered with cementitious mortar. There are no chimney pots present. There are no obvious signs of structural movement as there is no cracking in the render and the stack appears to be plumb.

The existing building section of the potential alternate/adaptative approach would require the use of traditional materials in and around the natural fabric of the building. The intact chimney stack will require removal of the cementitious render and application of a natural lime-based render, traditional capping, and flue pots to finish (retention of the chimney stacks would be recommended from the perspective of the preservation of the character of the buildings).

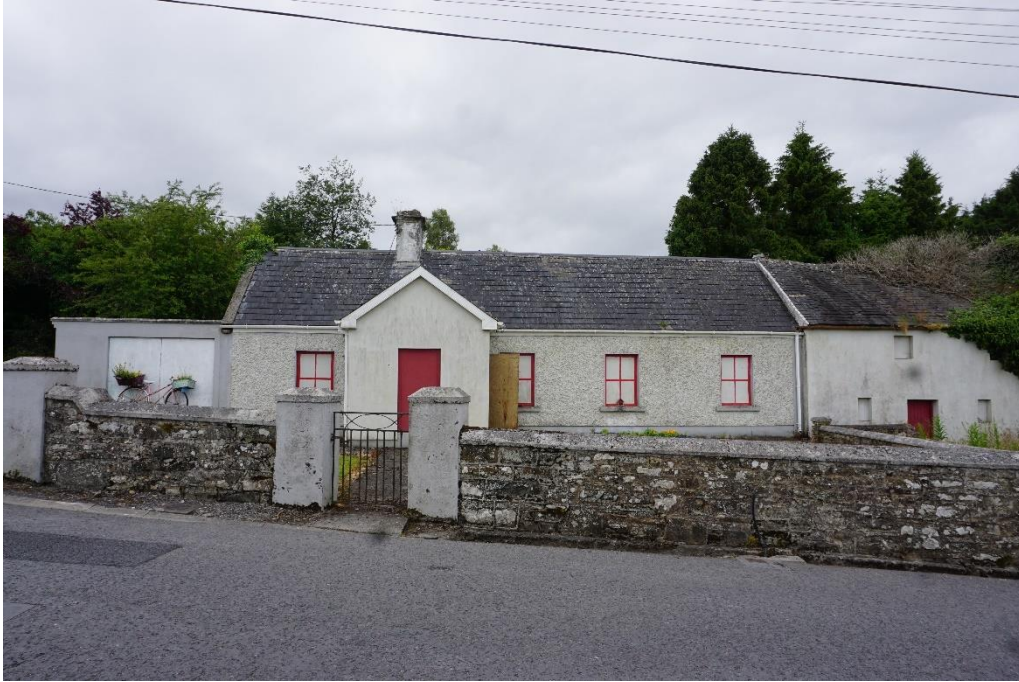
**Photograph 3 - Front Elevation of Dwelling from Eastern Side**

There are no obvious signs of failure of the roof structure or covering with no indication of water ingress. The roof of the original cottage is a mixture of modern and original timbers with a modern fibre cement slate (suspected asbestos) roof covering. A portion of the roof of the original cottage has an underlay, a portion has some parging and the remainder has no secondary protection. There is a modern roof with felt underlay and modern fibre cement slates to the rear extension and to the front porch.

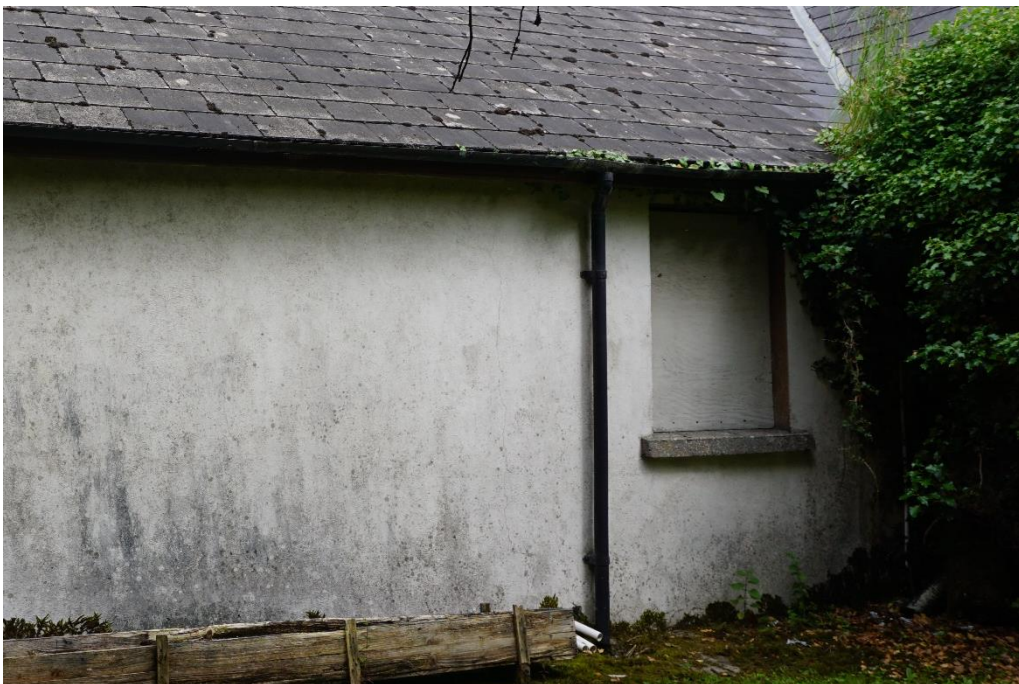
**Photograph 4 - Galvanised Steel Rainwater Goods on South Elevation of Modern Extension**

There is a mix of modern uPVC and galvanised steel rainwater goods present on the dwelling.

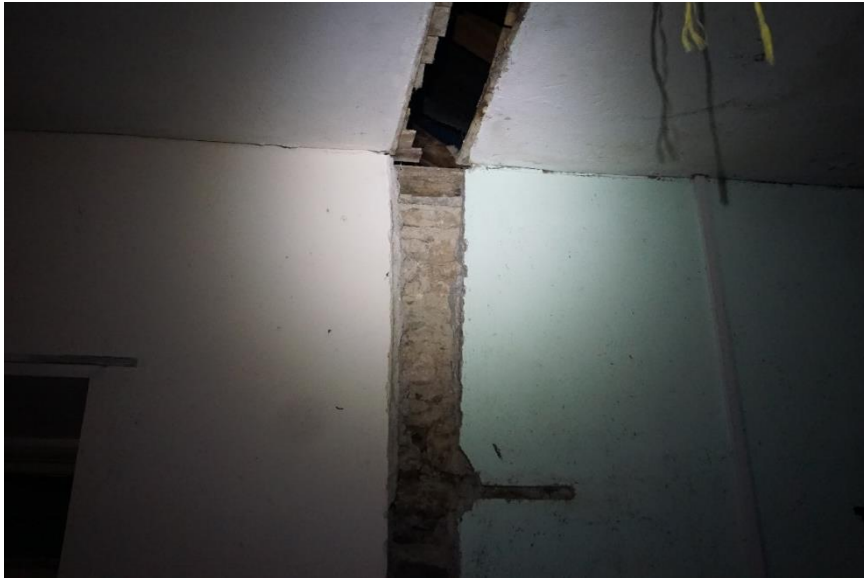
**Photograph 5 - Cementitious Render on Original Stone Wall in Living Room**

The original stone walls of the cottage have a cementitious dash render applied externally and a heavy cementitious render applied internally. The modern extension to the rear of the dwelling, the front porch, and the south garage extension are constructed in modern blockwork. A modern lining system has been applied to the walls of the most southerly room. There are modern stud partition walls internally which are in poor condition.

It is possible to retain the existing walls of both buildings and incorporate them into the proposed development. In the case of the house, the stone masonry walls have been rendered with a heavy cementitious render. The retention of the walls of the house will not be known until this render has been removed in full (a necessary act, given the construction form and incompatibility of the materials present). Should they be suitable for integration, remedial repair works will be required in the guise of raking and repointing of the masonry using a traditional lime mortar in order to stabilise the walls and prepare them for finishing (with a natural lime render, to ensure that vapour transmission through the natural fabric is controlled and as per original intention.

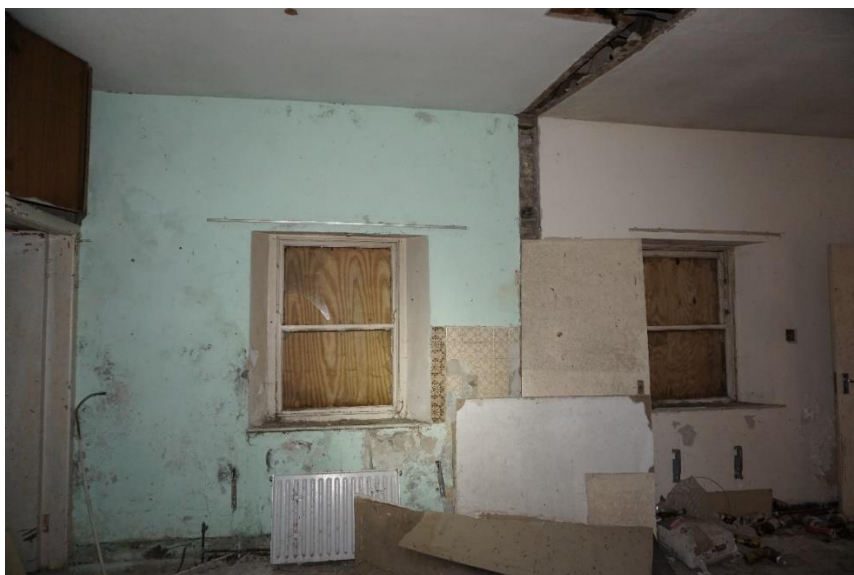
**Photograph 6 - Traditional Sliding Sash Window Assemblies in Living Room**

There is a mixture of traditional sliding sash window assemblies and modern timber casement windows in the original cottage. The traditional sliding sash windows are in a relatively fair condition that can be successfully repaired with new glazing panels installed. All the original internal window surrounds are no longer present.

It would be recommended to retain the sash up down assemblies, which are in relatively good repair. Upgrading them with slimlite double glazing and draught stripping to aid in reduction of heat loss.

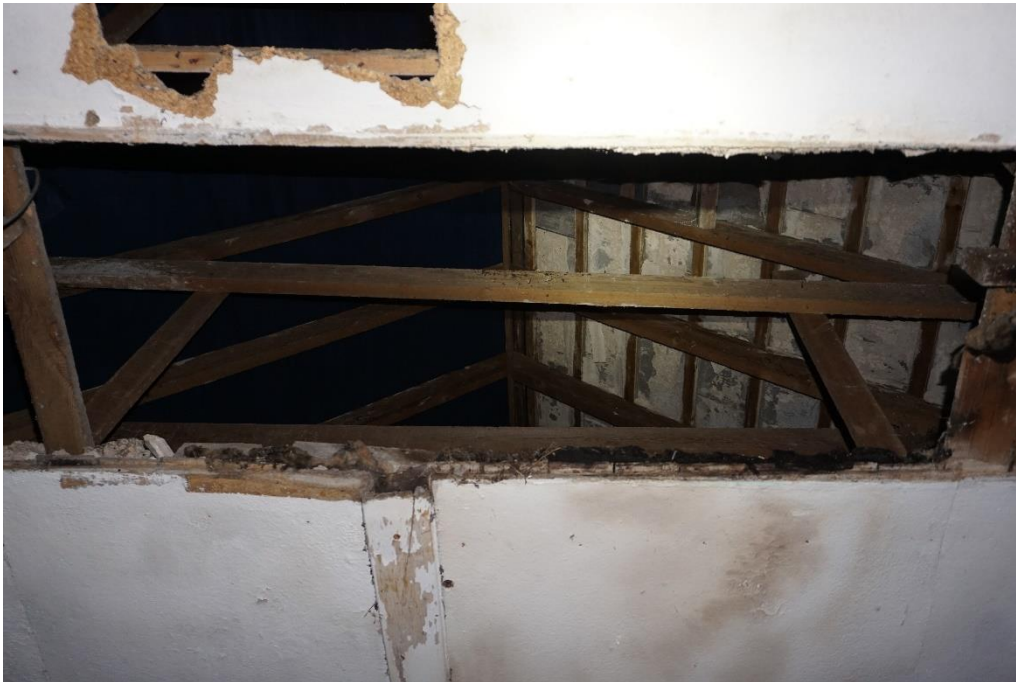
**Photograph 7 - Modern Plaster Board Ceiling in Living Room**

There are modern plaster board ceilings throughout the dwelling which are in very poor condition.

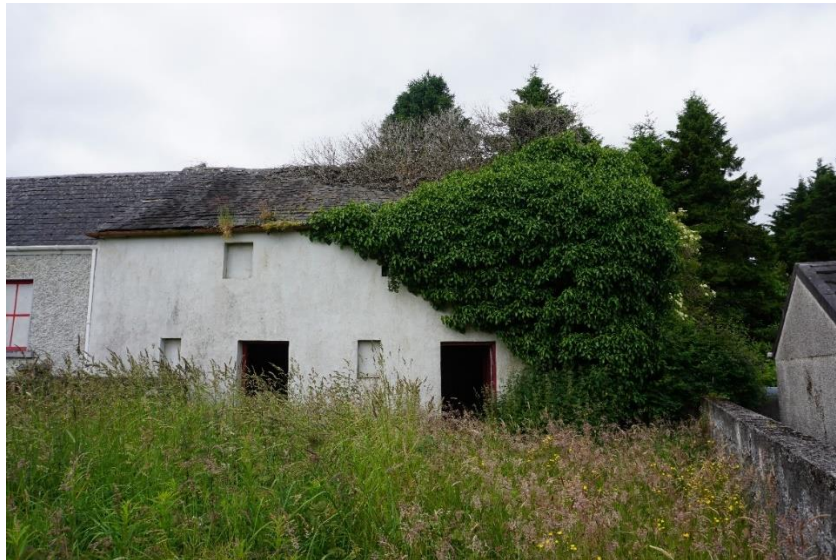
**Photograph 9 - Front Elevation of Outbuilding Showing Roof and Obscured Chimney**

The chimney cannot be seen due to severe vegetation growth and the condition could not be determined.

The original roof structure is present with the natural slate covering and ridge tiles. The loft was not accessible on the day of inspection therefore the condition of the timbers could not be determined. There are visible undulations in the roof structure, and the northern end has heavy vegetation growth.

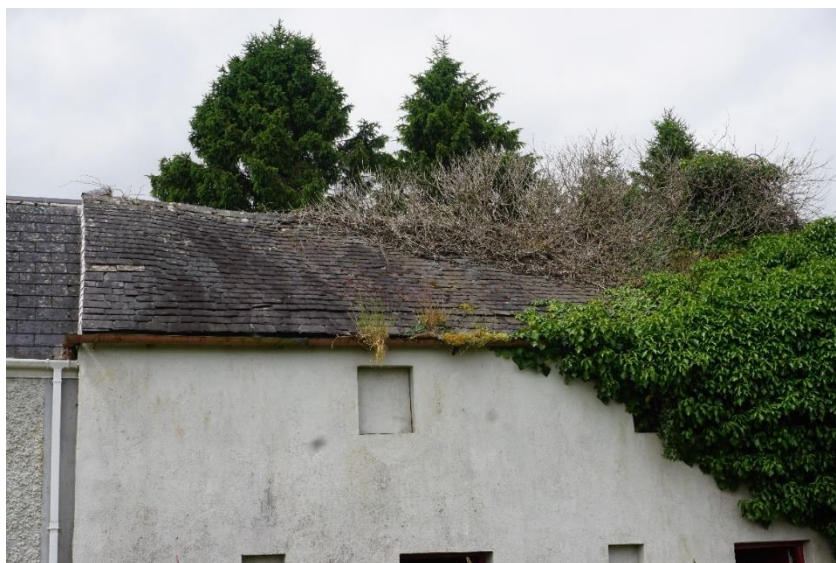
**Photograph 10 - Galvanised Steel Rainwater Goods on Outbuilding Front Exterior**

There are galvanised steel rainwater goods present on the outbuilding which are in poor condition.

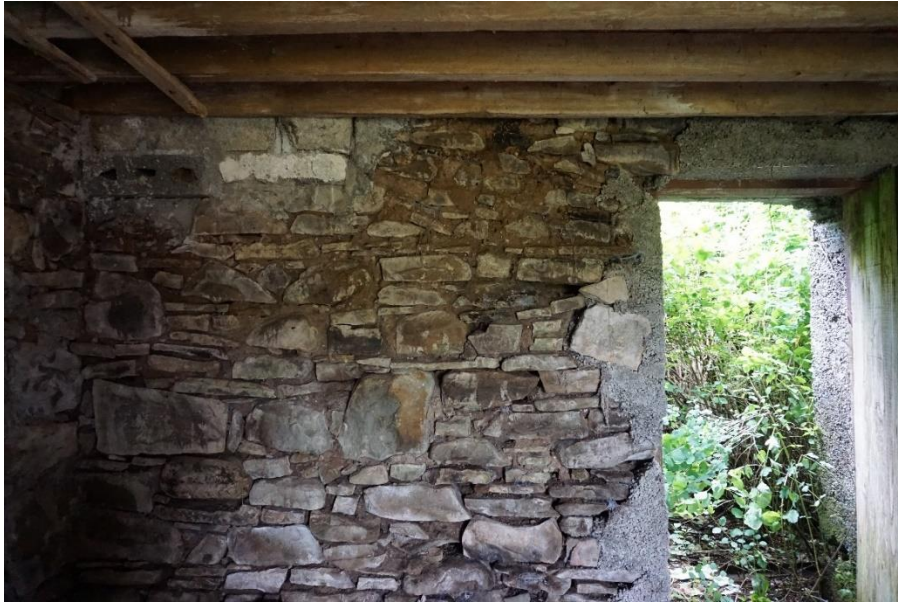
**Photograph 11 - Outbuilding Rear Interior Sandstone Wall**

The original walls throughout are of random coursed sandstone construction. The front elevation has a smooth rendered finish (suspected OPC render). The remainder of the walls are unfinished. Portions of the rear wall and northern gable were not visible due to heavy vegetation growth. There are no obvious visible signs of structural failure in the walls.

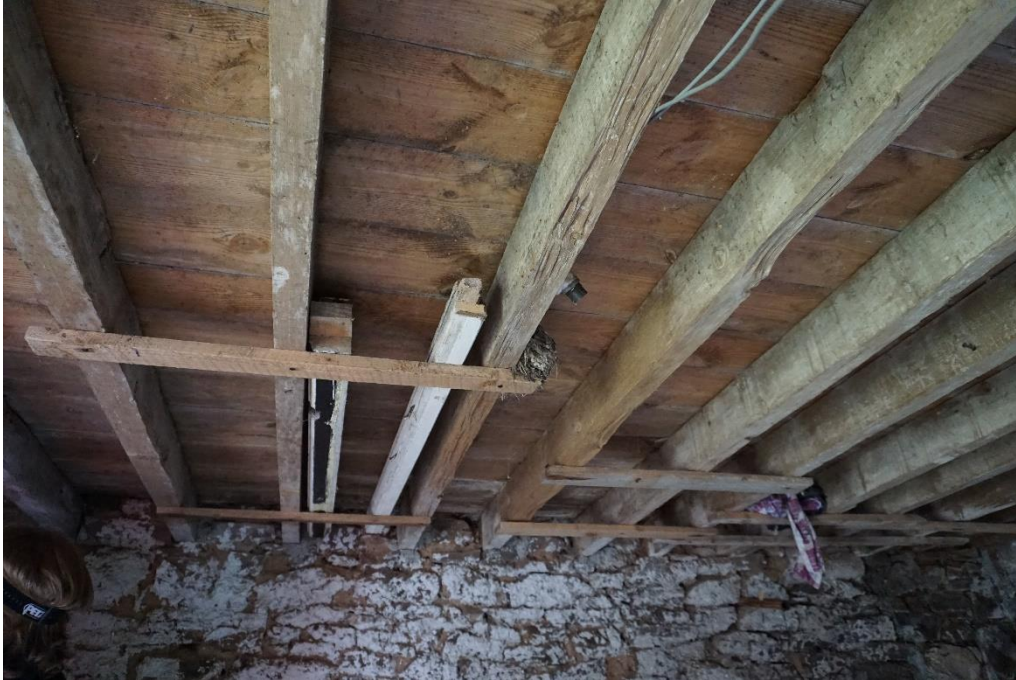
**Photograph 12 - Underside of Timber Suspended Loft Floor**

There is an original timber suspended loft floor which was only visible from the underside as the loft was not accessible on the day of inspection. The timbers are in relatively good condition for their age, however there are some visible signs of insect attack.
