# Consideration of Adaptive Reuse of Existing Dwelling and Outbuilding at Barkhill, Woodford, Co. Galway

July 2024  
GCC/HC/CMD

## 1.0 Introduction

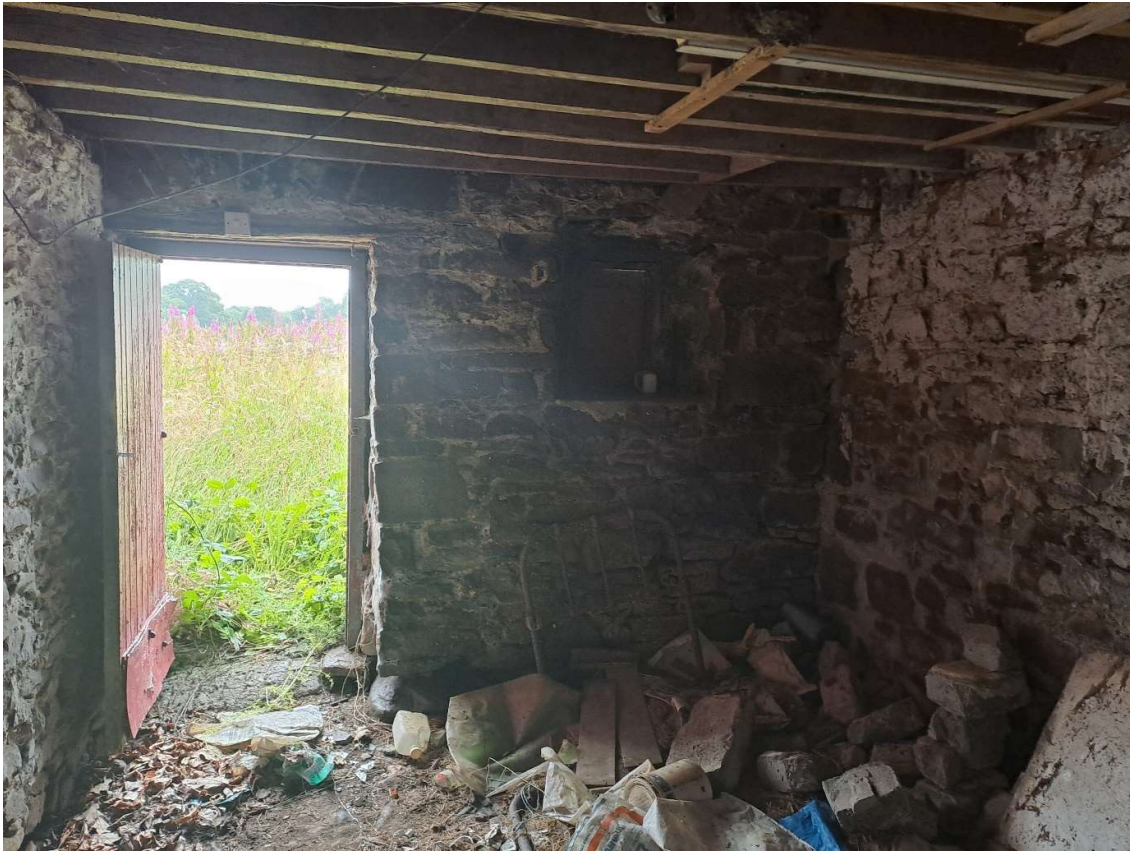
There are a number of areas of concern in relation to the above requirements. To address the issues highlighted in the photographs in Appendix A, the building is likely to require significant interventions including underpinning of the foundations, removal of inappropriate amendments to heads of opes and structural installation of lintels, removal of the internal separating wall, assessment of foundation to the rear wall (West) which is showing inappropriate stone sizing. The ivy growth to the North wall is significant and is evidently affecting the roof structure. The effects of the ivy on the structure of the North wall and chimney is unknown and would require assessment following ivy removal.

*Figure 3- Overview of stone structure missing adjacent to door ope threshold*

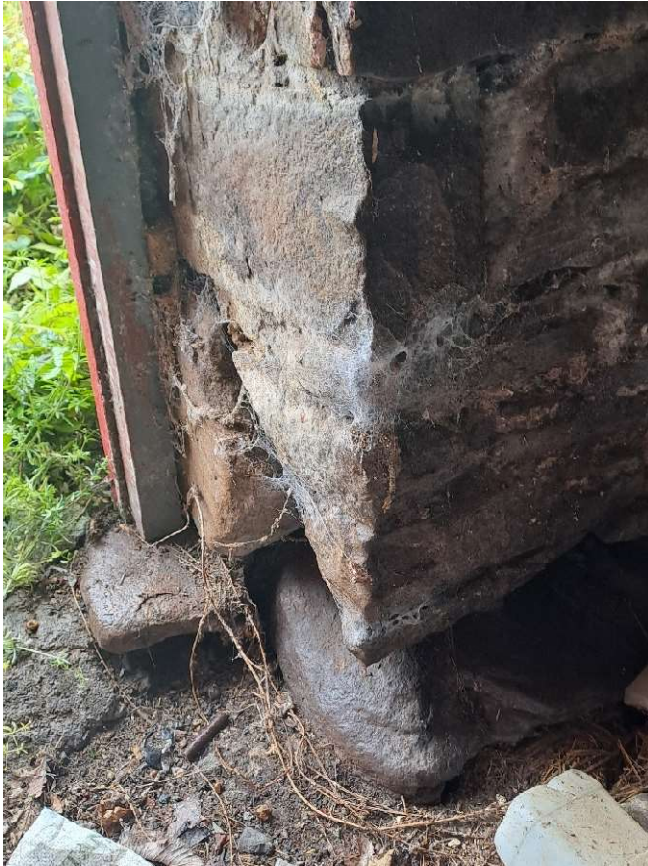
*Figure 4- Detail view of stone structure missing adjacent to door ope threshold*

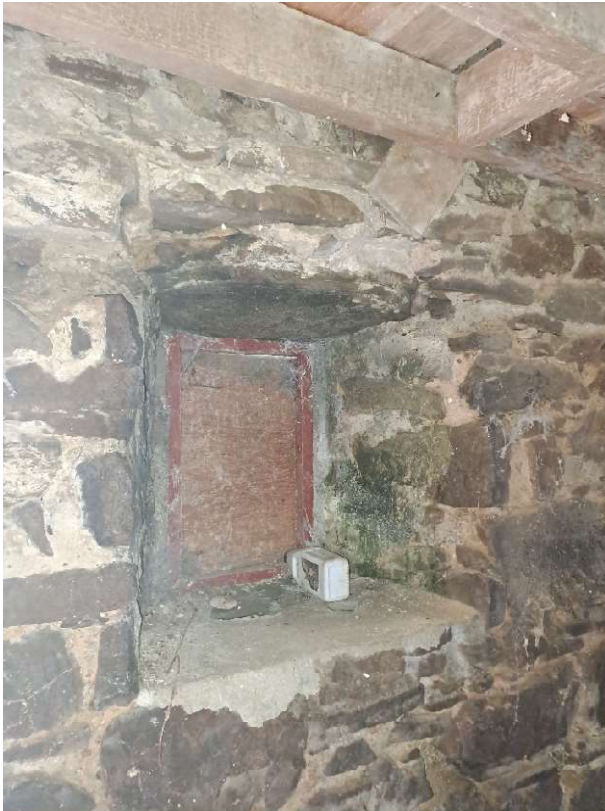
*Figure 5- Structural supports missing to internal head of window ope 1*

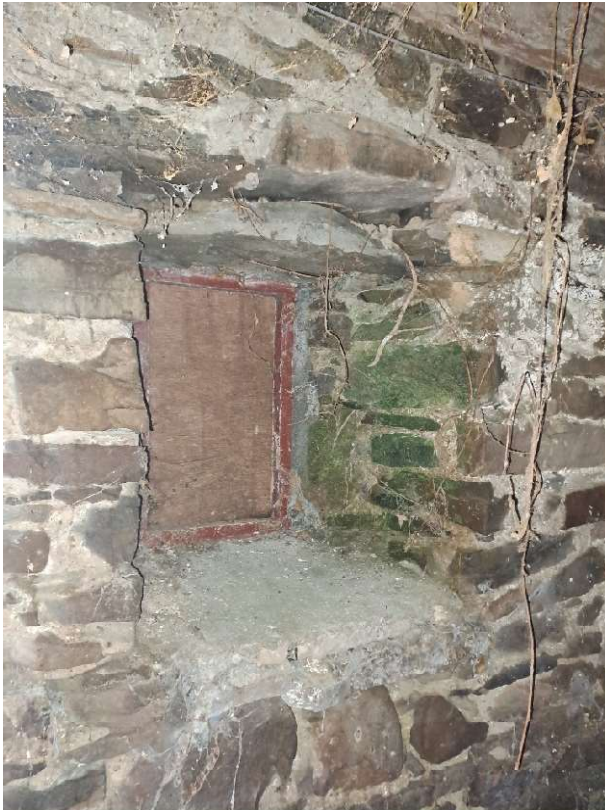
*Figure 6 - Structural supports missing to internal head of window ope 2*

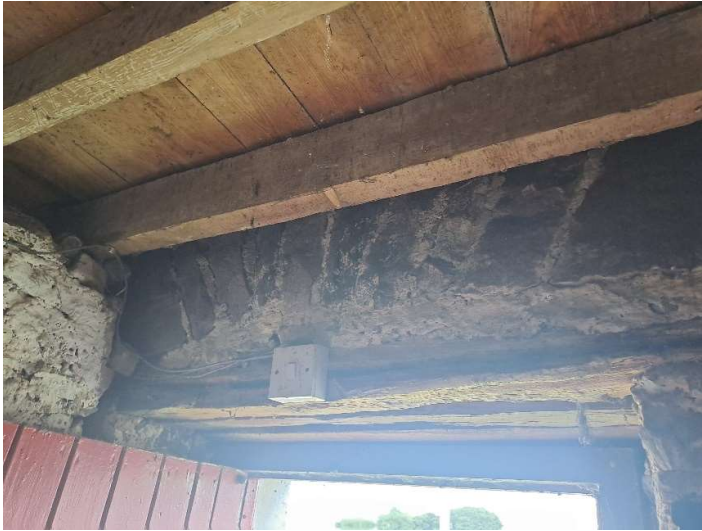
*Figure 7- Evidence of intervention to original arched door opening head*

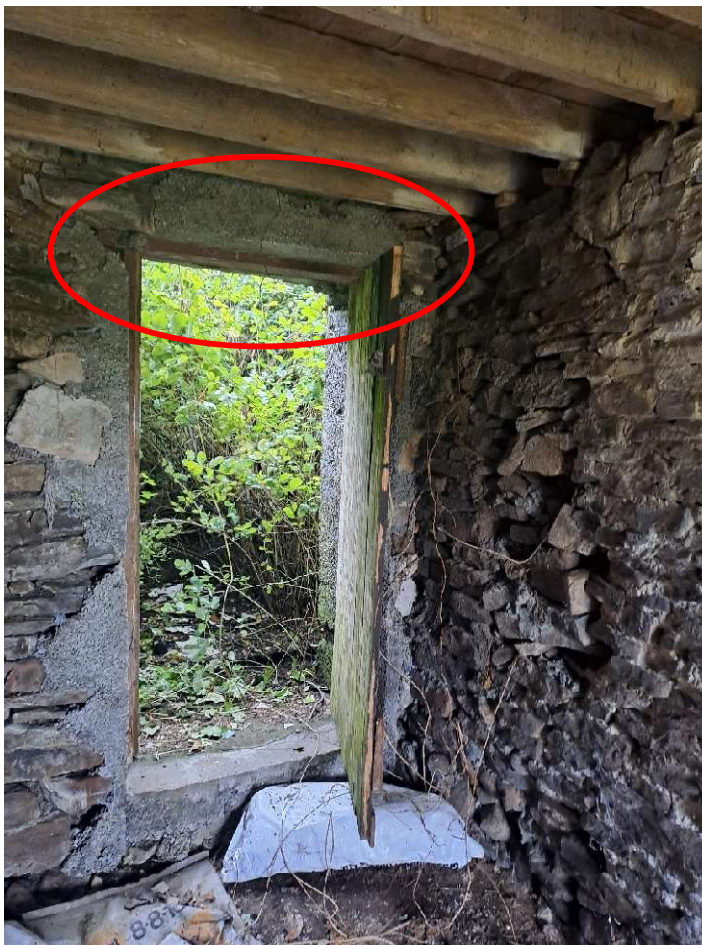
*Figure 8- Evidence of intervention to original rear wall to create a door opening (no structural lintel to head)*

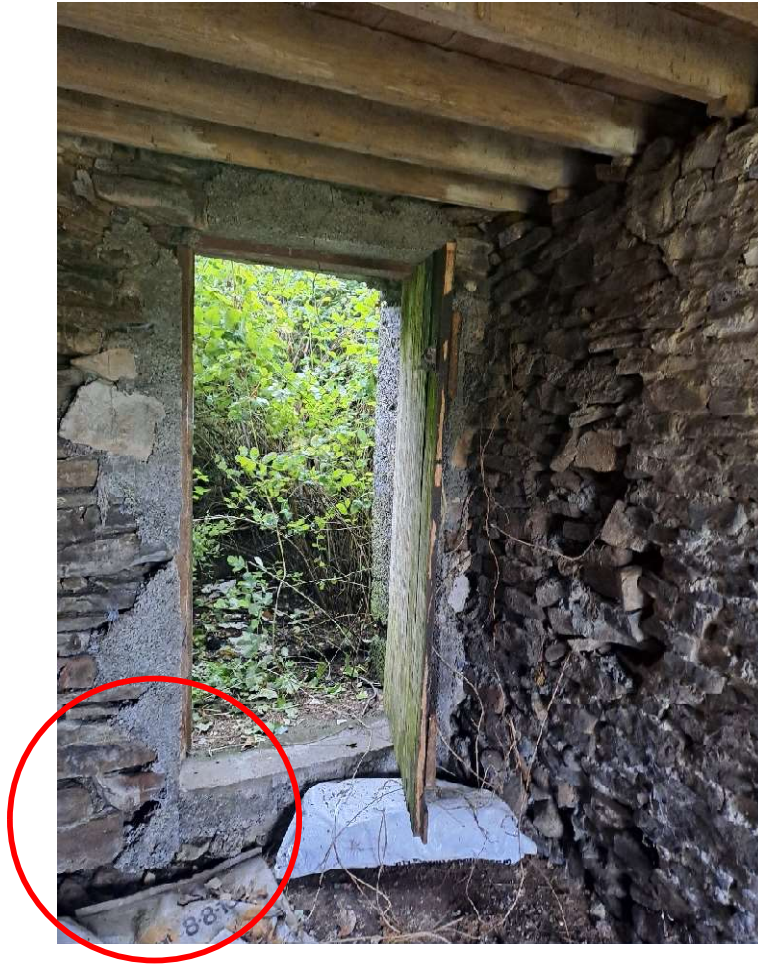
*Figure 9- Smaller stones at foundation level than that of the supported wall*

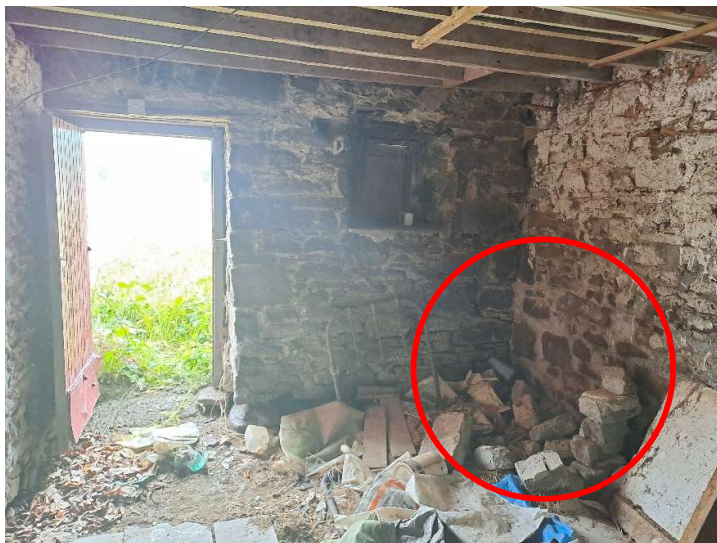
*Figure 10- Significant mortar infill to base of wall*

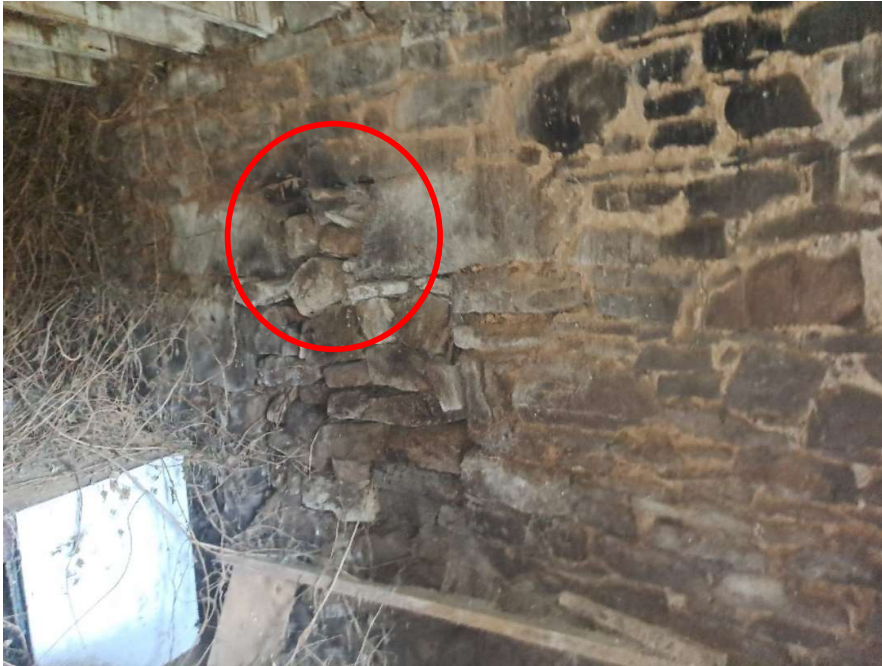
While there is evidence of an open fire and chimney to the North wall the structure appears to be compromised with the removal of the fireplace keystone. The condition of the chimney is unknown but the adjacent roof is evidently compromised with heavy ivy growth. Provision of a closed stove here would require significant intervention with removal of apparent load bearing stone to the fireplace. Further analysis of the chimney structure would be required on removal of the ivy. The building would require analysis to determine the most appropriate form of heating and pipework would be required in all instances which would be required to circulate below or through the external wall structure.

*Figure 11- Missing Keystone to original fireplace ope*

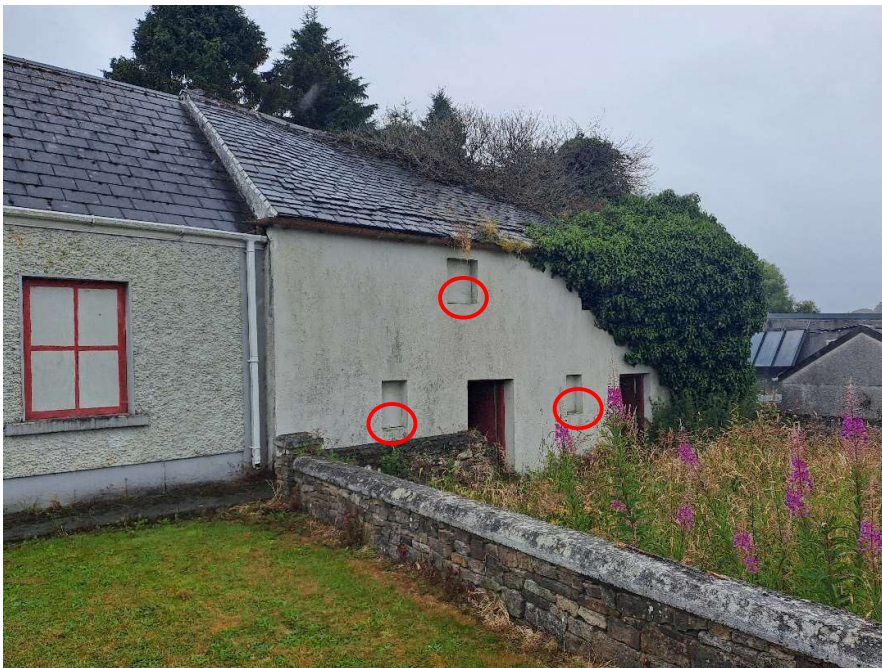
*Figure 12- No existing external cills to window opes*

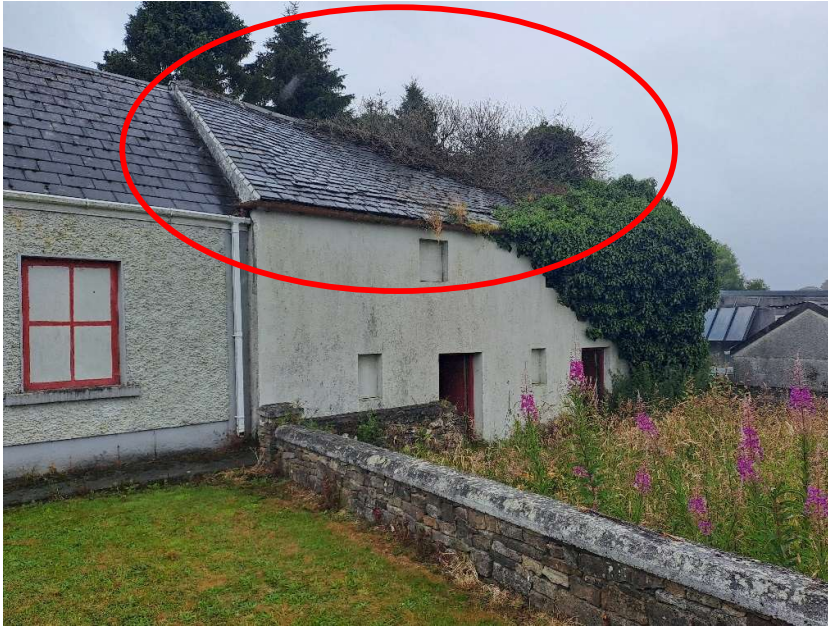
*Figure 13- Significant Ivy growth with visible undulations in the roof structure*

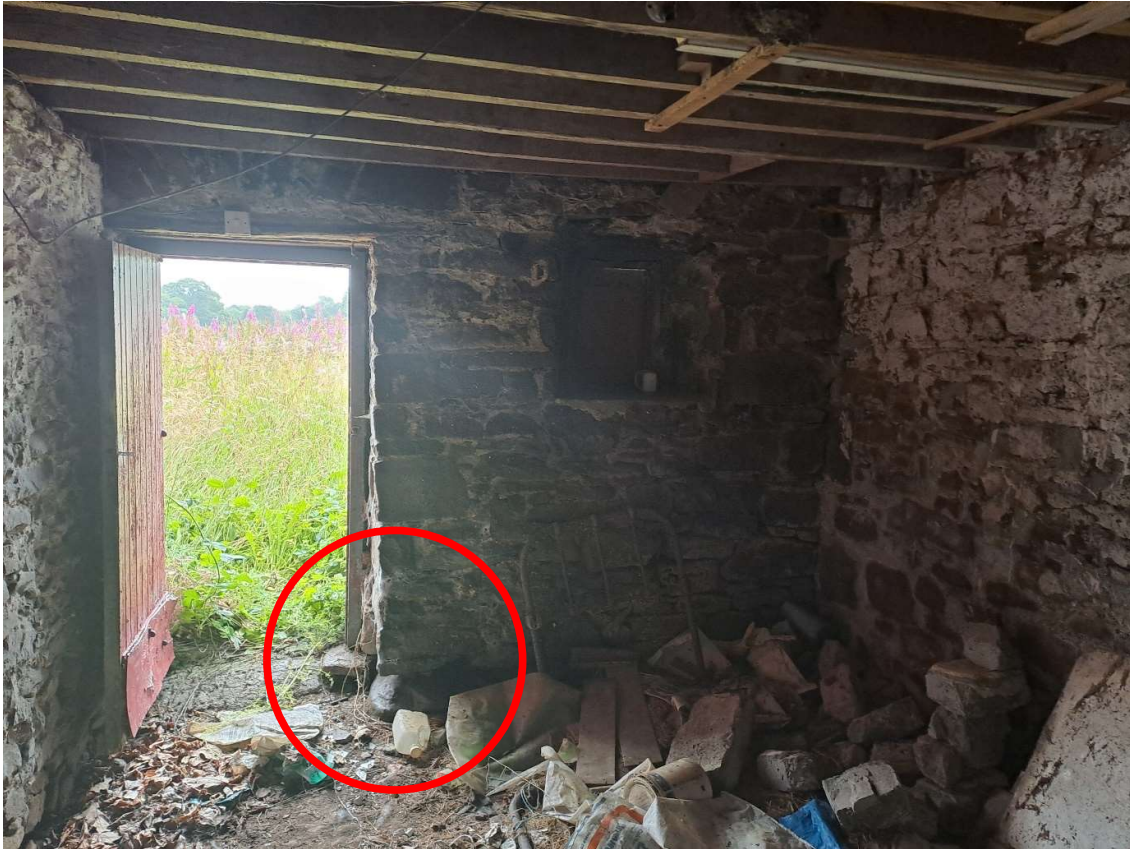
*Figure 14- Overview of stone structure missing adjacent to door ope threshold*

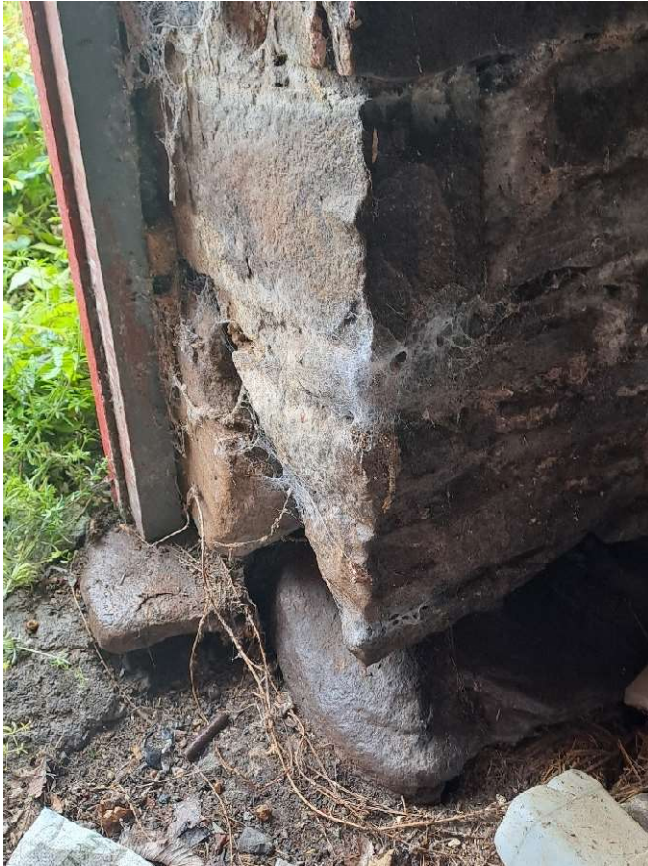
*Figure 15- Detail view of stone structure missing adjacent to door ope threshold*

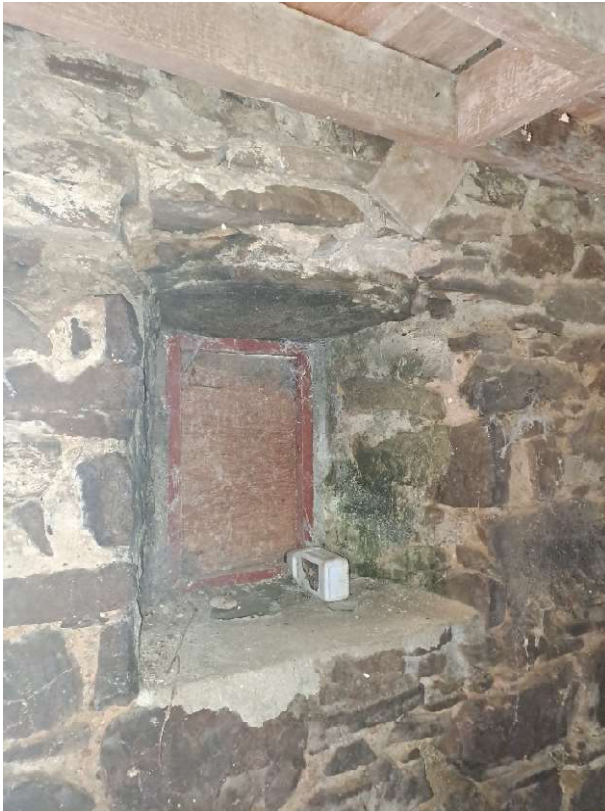
*Figure 16- Structural supports missing to internal head of window ope 1*

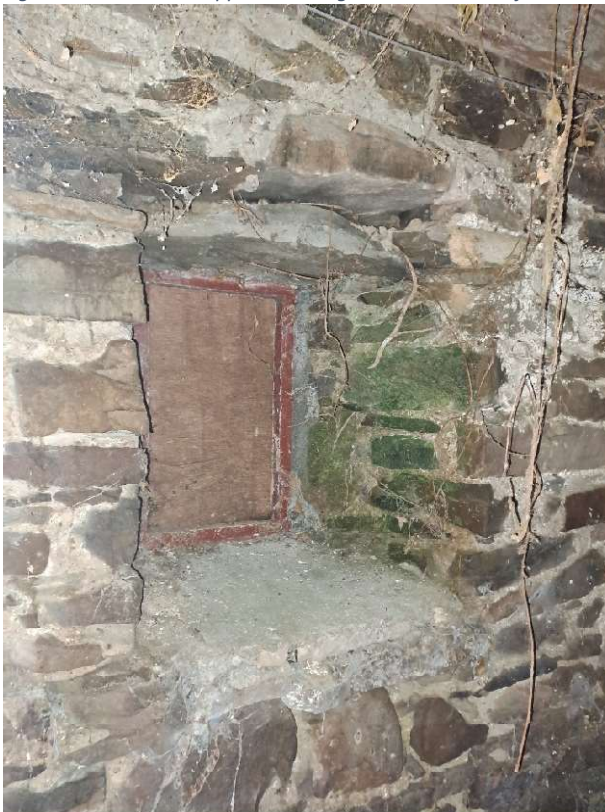
*Figure 17 - Structural supports missing to internal head of window ope 2*

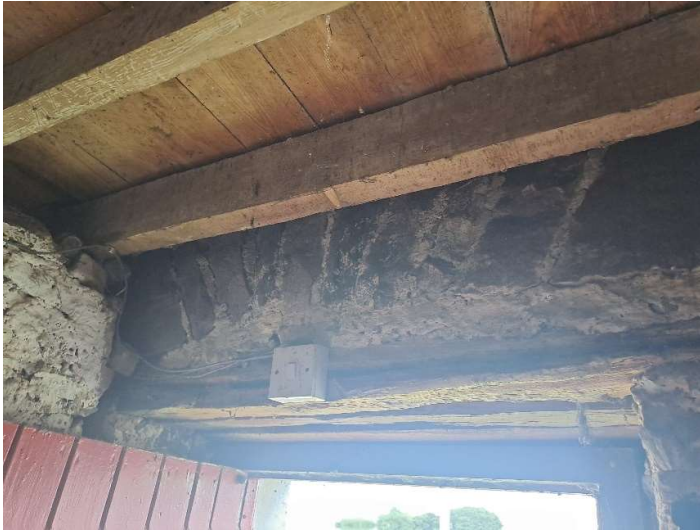
*Figure 18- Evidence of intervention to original arched door ope head*

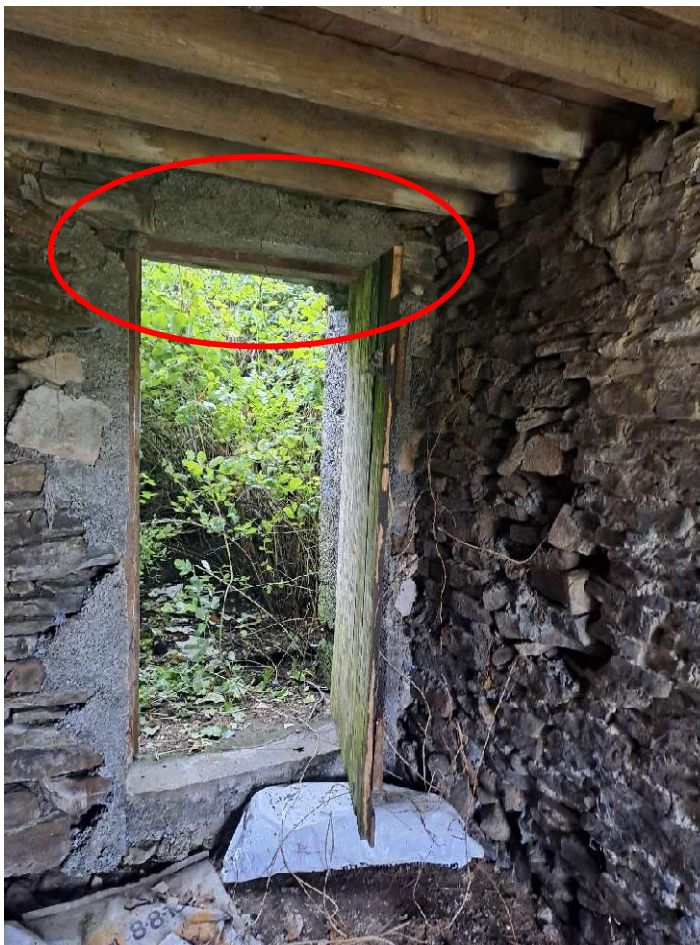
*Figure 19- Evidence of intervention to original rear wall to create a door ope (no structural lintel to head)*

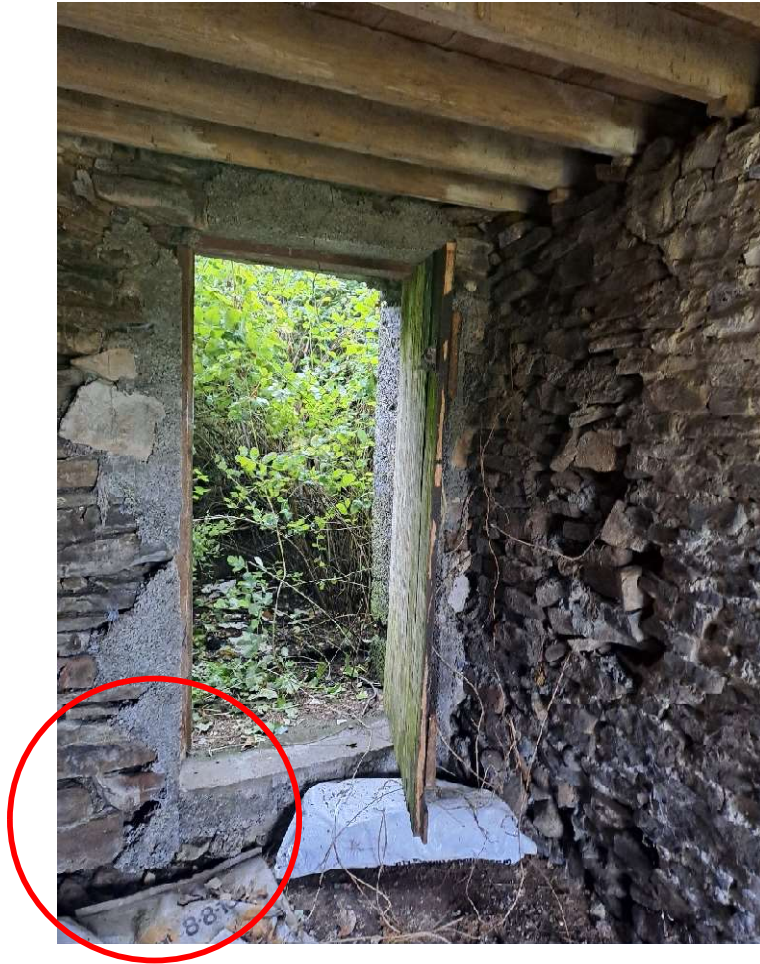
*Figure 20- Smaller stones at foundation level than that of the supported wall*

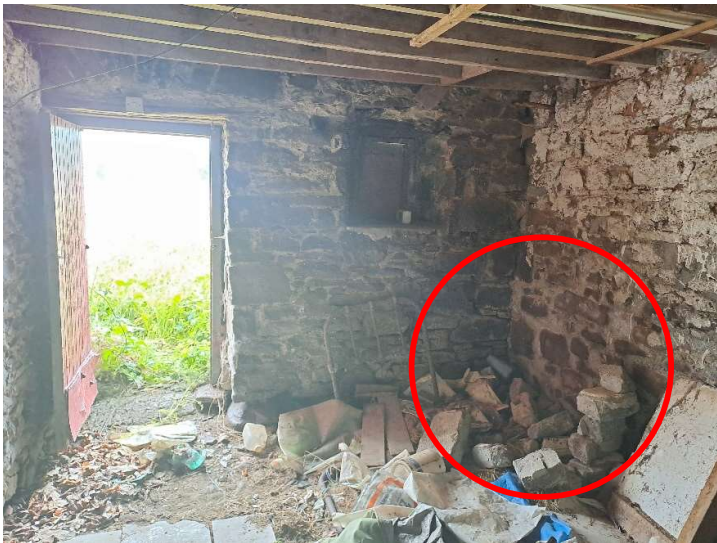
*Figure 21- Significant mortar infill to base of wall*

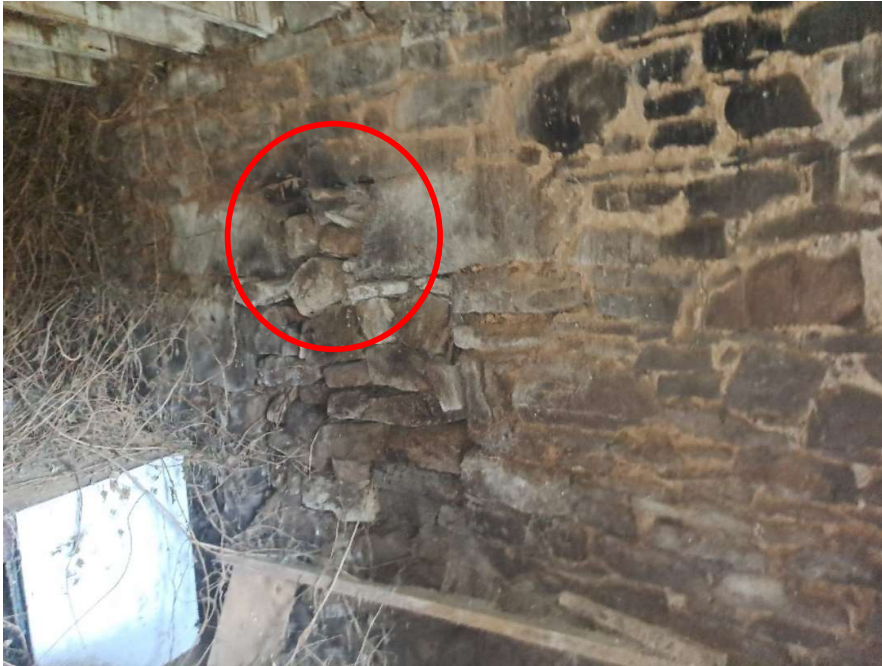
*Figure 22- Missing Keystone to original fireplace ope*

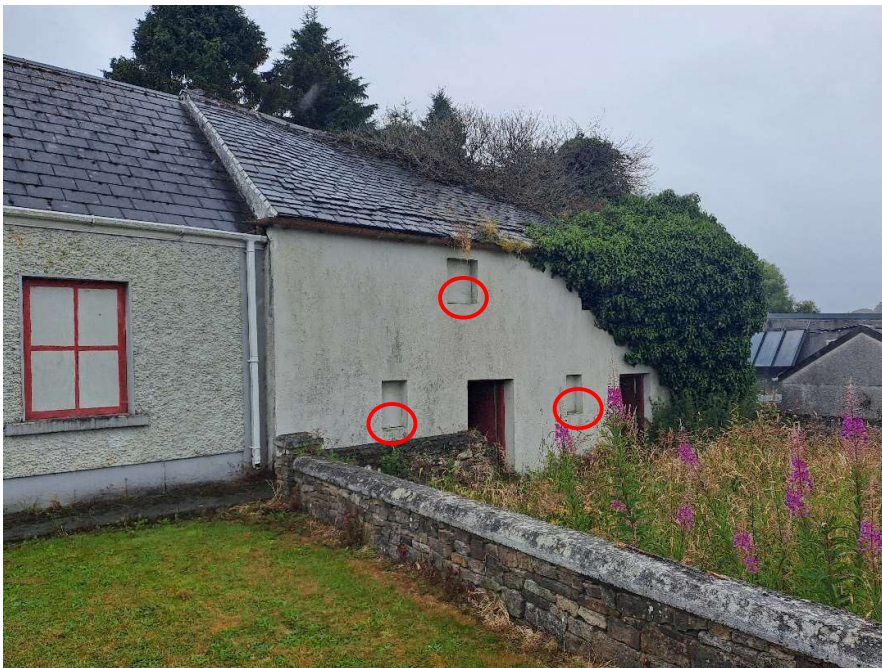
*Figure 23- No existing external cills to window opes*

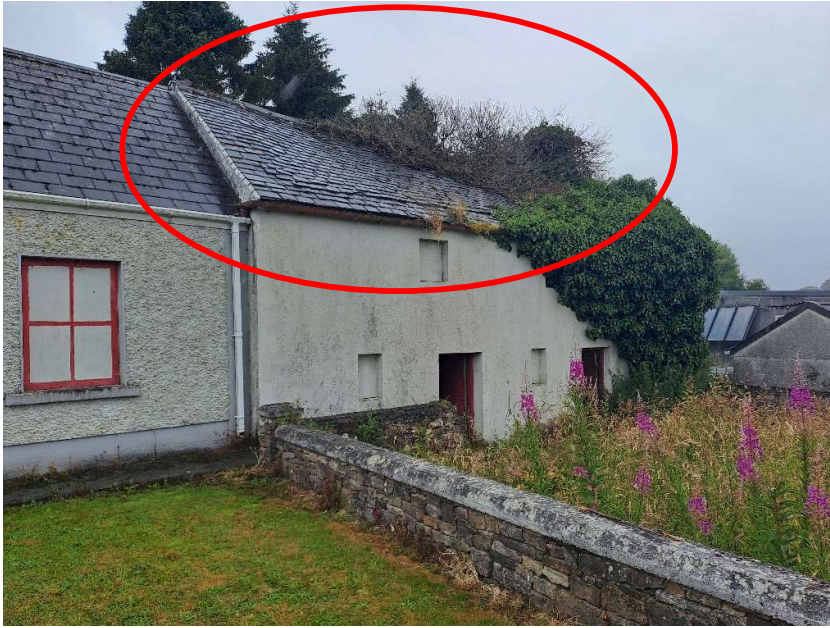
*Figure 24- Significant Ivy growth with visible undulations in the roof structure*
