**Dunlo Hill, Ballinasloe, Co. Galway**

## **Investigative & Condition Report**

**Client:** Galway County Council

**March 2023**

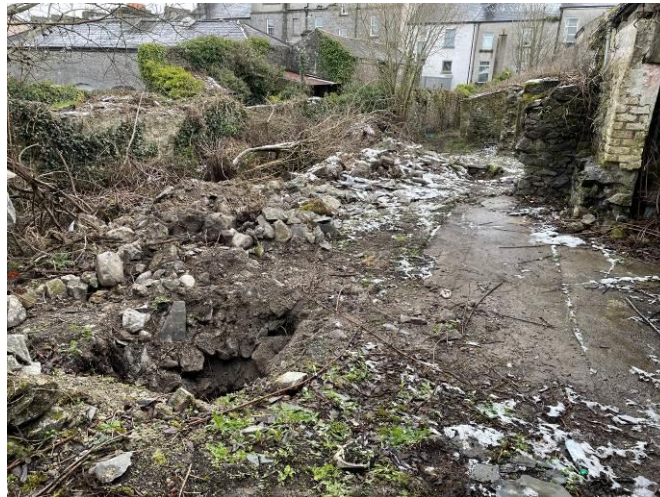
**Photograph 1:** Locations of trial holes at rear right side of the site

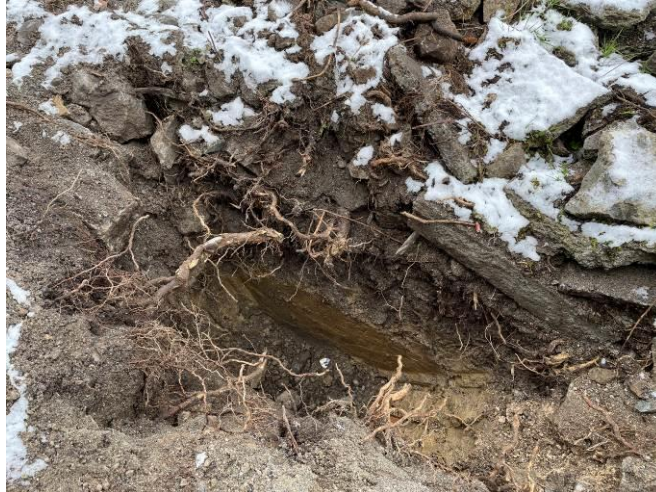
**Photograph 3:** Note the filled ground and debris overlying the solid layer at 1.3m below existing ground level

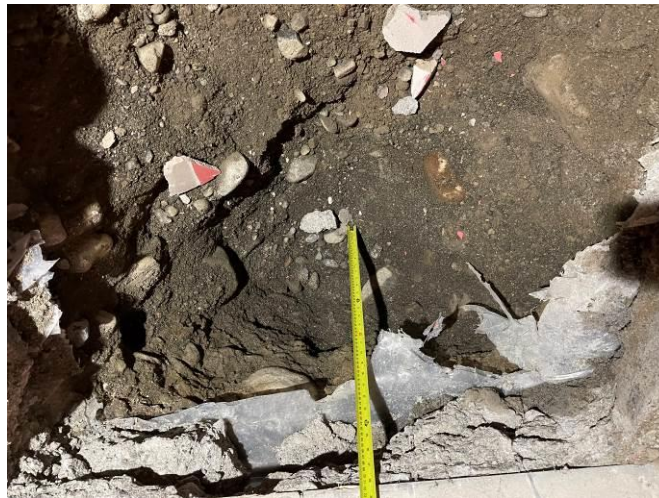
**Photograph 4:** Shallow depth of bearing stones under external / party walls of the existing dwellings (Unit 01). Typically, formation level is at 700mm below existing FFL

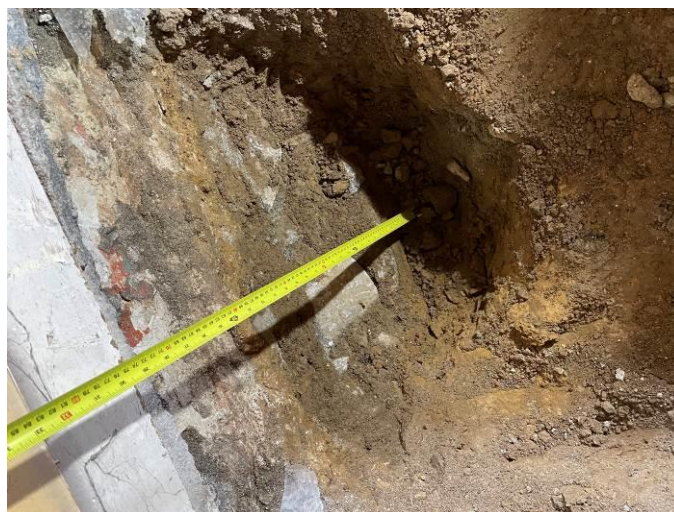
**Photograph 5:** Shallow depth of bearing stones under external / party walls of the existing dwellings (Unit 02)

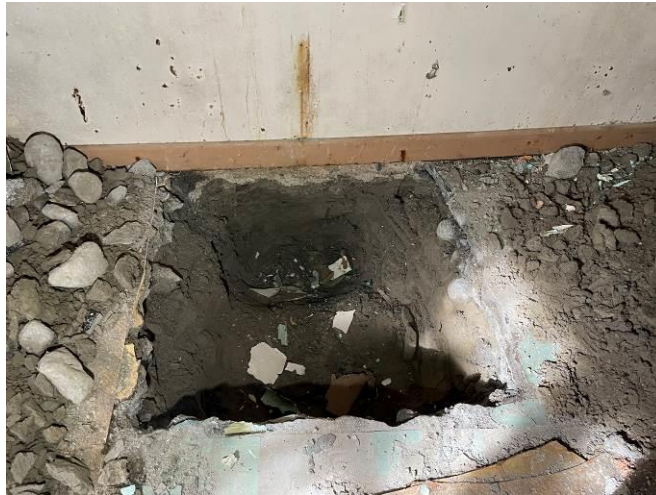
**Photograph 6:** Shallow depth of bearing stones under external / party walls of residential property adjacent to the Public House. Formation at 600mm below FFL

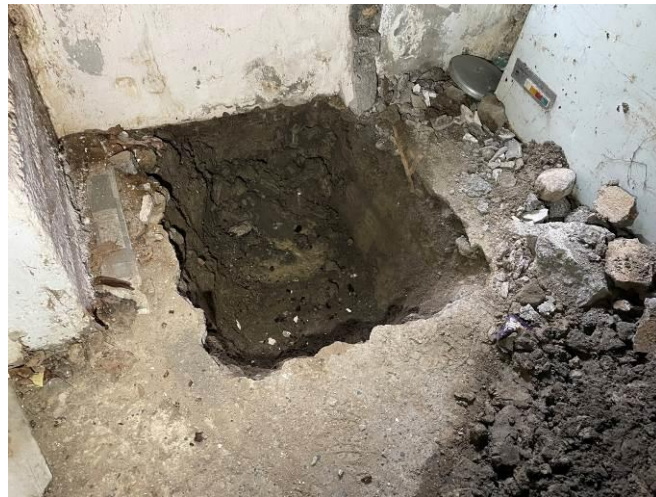
**Photograph 7:** Shallow depth of bearing stones under external walls of the Basement Area. Formation at 600mm below FFL

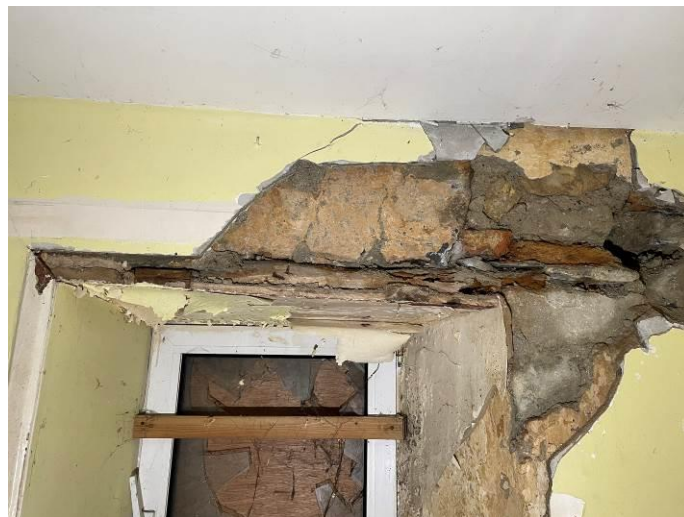
**Photograph 9:** Condition of Timber Lintels in Unit 03

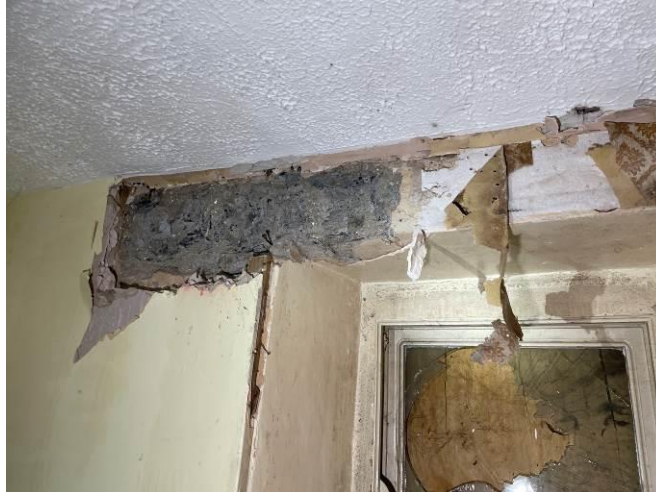
**Photograph 10:** Concrete & stone lintels were also noted in places within the residential properties

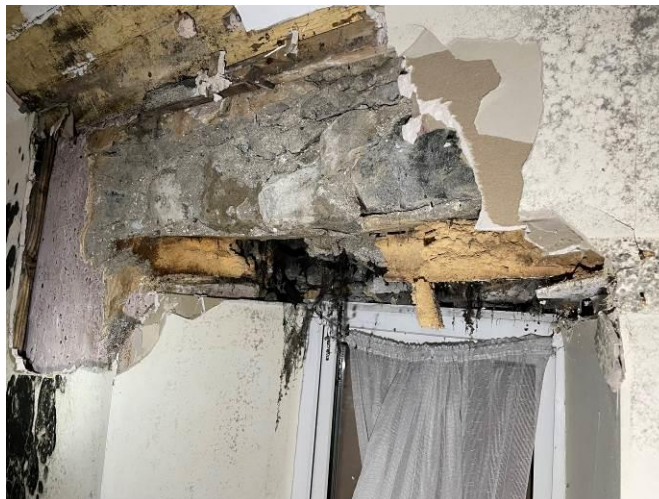
**Photograph 11:** Example of rotted and dilapidated timber lintel

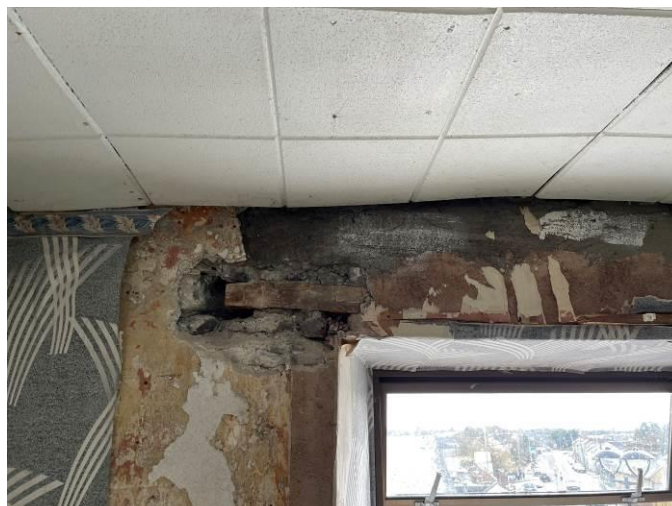
**Photograph 12:** Timber lintel within the public house part of the property

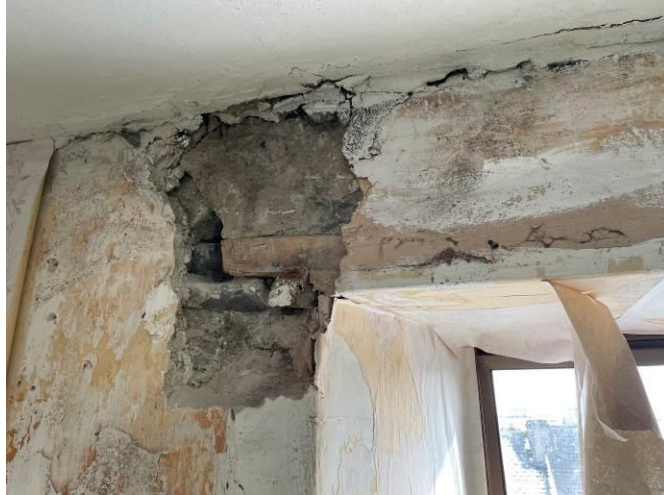
**Photograph 13:** Woodworm noted in a timber lintel within the public house part of the property

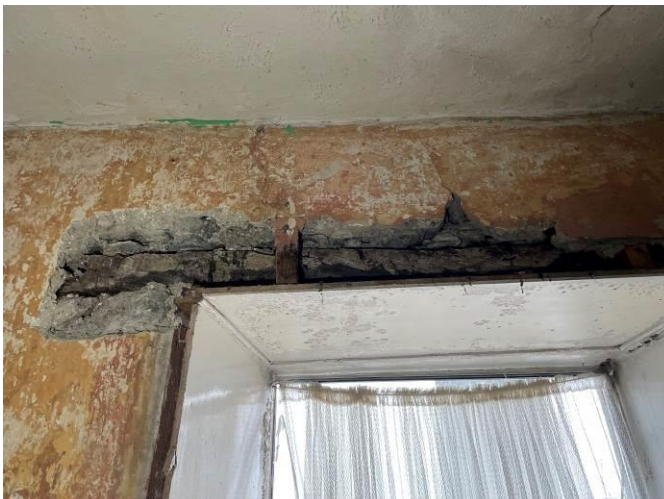
**Photograph 15:** Typical example of the dilapidated nature of the timber lintels

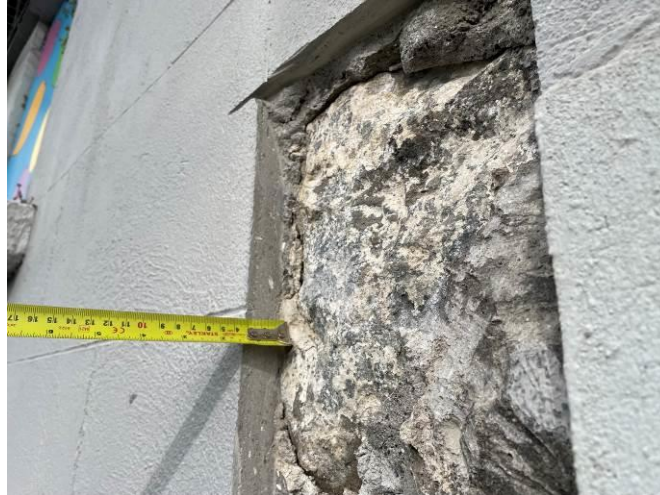
**Photograph 19:** Nature of the render and substrate in explorative hole at the front left side. The render is 30mm on average in thickness and well bonded to the stone

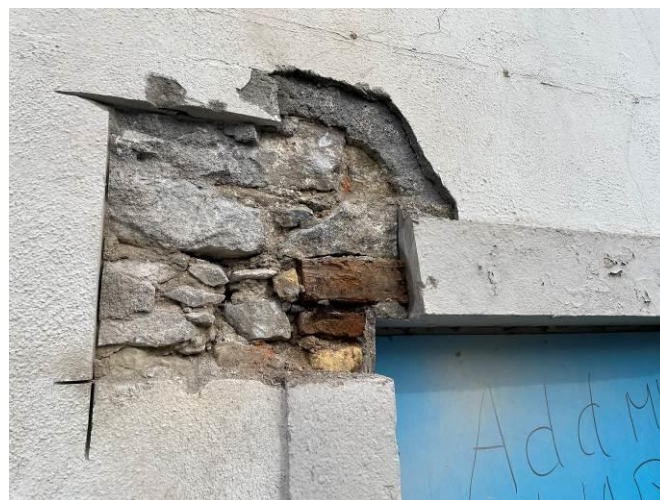
**Photograph 20:** Note the water damaged timber lintel on the front elevation

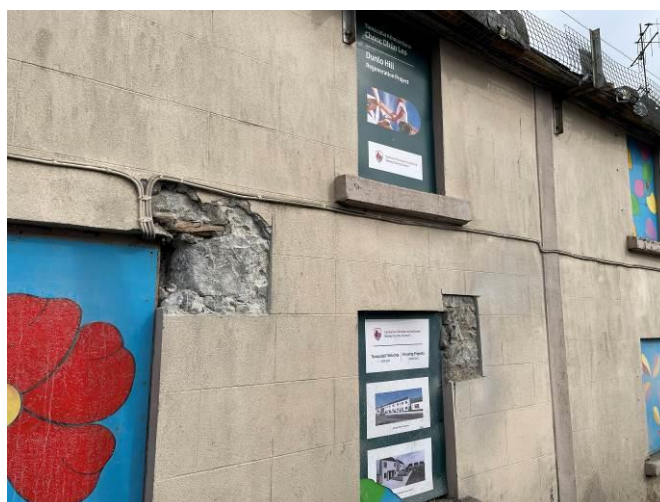
**Photograph 21:** Examples of the explorative holes in the render on the front elevations of the residential properties

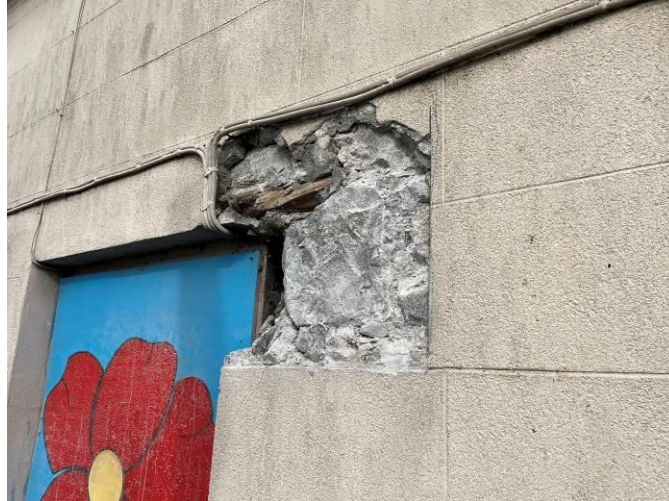
**Photograph 22:** Example of well bonded render and dilapidated timber lintel

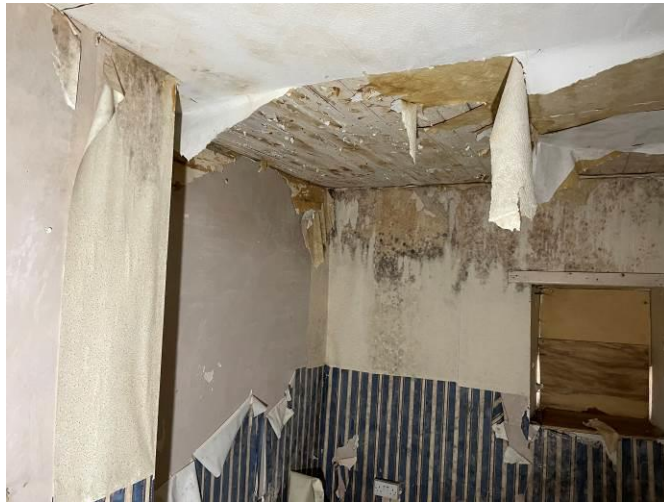
**Photograph 24:** Typical condition of the ceilings within the residential properties

- The internal walls and ceilings are in a very dilapidated condition within the residential properties and within the public house area and will need to be removed and replaced

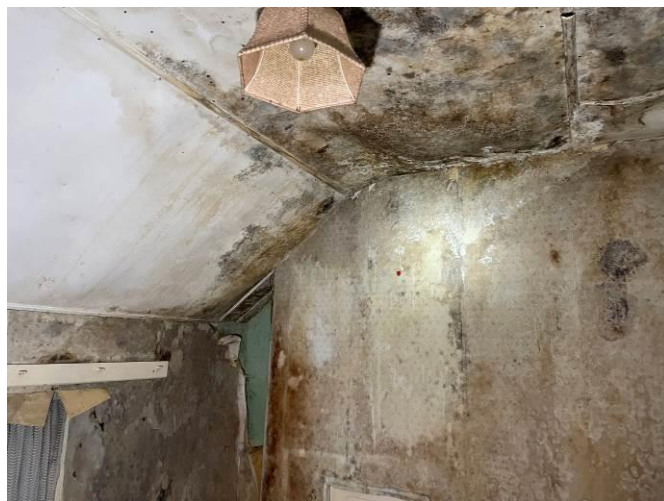
**Photograph 25:** Typical condition of the internal walls and ceilings within the residential properties

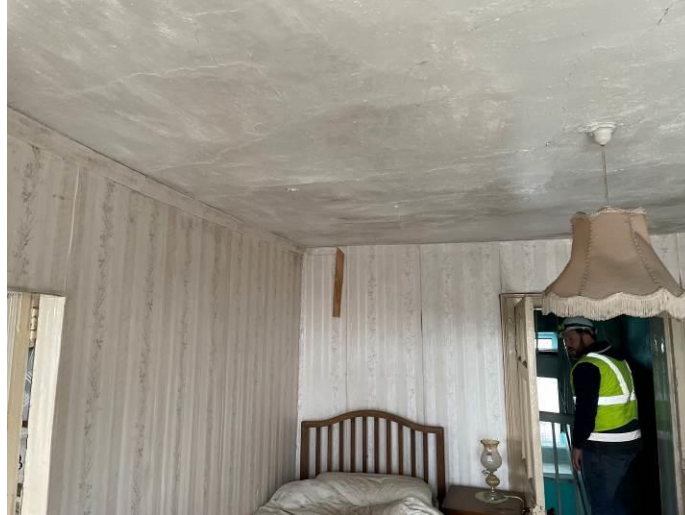
**Photograph 26:** Cracked and dilapidated nature of the ceilings within the public house area

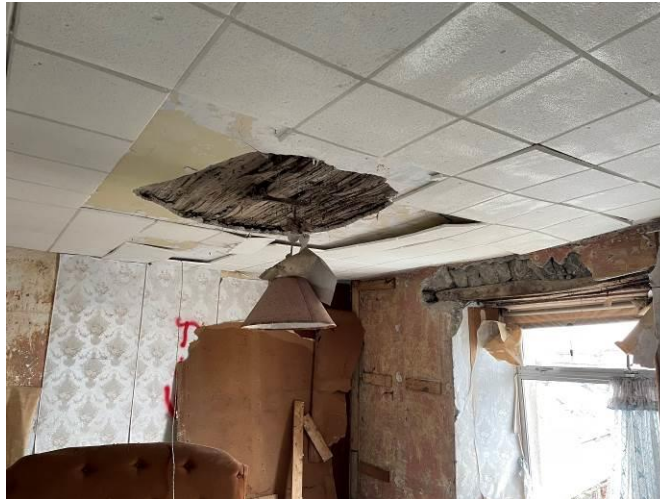
**Photograph 27:** Dilapidated nature of the walls and ceilings within the public house area

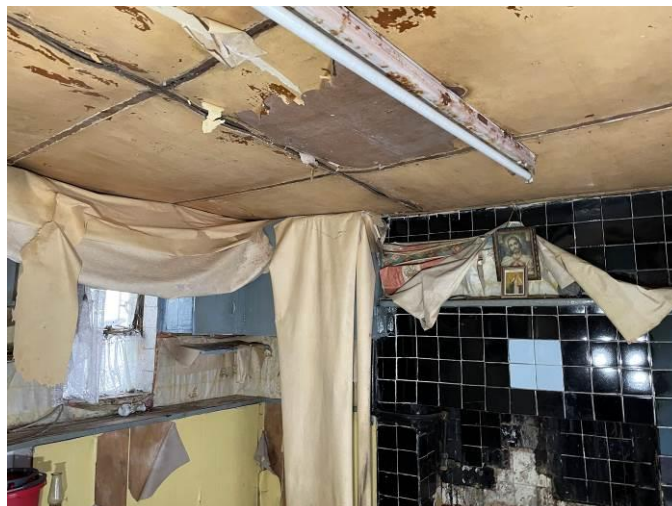
**Photograph 28:** Dilapidated nature of the walls and ceilings within the public house area

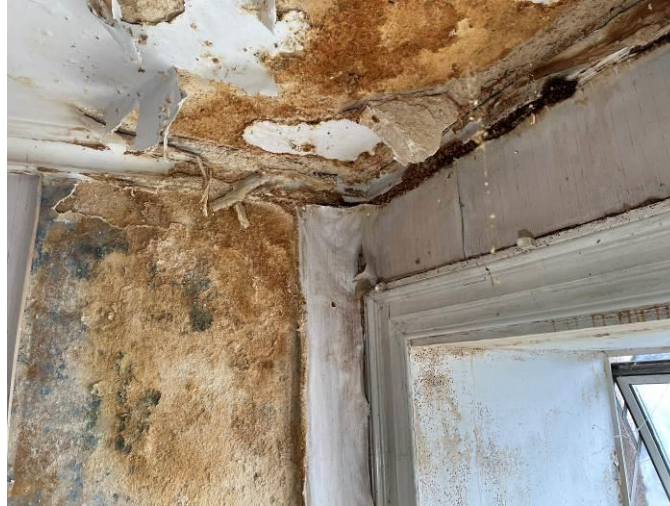
**Photograph 29:** Dilapidated nature of the walls and ceilings within the public house area

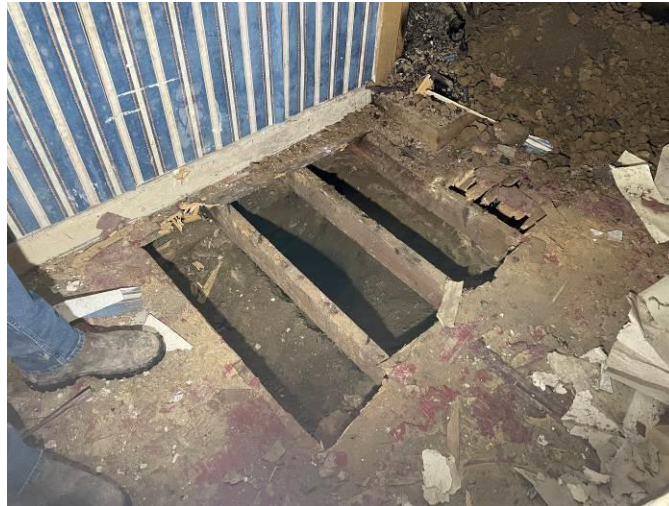
**Photograph 30:** Example of suspended timber floor within one of the residential units

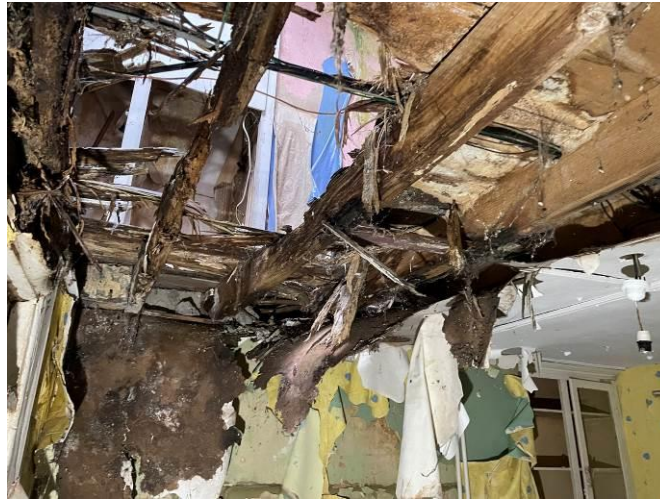
**Photograph 32:** First floor joists were found to be in this dilapidated condition within a number of the residential units

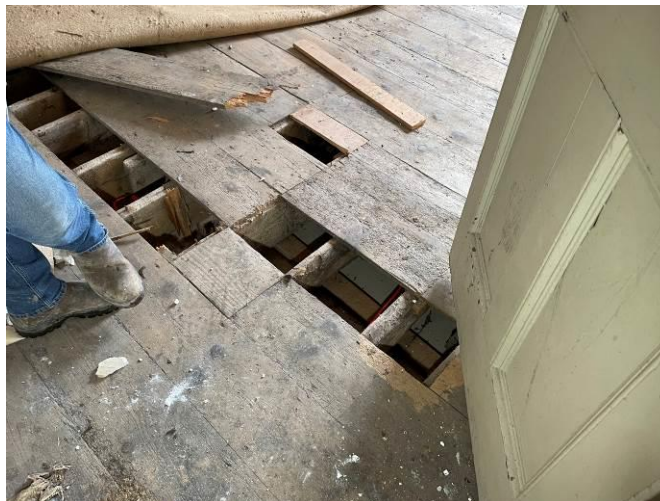
**Photograph 33:** Brittle condition of the floorboards and floor joists in the property adjacent to the archway

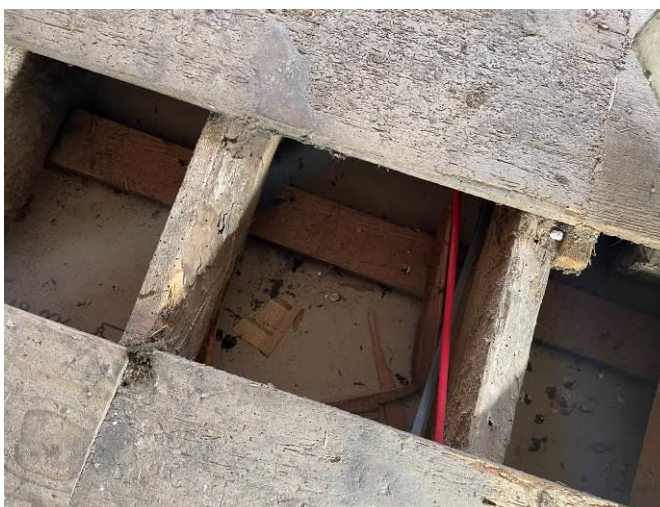
**Photograph 34:** Woodworm attack noted in the floor joists at the location above

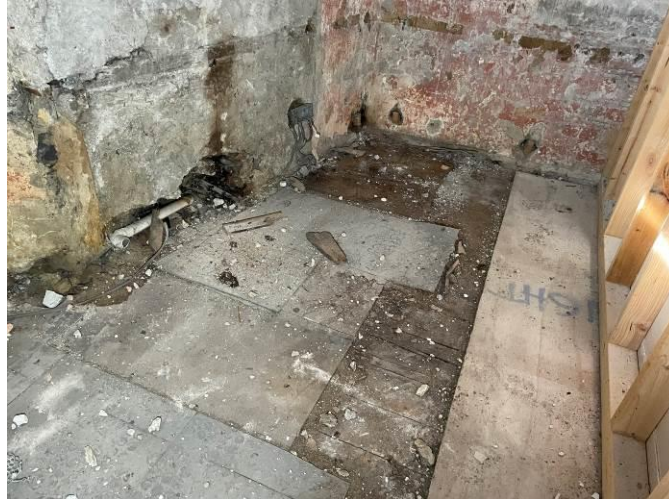
**Photograph 35:** Dilapidated condition of the timber floors and floor joists on the ground floor of the public house area

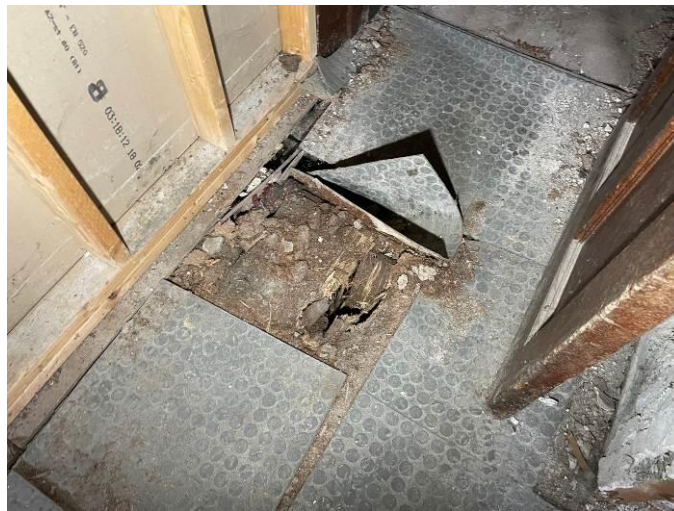
**Photograph 36:** Close up of the defects noted above

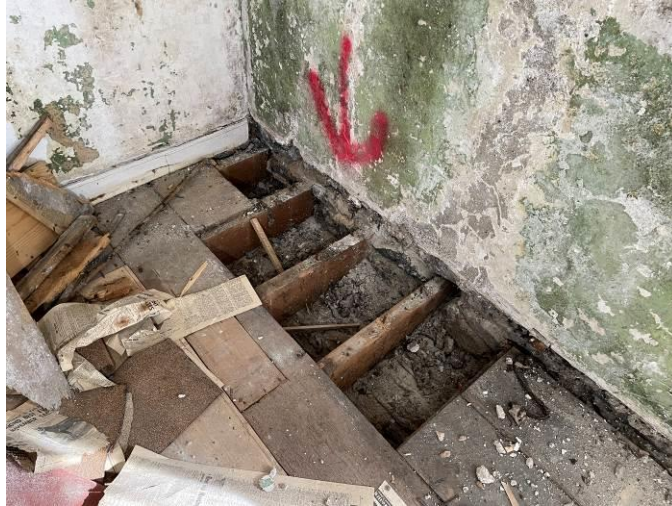
**Photograph 38:** Good condition of the timber second floor joists in the public house area

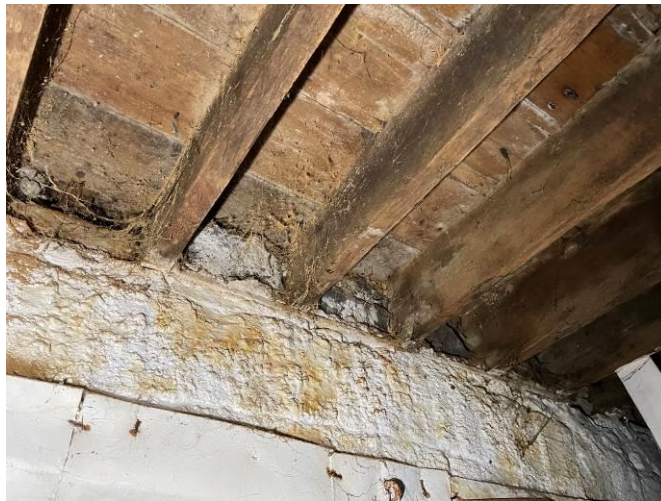
**Photograph 39:** Dilapidated condition of the timber floors and floor joists on the ground floor of the public house area

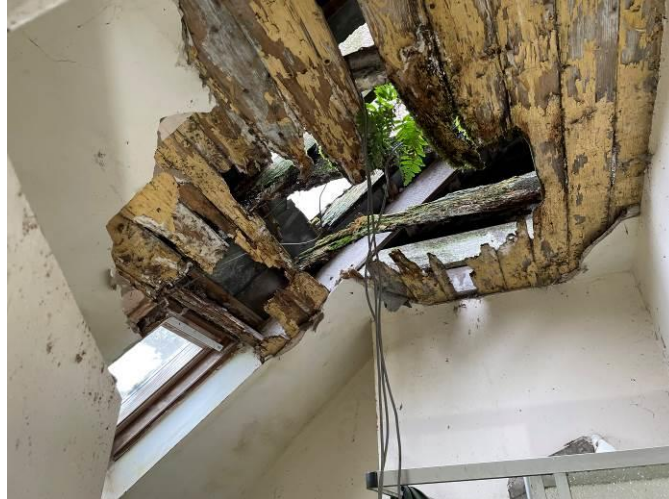
**Photograph 42:** Dilapidated nature of rear roofs of the residential properties

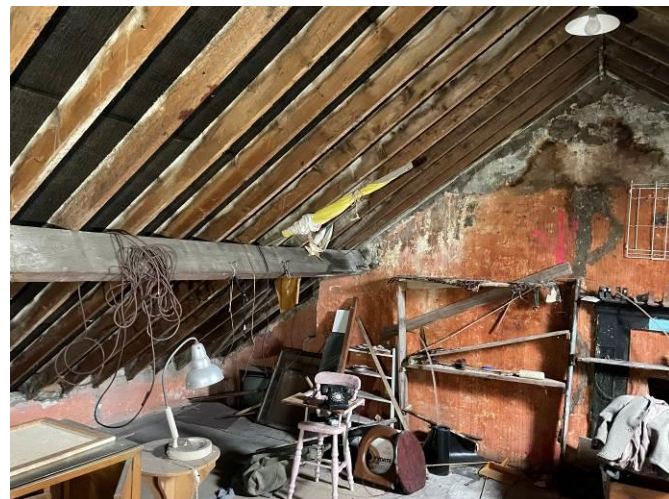
**Photograph 43:** Good condition of the attic space and timbers in the property adjacent to the public house

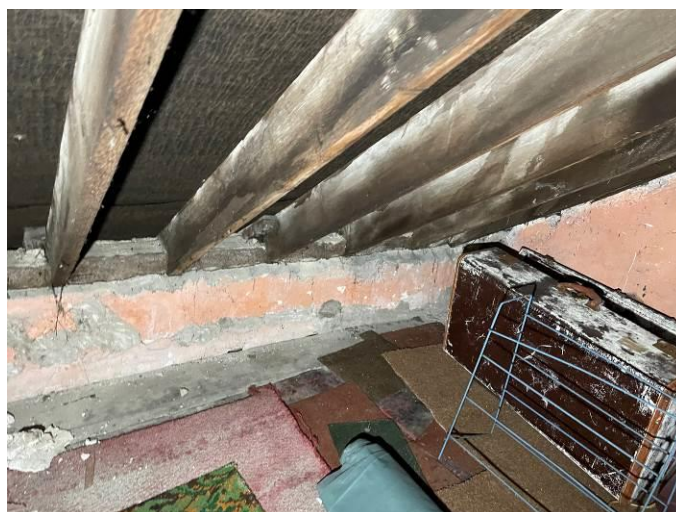
**Photograph 44:** Good condition of the attic space and timbers in the property adjacent to the public house

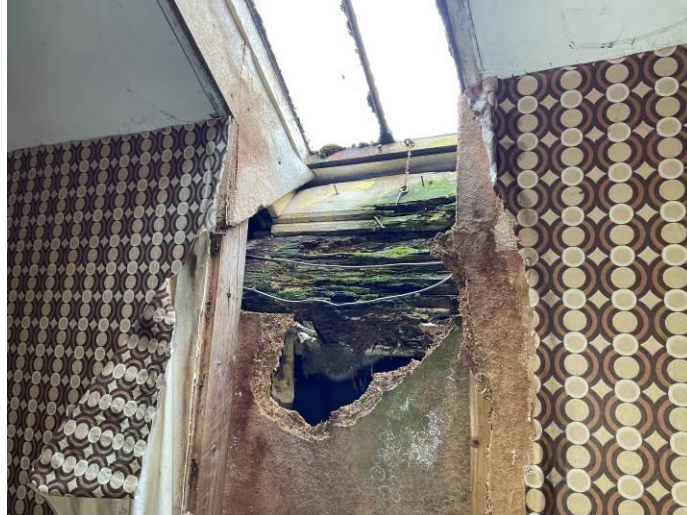
**Photograph 45:** Dilapidated and water damaged timber purlins in the residential property adjacent to the public house, left side

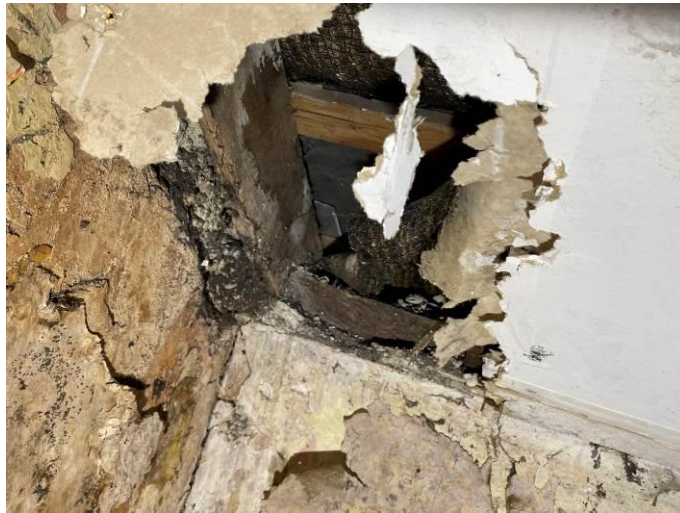
**Photograph 46:** Dilapidated and water damaged timber rafters in the residential property adjacent to the public house, left side

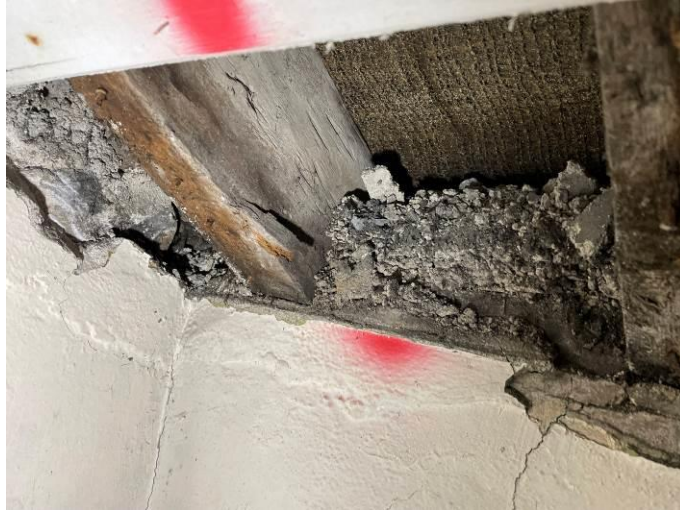
**Photograph 47:** Good condition of the rafters in the roof over the residential property to the right side of the public house

The roofs of the public house area and residential property to the right hand side can likely be retained but the timbers should be spray treated to prolong their lifespan.
