Asbestos Survey Report

(Refurbishment / Demolition Survey)

Ref No: HI15576

Location: Dunlo Hill, Townparks, Ballinasloe, Co. Galway

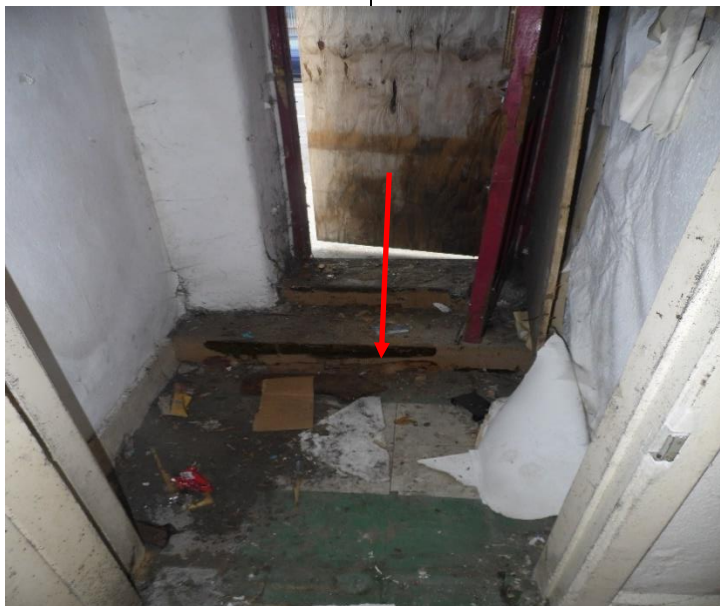
Room/Section: Terraced House #2
 Description: Vinyl Floor tiles and adhesive
 Sample Location: Small hallway inside front door entrance
 and around fire place in living area

Sample no(s): BS196143
 Amount: approx. 1 sq.m
 Access: Access to sample

Asbestos Type: **Chrysotile**
 Surface Treatment: **Reinforced composite and well bound material**
 Product Type: **Vinyl Floor tiles**
 Condition: **Poor**
 Material Assessment Score: **5(Low Risk)**

Recommendation: Removal Prior to demolition/Refurbishment taking place.

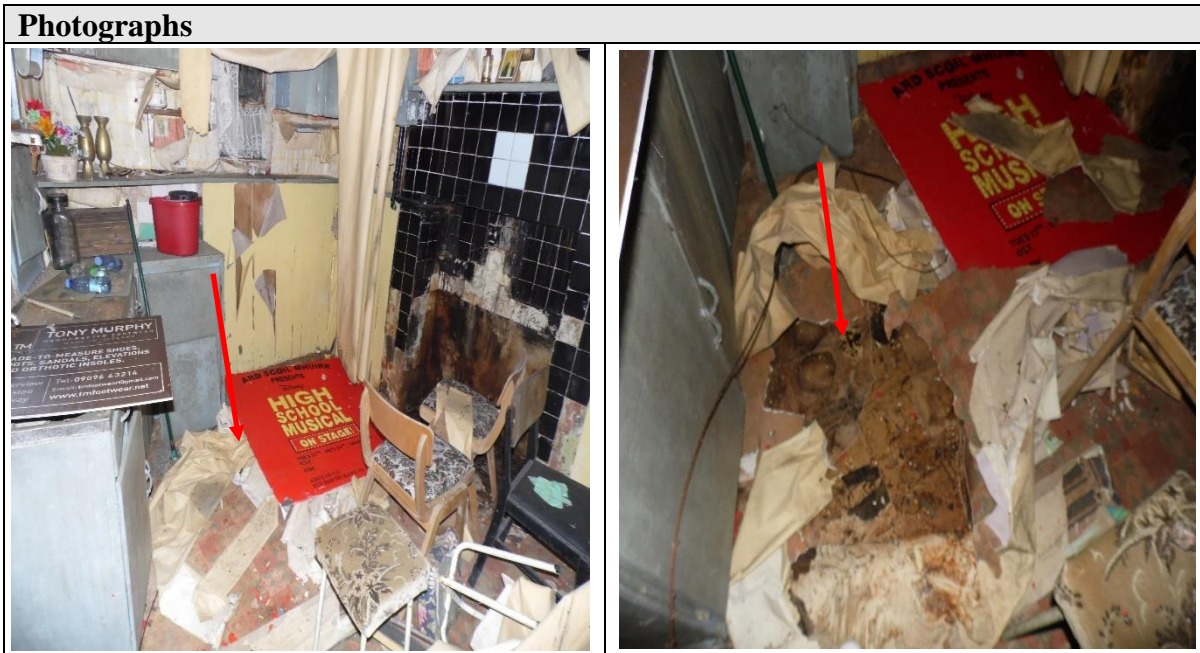
Details	
Room/Section: Townhouse (beside Dooleys) single storey extension to rear Description: Vinyl Floor tiles Sample Location: Kitchen	Sample no(s): BS196138 Amount: approx. 10 sq.m Access: Access to sample

Material Assessment	Score:
Asbestos Type: Chrysotile	1
Surface Treatment: Reinforced composite	1
Product Type: Vinyl Floor tiles	1
Condition: Poor	2
Material Assessment Score: 5 (Low Risk)	
Recommendation: Removal Prior to demolition/Refurbishment taking place.

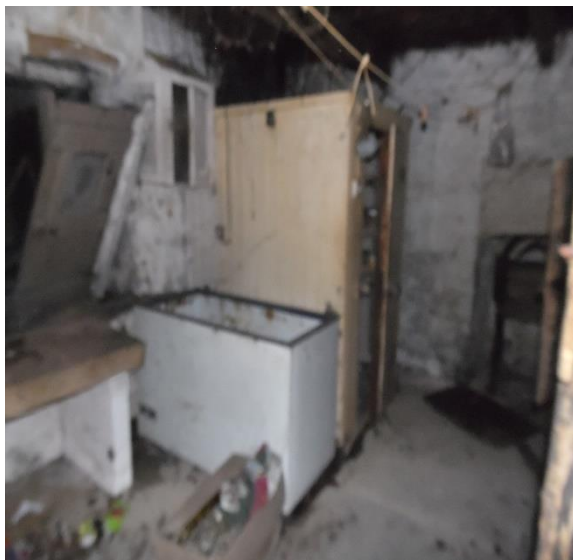
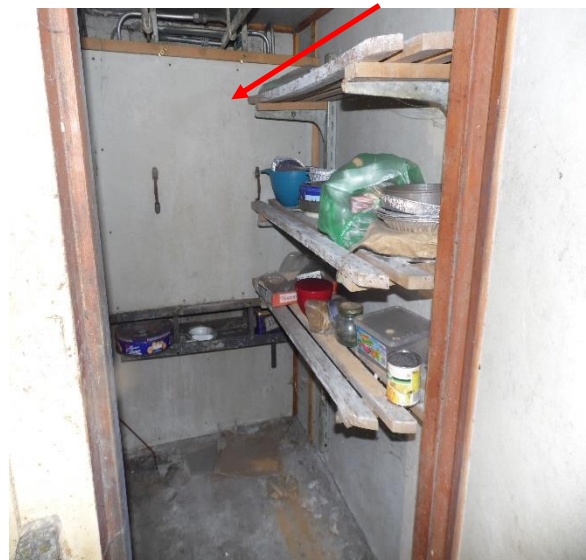
Room/Section: Cellar of Townhouse (Dooleys)
 Description: Cement panel lining
 Sample Location: Refrigerator room

Sample no(s): BS196137
 Amount: approx. 15-20 sq.m
 Access: Access to sample

Asbestos Type: **Chrysotile**
 Surface Treatment: **Asbestos Cement**
 Product Type: **Cement board insulation**
 Condition: **Good condition**

Material Assessment Score: 3 (Low Risk)

Recommendation: Removal Prior to demolition/Refurbishment taking place.

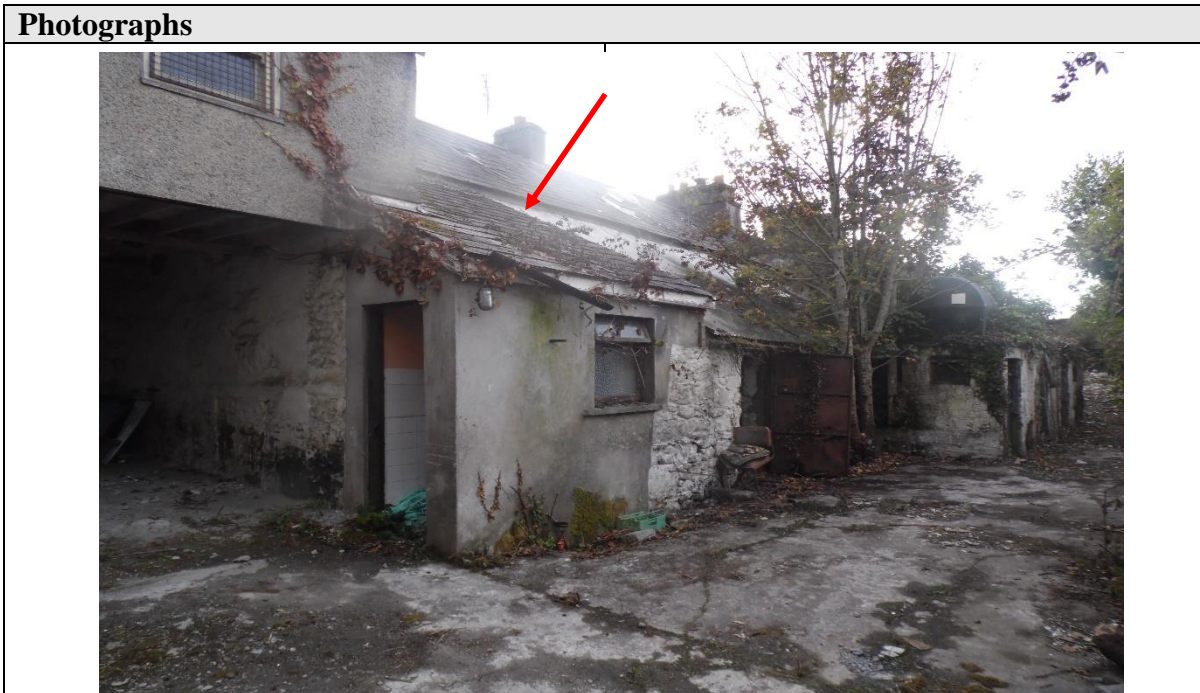
Details	
Room/Section: Courtyard to Rear Description: Asbestos Cement Roof Slates Sample Location: Lean-to roof Old Mens bathrooms	Sample no(s): BS196141 Amount: Approx 15 sq.m Access: Access to sample

Material Assessment	Score:
Asbestos Type: Chrysotile & Amosite	3
Surface Treatment: Asbestos Cement	1
Product Type: Roof Slates	1
Condition: Good condition	0
Material Assessment Score: 5 (Low Risk)	
Recommendation: Removal Prior to demolition/Refurbishment taking place.

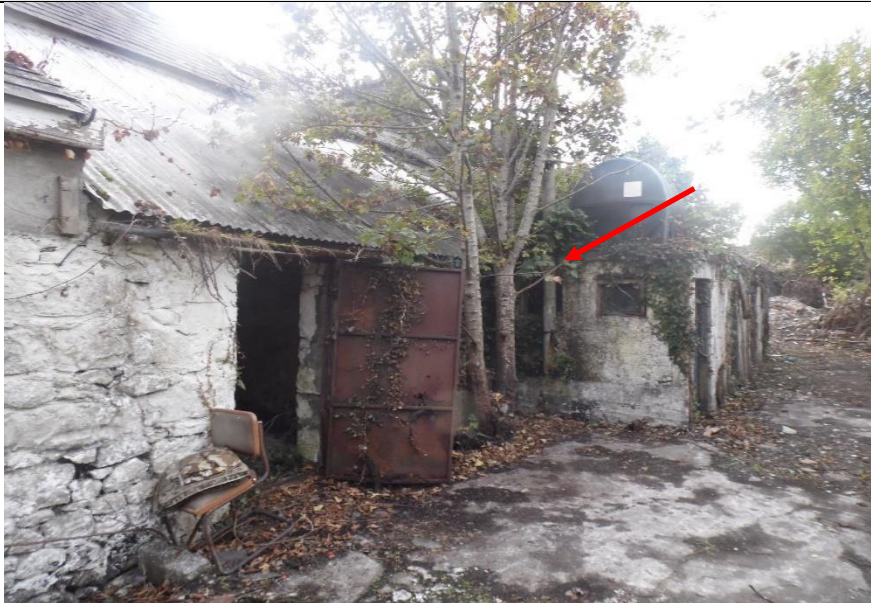
Room/Section: Courtyard at rear
 Description: Asbestos Cement Flu-pipe
 Sample Location: Old Boiler

Sample no(s): BS196140
 Amount: 3.5m
 Access: Access to sample

Asbestos Type:	Chrysotile	3
Surface Treatment:	Asbestos Cement	1
Product Type:	Flu-Pipe	1
Condition:	Good condition	0
Material Assessment Score: 5 (Low Risk)

Recommendation: Removal Prior to demolition/Refurbishment taking place.

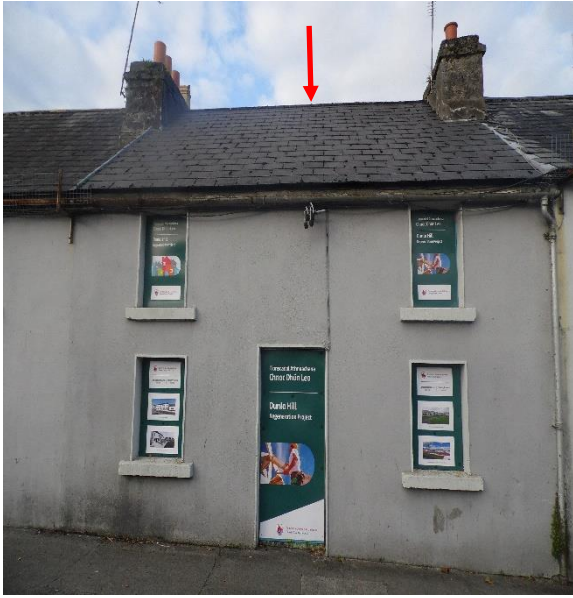
Strongly Presumed Asbestos Cement Roof Slates
(No Access to Sample)

Slates to Roof of Terraced House #5 are strongly presumed ACM's

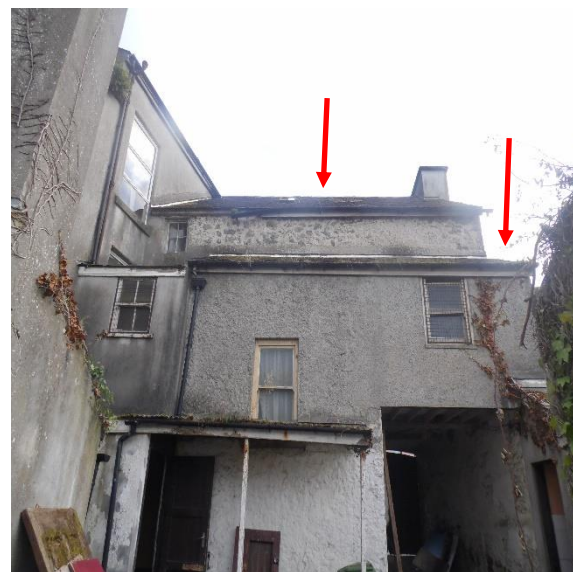
Slates to Roof of extension to rear of (Dooleys)Townhouse strongly presumed ACM's

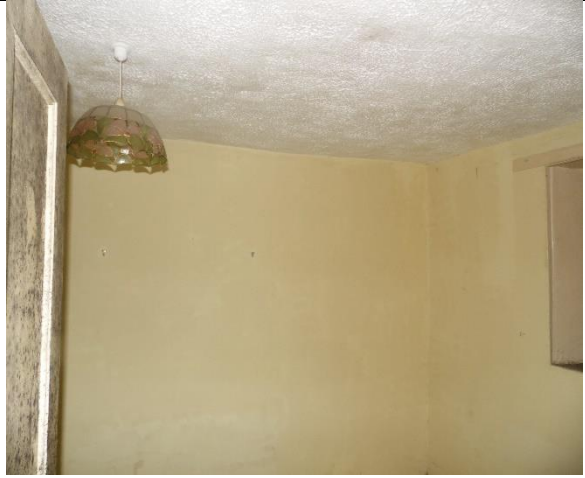
Floor: Ground
Room/Section: Terraced House #2
Description : No Asbestos Detected in sample taken of Textured coating
Sample Reference: BS196144

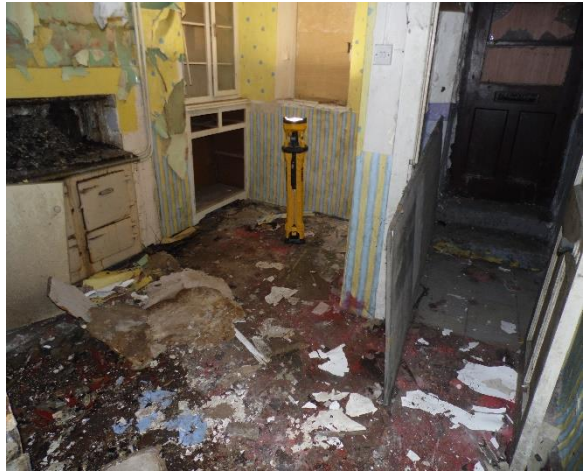
Floor: Ground
Room/Section: Terraced Houses #3 and #4
Description : No Asbestos Detected in samples taken of Floor Tiles
Sample References: BS196145 and BS196146
