# **BAT AND SWIFT SURVEYS AT DUNLO HILL TERRACE, DOOLEY'S PUB AND ADJOINING PROPERTY, BALLINASLOE, CO. GALWAY**

## **Report Prepared for**

OBFA Architects,  
1 Johnson Place,  
Dublin 2

**October 2022**

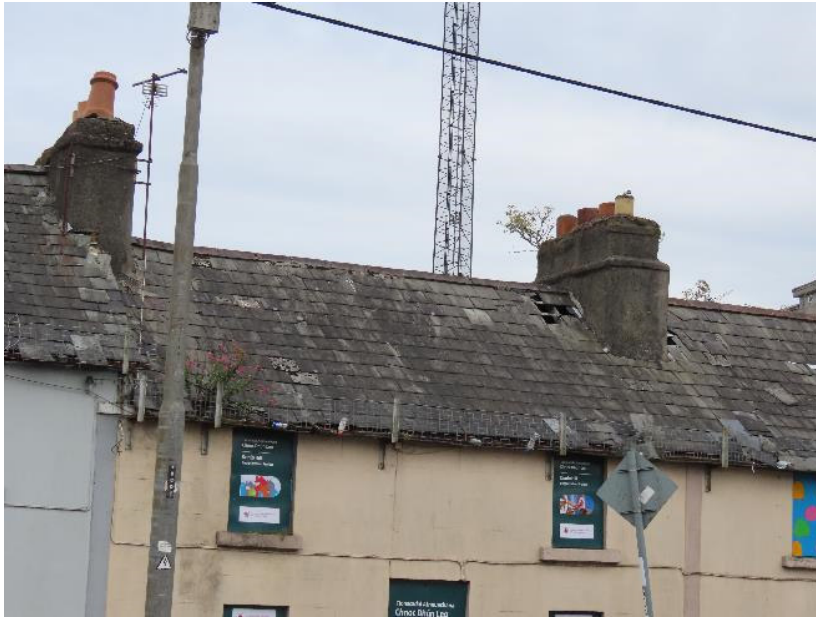
Many of the roofs of the cottages in the terrace are in poor structural repair with numerous missing slates. Holes in the roofs have allowed the ingress of water, leaving ceilings below in poor condition. The roof of P. Dooley's pub and the adjoining building are in good structural repair.

**Photo 4** - Property 4 – showing poor condition of roof. Wire slate guard in place to catch falling slates

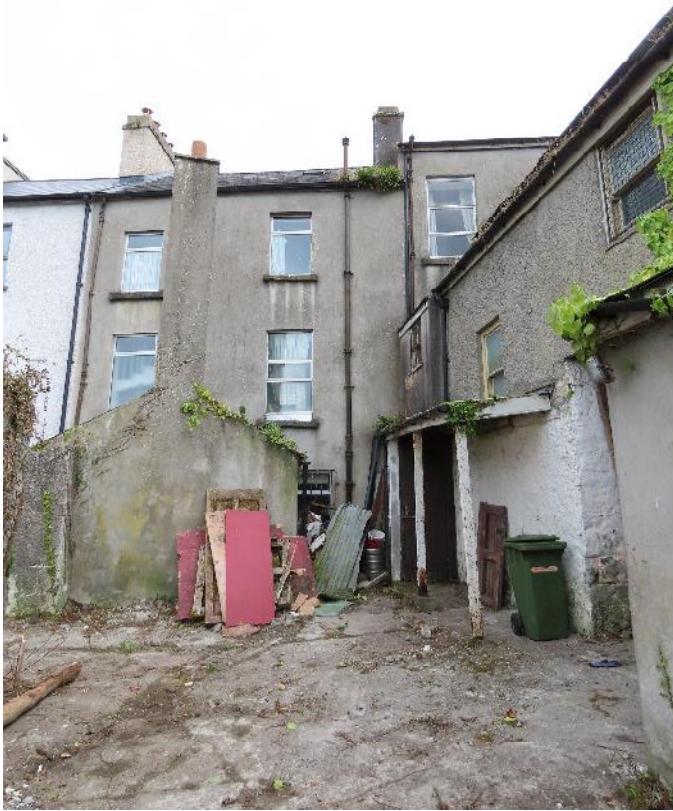
**Photo 9** – access to rear of building via archway between Dooley's pub and Dunlo Hill terrace. Several swallows' nests were recorded on roof timbers

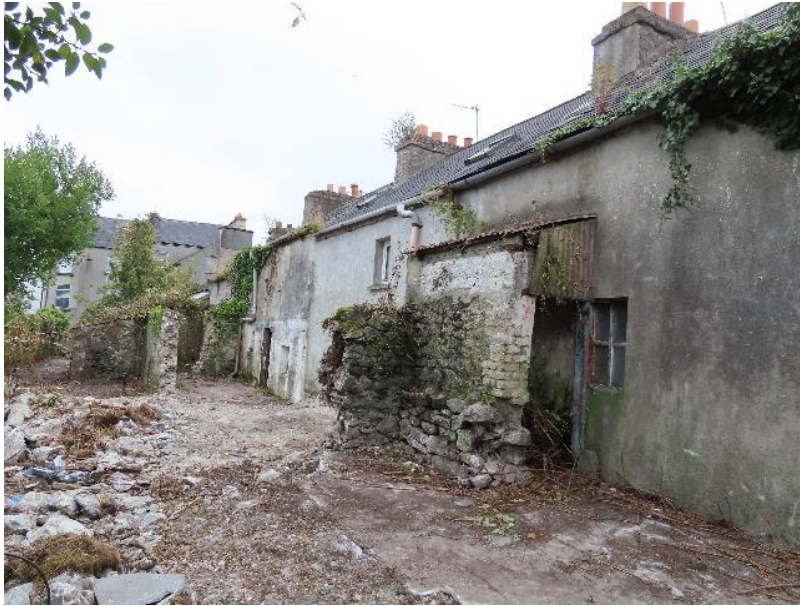
**Photo 15** – Lean-to stone shed to rear of westernmost property in Dunlo Terrace. This building was considered to have potential as a bat roosting site

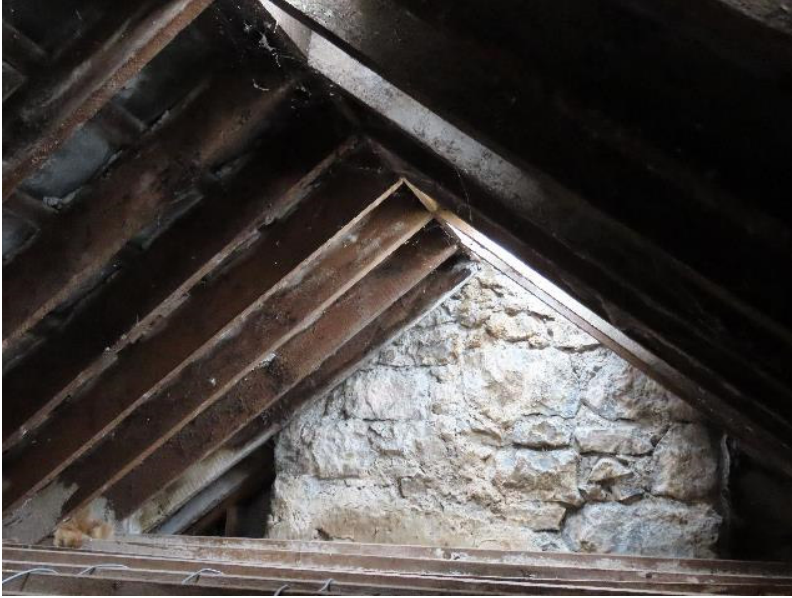
**Photo 21** - Hole in upstairs ceiling of Property 1 in Dunlo Terrace

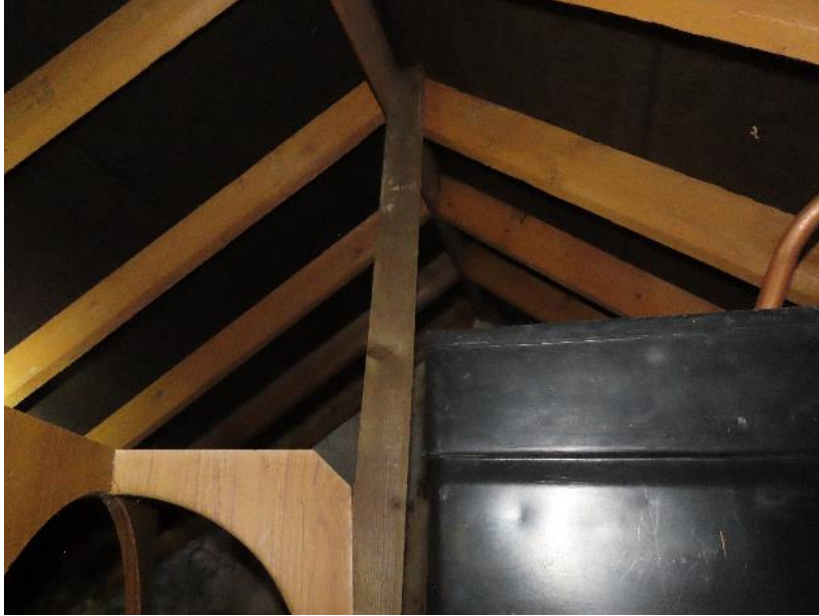
**Photo 27** - Attic space of Property 3. No evidence of usage by bats

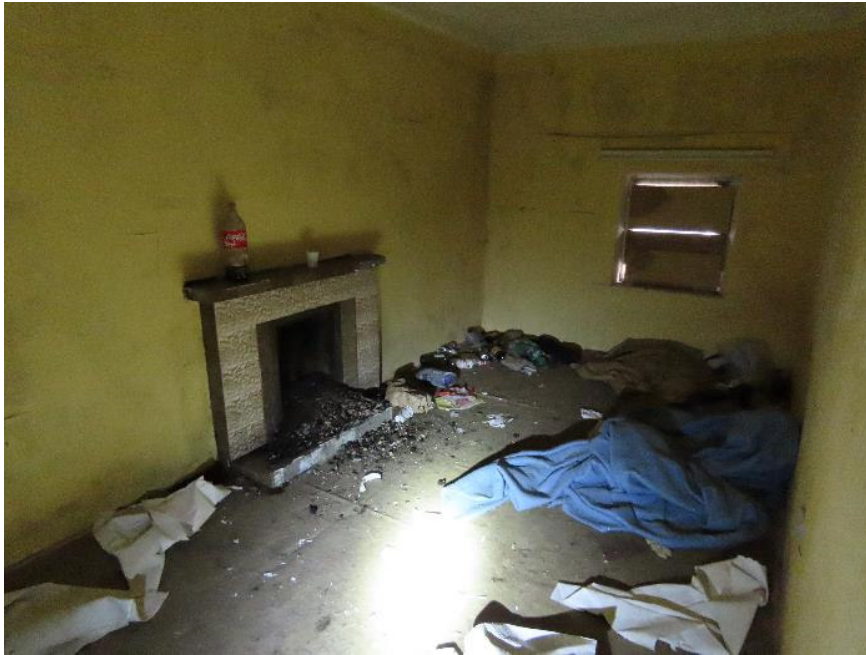
No bats or signs of bats were recorded in any of the nine buildings or in any of the outbuildings to the rear. A small number of butterfly wings were recorded on the floor of Property 3 which may be the feeding remains of a single Long-eared bat. No bat droppings were recorded. It was possible to access the attic spaces of all nine buildings. There were no accumulations of droppings anywhere in the buildings or outbuildings.

**Photo 29** - Floor of Property 3 with some butterfly wings and a few droppings of Brown long-eared bat. Used as a feeding perch by a single bat

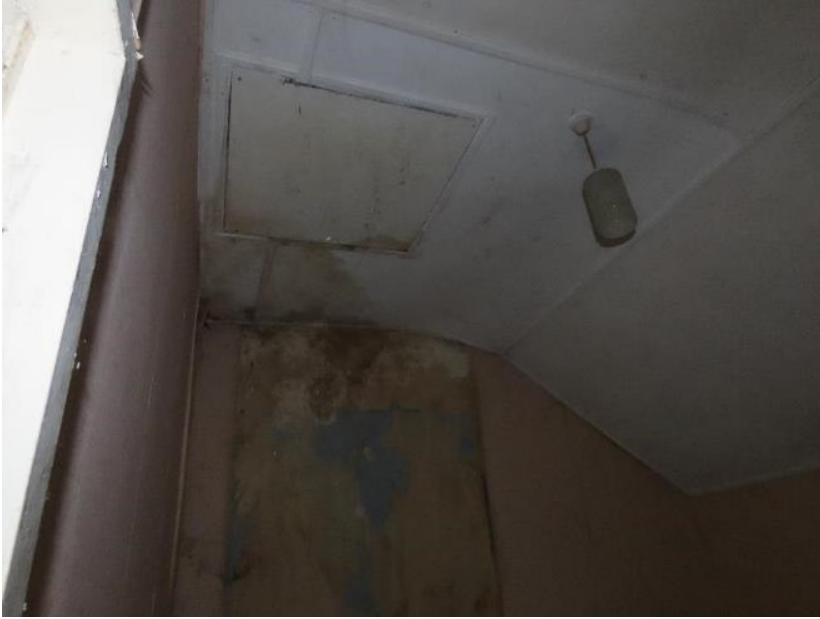
**Photo 36** – damage caused by water egress in property No 6

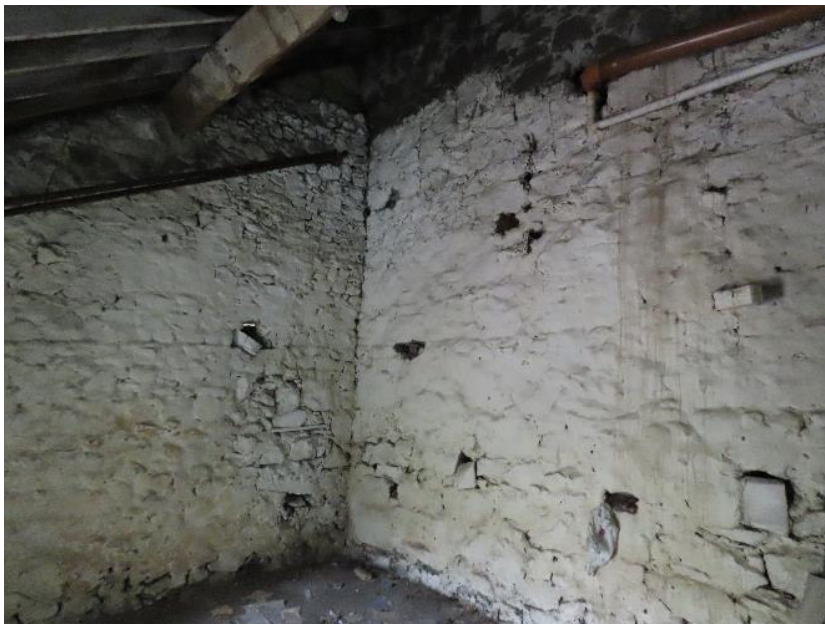
**Photo 44** - stone shed to rear of Dooley’s pub. This shed was considered to have potential as a roosting site for bats

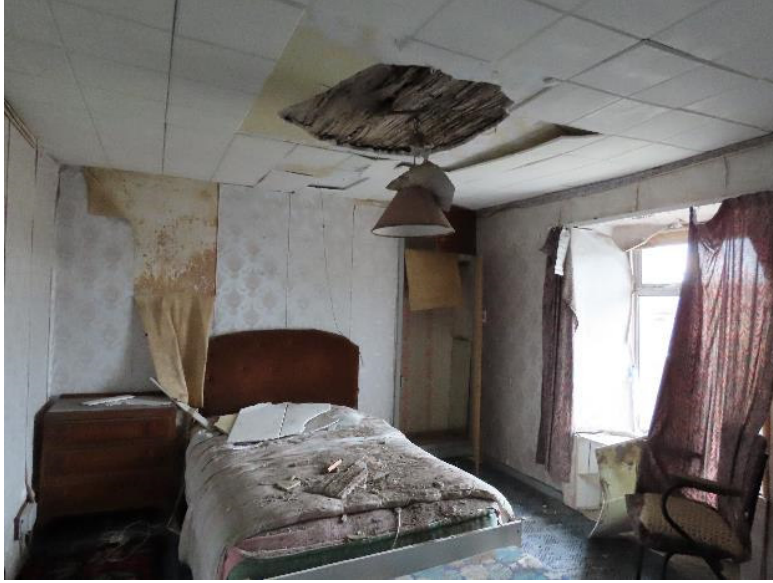
**Photo 57** – bedroom with damaged ceiling

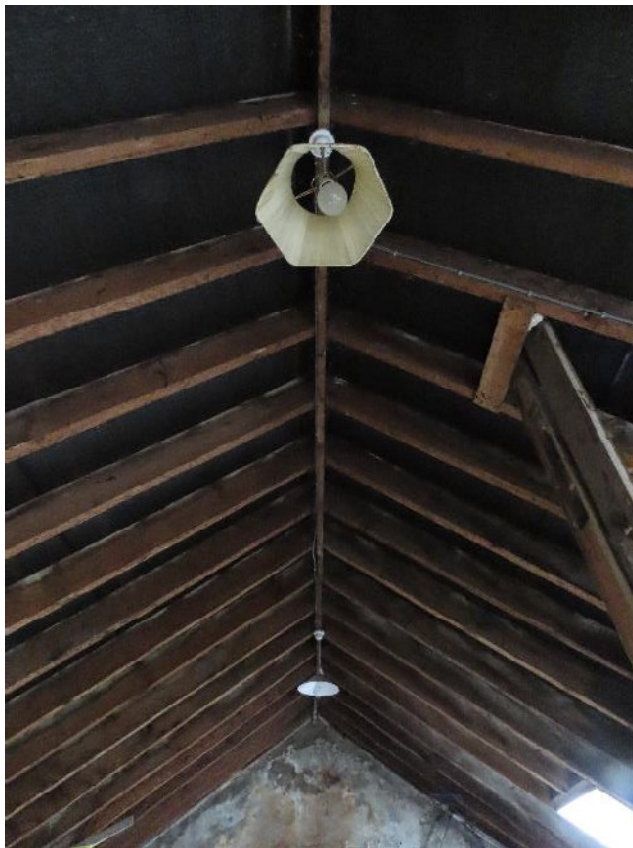
**Photo 60** – exposed timbers in attic space – no evidence of bats
