## PRELIMINARY DAMP & TIMBER DECAY REPORT

**Re: Renovation & Alterations at Dunlo Hill/Dunlo Street, Ballinasloe, Co. Galway.**

**The Buildings Inspected:** A set of seven workers' cottages. A two-bay by two bay three-storey end-of-terrace building (former pub which is a Protected Structure RPS 2730) with a two bay two-storey addition. A two-bay, three-storey terraced building (townhouse).

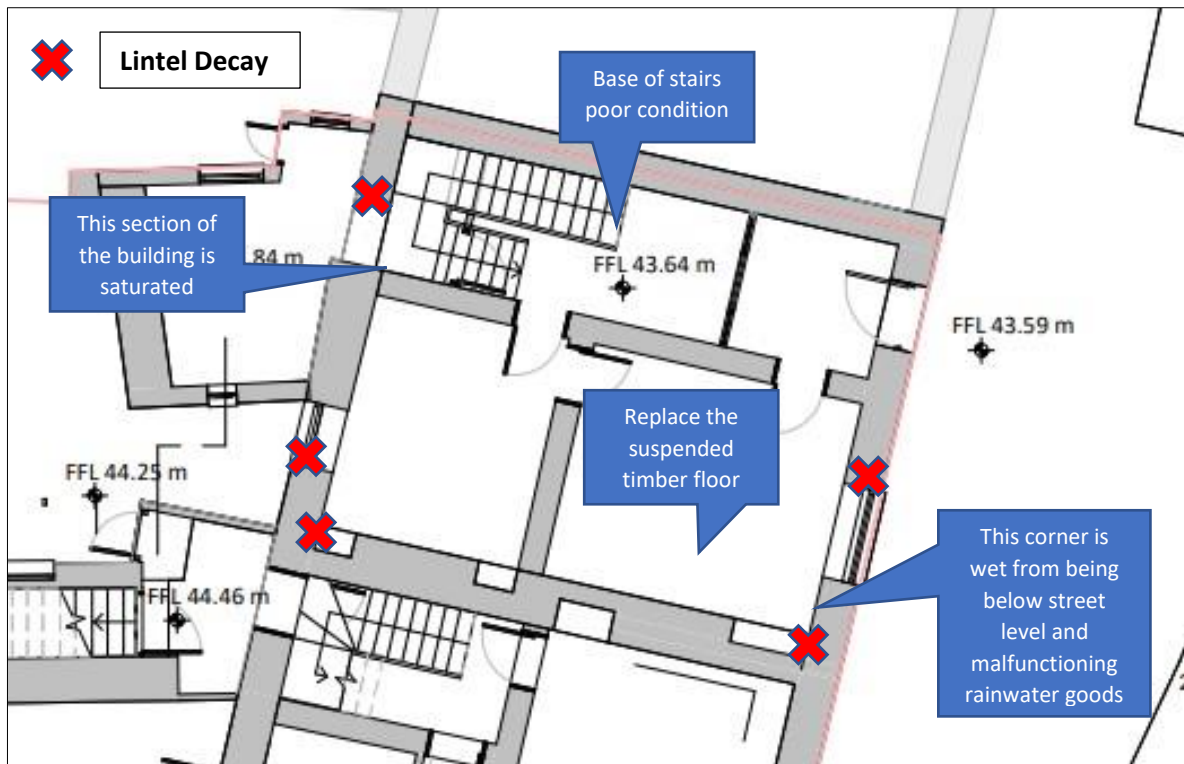
The ground floor is a suspended timber floor at the front, with long-term decay from a high moisture content and poor subfloor ventilation. The remaining floors are solid, presumably without any form of DPM present based on the high moisture content.

Figure 2. Shows the ground floor of the Three Storey Townhouse.

The following proposal is subject to further review when the masonry is fully accessible. We recommend that all floors be removed in full. We recommend that a Geocell/Glapur foam glass aggregate is installed as per the engineers' detail. Allow for additional depth adjacent to all external walls; this detail reduces capillary action against the external walls.

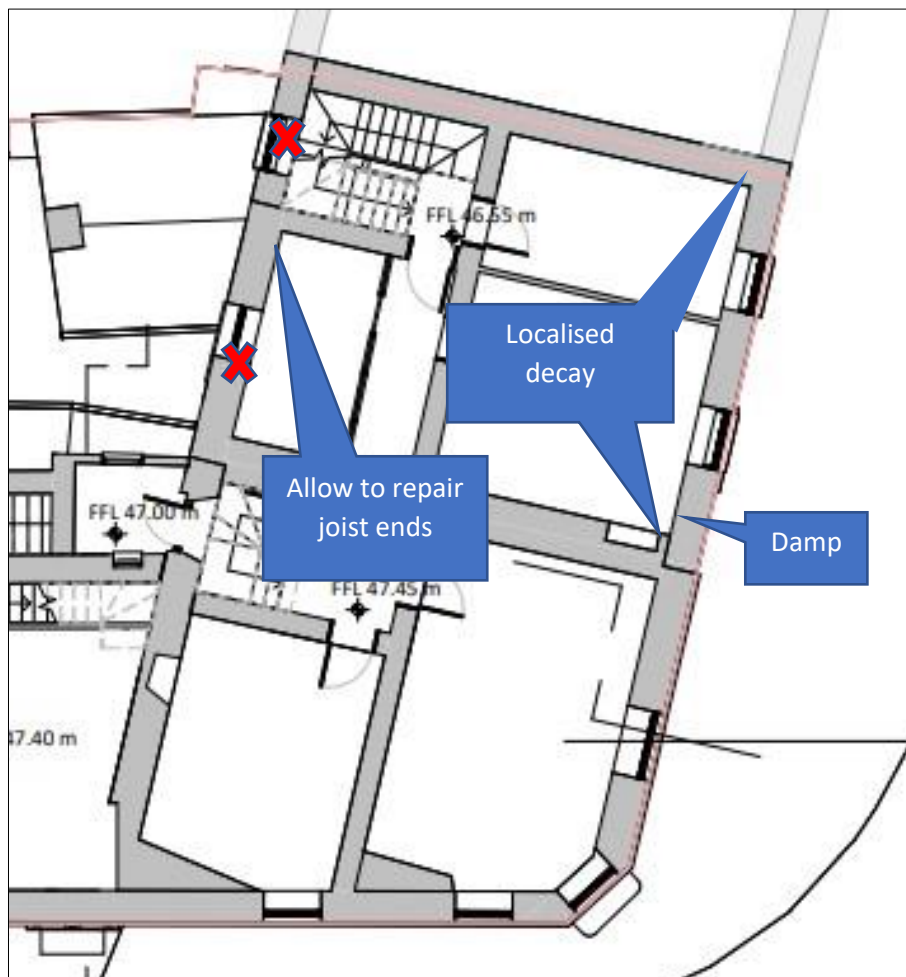
The first-floor joists are parallel to the front wall at the front of the building. The bearing end of the joist closest to the wall has some decay present on both sides of the building. The floor joists in the main bedroom have some deflection due to the room's span but are generally reasonable.

The lintel in the rear bedroom has signs of decay and should be replaced in full as per the engineers' detail.

*Figure 4. Shows the first floor of the Three Storey Townhouse*

We recommend that you allow for repairing 25% of all floor joists at this level, subject to further review when they are fully accessible. Allow for reviewing all chimney and stair trimming timbers when fully accessible.

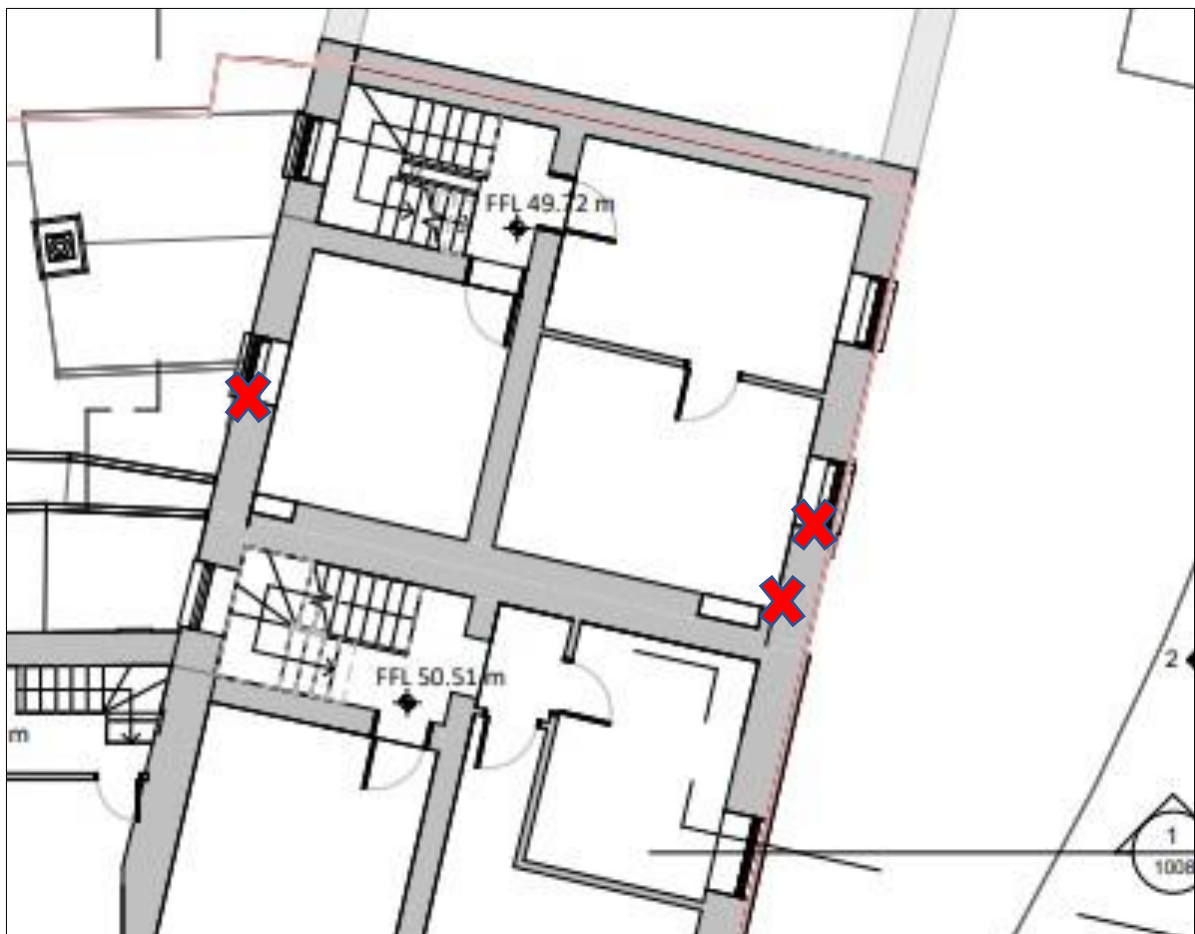
The lintel in the front bedroom has signs of decay and should be replaced in full as per the engineers' detail. Allow for replacing the adjacent window lintel, subject to further investigation. The rear lintel shows signs of deterioration and should be further reviewed when accessible.

*Figure 5. Highlights areas of damaged lintels on the second floor.*

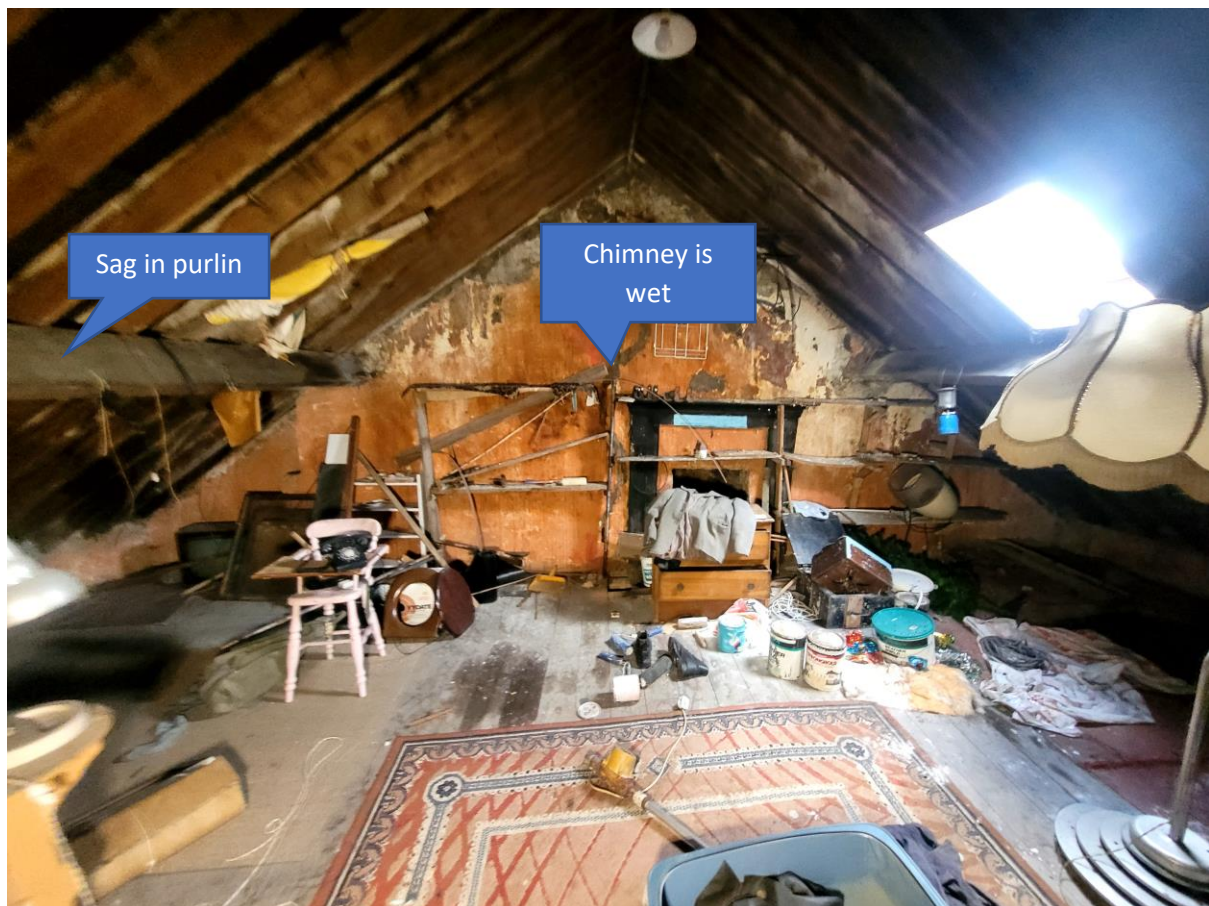
The roof consists of a traditional cut timber roof as the primary structure which rest on a long purlin. The floor joists in the attic are light and have deflected considerably as a result. We recommend that the entire floor is reviewed. The roof is slate covered and underdrawn with a non-breathable sarking felt, presumably installed in the 1970s. The attic void has little ventilation cross ventilation but vents through the chimney. The roof structure is generally reasonably maintained, with localised decay noted primarily at both gables, which requires local repair

We have recorded that there is evidence of light scattered common furniture beetle (*Anobium punctatum*) within the roof space. The floorboards and joists have heavy damage in some areas.

The span of the purlin at the front of the building is long and has deflected in the centre. We recommend that the purlin is strengthened/supported as per the engineers' detail. The purlin at the rear is cut to allow headroom into the attic. The bearing ends of the purlins show signs of decay where they are embedded in the wall/chimney. We recommend that all decayed timber be cut back and a steel splice/shoe detail installed per the engineers' detail.

*Figure 6. Shows a broad view of the attic space.*

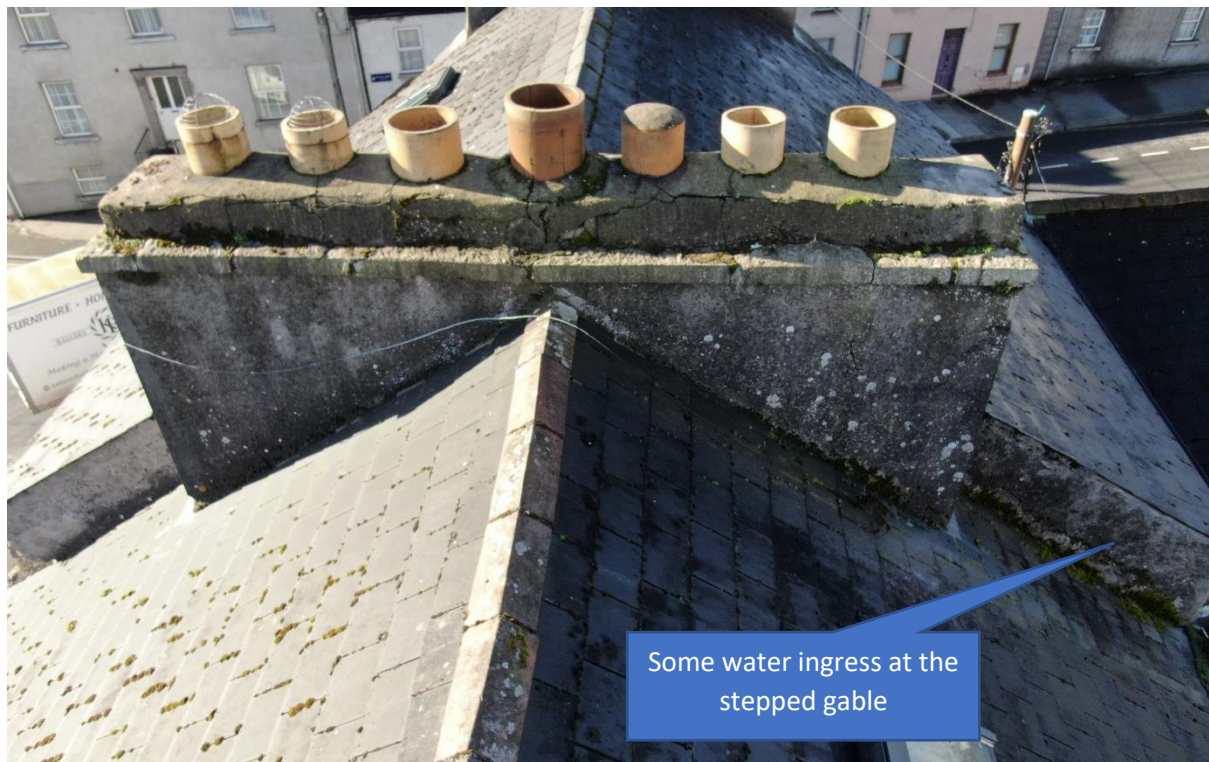
Both chimneys allow water ingress, and the shared chimney with Dooley's pub is in poor condition. The stepped section of the gable (where the roof abuts Dooleys) requires specific attention.

*Figure 7. Shows an aerial view of the shared chimney.*

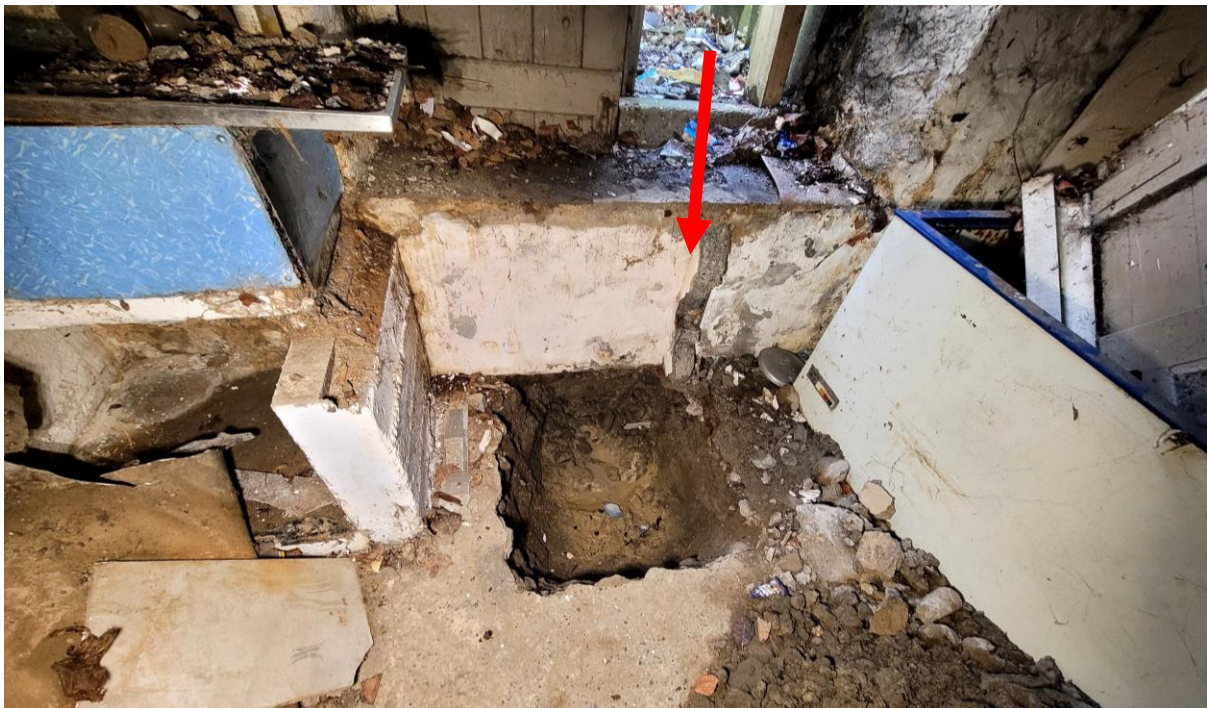
All timbers within the basement have decayed from wet rot and woodboring beetle. This includes the lightwell window lintels and rear lintels, the bottom of the stairs and supporting timbers.

The chimney/fireplace in the basement was particularly wet during our inspection.

*Figure 8. Shows the area exposed in the basement. Note the water ingress through the light well.*

We recommend that all timbers in the basement are entirely replaced as per the engineers' detail.

We recommend that the basement is fully waterproofed using the following membrane. We do not recommend cementitious tanking as it can have knock-on effects and is generally irreversible for use in a protected structure.

We recommend that a Vapourflow basement ventilation system is installed as part of crossflow ventilation.

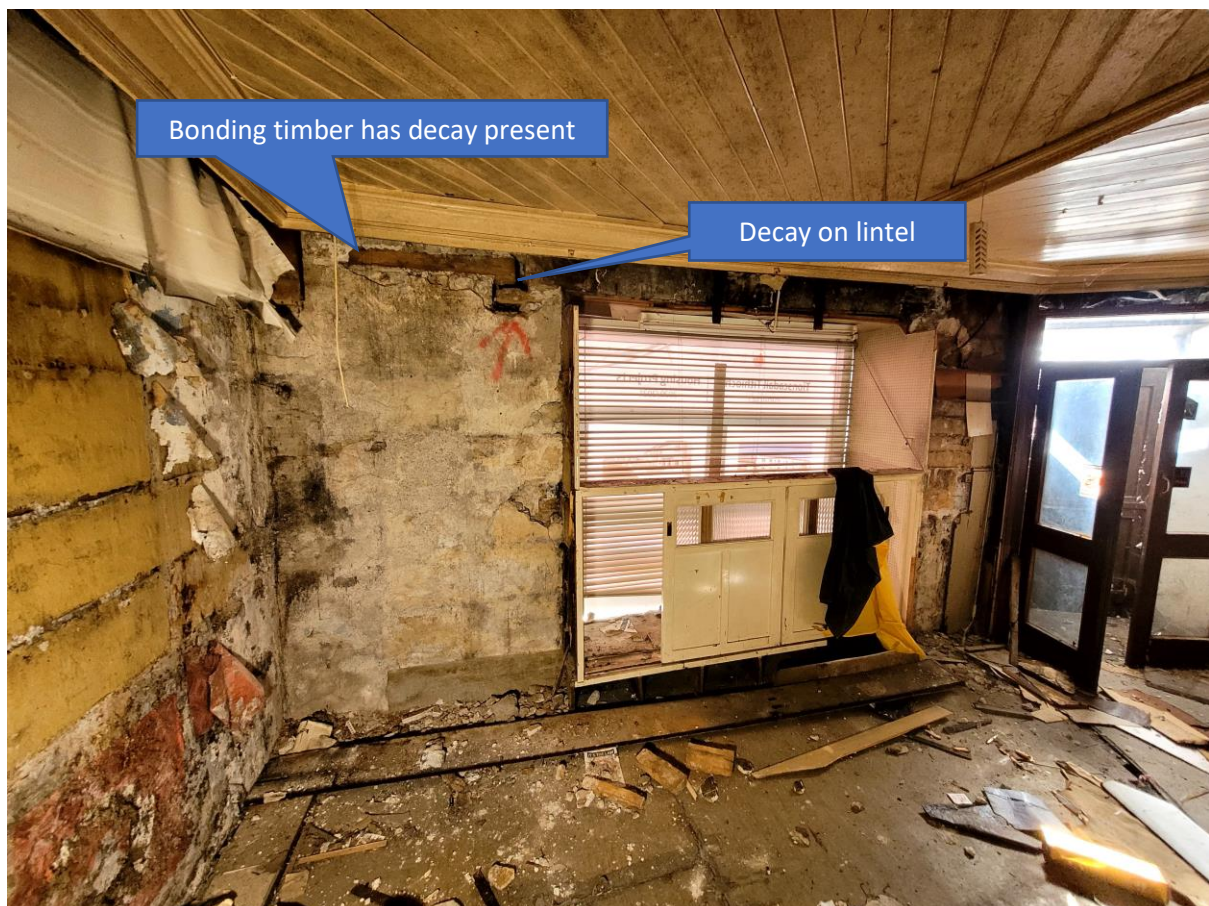
The ground floor of the pub area is in poor overall condition. The joist ends in the walls are heavily decayed, and there is a deterioration of the main floor joists as a result of being damp for an extended period of time. There have been supporting timbers installed at some point which are sagging. We recommend that the floor is replaced in full as per the engineers' detail. We recommend that all new timbers installed are certified pressure treated and that they rest on steel rather than becoming embedded in a damp wall on completion.

*Figure 9. Shows a broad view of the ground floor of Dooleys Pub.*

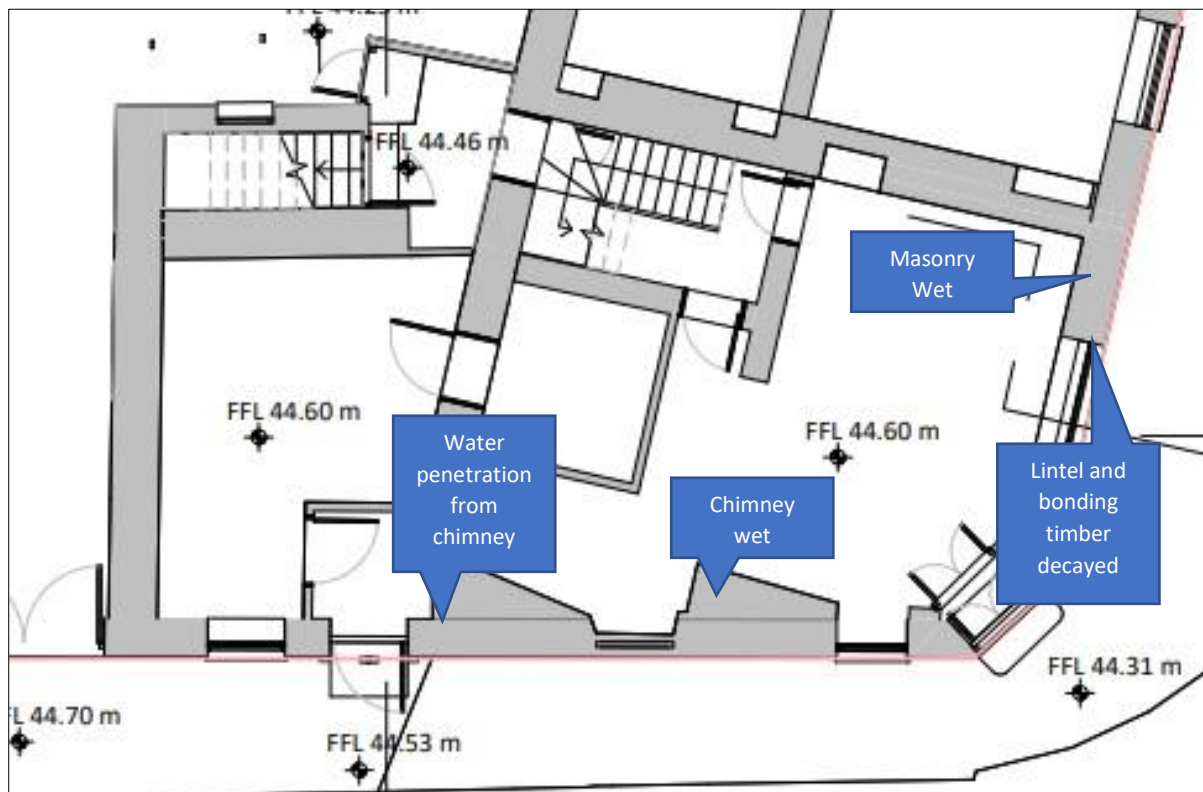
The timber lintel over the main shopfront has decay present on the east side where it was exposed. We recommend that the lintel be exposed for further review during the project and that, from a quantity point of view, it is replaced in full as per the engineers' detail.

There is an embedded bonding timber adjacent to the lintels that has heavy decay and should be removed, and the socket is infilled with masonry and lime mortar.

Figure 10. Shows a marked-up section of the ground floor in Dooley's Pub

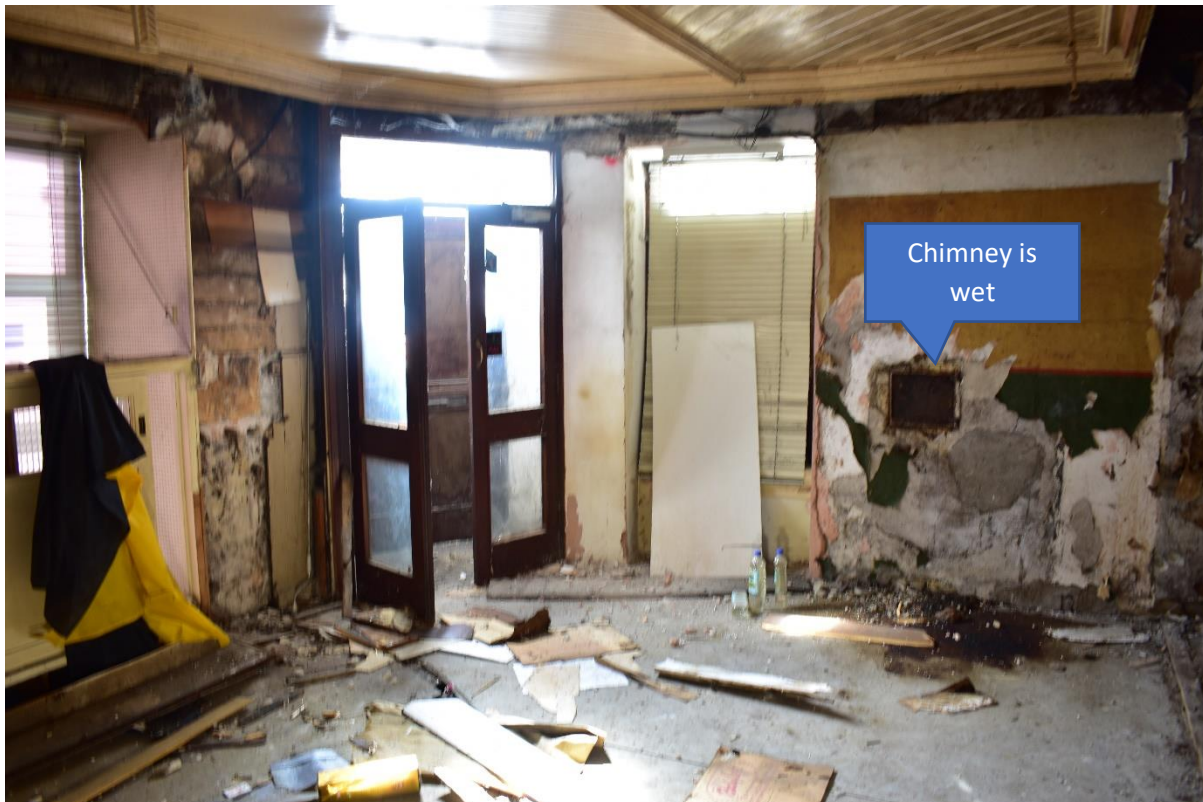
The fireplace/chimney was wet in this location during our inspection and heavily contaminated with salts.

Figure 11. Shows a broad view of the ground floor, including a section of the chimney that is currently wet.

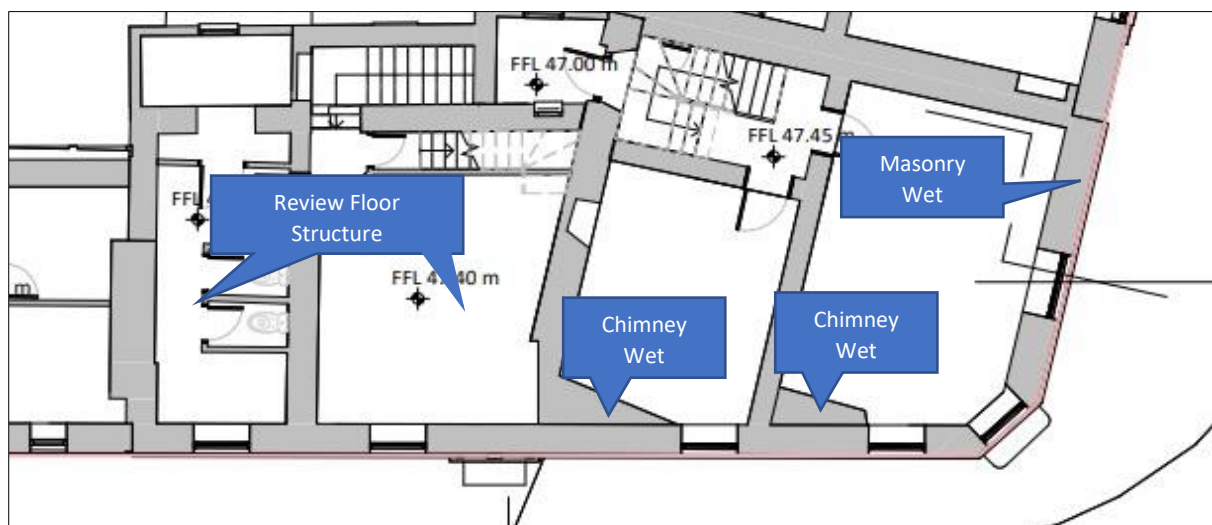
The first floor in the two-story section has heavy damage from the common furniture beetle, and the joists in the main room are supported on a steel midway. This section should be treated and strengthened or replaced per the engineers' detail. Review the joist ends when accessible. The joists over the carriageway have some damage from common furniture beetle. Similarly, they should be treated and strengthened/replaced as per the engineers' direction.

Figure 12. Shows a marked section of the first floor of Dooley's Pub.

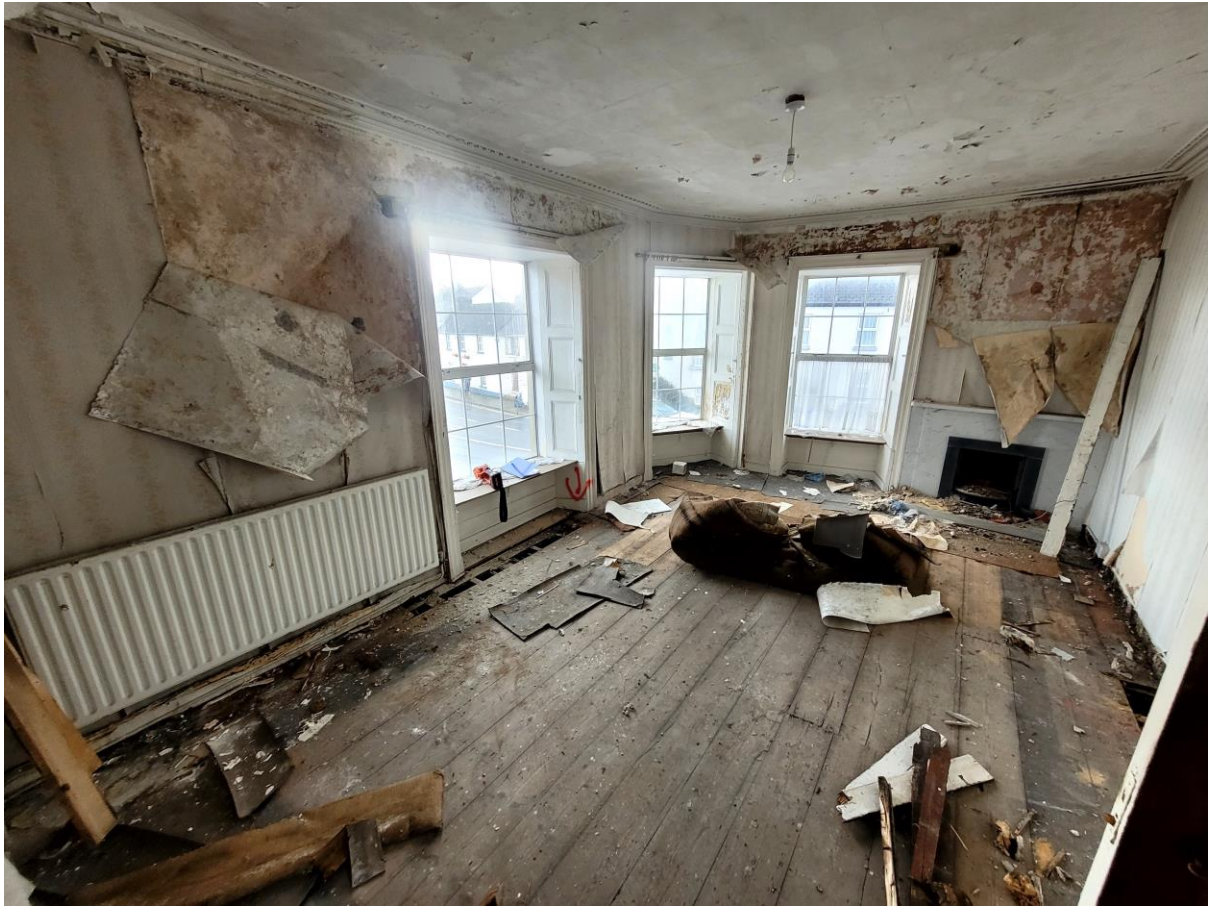
The wall is wet at the junction with the three-storey townhouse due to malfunctioning rainwater goods. The chimneys at the Dunlo Hill elevation were damp due to water ingress. The front wall has a high moisture content present as the gutter is missing at the roof level. The wall plaster is in overall poor condition and contaminated with salts from water ingress.

Both lintels exposed were reasonable. The bearing pad on the east window has decay present, and the centre lintel may have decay present based on the condition of the lintel at the second-floor level. We recommend that all lintels be reviewed during the project and allow to replace one at this level, subject to further review.

*Figure 13. Shows a broad view of the first-floor front room.*

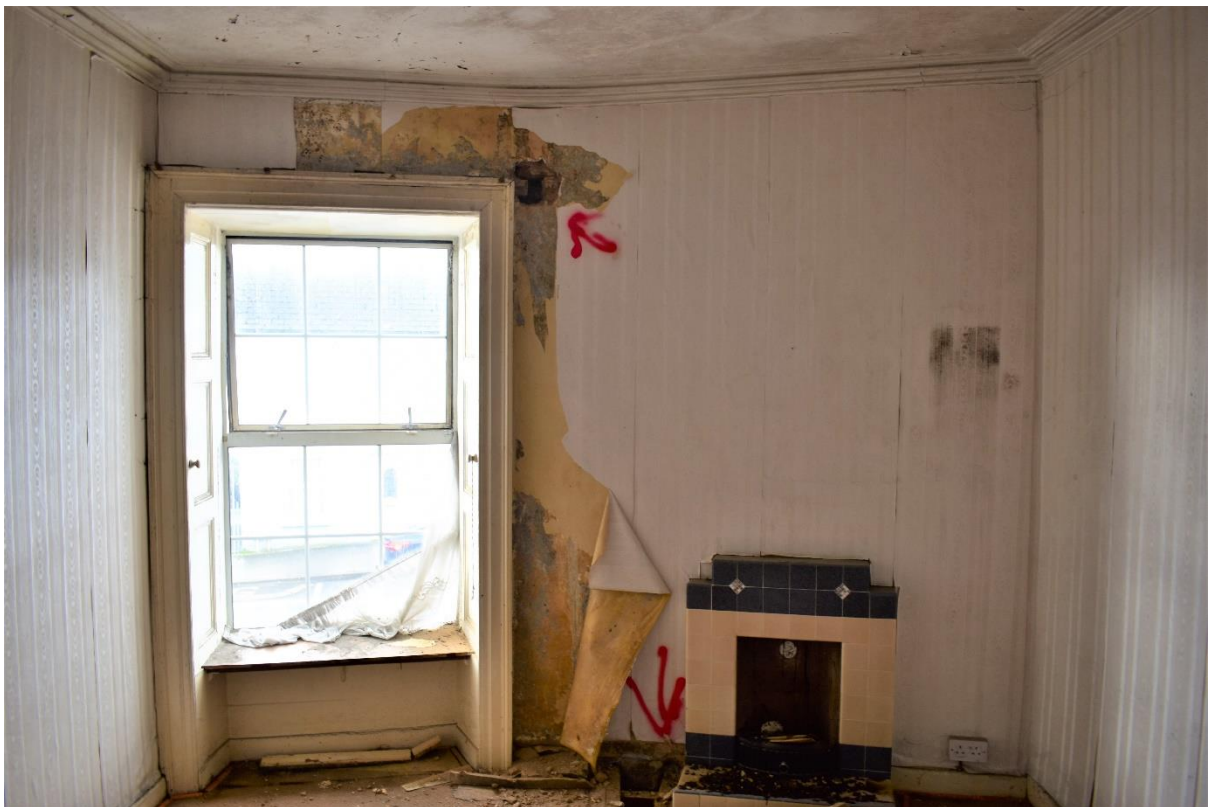
*Figure 14. Shows pockets exposed on the Dunlo Hill elevation.*

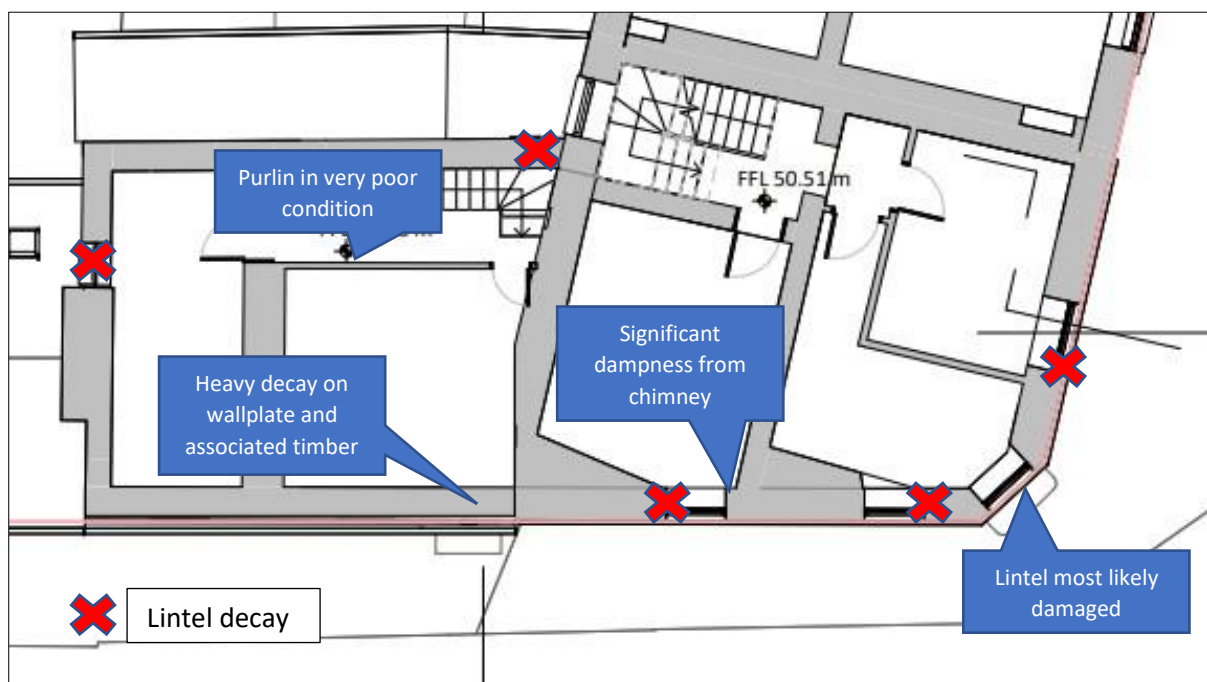
We have noted that all three lintels exposed at the front of the building have decay present, and the remaining two are likely to be in a similar condition. Allow for replacing all lintels at this level, subject to further review.

The wall plaster is in very poor condition at this level and contaminated with salts from water ingress. There is foil-backed lining paper used at this level, suggesting an ongoing issue with dampness at this level.

*Figure 15. Shows marked-up areas of decay at the second floor level.*

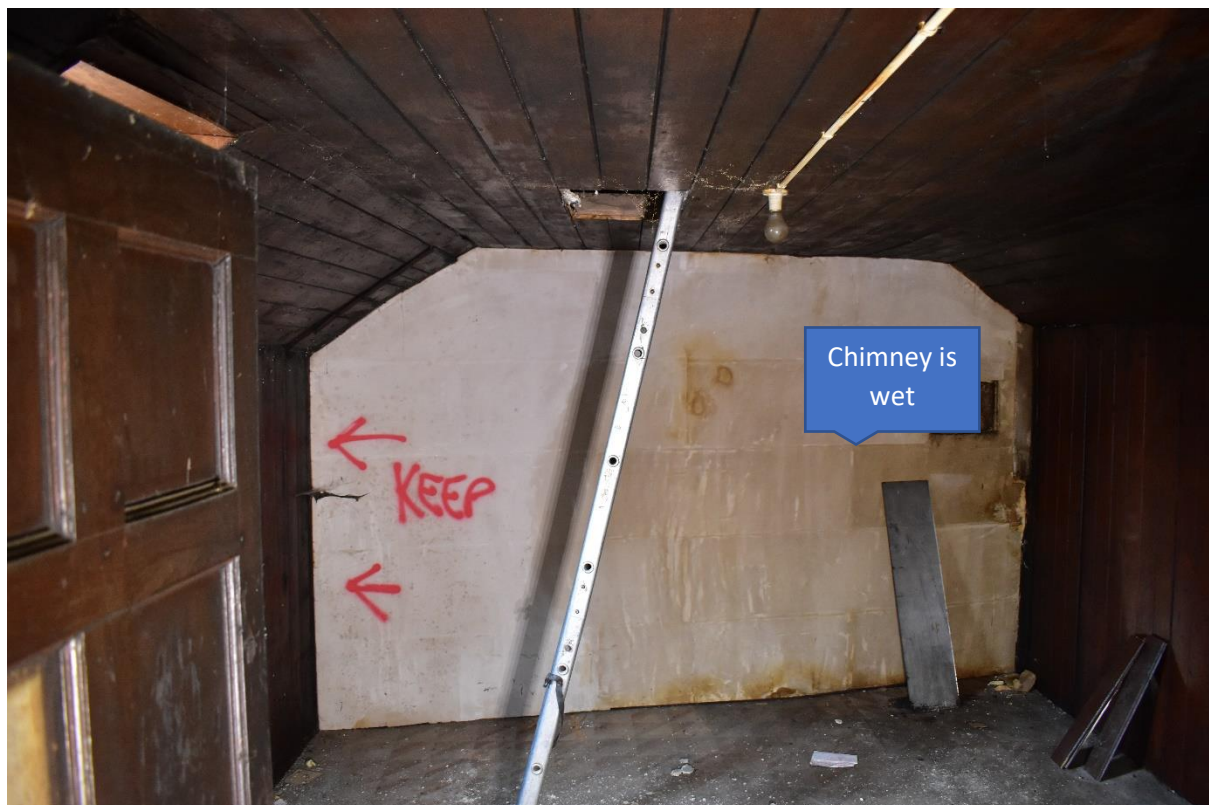
The main roof consists of a traditional cut timber roof as the primary structure. The roof structure is generally reasonably maintained, with localised decay noted primarily at the gable and chimney, which requires local repair. The roof is slate covered and underdrawn with a non-breathable sarking felt, presumably installed in the 1970s. We have noted that the purlin ends embedded in the common chimney have decay present and require repair as per the engineers' detail.

The old lime parging/torching is left on the flooring since the roof was stripped. We have not accessed the floor joists at this level. We have recorded that there is evidence of light scattered common furniture beetle (*Anobium punctatum*) within the roof space. The floorboards and joists have heavy damage in some areas.

The chimney is again consistently damp in this location due to water penetration.

*Figure 16. Shows the broad view of the attic room in Dooley's Pub.*

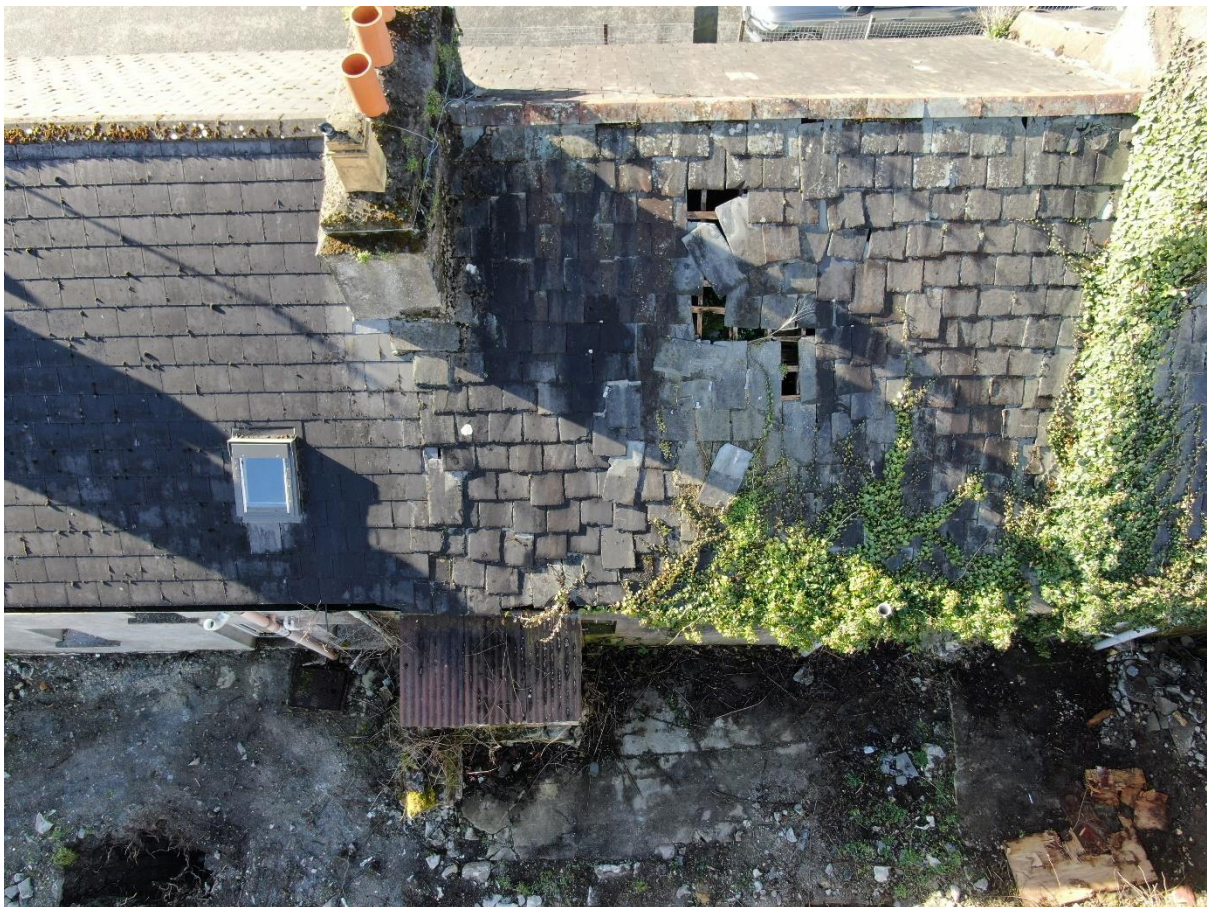
The worker's cottages are in poor overall condition. The properties range from hazardous due to failed floor structures to a fair condition where the unit is reasonably intact. Unit 3 is in the best overall condition; however, this building has been altered in the past.

Apart from Unit 3, all roofs are in inferior condition, and some have failed allowing a significant amount of water into the buildings.

Figure 18. Shows an aerial view over a typical cottage that is in poor condition.

In our view, based on the level of decay present, we suggest that the entire timber structure – Roof, First floors, Suspended timber floors and Timber lintels are replaced in full as per the engineers' detail.

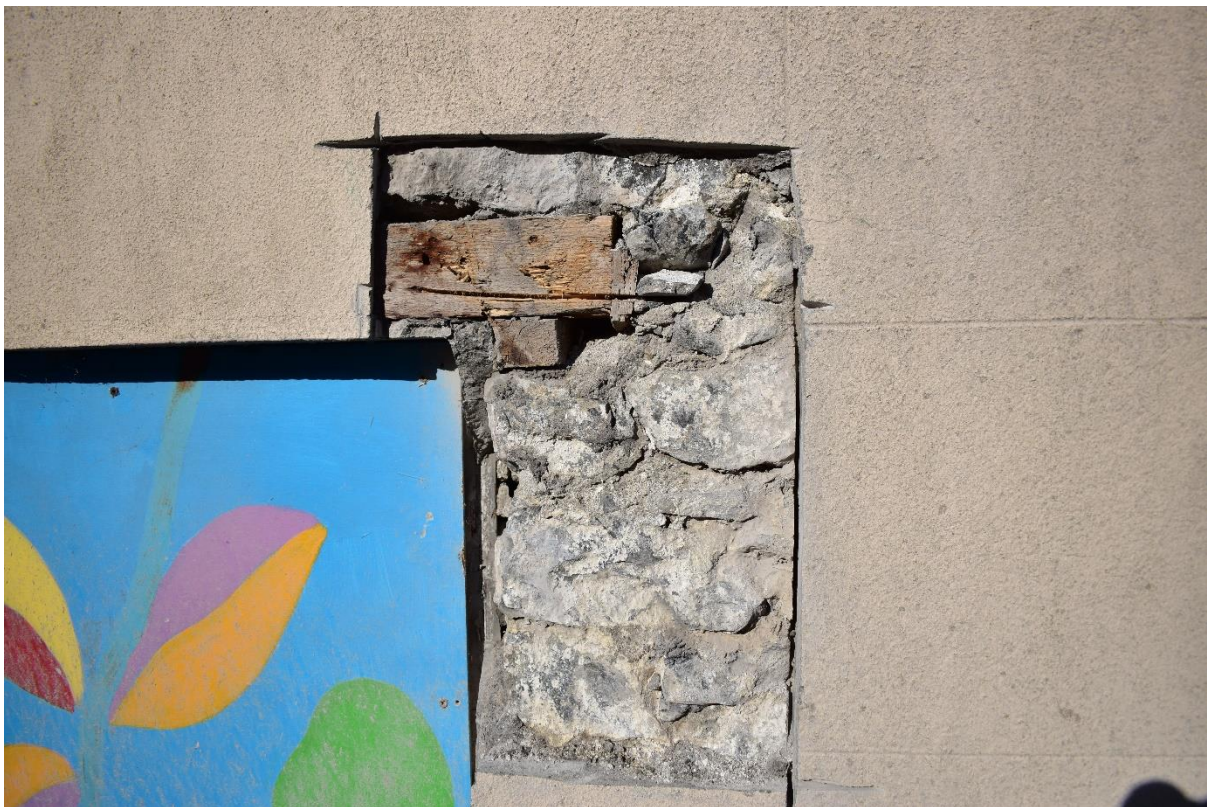
*Figure 20. Shows a section of removed render that has exposed an external timber.*
