CLIFDEN TOWN PUBLIC REALM ENHANCEMENT PROJECT INCLUDING  
CLIFDEN HARBOUR PARK AND BEACH ROAD QUAY CLIFDEN

STAGE 1 ROAD SAFETY AUDIT

| Document Control Sheet | |
|---|---|
| Document Reference | 11252TR01 RSA |
| Report Date | October 2024 |

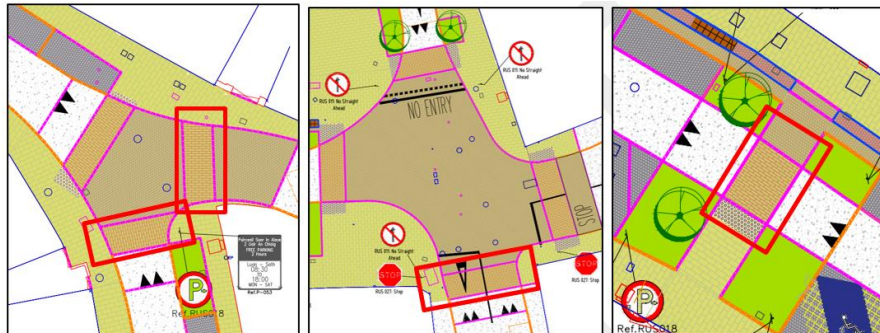
The Audit Team observed on site a number of tactile paving was absent at numerous proposed crossings. The Audit Team are concerned this may result in visually impaired personal will enter the roadway. This may result in a collision between a vulnerable road user (VRU) and a vehicle.

Figure 2-1 Examples of Discrepancy of Tactile Paving Provisions (Dwg No. 11623\_LD\_HL\_TC\_003)

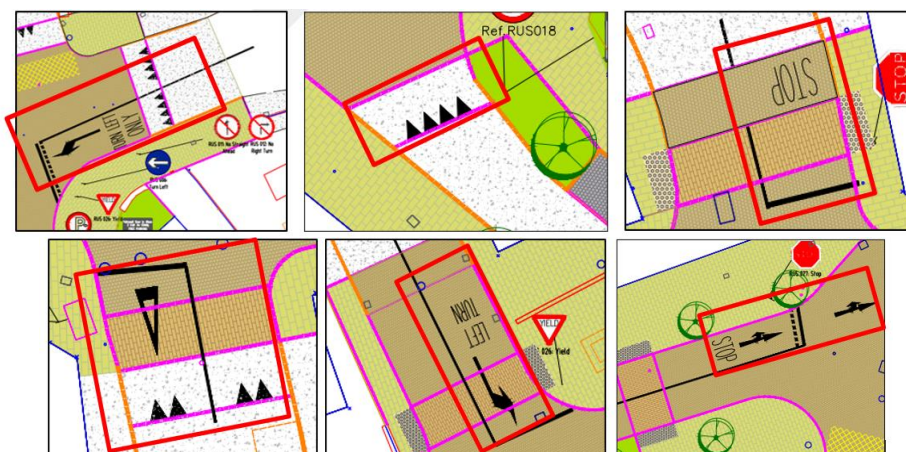
The Audit Team observed on the design that the proposed road markings are not in accordance with chapter 7 of the Traffic Signs Manual (TSM). The Audit Team are concerned that the Inaccurate Road marking selection and location could result in a false expectation of the upcoming traffic. This may result in collisions between vehicles or increased risk of collisions with VRU.

Figure 2-2 Examples of Discrepancy Road Markings (Dwg No. 11623\_LD\_HL\_TC\_002)

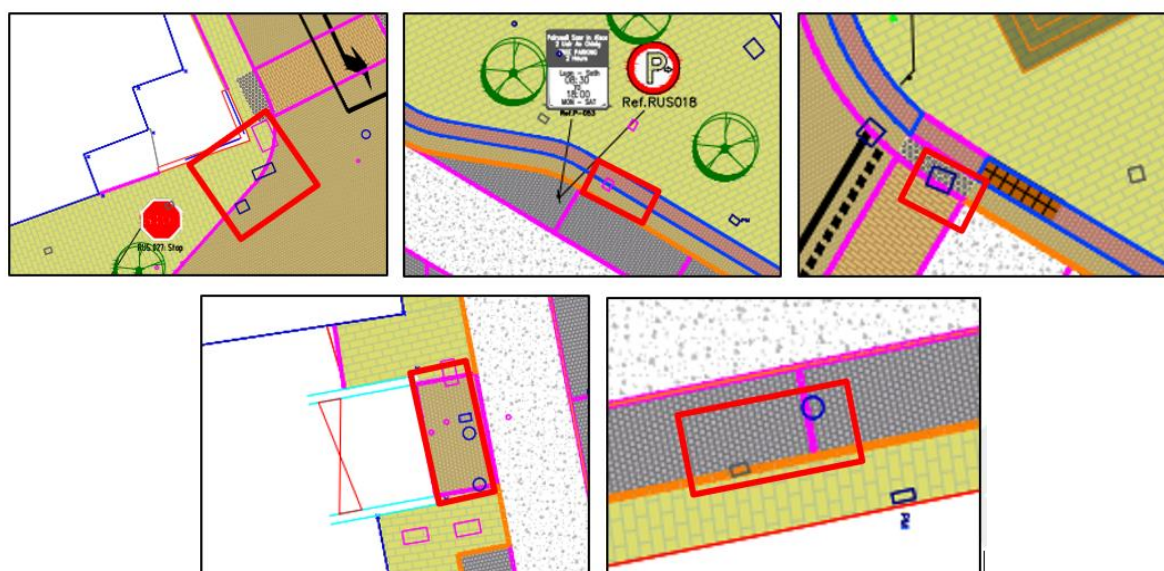
The Audit Team observed on site a number of clashes with existing utilities, poles interfacing kerb lines and obstructing footways. The Audit Team are concerned this may result in trip and point of hazards for VRU. This may result in an obstruction for VRU and vehicles.

Figure 2-3 Examples of Clashes with Existing Utility Chambers and Proposed design (Dwg No. 11623\_LD\_HL\_TC\_003)

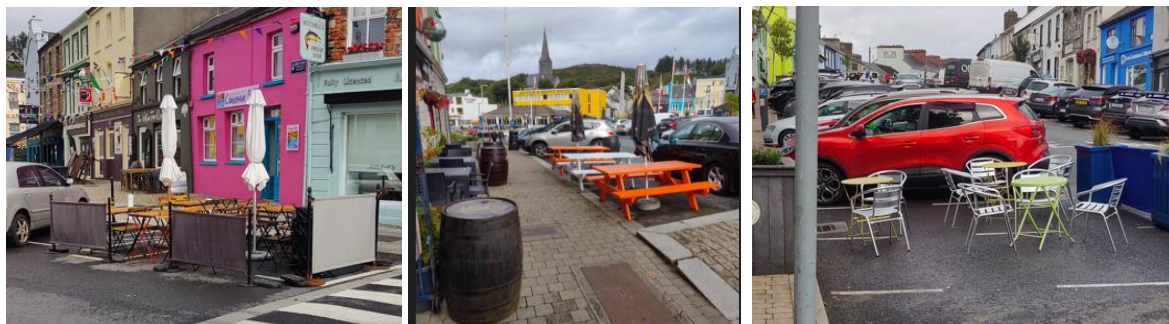
The Audit team observed on site a number of local traders are operating within parallel parking areas and offline parking areas on Market Street. The Audit team are concerned the failure to cater for the existing traders may result in the setting up of the stalls in unsuitable locations. This may result in creating hazardous situations for VRU.

*Figure 2-4 Examples of Existing Local Traders in Market Street.*

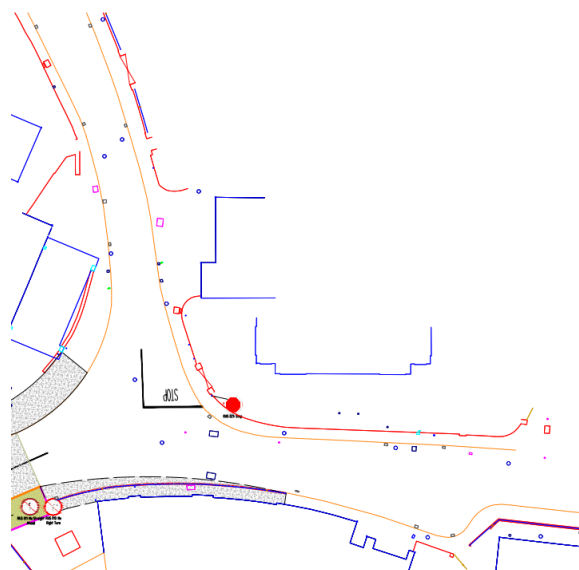
The Audit team observed on site that a proposed full upstand is shown on the drawings but on the drawings no information on tie in location has been provided. The Audit Team is concerned that an incomplete tie in design may result in drivers' confusion or entry into adjacent facility. This may result in a collision between a VRU and a vehicle.

Figure 2-5 Example of Lack of Tie in Location provided (Dwg No. 11623\_LD\_HL\_TC\_002)

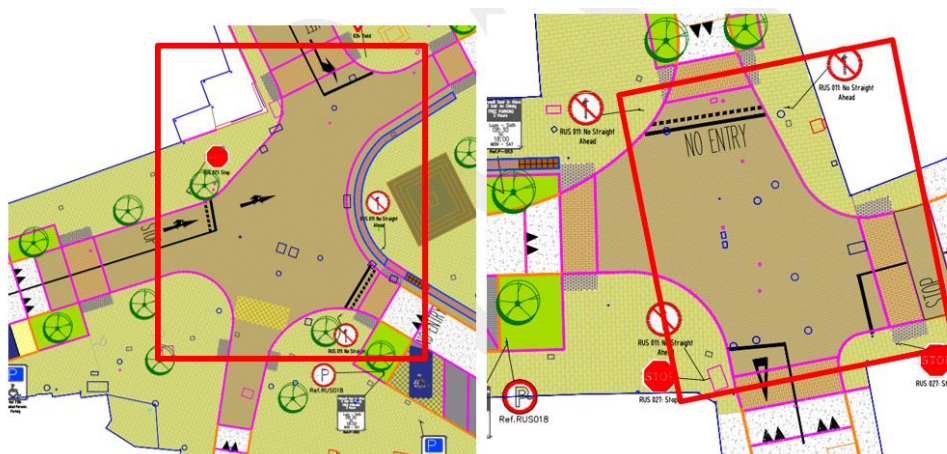
The Audit Team observed the preliminary design that no details of the operation of the junction have been provided to the Audit Team. The Audit Team are concerned that the lack of clarity on priority of road users could result in driver confusion and turning collisions. This may result in a collision between a VRU and a vehicle.

Figure 2-6 Example of no details of priority at junctions have been provided (Dwg No. 11623\_LD\_HL\_TC\_001 & 002)

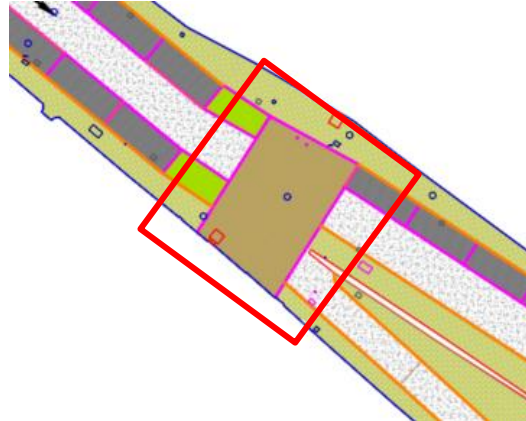
The Audit Team observed the preliminary design that no details of the footway continuity have been provided to the Audit Team. The Audit Team are concerned that the lack of clarity on priority of footway could result in VRU and driver confusion. This may result in a collision between a VRU and a vehicle.

Figure 2-7 Example of no details of priority at footway have been provided (Dwg No. 11623\_LD\_HL\_TC\_002)

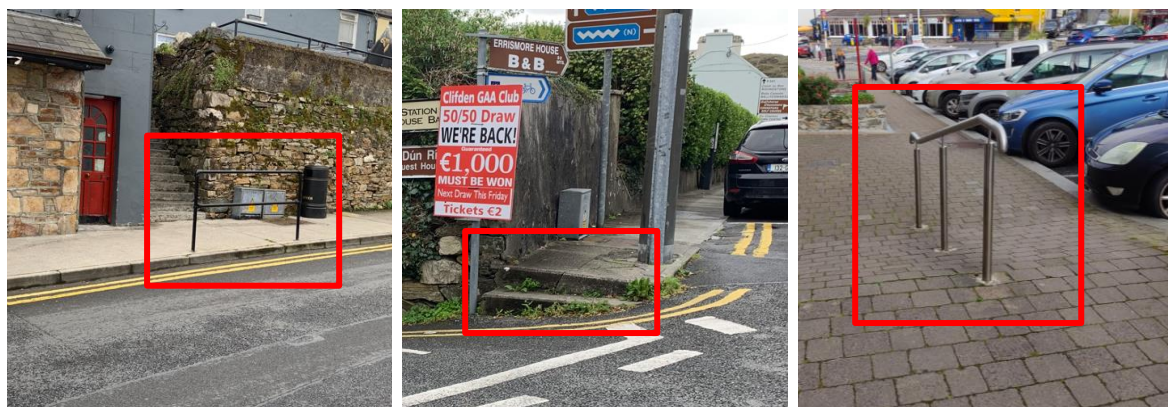
The Audit Team observed on site numerous areas where clashes occurred with existing urban realm infrastructure. The Audit Team are concerned this may result in obstruction for VRU. This may result in an obstruction for pedestrians leading to potential collisions and conflicts occurring.

Figure 2-8: Existing Obstructed Regulatory Sign

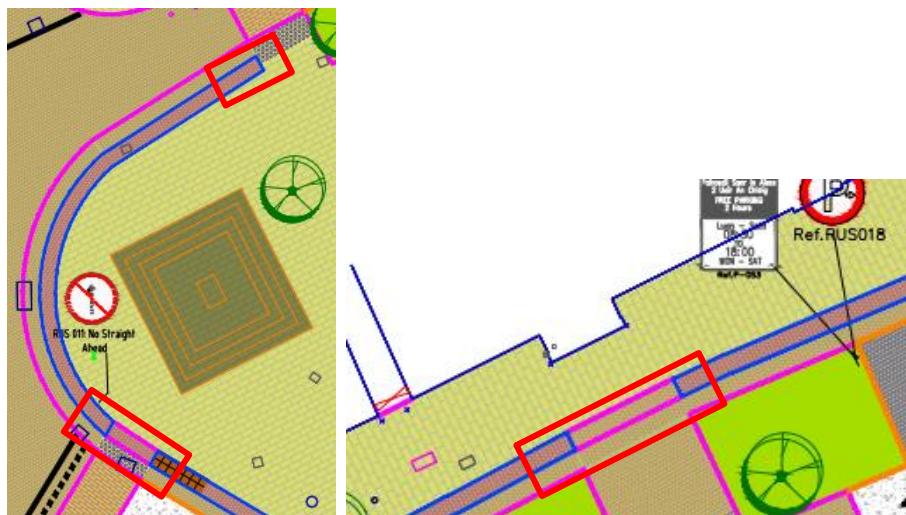
The Audit team noted that no transition detail has been provided at the termination of this cycle lane as part of the preliminary design. The Audit Team are concerned that this may give rise to a conflict point between pedestrians and cyclists. This may result in an obstruction for VRU and cyclists.

Figure 2-9: No Proposed Cycle Lane termination measure (Dwg No. 11623\_LD\_HL\_TC\_001)

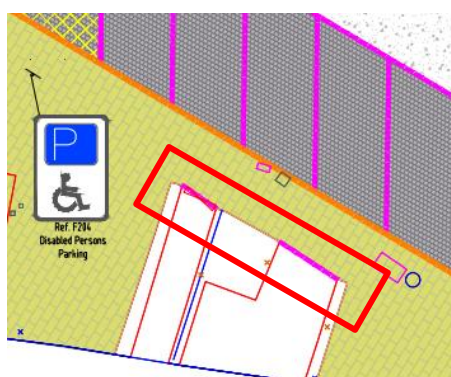
The Audit Team observed the preliminary design proposed paving works and does not include a treatment to provide warning to visually impaired road users. The Audit Team are concerned that this may result in a trip hazard for VRUS. This may result in collisions with visually impaired users and VRUs.

Figure 2-10: Example of Existing Steps (Dwg No. 11623\_LD\_HL\_TC\_001)

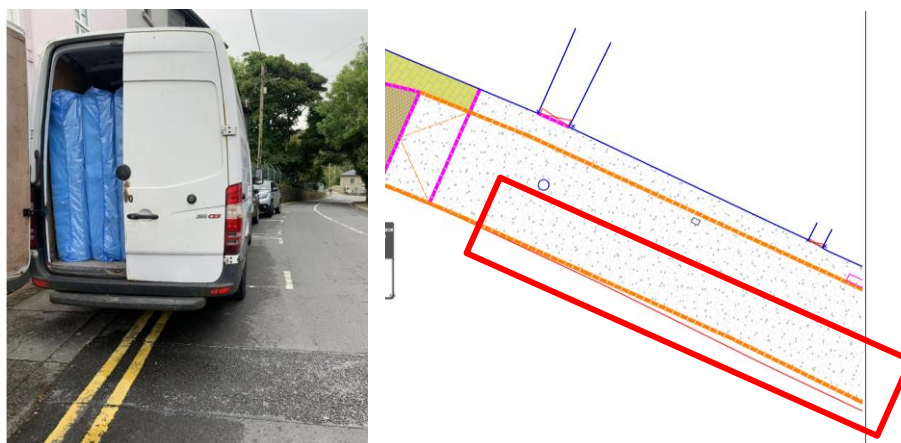
The Audit Team observed on site that parking facilities have not been provided for this location. The Audit Team are concerned the lack of parking can enforce drivers to park on the footway. This may result in an obstruction to the footway.

Figure 2-13: Existing Upstand Kerb and Parking (Dwg No. 11623\_LD\_HL\_TC\_003)

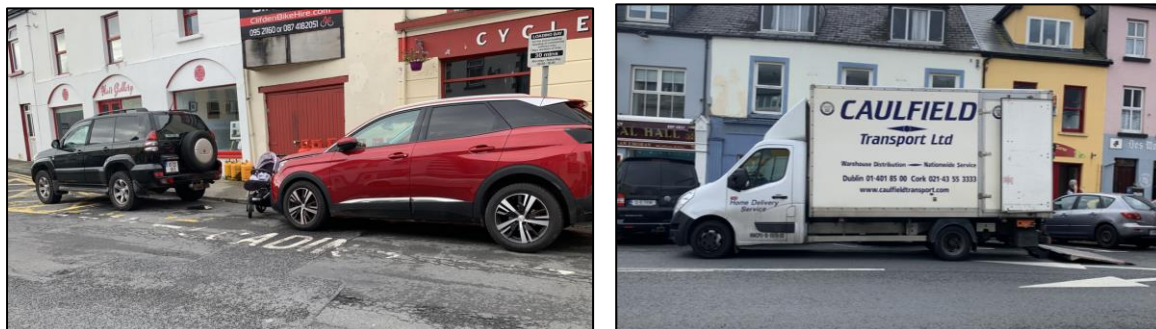
The Audit team observed on site that the existing loading bay has not been incorporated into design. The audit team are concerned this may lead to parking two abreast when loading is required. This may lead to driver frustration, unsafe overtaking and head-on collisions.

Figure 2-14 Loading Bay

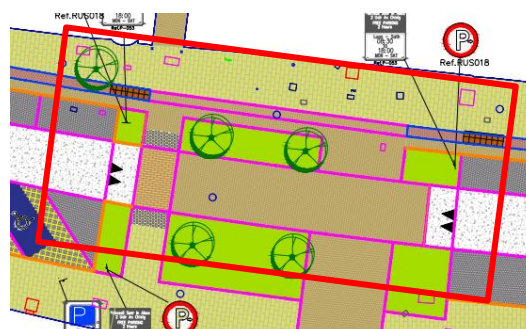
The Audit team observed on the design that the proposed trees is shown on both side of the footway and cycleway. The Audit are concerned that cyclists or pedestrians may proceed into the path of oncoming traffic. This may result in a collision between VRU and a vehicle.

Figure 2-15 Pedestrian and Cyclists Visibility (Dwg No. 11623\_LD\_HL\_TC\_003)

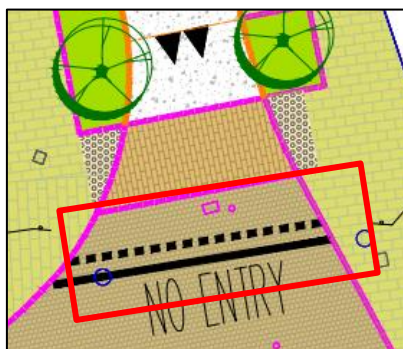
The audit team noted 'No Entry' road markings is proposed with the wrong orientation. The audit team are concerned this may lead to drivers' confusion. This may result in collisions between vehicles or increased risk of collisions with VRU.

Figure 2-16 No Entry Road marking (Dwg No. 11623\_LD\_HL\_TC\_003)

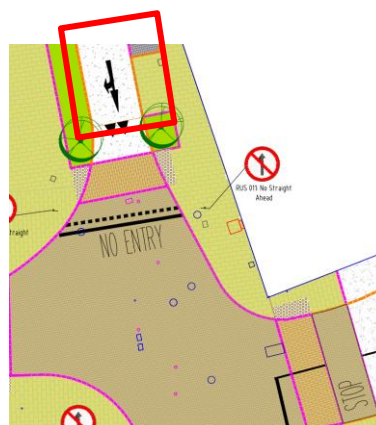
The Audit team observed that at the Junction coming from Bridge Street, a left turn road markings has not been proposed. The audit team are concerned this may lead to drivers' confusion and late turning movement without warning. This may result in a collision between VRU and a vehicle.

Figure 2-17 Left turn road marking not included on the design (Dwg No. 11623\_LD\_HL\_TC\_001)

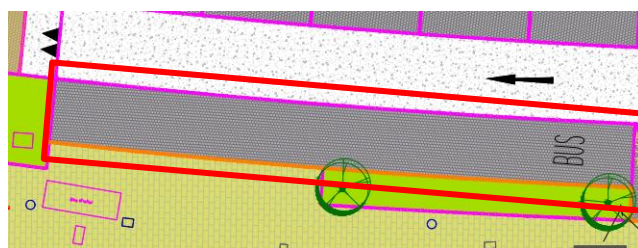
The Audit team observed on site that no detail on road marking and taper lengths have been provided for the bus bay. The Audit are concerned that the bus will restrict visibility to/from pedestrians who are using the adjacent crossings. This may result in a collision between VRU and a vehicle.

Figure 2-18 Bus Bay Road marking and taper (Dwg No. 11623\_LD\_HL\_TC\_001)

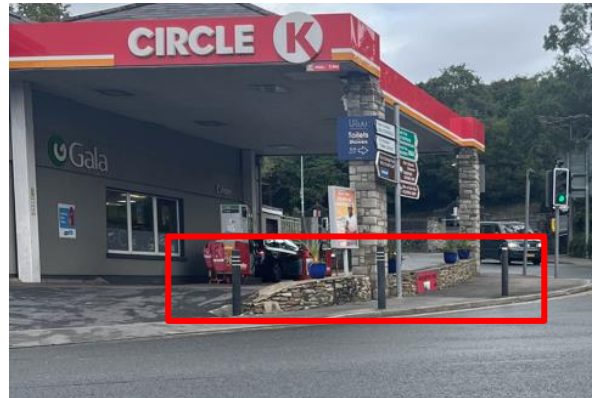
The Audit team observed on site that during the site visit that no details has been provided on the existing bollards in front of Circle K at Main Street.

*Figure 2-19 Existing Bollards*

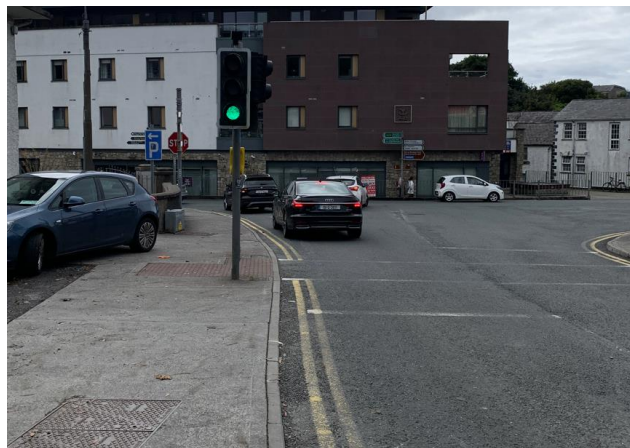
The Audit team observed during the site visit that the visibility of the stop line road marking overshoots the stop line. The Audit are concerned that vehicles at the stop line won't see the upcoming traffic from Main Street. This may result in a collision between vehicles.

*Figure 3-1 Stop Line Road Marking*

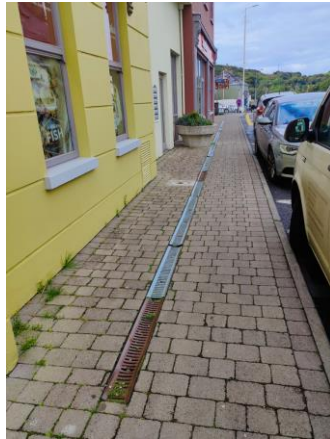
The Audit team observed during the site visit that the Aco drain has not been included in the proposed design. This can lead to future drainage issue.

*Figure 3-2 Existing Aco Drain*

The design team should ensure that ECO drain is included in the design.

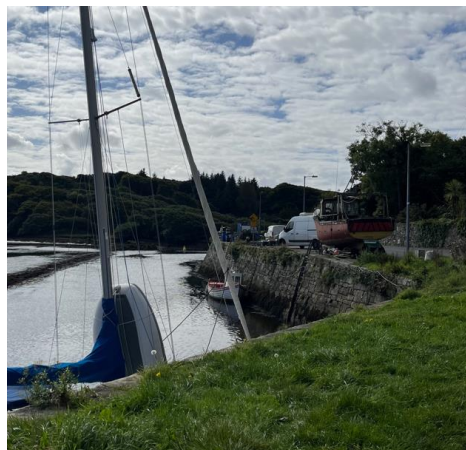
The Audit team observed during the site visit that no boundary treatment has been provided to protect road users near the pier along an active docking area. This may result in vulnerable road users (inc. pedestrians, cyclists, scooter users, motorcyclists, less abled and mobility impaired users) falling into the water.

*Figure 5-1 Boundary Treatment not proposed on design.*
