Clifden Town Centre Enhancement

Structural Condition Inspection for Quay Wall

Document Control Sheet	
Document Reference	RP01
Report Status	Final
Report Date	April 2022
Current Revision	A
Client:	Galway County Council
Client Address:	Prospect Hill, Galway, H91H6KX
Project Number	11252

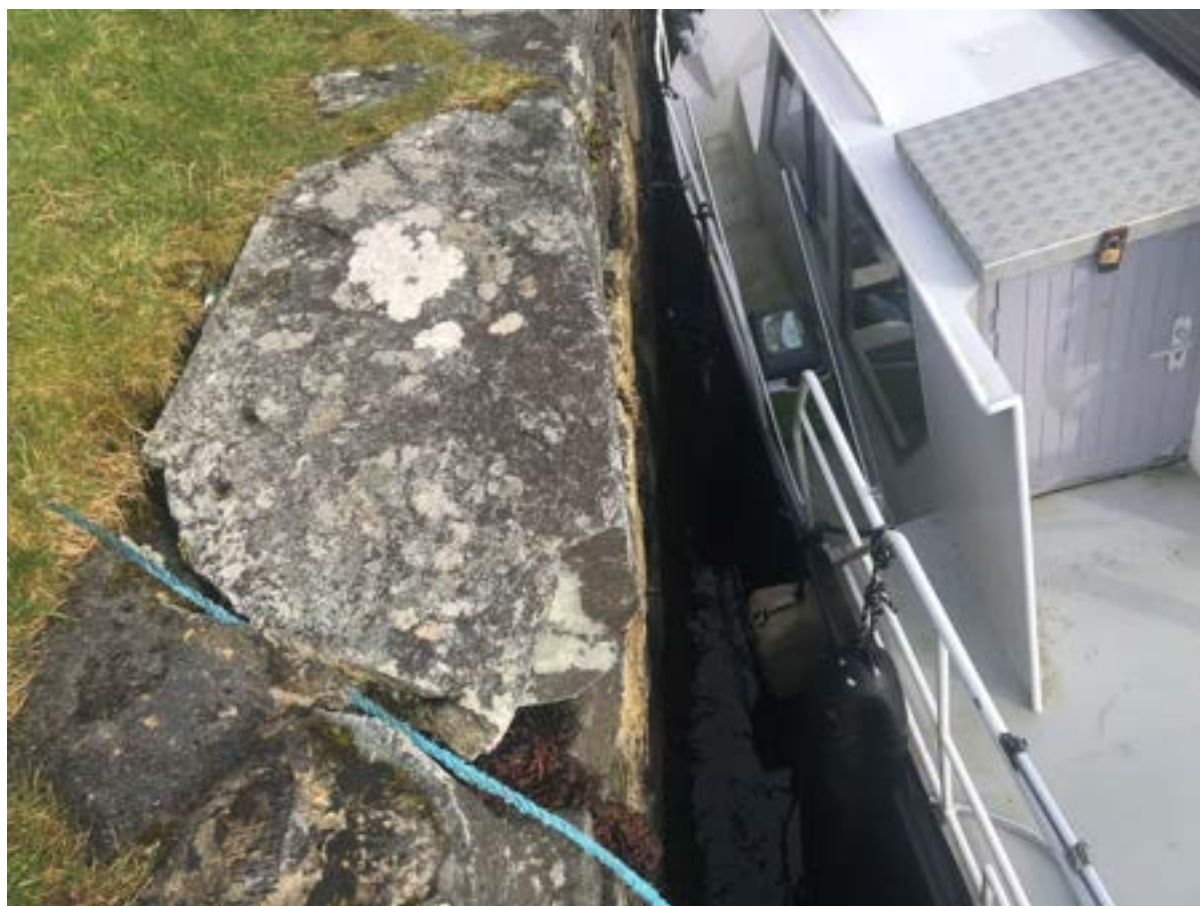
Notwithstanding its shortcomings as outlined above, there is no evidence of significant movement, settlement or distortion of the wall. Some of the facing stones have become dislodged and fallen into the sea. Some of the capping pavement stones have been pulled out of position, it seems because mooring lines have on occasions got into gaps between the pavement stones and caused them to move as the boats moved in the wind and tides.

Figure 2 - Capping stones dislodge by mooring lines

Based on our inspection, we find the current structural integrity of the wall to be sound. However, we do have concerns that the capping stones can be dislodged by mooring lines and this could lead to deterioration of the walls structural integrity.

- Any stones that have become dislodged from the pier wall should be reset. The stones should fit tightly alongside each other, and this may require new cut stones to suit the wall.
- Vegetation should be removed and the stonework in the wall should be pointed in so far as it can.
- Mortar should be place between the capping stones to prevent mooring lines from snagging in them and pulling the stones out of position.

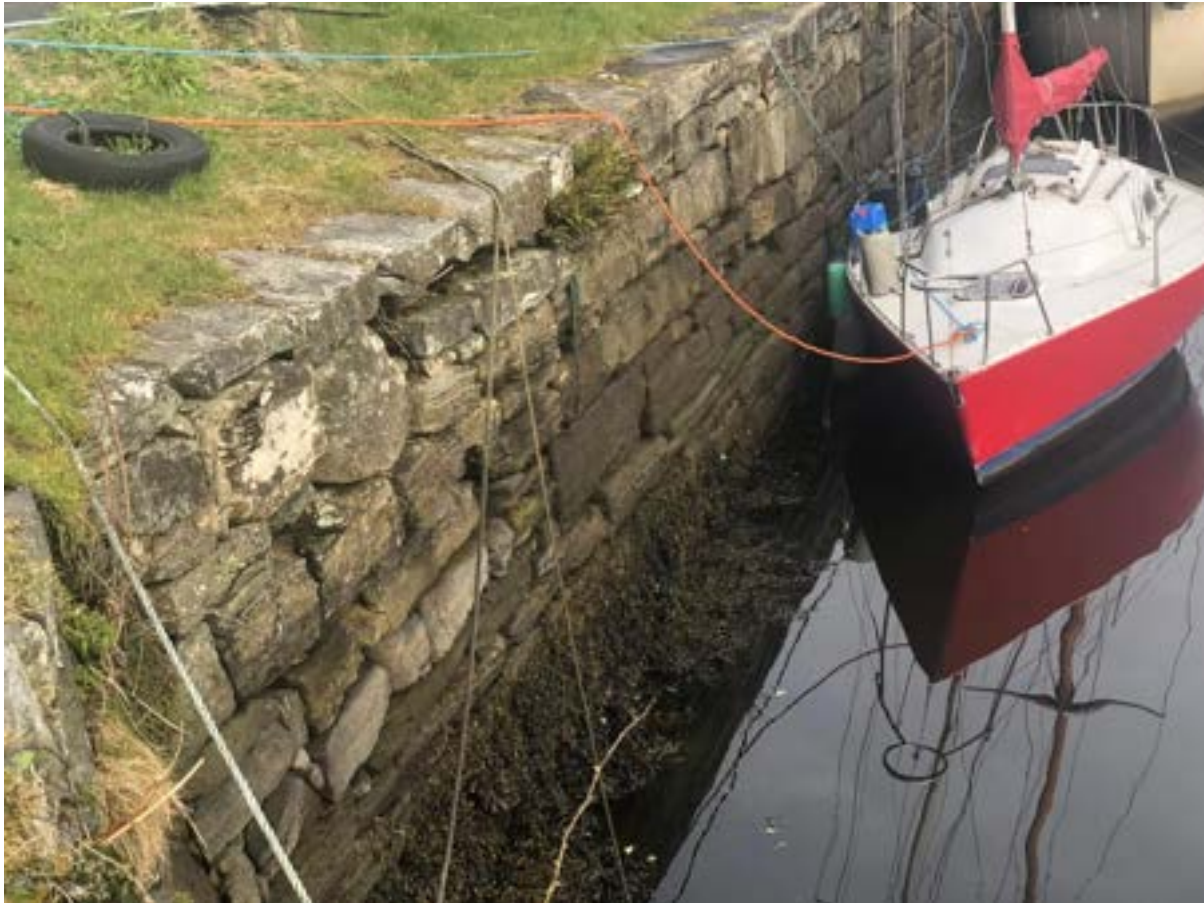
Figure 3 - Vegetation and stonework dislodged
