ACP *Architectural Conservation Professionals*

**cabe**
builtenvironment
AWARDS 2024

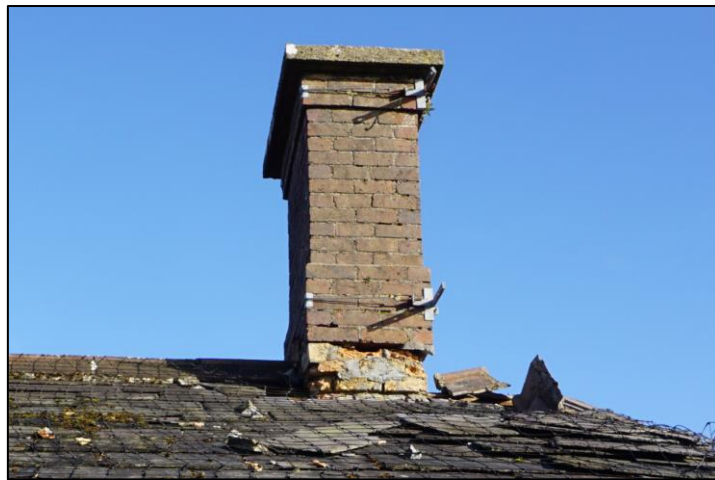
Photograph 1: View of the southern-most stack

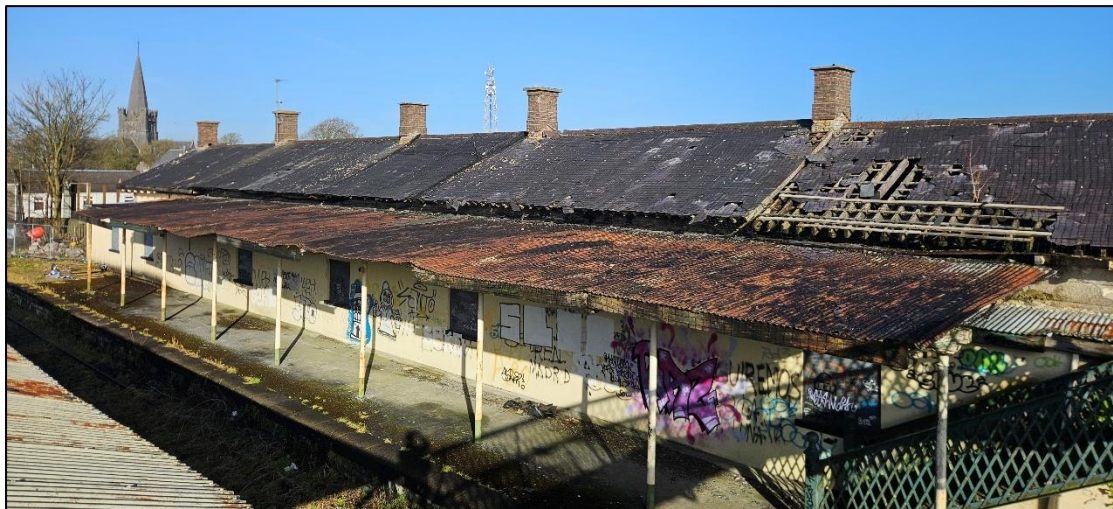
Photograph 2: View of the western roof planes in very poor condition

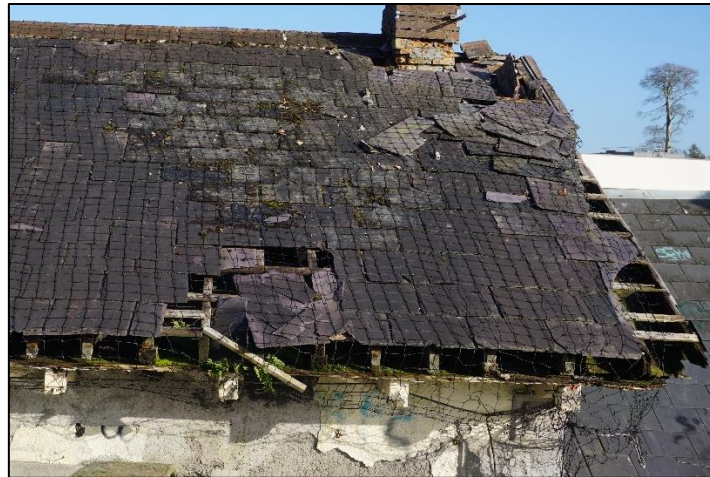
Photograph 3: View of decayed roof timbers

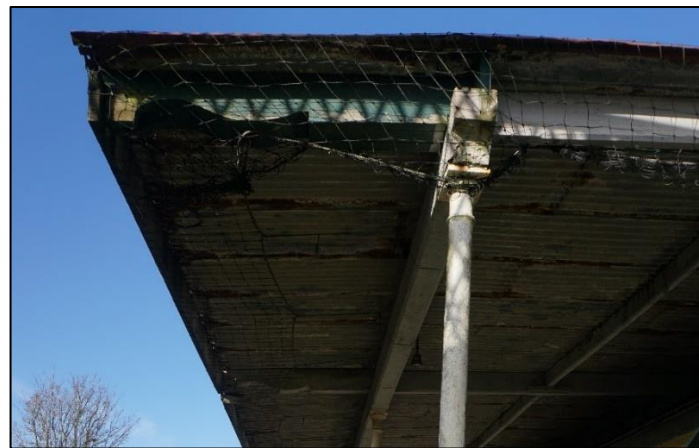
Photograph 4: View of lean-to structure

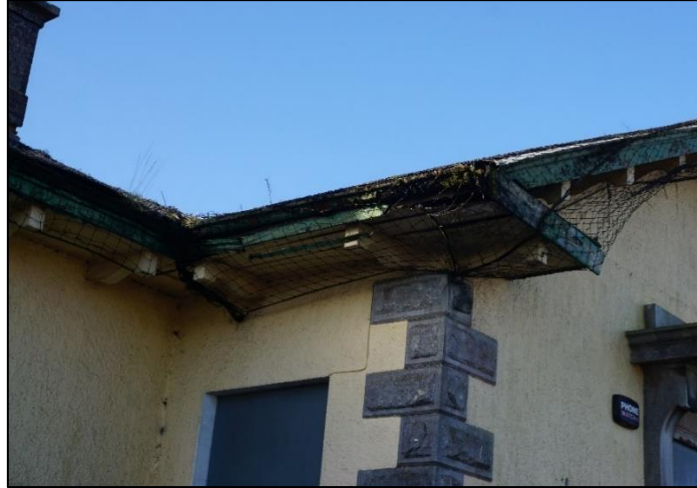
Photograph 5: View of blocked and rusted cast iron gutter

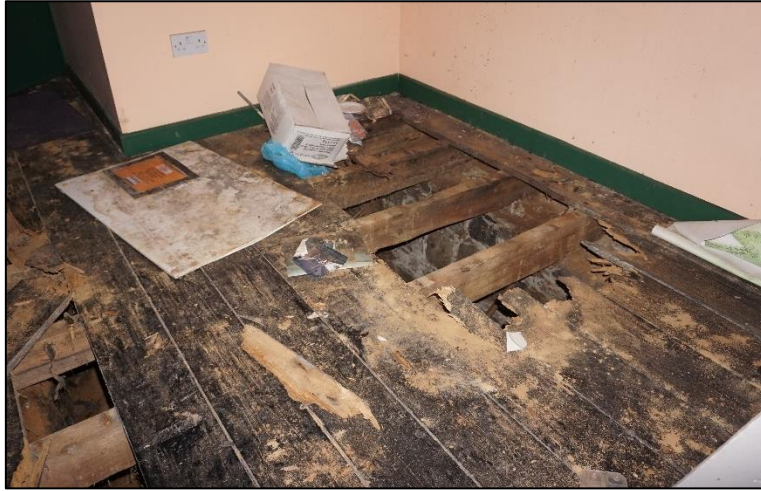
Photograph 6: View of a suspended timber floor in very poor condition

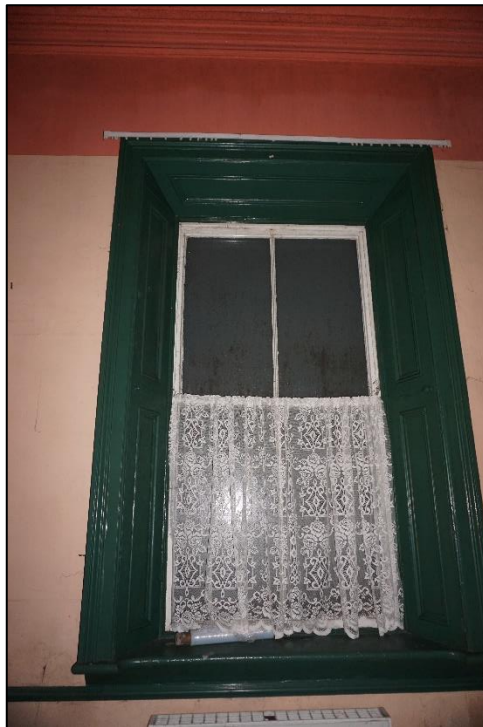
Photograph 7: View of an original timber sliding sash window assembly

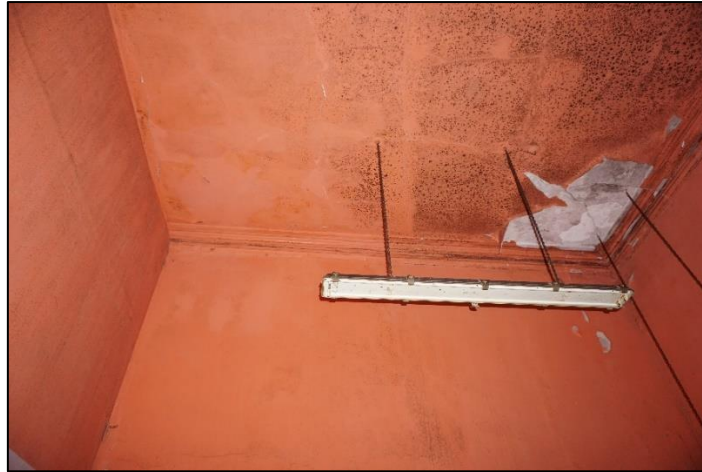
Photograph 8: View of original lath and plaster ceiling with decorative plaster coving

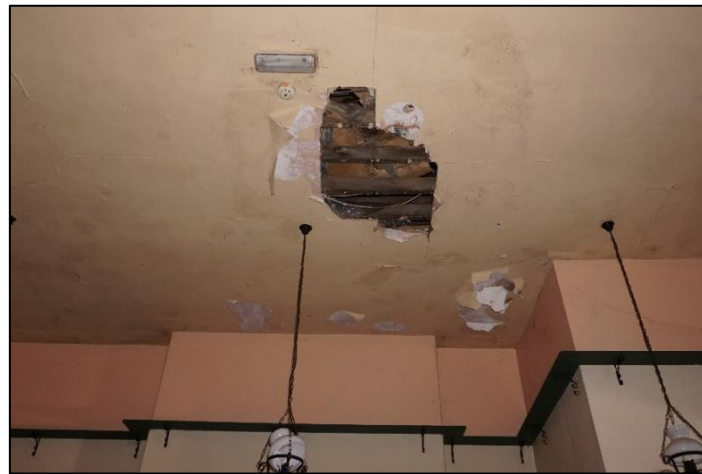
Photograph 9: View of modern plasterboard ceiling in the entrance hall

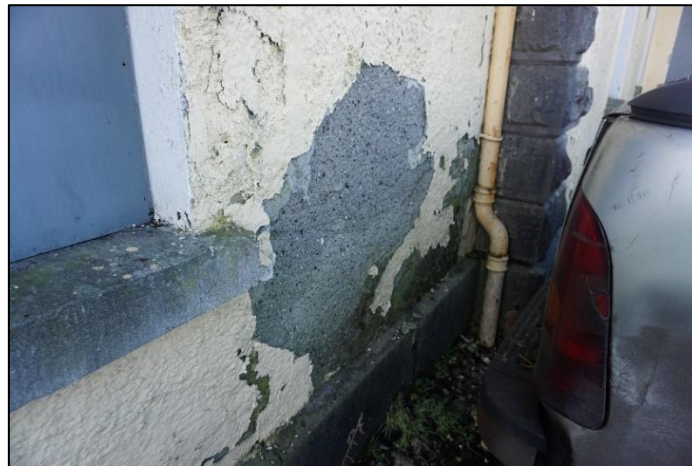
Photograph 10: View of suspected modern OPC external render

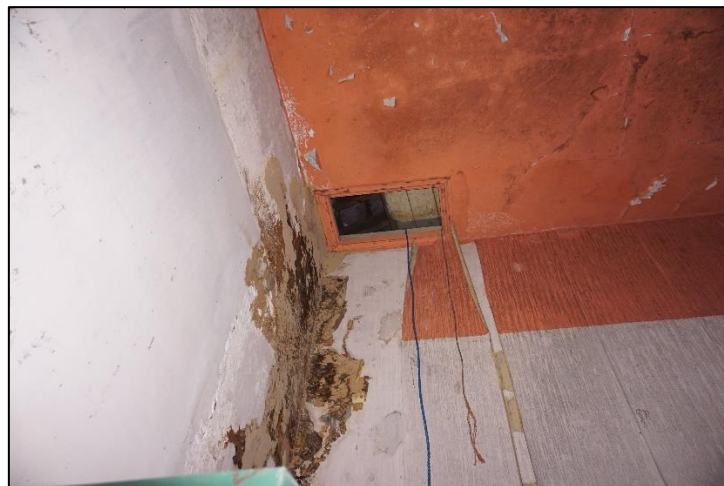
Photograph 11: View of internal wall suffering from water ingress

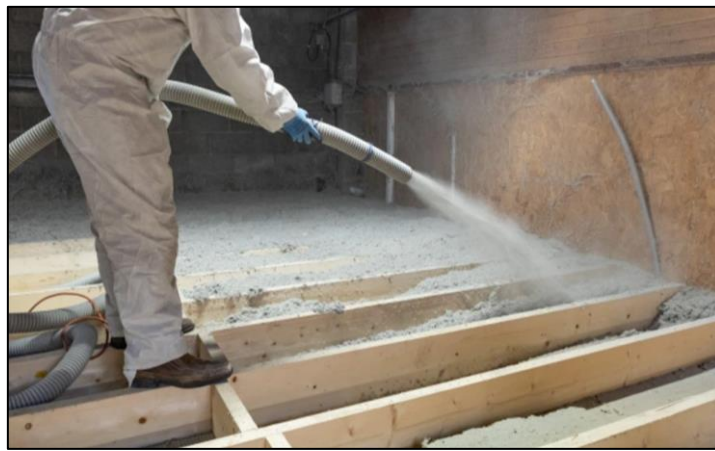
Photograph 12: Example of Cellulose being sprayed in between ceiling joists in an attic³

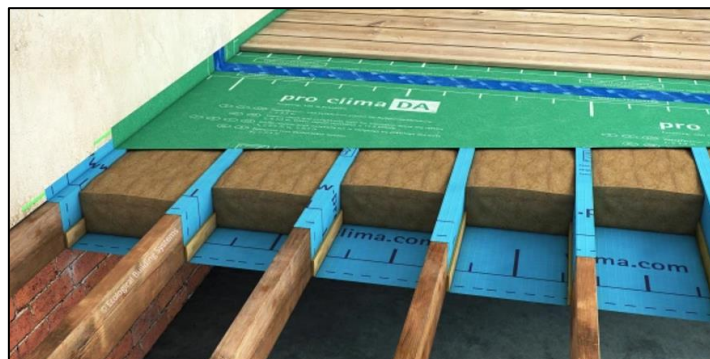
Figure 5: Diagram of a suspended floor retrofitted with insulation⁴
