## Building Conservation Assessment

Vicar Street, Tuam, Co. Galway

**Client:** Galway County Council, Housing Department

**Date:** 10<sup>th</sup> September 2024

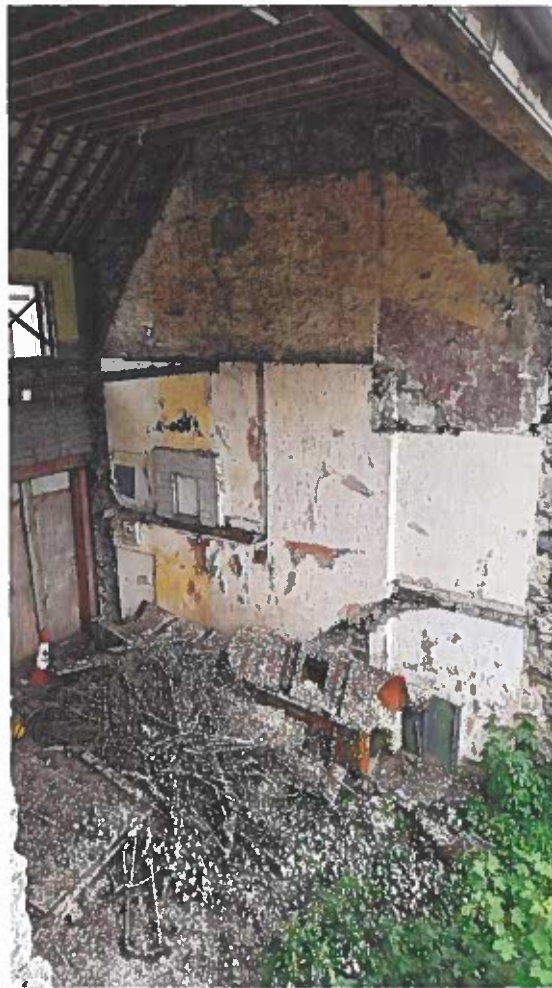
Internally, the gable abounding the Connaught Arms was observed from afar as being of natural stone construction, appearing intact but with some visible cracking.

Photograph 3 View of Building "A" Party wall, shared with the "Connaught Arms".

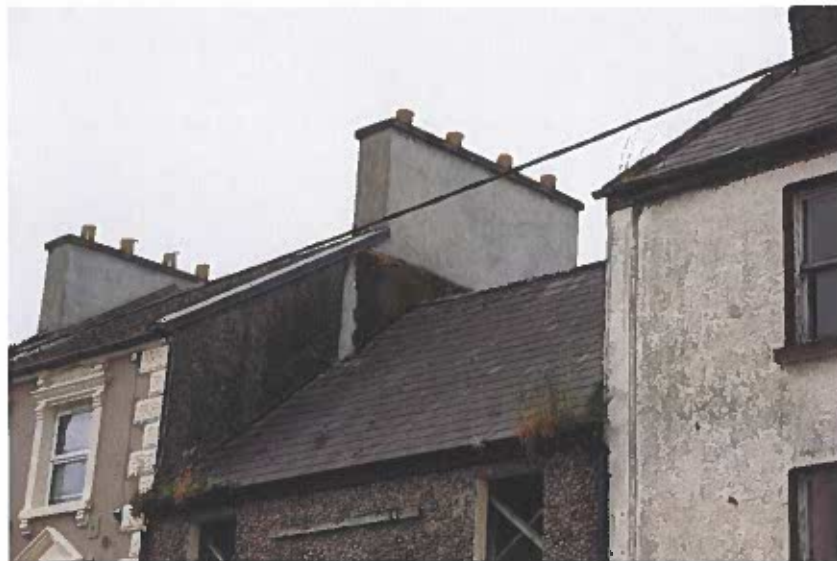
The chimney stacks, as viewed from the ground, are rendered with a smooth render (shared with the "Connaught Arms") and the remnants of a dashed render (shared with the "Bargin Basket").

**Photograph 4 Smooth Rendered Stack of the “Connaught Arms” serving Building “A”**

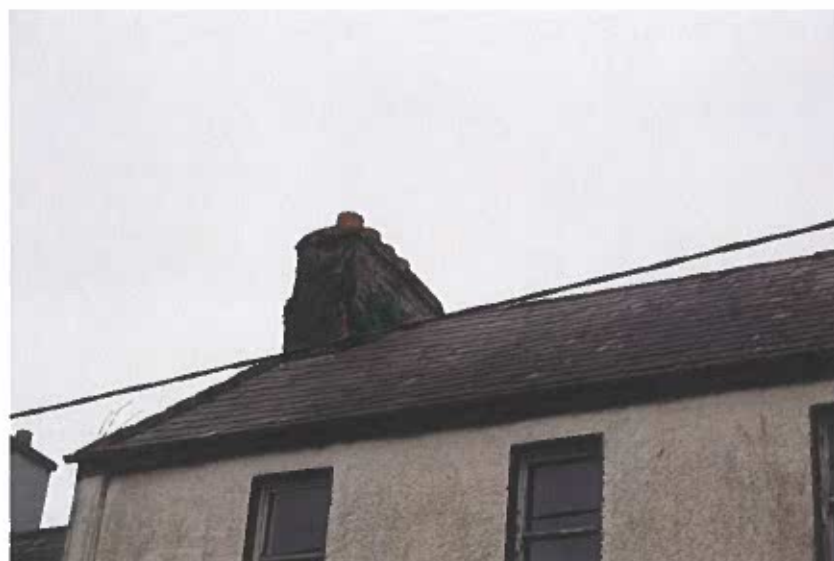
The Chimney System viewable from within the attic space of “The Bargin Basket” is also of natural stone construction. The masonry section of this system on view also appeared in a reasonable state of repair, but with some notable staining from soot migrating through the masonry.

**Photograph 5 Chimney Stack on party wall between Buildings “A” and “B”. Natural Stone Construction exposed under the failed render.**

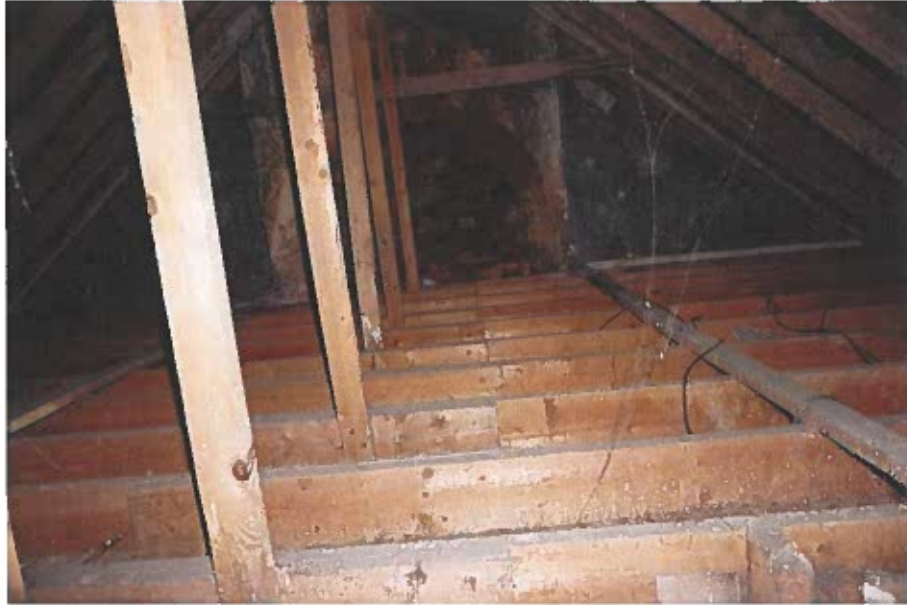
**Photograph 6 Chimney system of Buildings "A" and "B". Note staining.**

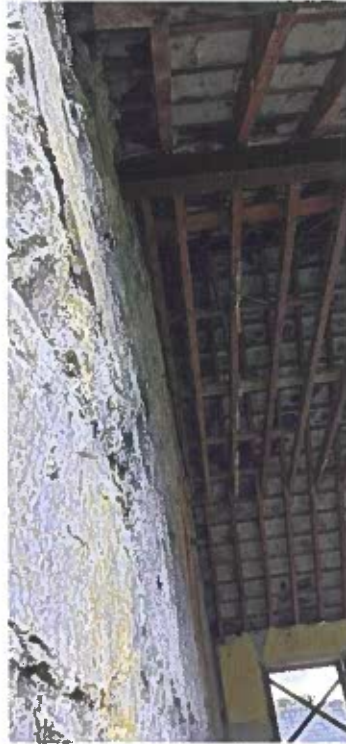
**Photograph 8** View up to the roof structure of Building “A”. Note surviving lime parging.

The roof covering, a natural slate, is largely intact, with a section notably missing from the rear roof plane at eaves (remnants thereof). The roof structure that could be viewed also appeared largely intact with no obvious undulations externally.

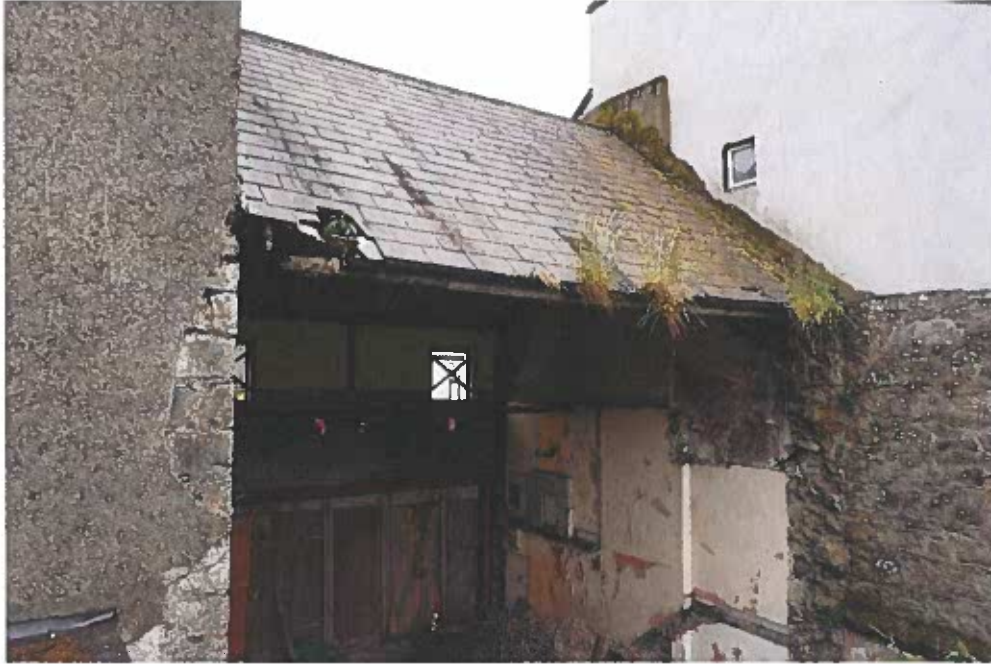
The front wall of the building has been largely replaced with a steel structure and modern blockwork up to the first-floor window opening level. There appears to be natural stone construction present from that point up. The party walls are intact, with the chimney systems running through both, of natural stone construction.

**Photograph 10 General view into Building "A" with the structural walls on view.**

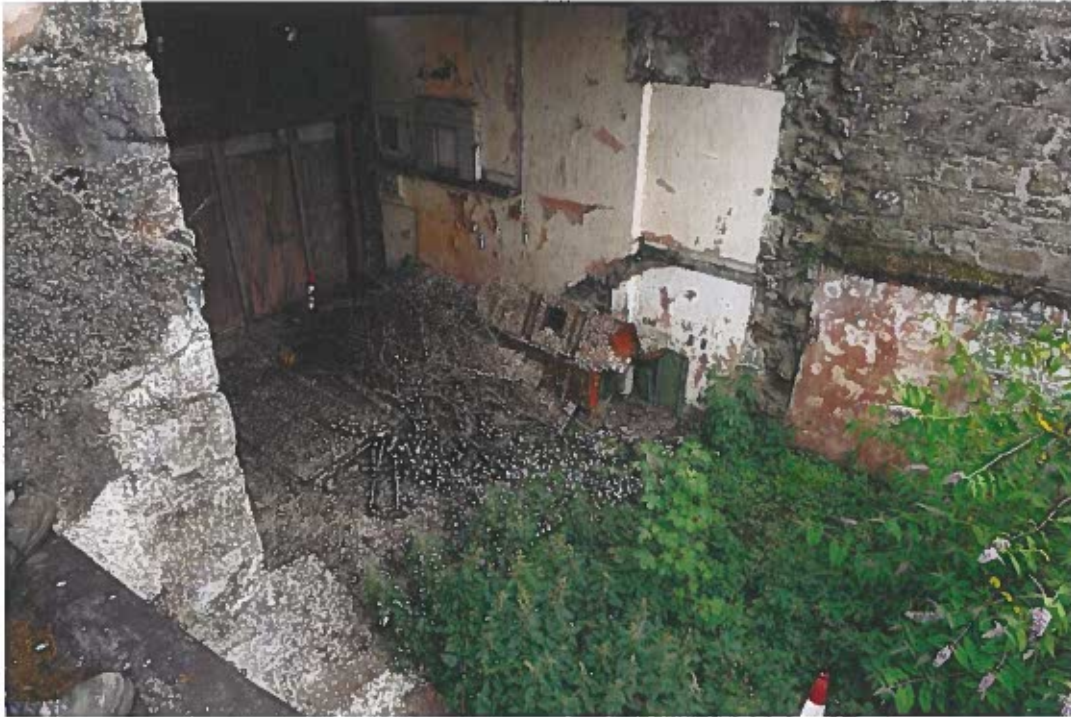
The surviving floor fabric could not be assessed. It was noted to be covered in guana and debris on the day of inspection with no direct access.

**Photograph 11 View to the ground floor of Building “A”.**

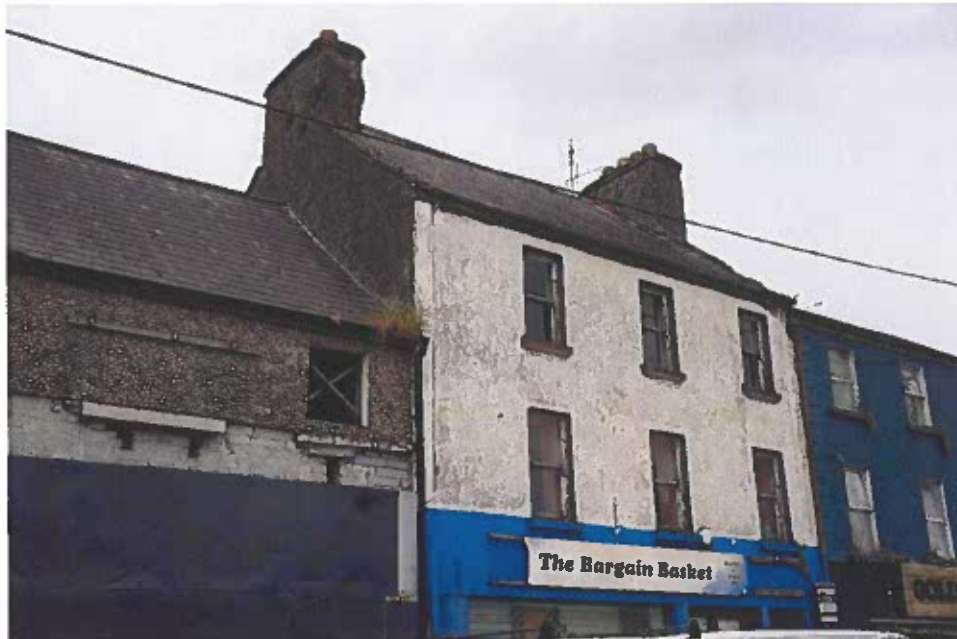
Building “B” also share its chimney systems with the neighbouring buildings. Both chimney stacks are rendered with a cementitious dash, with natural stone construction viewable where the render has failed.

Photograph 12 General view up to the chimney stacks from the street.

The existing building section of the potential alternate/adaptative approach would require the use of traditional materials in and around the natural fabric of the building. The intact chimney stacks will require removal of the cementitious render and application of a natural lime-based render, traditional capping, and flue pots to finish (retention of the chimney stacks would be recommended from the perspective of the preservation of the character of the buildings).

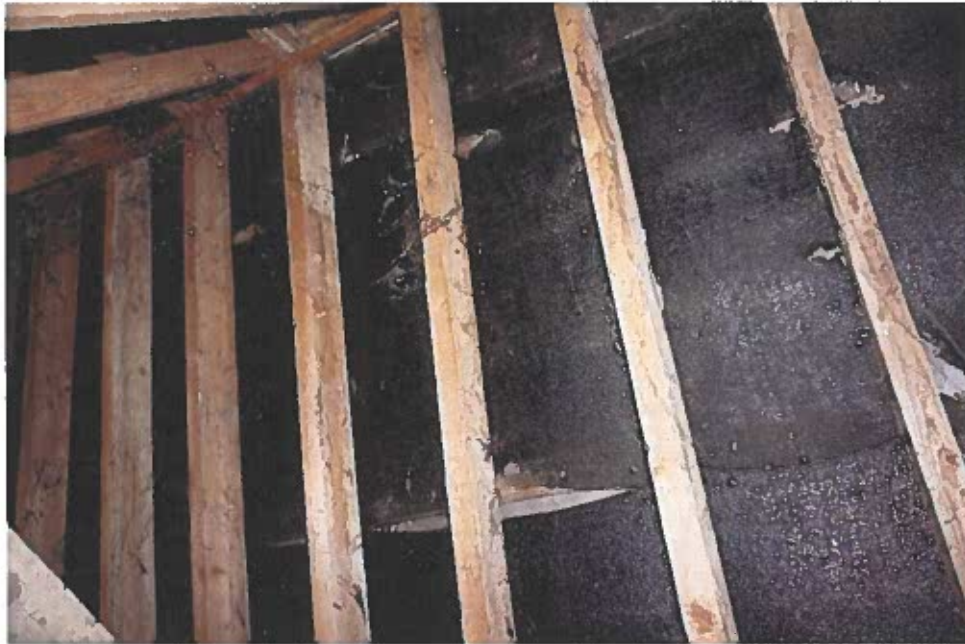
The roof covering of building “B” is of natural slate, with a bituminous felt underlay. All noted to be failing. There are concrete barges at the gable eaves, also in poor repair.

**Photograph 16 View of the underside of the roof covering. Bituminous felt in very poor repair, natural slate covering on view.**

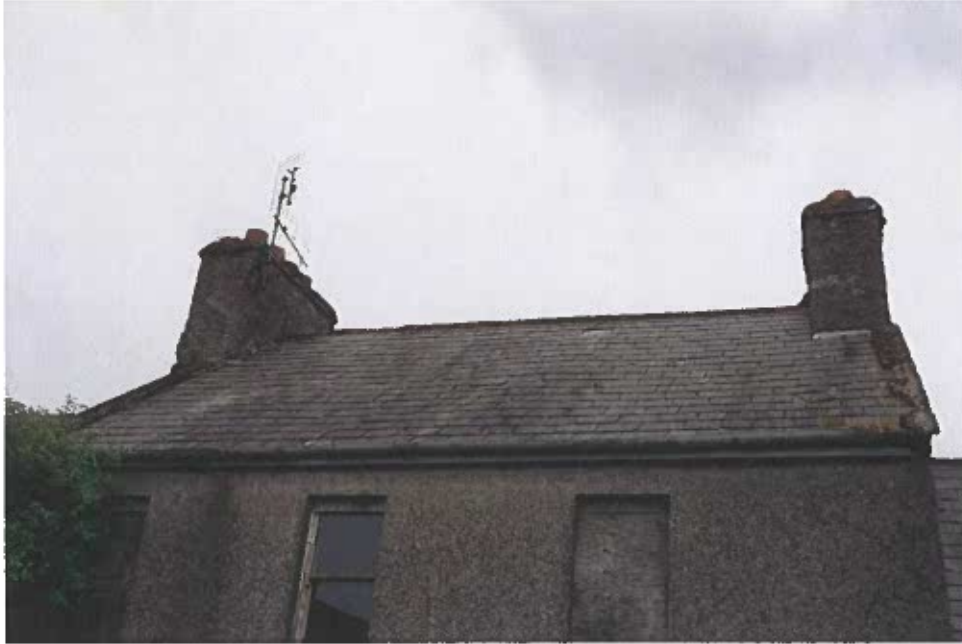
**Photograph 17** Rear roof plane of building “B”. Natural slate covering. Note condition of concrete barges.

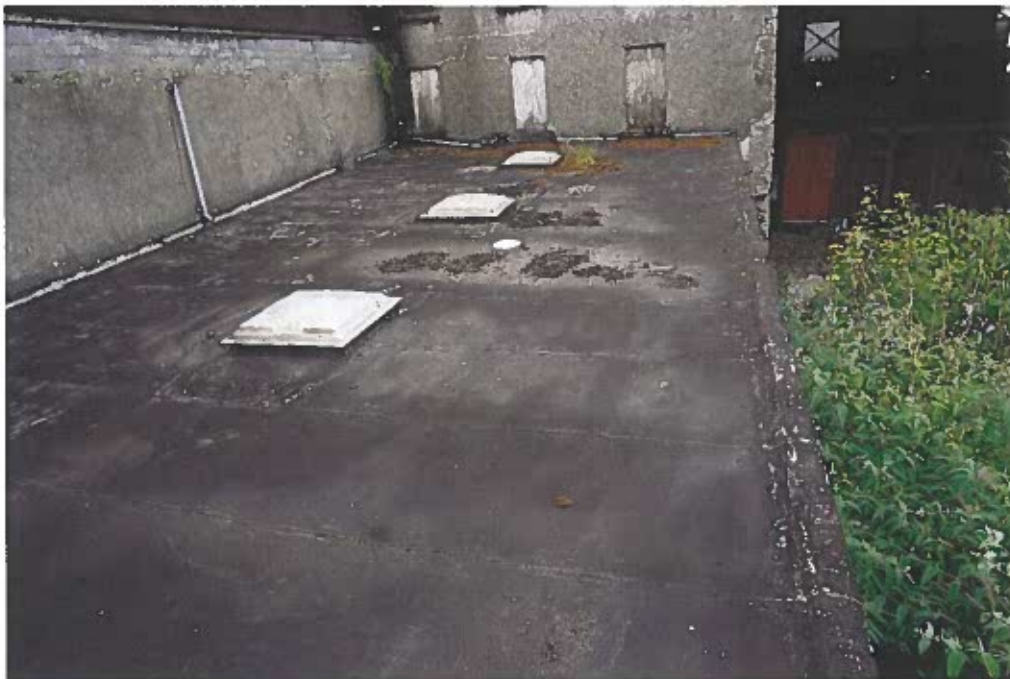
**Photograph 18** Modern flat roof to the ground floor extension of the shop.

The extension to the rear of building “B” is fitted with a modern felt lined flat roof.

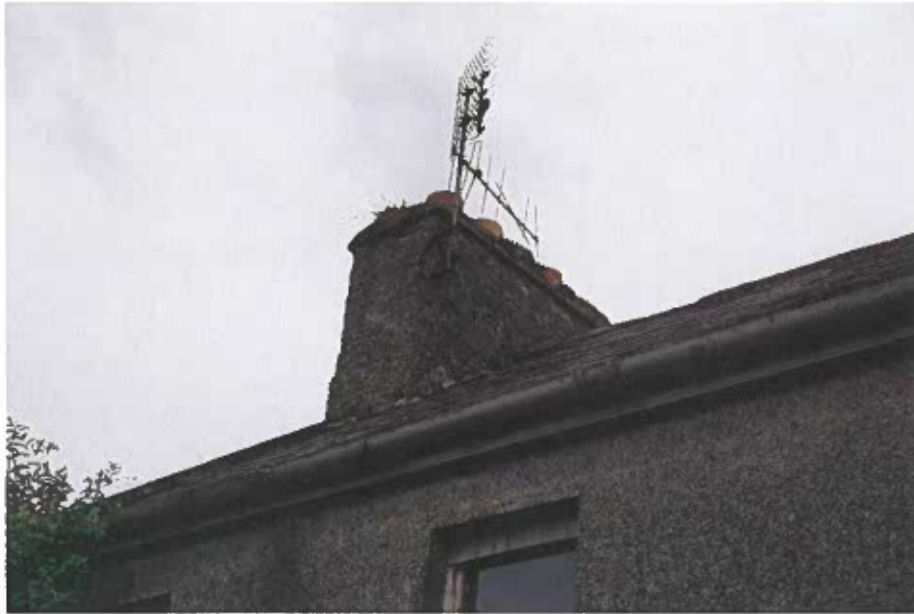
The rainwater goods appear to be a metal galvanised installation. They are noted to be in poor repair viewed from a ground vantage point.

**Photograph 19 View to eaves, rear of building "B" showing the gutters.**

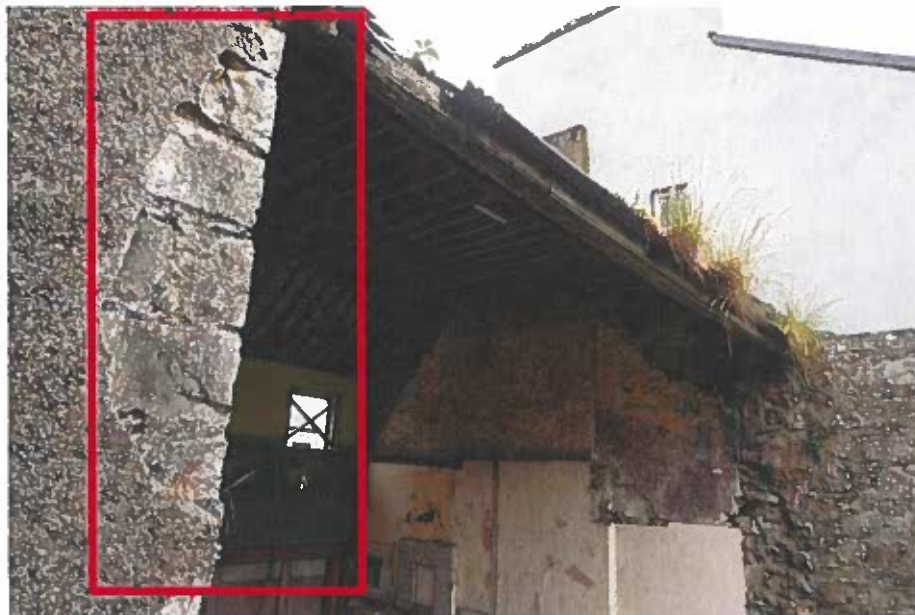
The original footprint of building "B" sits to the front of the existing building. It is of traditional build (natural stone construction, evidenced by the visible masonry within the roof void and externally where render has failed).

These structural walls appear in good repair, with no visible patent defects. The walls of the first floor are drylined.

**Photograph 20 View into building "A". Note exposed masonry beneath the failed render of building "B".**

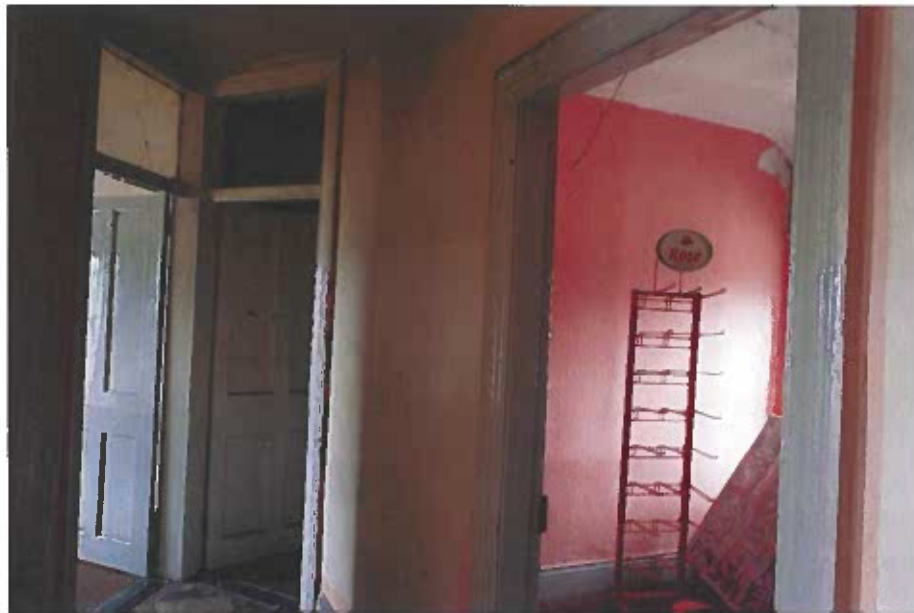
The internal partition walls appear to be replacement (most likely plasterboard, replacing the original in or around the same time as the roof works perhaps).

**Photograph 21 First floor hallway. Partition walls to the bedrooms.**

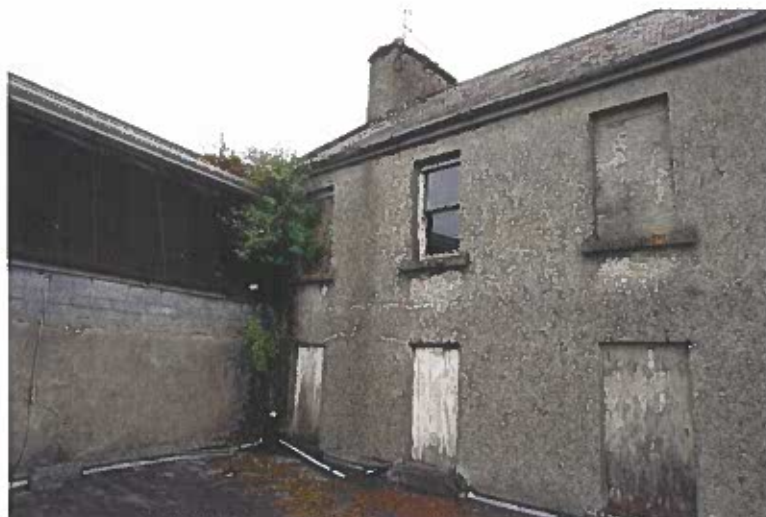
**Photograph 24 Rear fenestration of building “B”.**

All of the assemblies are in a poor state of repair.

It would be recommended to retain the sash up down assemblies where possible, with replacement replicas of the existing where deemed unusable. Upgrading the assemblies with slimlite double glazing and draught stripping to aid in reduction of heat loss.

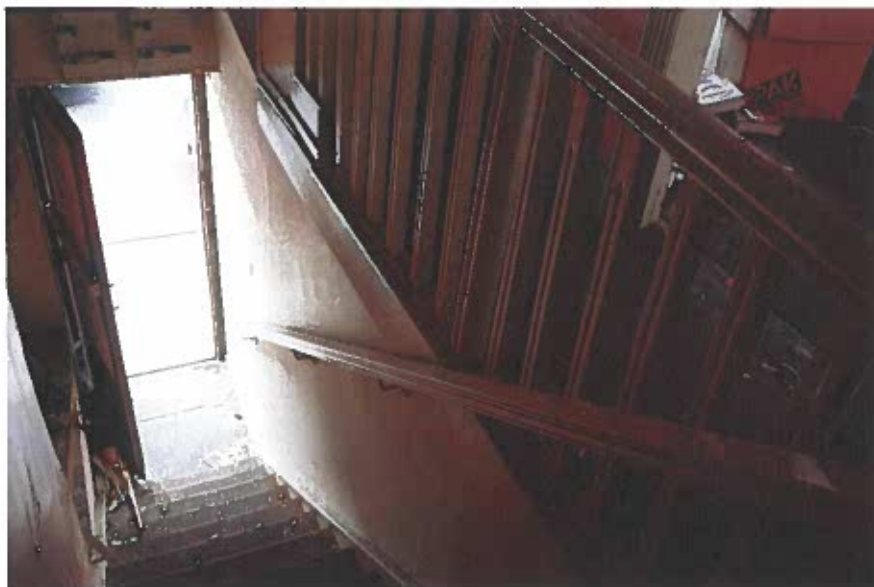
The existing staircase is a timber installation consisting of three flights and three landings. This assembly is most likely a replacement of the original, given the fabric on view. The assemblies are noted to be in a fair state of repair as presented on the day of inspection.

**Photograph 26** View down the stair flight to the entrance door.
