**Stage 1/2 Road Safety Audit  
Proposed Residential Development  
Gort Mhaoilir, Athenry, Co. Galway**

| <b>Document No:</b> | 242462-ORS-XX-XX-RP-TR-13g-002 |

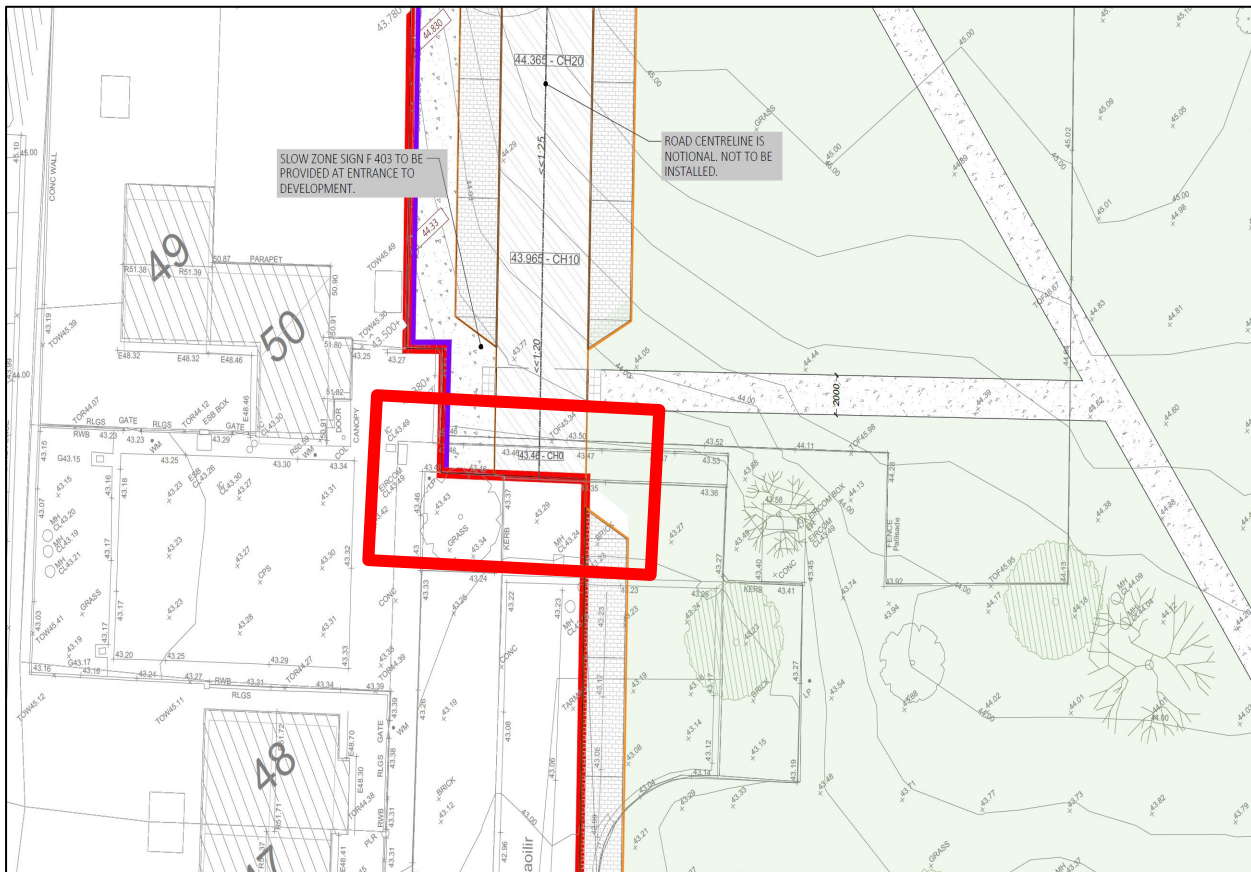
##### Problem No.01: Tie-in with Existing Estate Road

The audit team note from the drawings provided that the road widths between the existing and proposed estate varies. The audit team has concern's that vehicles exiting the estate could collide with the existing planter at this location and cause injury to the occupants of the vehicle.

| Problem Reference in Safety Audit Report | To Be Completed by the Designer | | | To be Completed Audit Team Leader |
|---|---|---|---|---|
| P1 | Yes | Yes | | |

The design team should ensure a smooth transition between the existing and proposed estate roads and provide the appropriate signage to indicate the narrowing of the road.

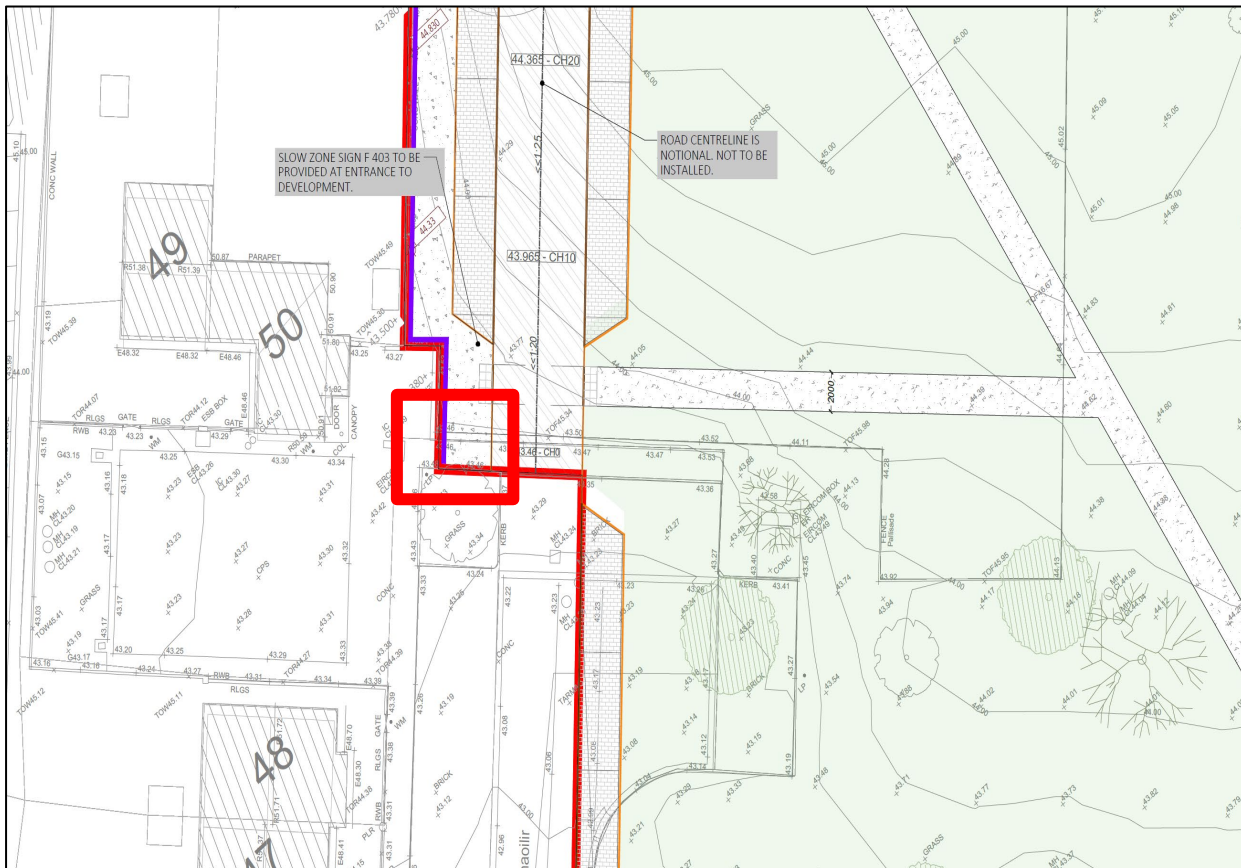
## Problem No.02: Tie-in to Existing Footpath

The audit team note from the site visit and drawings and the site visit that the existing footpath is narrower than the proposed at the intended tie in location. It is not clear how the existing and proposed footpaths are to tie in with each other. Lack of an appropriate tie-in to the existing footpath could lead to pedestrian trips and falls.

| Problem Reference in Safety Audit Report | To Be Completed by the Designer | | | To be Completed Audit Team Leader |
|---|---|---|---|---|
| P2 | Yes | Yes | | |

The design team should provide provision for appropriate tie-in and width to the existing footpaths.

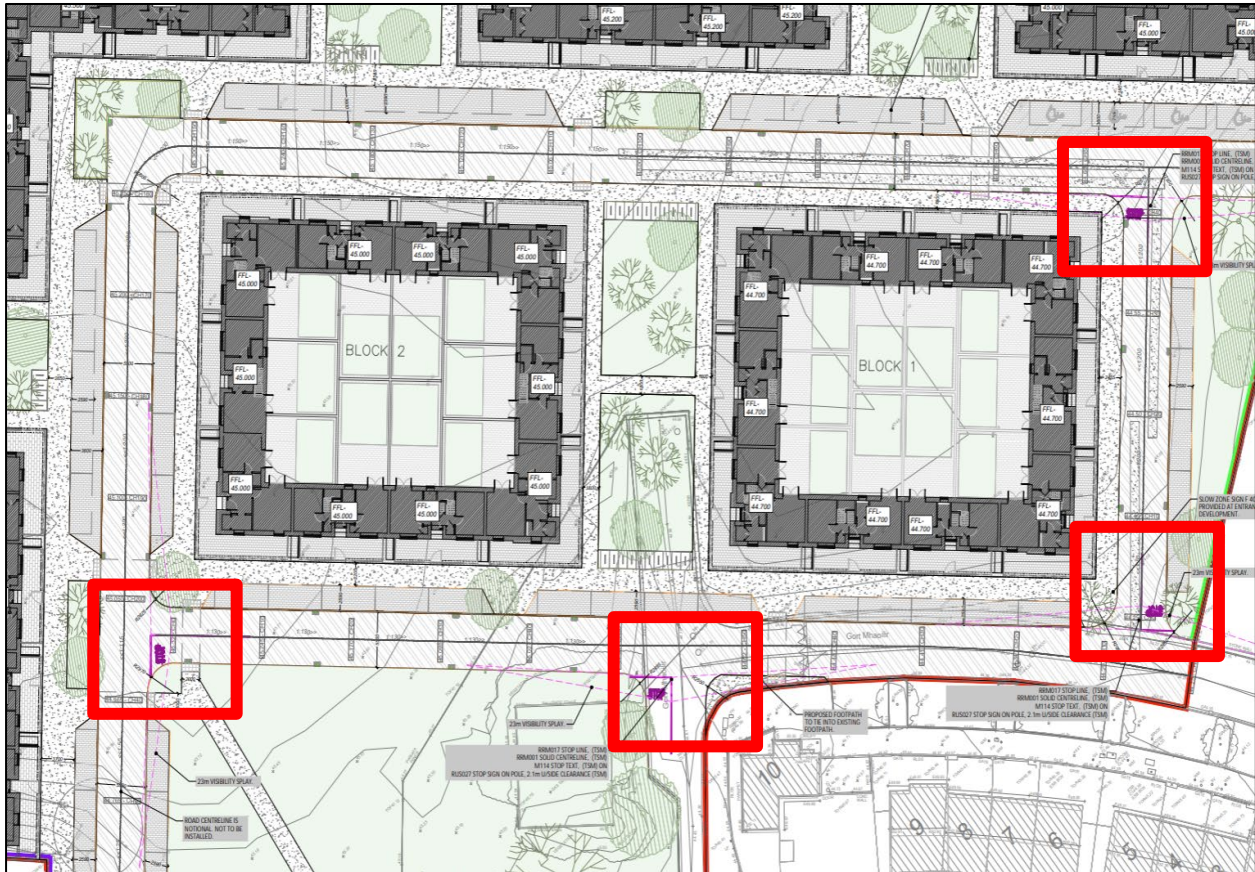
### Problem No.03: Sightline Availability

The audit team note that there are no sightlines in the drawings provided to demonstrate that appropriate sightlines can be achieved when vehicles are entering and exiting the development. The audit team is concerned that the appropriate sightlines cannot be achieved as boundary walls, landscaping and parked cars along the carriageway may obstruct visibility at the junctions. This could result in vehicles encroaching onto the main carriageway into the line of oncoming vehicles which could lead to sideswipe or side impact type collisions.

| Problem Reference in Safety Audit Report | To Be Completed by the Designer | | | To be Completed Audit Team Leader |
|---|---|---|---|---|
| P3 | Yes | No | Due to the road geometry we feel the design speed of the development would not be met at this location. And that a 15kph design speed would only require a visibility splay of 14m | Yes |

The design team should ensure that clear visibility is provided in both directions and that visibility envelopes are clear of any obstacles.

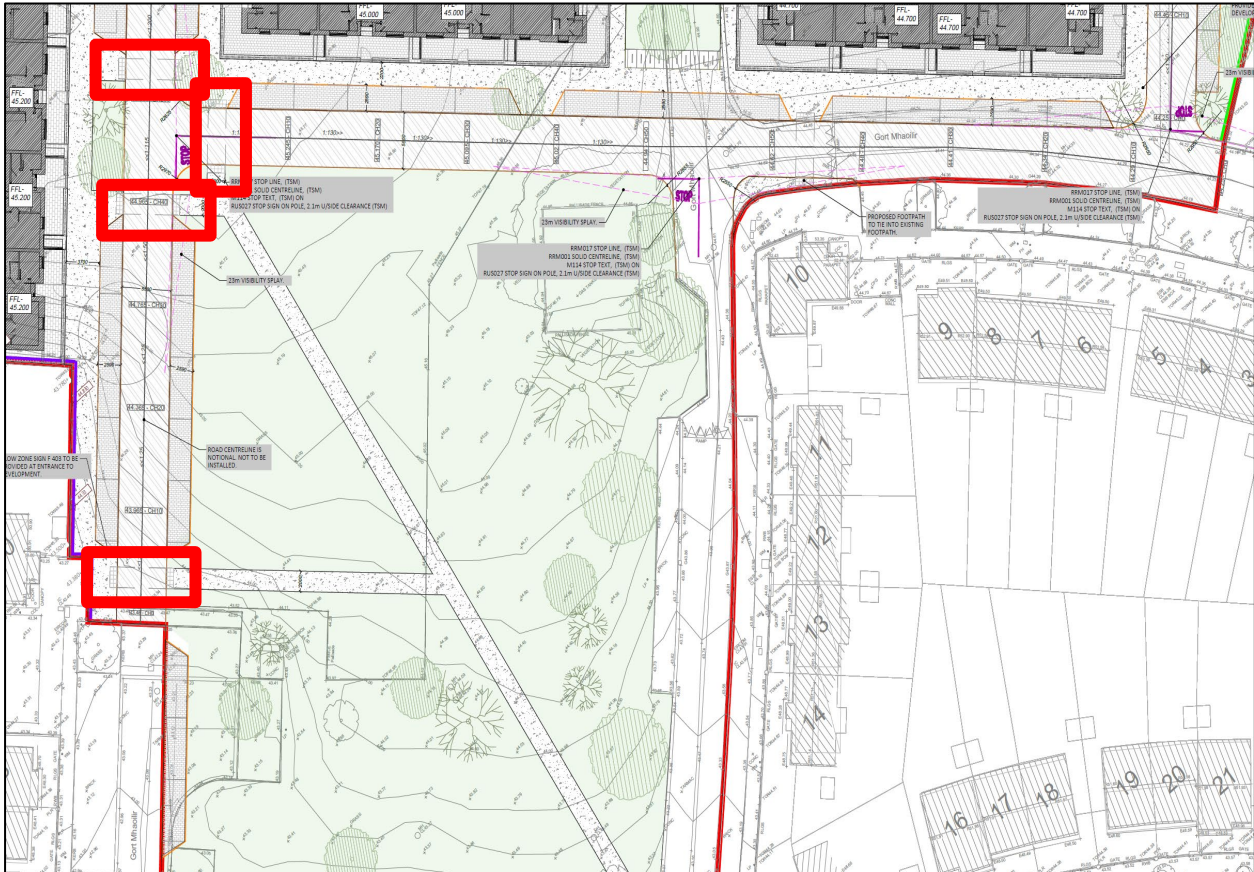
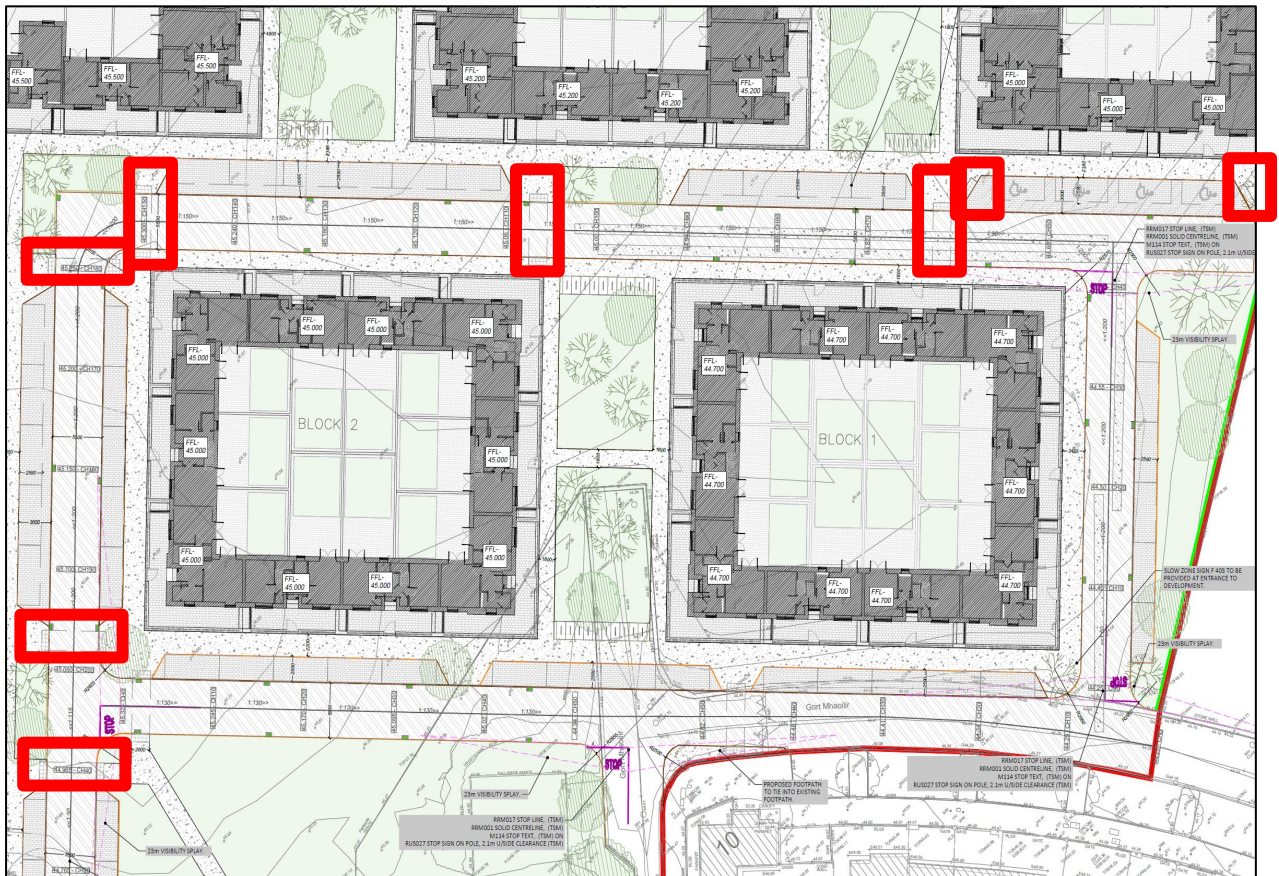
## Problem No.04: Kerb Heights at Uncontrolled Crossings

The audit team note that uncontrolled crossings are detailed at the locations identified. It is unclear from the drawing if the kerbs at the crossings are full height or dropped. The audit team is concerned that pedestrians especially those with mobility impairments could trip and fall while stepping up or down from a full height kerb causing injury.

| Problem Reference in Safety Audit Report | To Be Completed by the Designer | | | To be Completed Audit Team Leader |
|---|---|---|---|---|
| P4 | Yes | No | Dropped Kerbs Shown at all crossing locations | Yes |

The design team should provide the appropriate dropped kerbing and tactile paving at the uncontrolled crossings.

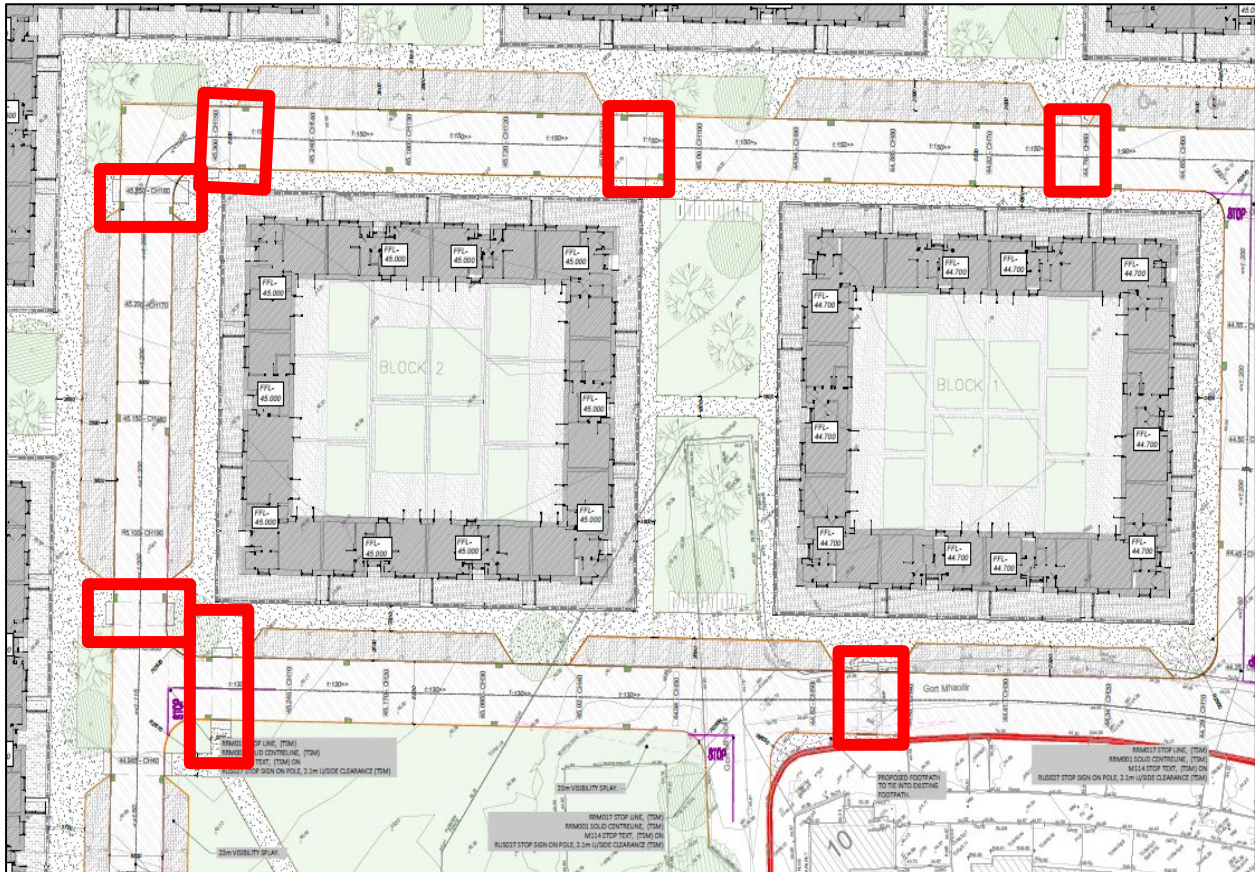
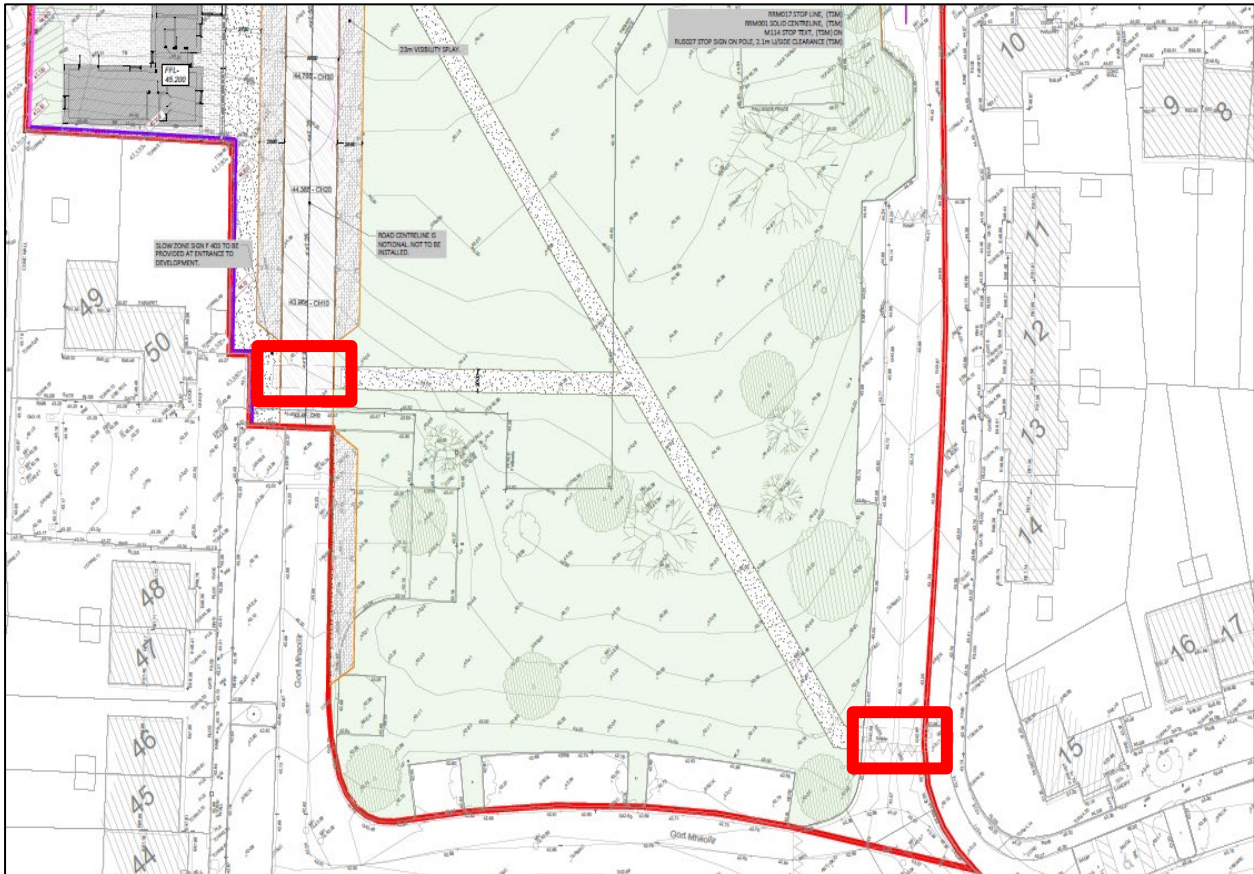
## Problem No.05: Pedestrian Visibility at Uncontrolled Crossings

The audit team note that the proposed drawing does not detail the visibility from the uncontrolled crossing at the locations identified. It is not clear from the drawings if appropriate visibility is provided for at the crossings. The audit team is concerned that parked vehicles and vegetation may restrict visibility for both pedestrians and vehicles approaching the crossings which could lead to conflicts between pedestrians crossing and vehicles on the internal road.

| Problem Reference in Safety Audit Report | To Be Completed by the Designer | | | To be Completed Audit Team Leader |
|---|---|---|---|---|
| P5 | Yes | No | Sightline for Pedestrian will be at kerb line. | Yes |

The design team should provide pedestrian visibility splays and forward visibility splays along the internal road to ensure visibility is not obstructed by any permanent features.

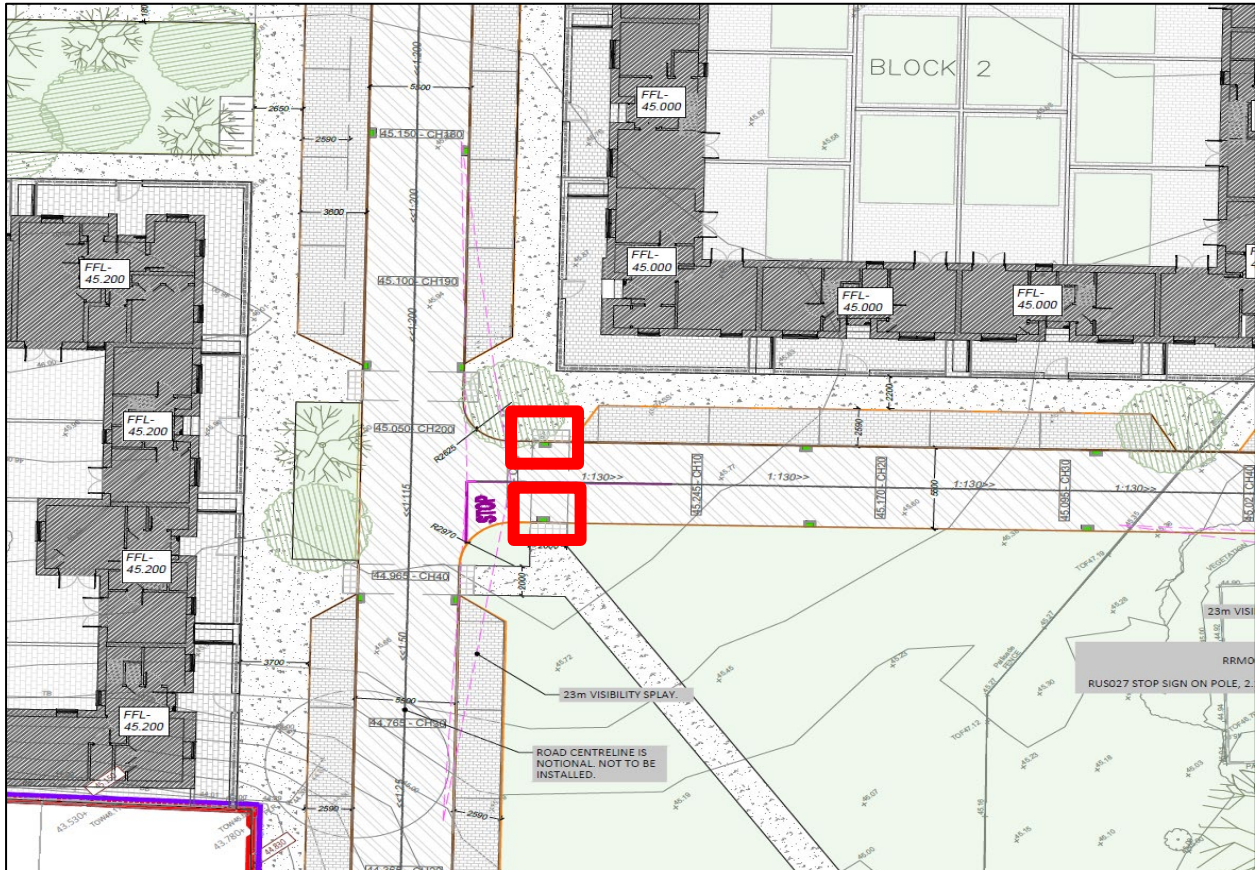
## Problem No.06: Inappropriately Located Gullies

The audit team note from the drawings provided, that there are gullies located within areas designated for vulnerable road users at the locations identified. Inappropriate gully positioning may lead to potential trip and fall hazards for vulnerable users.

| Problem Reference in Safety Audit Report | To Be Completed by the Designer | | | To be Completed Audit Team Leader |
|---|---|---|---|---|
| P6 | Yes | Yes | | |

The design team should ensure drainage gullies are strategically positioned outside of pedestrian crossings.

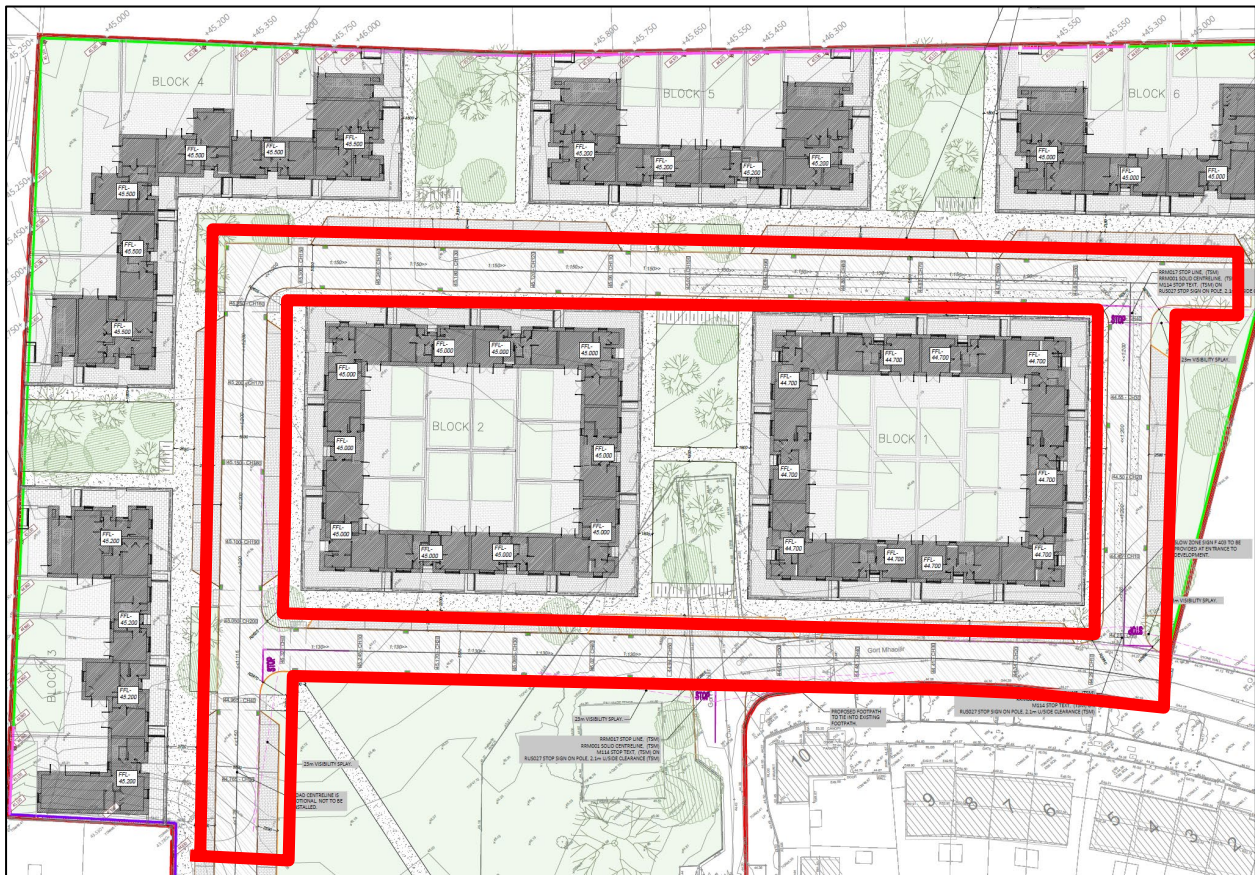
## Problem No.08: Speed Control Measures and Road Widths

The audit team noted from the drawings provided, that there are no speed control measures proposed throughout the scheme. The audit team are concerned that the layout as its currently presented particularly with the long straight stretches could encourage higher speeds which could put vulnerable users within the development at risk of serious injury.

| Problem Reference in Safety Audit Report | To Be Completed by the Designer | | | To be Completed Audit Team Leader |
|---|---|---|---|---|
| P8 | Yes | Yes | | |

The design team should ensure that appropriate speed control measures are incorporated within the development to reduced vehicular speeds.

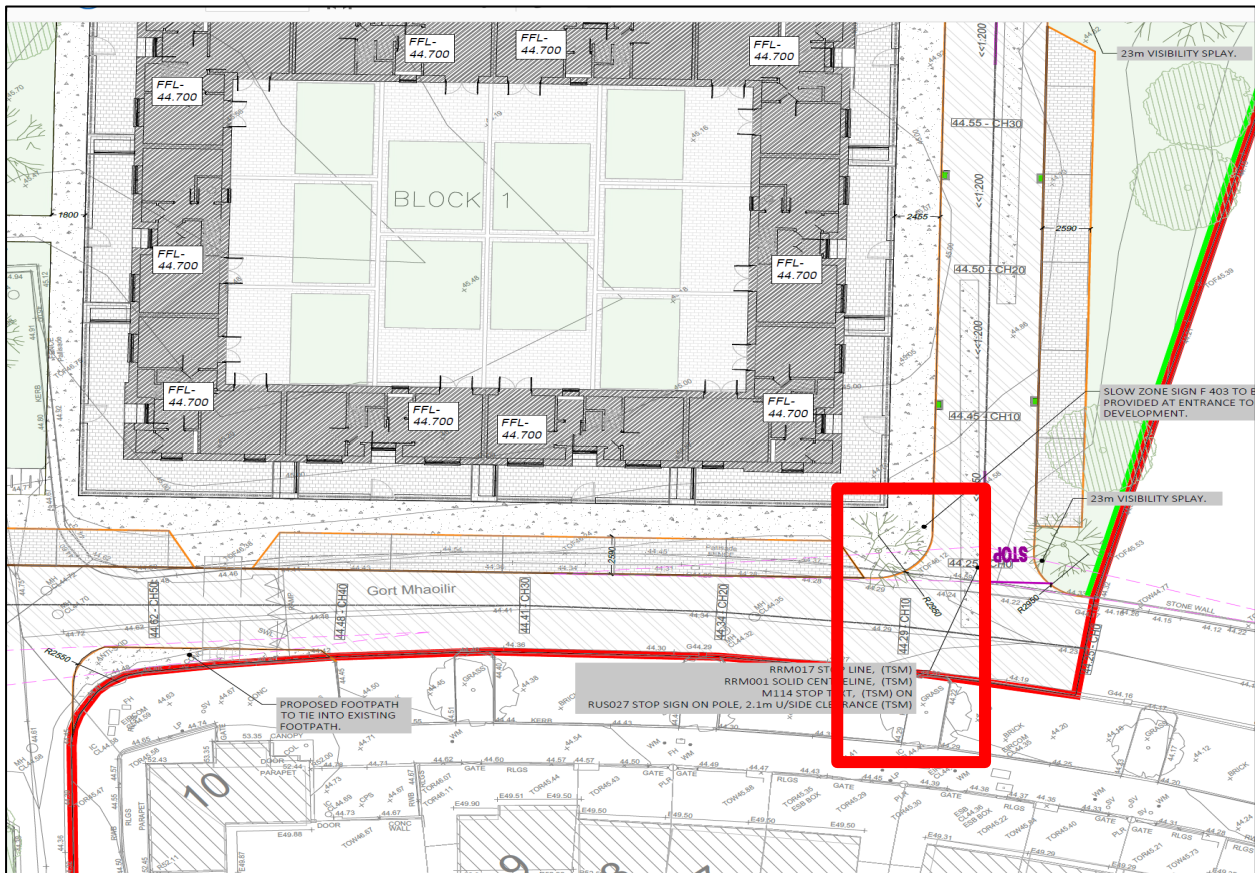
### Problem No.09: Desire Line

The audit team note from the provided drawings that there is no crossing points proposed on the pedestrian desire line. The audit team has concern's that pedestrians will cross on the desire line for which there is no pedestrian facilities for on both sides of the road. This could lead to slips and trips leading to injury of pedestrians.

| Problem Reference in Safety Audit Report | To Be Completed by the Designer | | | To be Completed Audit Team Leader |
|---|---|---|---|---|
| P9 | No | No | No crossing point as this location as it would be interfering with existing parking. GCC | Yes |

The design team should ensure that crossing points are provided along desire lines.

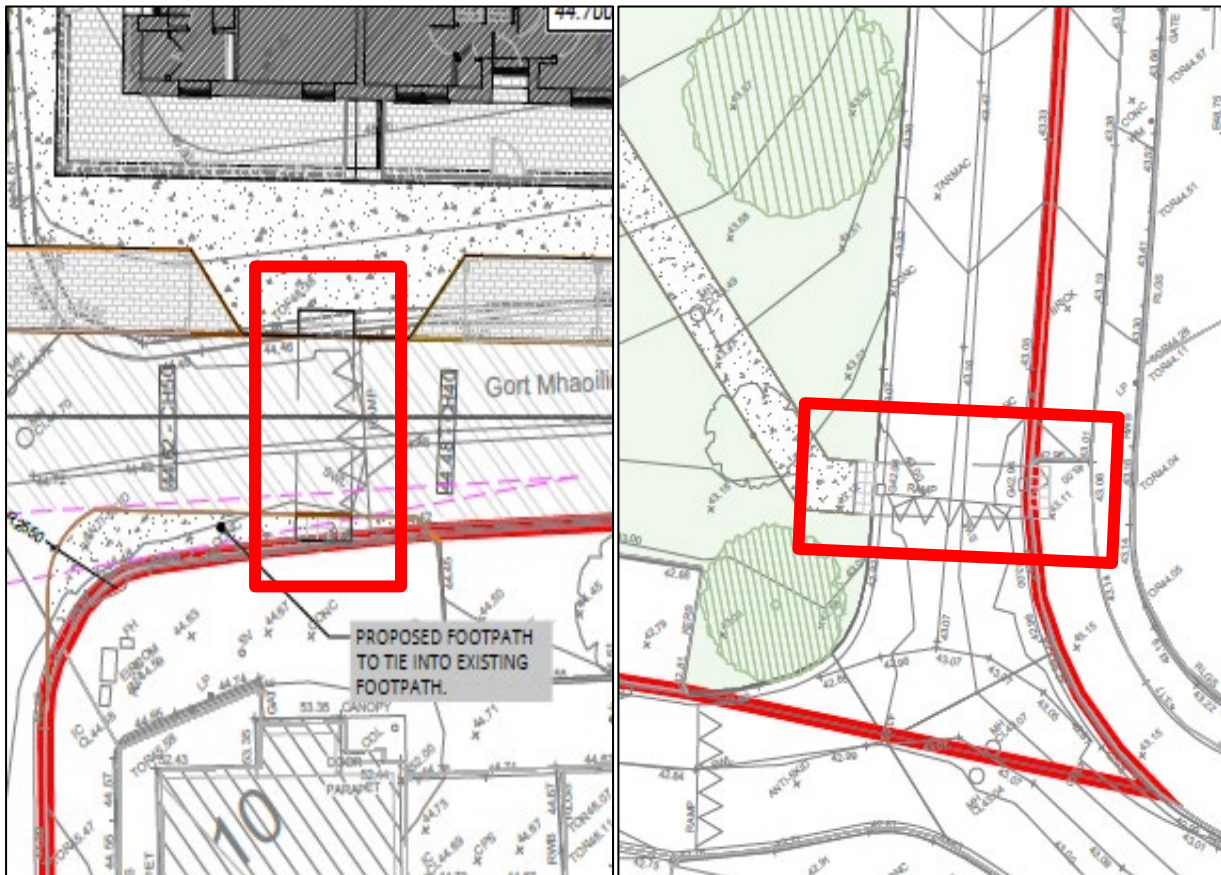
## Problem No.10: Location of Uncontrolled Crossing

The audit team note from the drawings provided that the proposed uncontrolled crossings appear to be on the sloped section of the raised table. The position of the crossings leads to an uneven surface particularly for mobility impaired pedestrians which could result in slips, trips and falls at the crossing location which could lead to injury.

| Problem Reference in Safety Audit Report | To Be Completed by the Designer | | | To be Completed Audit Team Leader |
|---|---|---|---|---|
| P10 | Yes | Yes | | |

The design team should provide the uncontrolled crossings in the appropriate position on the raised table.
