Tree Report for the proposed  
Galway County Council Social Housing Project  
in Portumna

Prepared for:  
Simon J Kelly Architects  
21 Middle Street  
Galway  
H91 YP9F

Date: 17<sup>th</sup> February 2025

Prepared by:  
Drew Bardell Arb Dip, 'Tech Arbor A'  
Beith Tree Consultancy  
Ballinasloe  
Co Galway

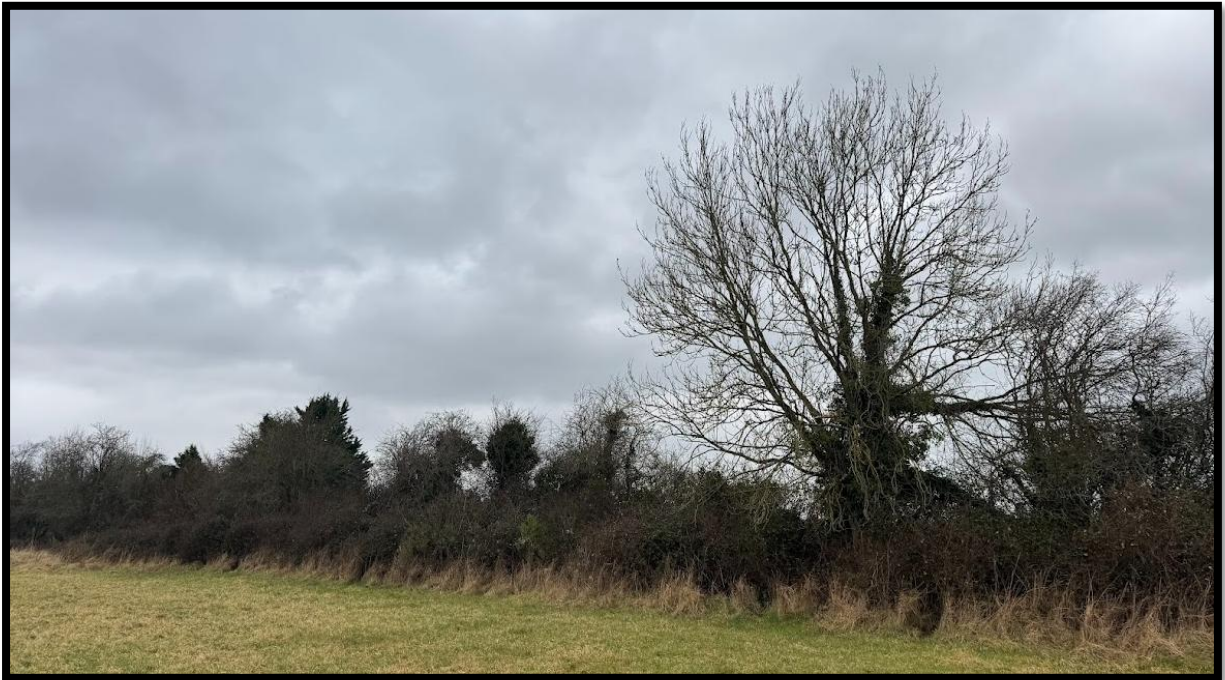
Image taken looking northeast along the northern boundary.

This section of the site contains a continuous native hedgerow that stretches from east to west along boundary dividing existing pasture fields. The species mix is predominantly whitethorn (*Crataegus monogyna*), these are the taller trees in the image above and blackthorn (*Prunus spinosa*) these are the lower more dense trees.

Tag 32 is a single mature Ash tree (*Fraxinus excelsior*) along this boundary. On the day inspection it was noted that a single upright stem had broken out of the crown of this tree and is now hanging over the northern hedgerow. Tag 32 will need to be removed to facilitate the housing project.

Tag 32 was numbered and classified as a tree of moderate-quality Category B,3 (as per Table 1 of BS5837:2012)

The hedgerow was classified as trees of moderate-quality Category B,3 (as per Table 1 of BS5837:2012)

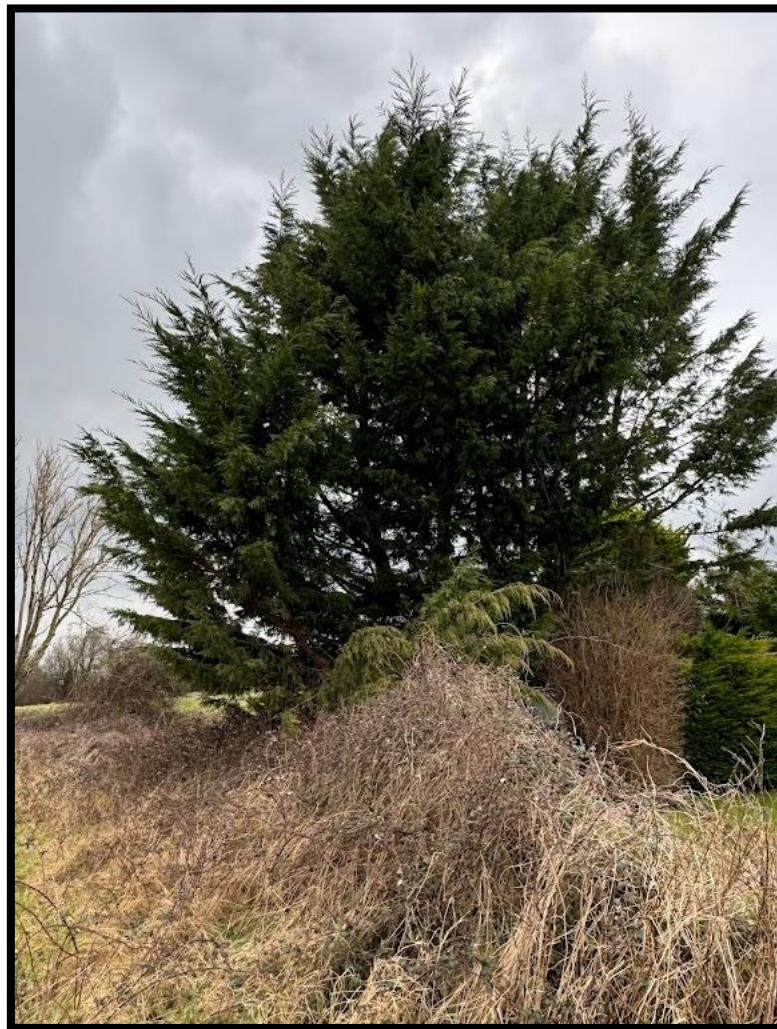
However, sitting very close to the site boundary in an adjacent garden is a large Leyland cypress (*Cupressus x leylandii*). This tree is located just to the south of the Japanese knotweed and there are overhanging branches into the site, approximately 5m from the boundary wall. See image below. This tree is indicated as T33 on the maps below but is not tagged or measured due to being in a neighbouring property.

Image taken of leylandii adjacent to the eastern boundary.

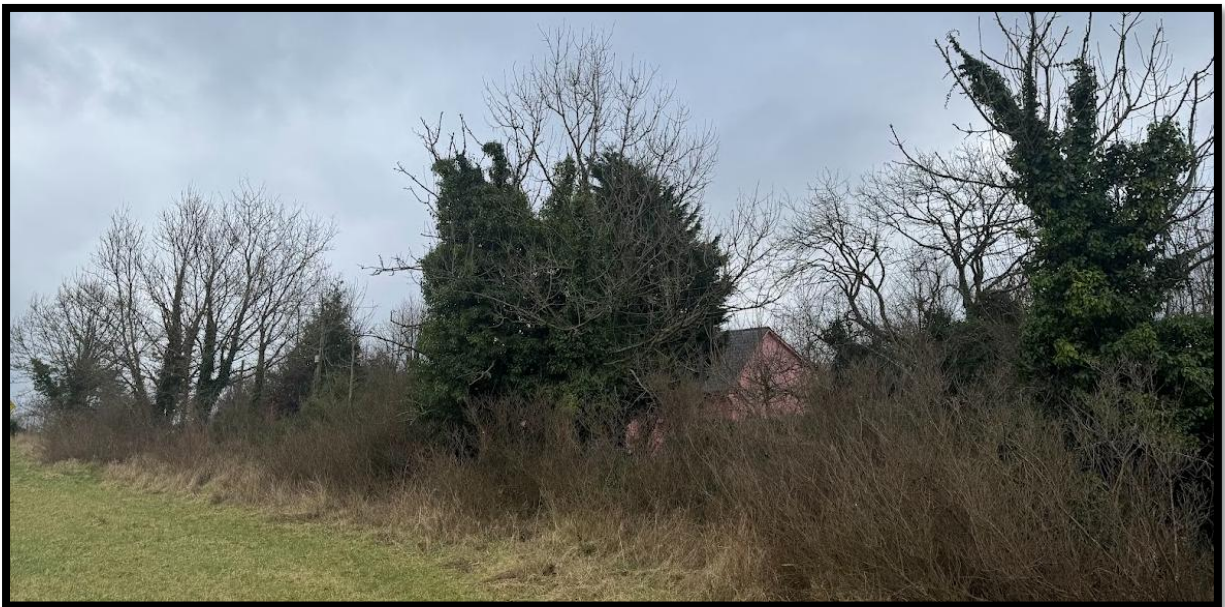
From Tag 27-Tag 31 there is some dense scrub extending to approximately 4m north into the site and this is 1.5m in height.

View of southern boundary looking southeast, scrub extending north into the site.

Tag 26, 29 and 31 were classified as trees unsuitable for retention category U (as per Table 1 of BS5837:2012).

Tag 25, 27, 28, and 30 were classified as trees of low-quality Category C,2 (as per Table 1 of BS5837:2012)

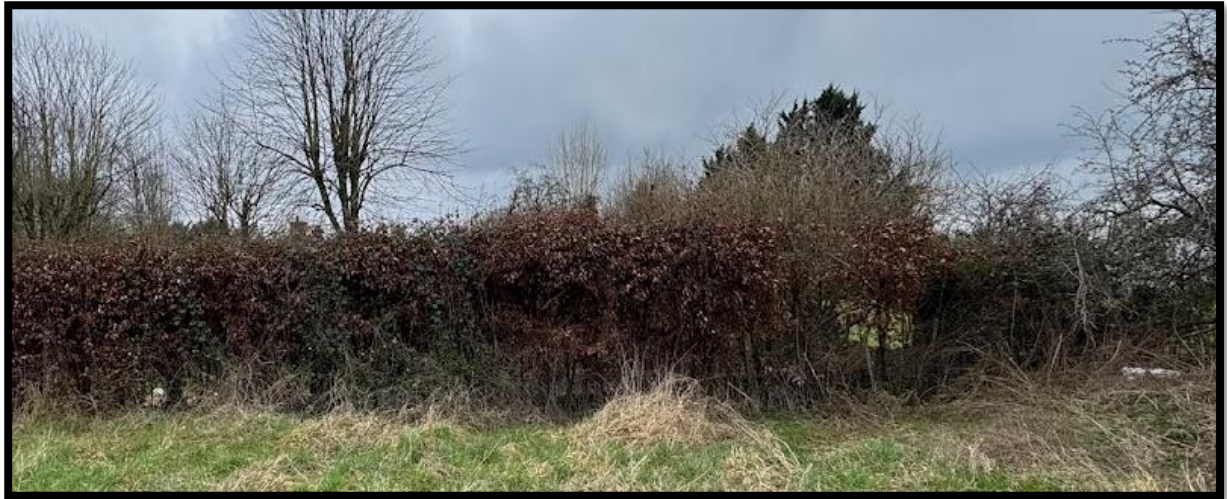
There are no trees to be included in the survey along this boundary. However, there is a young beech hedge (*Fagus sylvatica*) in an adjacent property in the far northwest corner of the site. Image below.

Bech hedge on the far northwest corner of the site in an adjacent property.

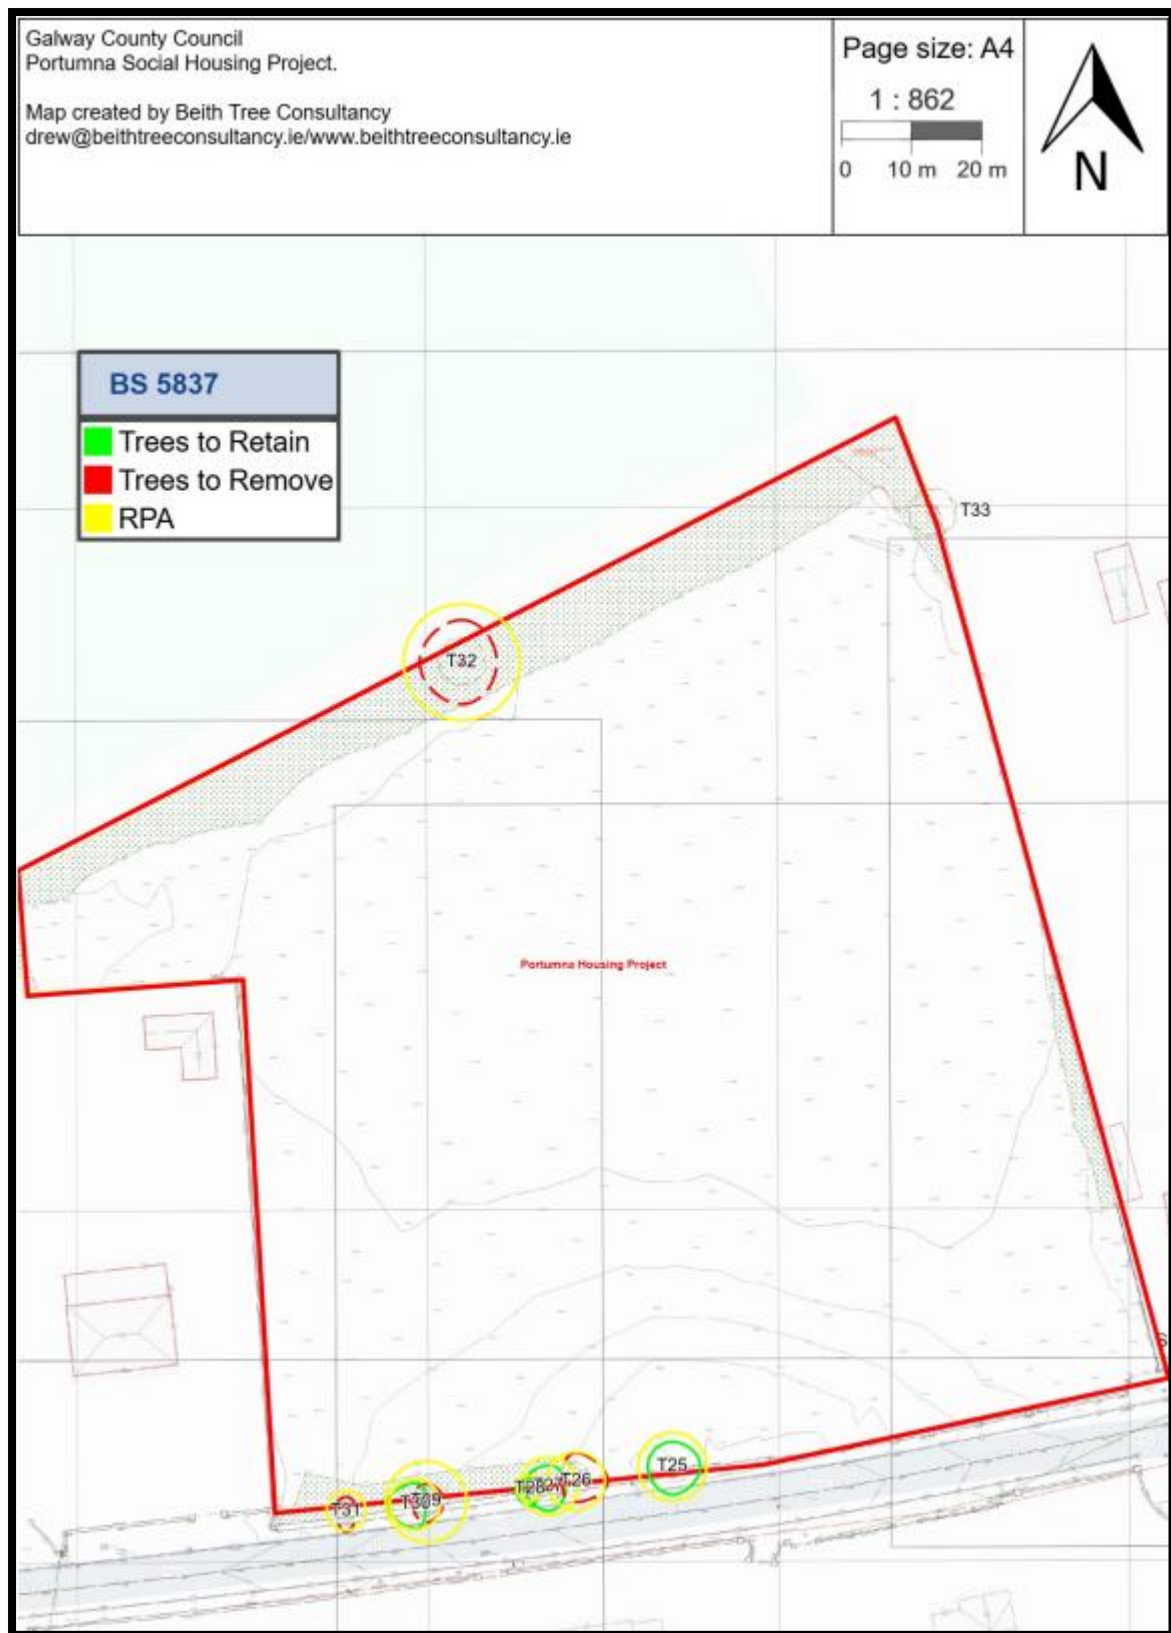
## Trees to remove or retain

1.2.2 Three Ash trees require removal from site due to poor physiological and structural health and 1 mature Ash requires removal to facilitate the construction design.

- To compensate for the necessary removal of 3 Ash trees on the southern boundary of the site due to poor structural and physiological health and 1 mature Ash tree on the northern border to facilitate the construction design new tree plantings should be considered.
