Farranamartin, Tuam

Co. Galway

Stage 1

Road Safety Audit

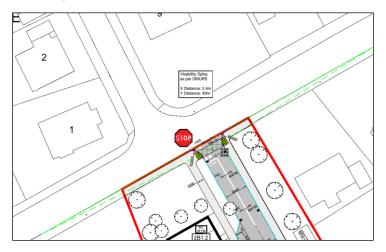
Figure 2-5 Visibility Splay

The Audit Team noted on the design drawings the visibility splay, at the proposed access. The Audit Team is concerned that the visibility splay shown are for vehicles on the pedestrian crossing, not at the STOP line. Inadequate visibility may result in vehicles entering the carriageway with oncoming vehicles, which may result in a side swipe type collision.

The design team should ensure visibility splay is provided as per standard.

| | To Be Completed by Audit Team Leader | | | |
|--|---|--|---|--|
| 2.5.1 | YES | YES | | |

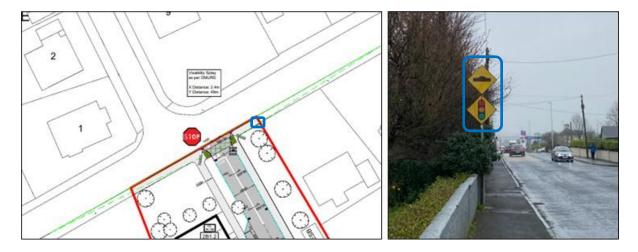
Figure 2-6 Visibility Envelope - Warning Signage

The Audit Team observed onsite the location of the existing warning signage. The Audit Team are concerned that the high sided vehicles will have their visibility obstructed by the signage when exiting. Inadequate visibility may result in vehicles edging out into the carriageway, which may result in a side swipe type collision with approaching vehicles.

The design team should ensure the visibility envelope is clear form any obstructions.

| | To Be Completed by Audit Team Leader | | | |
|--|---|--|---|--|
| 2.5.2 | YES | YES | | |
