G467: N83 BRIDGE STREET DUNMORE

## SECTION 177AE DEMOLITIONS REPORT

For  
**Galway County Council**  
30 June 2025

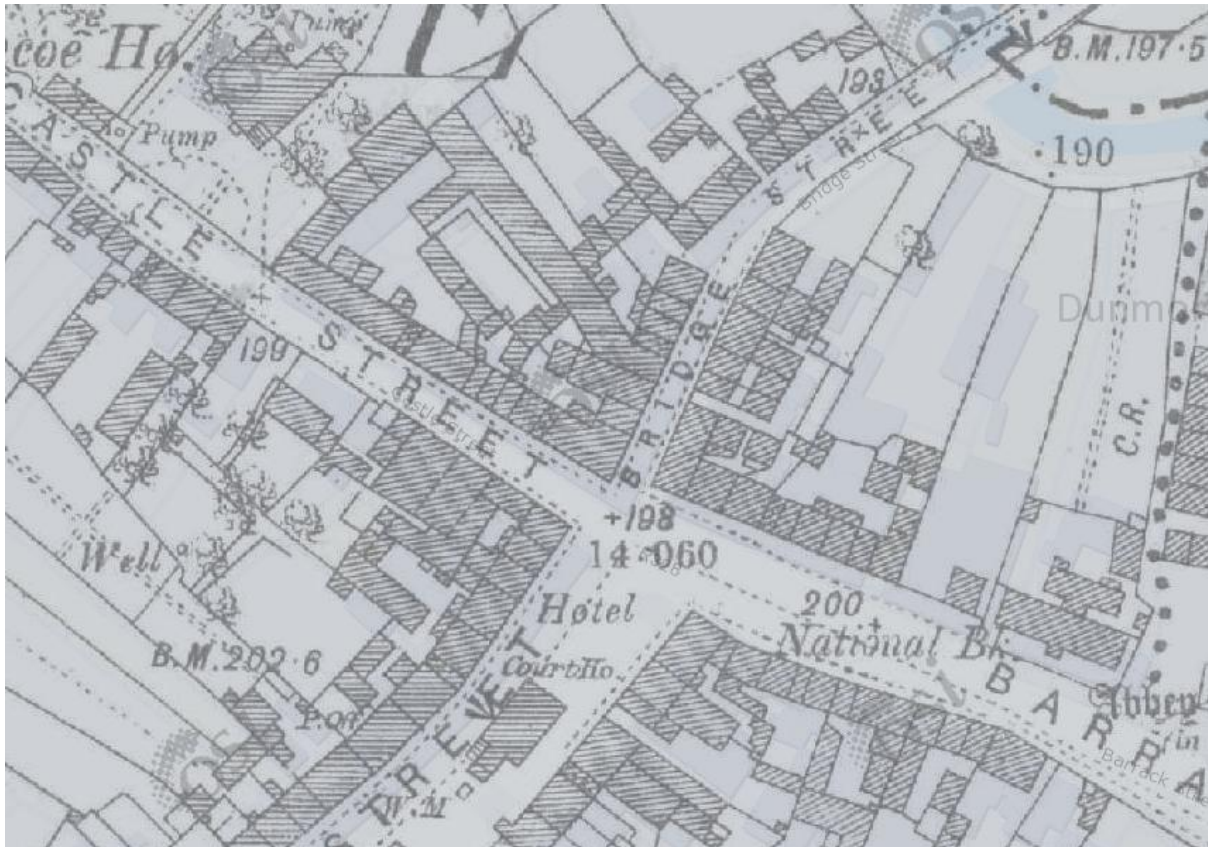
*Figure 1.1: Geohive Historic map 1888-1913, Dunmore, Bridge Street*

On review of Historic Geohive mapping the period of construction for all structures along Bridge Street is likely to range from early 1900's to 1950s. An Dún Rí Public House on the corner of Bridge Street and Castle Street has been recently refurbished. It is noted that the alignment of buildings along Bridge Street has not altered since 1913. The Geohive historic maps indicate the section of Bridge St. to be widened always consisted of a carriageway with reduced width as illustrated in Figure 1.1 below.

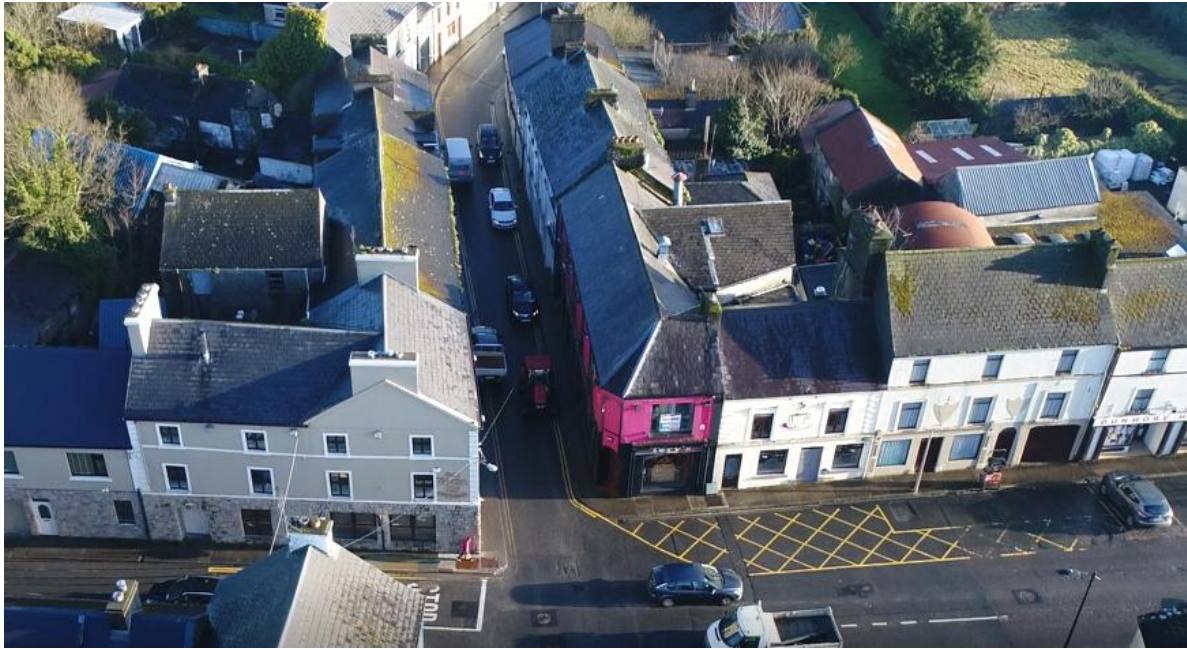
*Figure 4.1: Aerial View of Bridge Street, Dunmore*

The undertaking of works will require the assessment and monitoring of all adjacent buildings during the construction contract. The existing two and three storey buildings along Bridge Street comprise traditional masonry and timber floor and roof construction.

Buildings 1 – 7 comprise a terraced configuration. Building No 7 to the North of the terrace comprises an open green area adjacent off the north gable end. It is proposed to demolish the northern boundary of this building to allow an access route along the rear of the properties on a north – south axis. The cleared area will allow for the storage and removal of segregated demolition waste in large commercial skips. The southern end of the terrace at building No 1 will require a detailed demolition methodology to ensure the stability of the adjoining building to the east which is to be retained in the scheme.

The demolitions will comprise an initial soft strip out followed by removal of roof finishes, roof timbers, internal floors followed by demolition of the external walls and grubbing up of foundations.

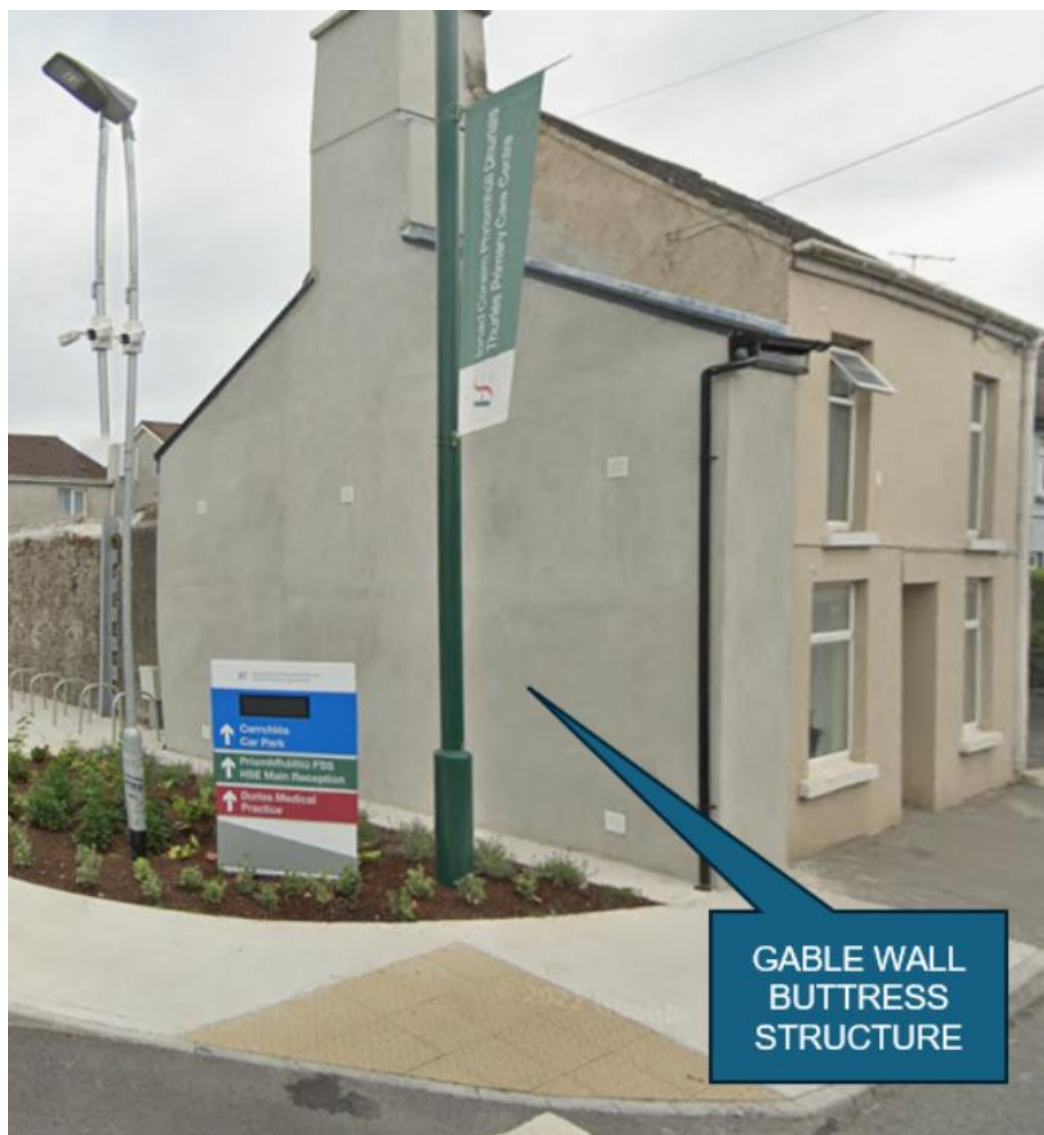
*Figure 4.2: Gable Wall Buttress Structure, Dunmore*

The removal of building No 1 to the south will involve the removal of the roof as well as its front and rear walls. The east side party wall of house No 1 is lower than the adjoining retained building to the east. The retained building has a partially exposed gable end wall presently as the roof of building No 1 is approximately 2m lower than the roof of the retained building. There is a chimney stack on the party wall of the two buildings. The chimney stack projects to a level higher than the building line to the east and it is therefore concluded that flues within the chimney serve the building that is to be retained. Therefore, the chimney on the party wall will have to be retained. This will add additional overall stability to the party wall on completion of the works.

The demolition of building No 1 will result in the full exposure of the gable end/ party wall to the retained building adjacent. We acknowledge that the higher portion of the wall is already exposed to the elements however, the adjoining property will lose the weather and thermal protection offered by the adjoining building No 1 which is planned to be demolished. We recommend that the full height wall from ground level to the roof level be remediated immediately following demolition with the addition of externally applied insulation and render. This will involve some stripping of the existing roof slates and re-roofing

comprising an extended roof to cover the insulated panel and render below. This work will be carried out by a separate specialist contractor.

Strengthen of existing structure adjacent to building unit 1 with introduction of gable wall buttress structure as show in below Figure 4.2. Also a mural art design is being proposed by landscape architect.

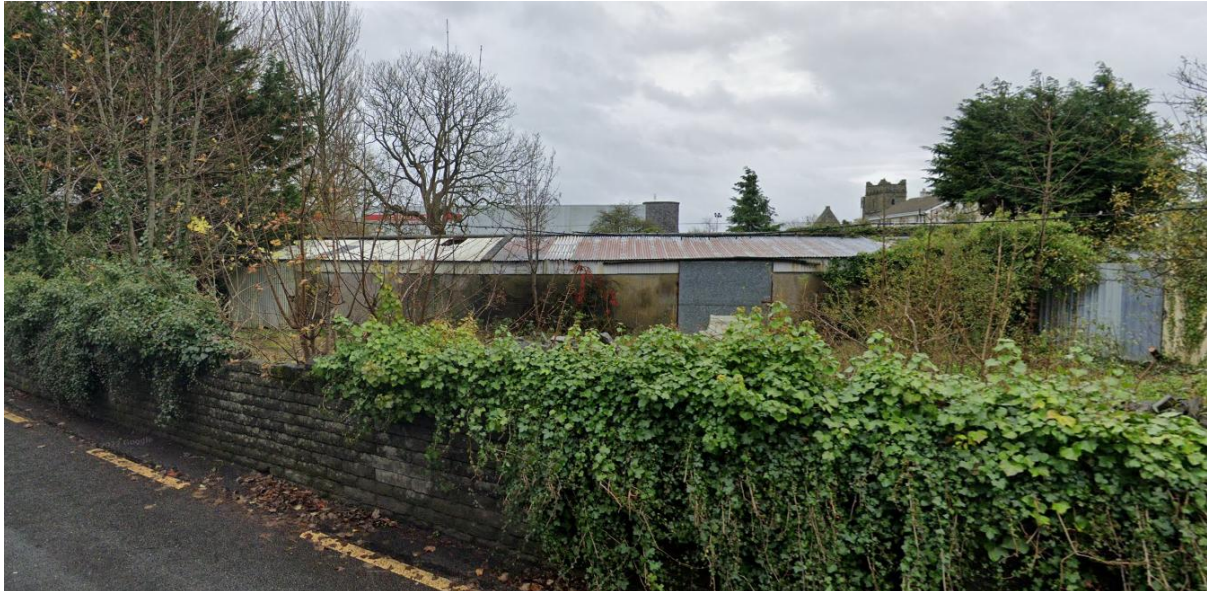
*Figure 5.1: Side View of Bridge Street, Dunmore showing Units 9 & 10*

Buildings numbered 8, 9 and 10 are temporary units. Refer to figure 5.1 below for side views of each unit.

The building is a small, single-storey structure primarily composed of corrugated metal sheeting for the roof and walls, supported by a timber or steel frame, and likely rests on a basic concrete base. The demolition is being carried out to clear the site for development of public realm landscaping design. A detailed site survey will be conducted prior to demolition, including photographic documentation, condition reports, and inspections for any hazardous materials such as asbestos or lead-based paint. Necessary permits will be secured from local authorities, and utility companies will be notified to disconnect and safely cap all services. Nearby property owners and relevant stakeholders will be informed of the demolition schedule to ensure awareness and cooperation.

The demolition will be executed manually due to the structure's modest scale and materials. Work will commence with the removal of the corrugated metal roof panels, followed by dismantling of the wall sheeting and structural framework in a top-down, controlled sequence. If necessary, the concrete base will be broken up using a mechanical breaker. The demolition area will be secured with fencing and signage, and a safety exclusion zone will be enforced at all times.
