Loughrea Townhall

Barrack Street, Loughrea, Co. Galway

Architectural Survey & Assessment

to accompany Part 8 Application

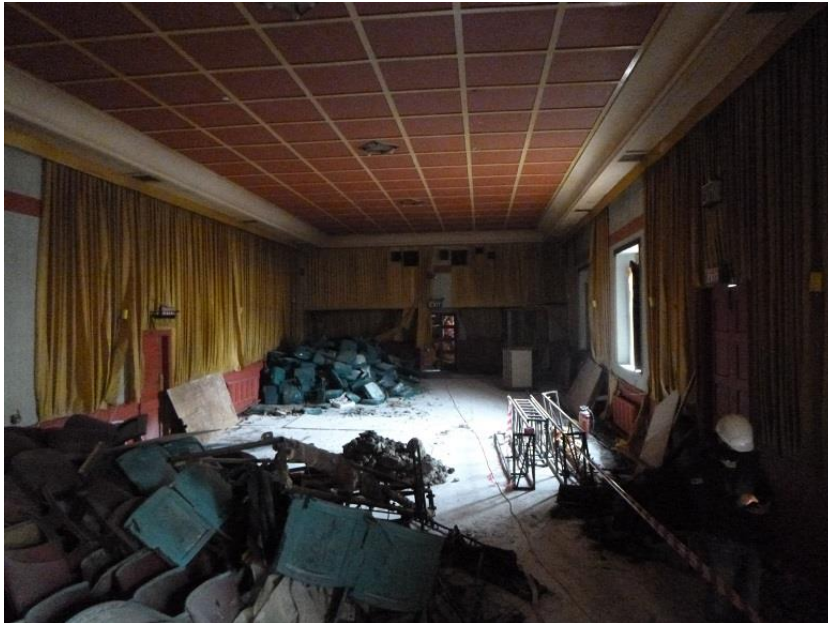
The suspended ceiling over the auditorium is of framed timber construction, with asbestos fibre reinforced infill panels with a render coating over (see photo 2). Water ingress, originating at the junction between the chimney stacks and the eaves, has resulted in localised degradation of the building fabric however, the first-floor steel beams appear to be salvageable. The external walls are clad in a dry-lining system which is comprised of metal pegs fixed into the masonry walls supporting timber battens with timber lath secured to

Photo 2. The Cinema with the original seating removed and stacked

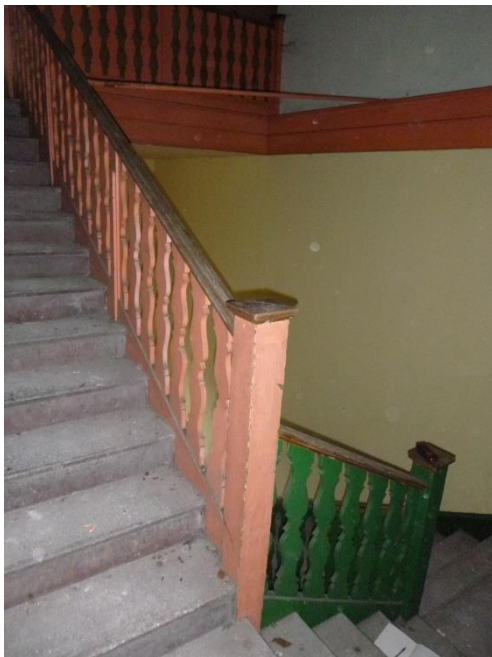
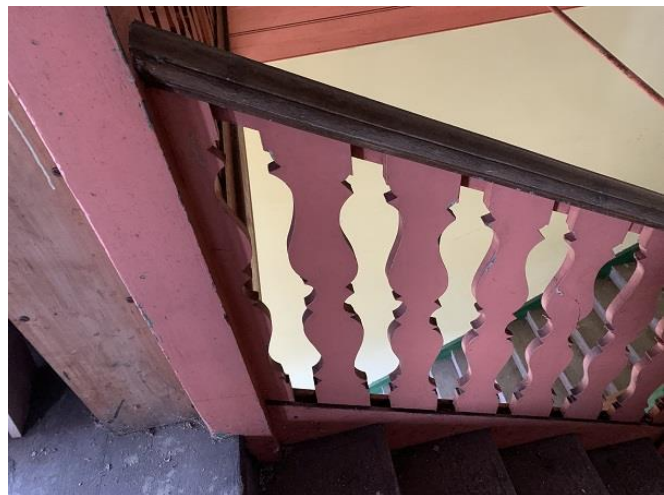
The main staircase in the western-most lobby is of generous width. It has a terrazzo finish which matches the floor finish of the entrance lobby. The balustrade has flat carved uprights, with curvilinear profile exercised with unexceptional craftsmanship, and dates from a later period. The stair leads to the first-floor ballroom and the annex building.

Photo 3 & 4. The main stairs

The lobby floor and stairs are finished in terrazzo which will be cleaned. The timber balustrade, which is of crude design and execution, will be removed and replaced with a code compliant balustrade. The existing timber handrail will be scrutinized upon its disassembly to determine if it can be reused. Its profile is not unique and if necessary, could be reproduced to suit the new balustrade. The ticketing hatch below the stairs will be retained.

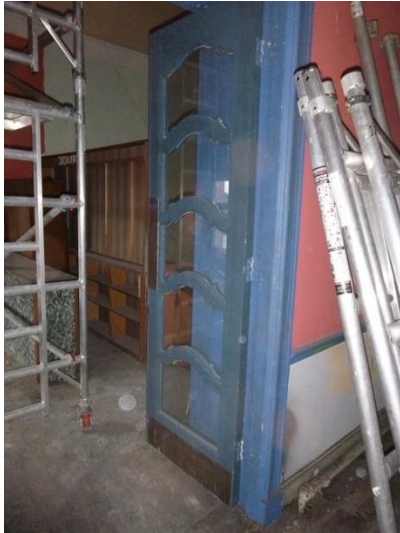
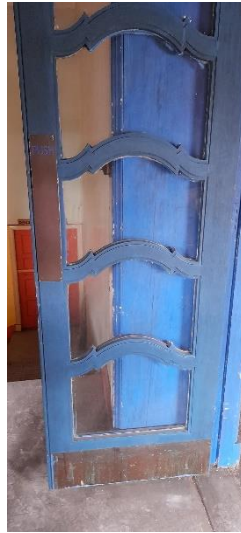
The first-floor ballroom is accessed by way of double doors with glazed infill panels framed by arching timber rails. Unfortunately, these doors are in poor condition and are not fire-resisting and as such will have to be replaced once the building comes into use.

Photo 5 & 6. The Ballroom glazed doors

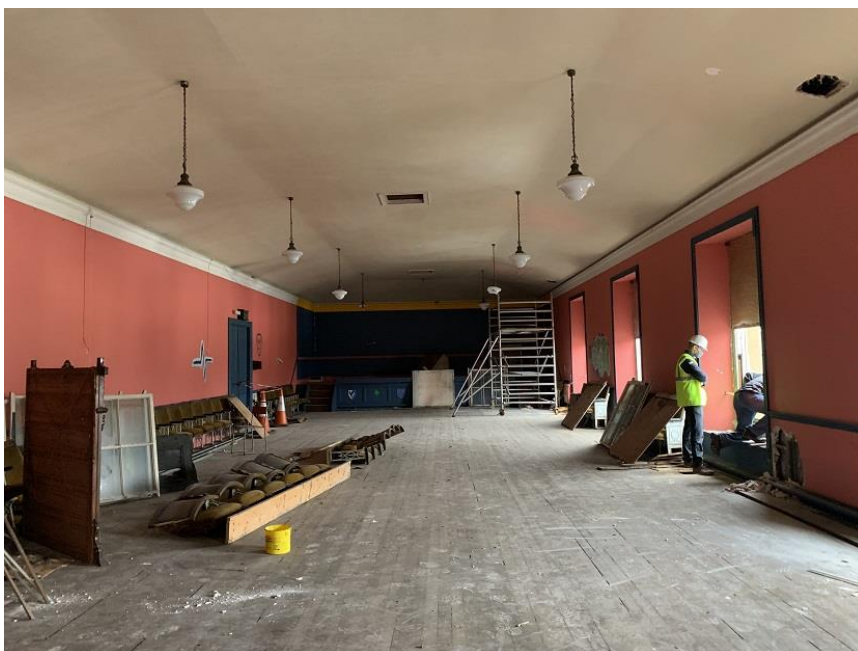
The ballroom fixtures and finishes still hark to its former use. The northern wall is lined with cast-iron framed cinema-style seats similar to those downstairs. The timber floor boards are well worn and around 50% will need to be replaced with the remainder being salvageable. The translucent white glass pendulum light fittings remain bar a number which have been vandalised. The vaulted ceiling is of painted plaster board on timber battens supported by metal trusses. The walls are dry-lined in the same construction as the ground floor. The stage at the eastern end of the hall, which is of solid construction with a linoleum covering that contains asbestos, is in fact the roof over the projector room.

Photo 7. The Ballroom interior looking east

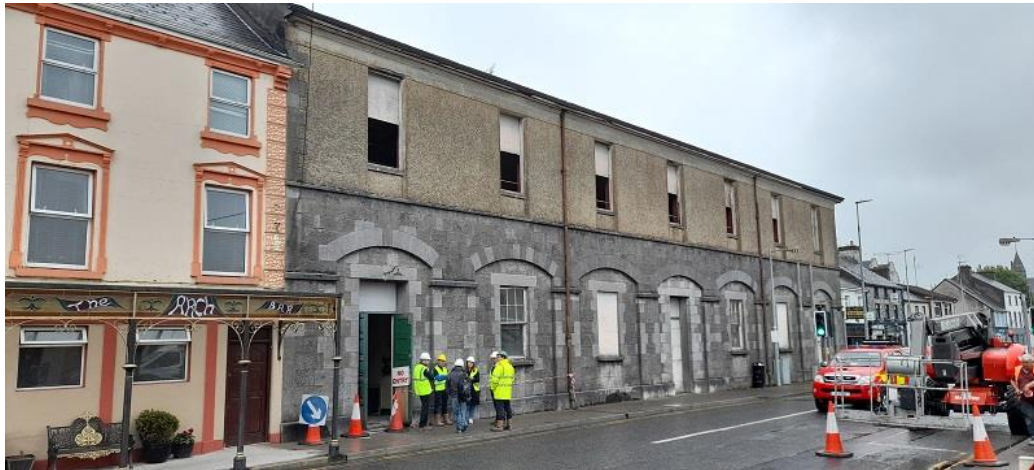
The ground floor walls are clad in ashlar limestone with fine joints pointed in limestone. The pointing is largely in good condition which, upon inspection, would only require localised repairs. The first-floor walls are finished in rough dash render with a smooth plaster band and moulded cornice below the eaves. There is some hairline cracking in the plaster and some evidence of delamination.

Photo 8.
Main building external wall finishes

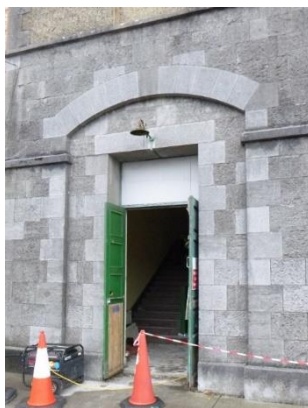
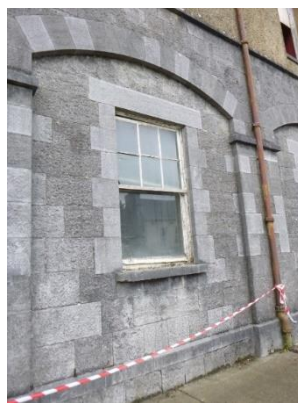
The fenestration pierces blind arcades at each bay along the Barrack Street and Church Street. The ground floor windows and doors have cut stone lintols and on these elevations. Some of the stone sills require localised repairs. The original 2 leaf, 5 panel timber doors on the Barrack Street elevation have fallen into disrepair as have the windows and need to be replaced. The easternmost door has been altered from a 5 panel to a 4-panel door to accommodate the later installation of the raking cinema floor in the 1930's. The granite steps would have been introduced here at the same time. The timber latticed rectangular glazed panels above the doors remain in position (see photo 12).

Photo 9 & 10 Main building Ground Floor doors and windows on street elevations

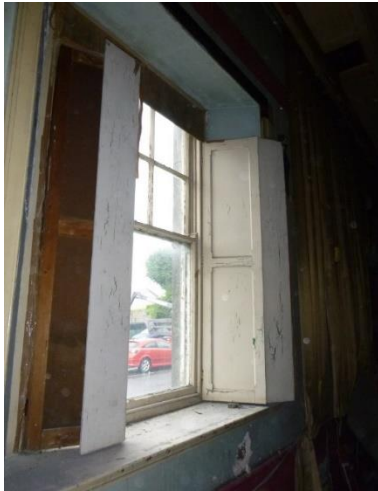
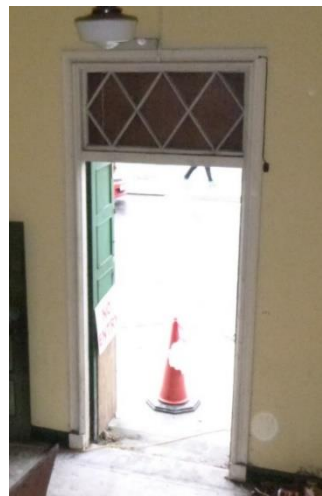
The ground floor windows have panelled timber shutters which appear to have been modified using poor quality materials and craftsmanship (see photos 11, 40 & 41). It is worth noting that the first-floor windows have no shutters.

Photo 11 & 12. Ground Floor Cinema windows & Main building entrance doors lattice fan light window

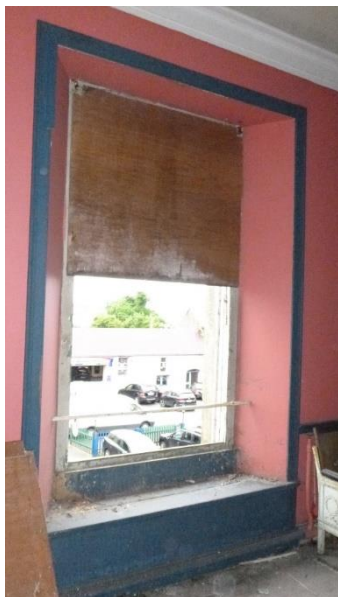
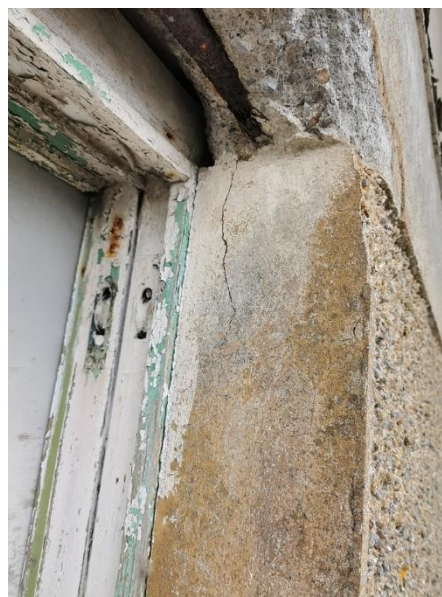
The original window sashes have been removed from the frames at first floor. All the original window timbers have decayed and will have to be replaced. First floor windows are 6 / 6 pane sliding sash whilst the ground floor windows are 6 panes over one large clear pane. Upper windows have reinforced concrete lintols which have started spalling and will either need to be repaired or to be replaced (see photos 13 & 14). The Church Street gable elevation window was boarded up at the time of inspection however Gerry McManus describes it as being ‘...an 8-pane light over two 3 pane casements.’ (2013). A painted metal bar has been inserted into the masonry sides of each window to serve as protection from falling which is made possible by the omission of shutters.

Photo 13 & 14. First Floor Level Ballroom windows with steel bar as protective barrier. Spalling concrete lintol

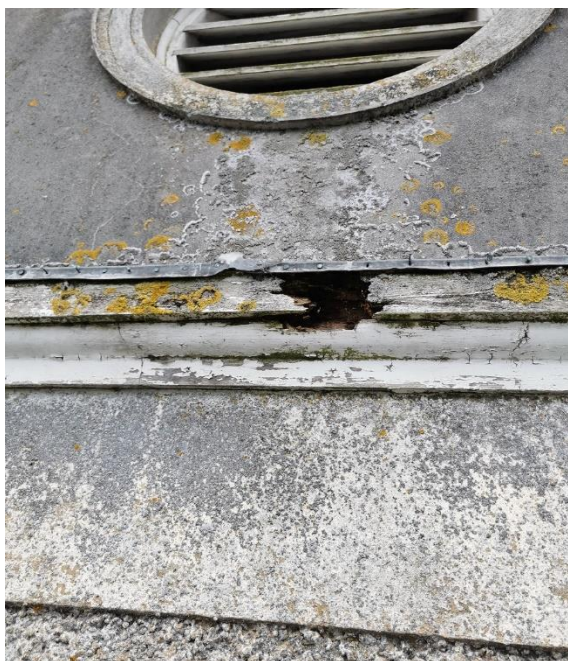
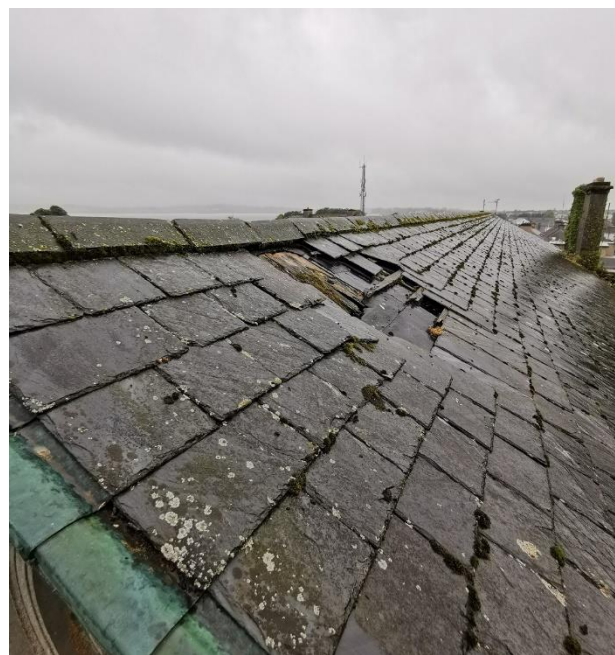
The projecting eaves and verges are of timber construction. The timber fascia is profiled and along with the timber soffit, is in poor condition. The projecting verges are of timber construction and are flashed in copper (see photo 16). The bottom cord of the triangular feature which forms the gable pediment is also made of profiled timber which is flashed in lead (see photo 15). The verge timbers are in poor condition however, those parts clad in copper could be preserved.

The eastern gable verge is in poor condition. A relatively recent repair was made to it using a bitumastic membrane which was then rendered over with using a sand and cement mix.

Photo 15 & 16. Lead flashing on the eastern gable and copper flashing of the verges

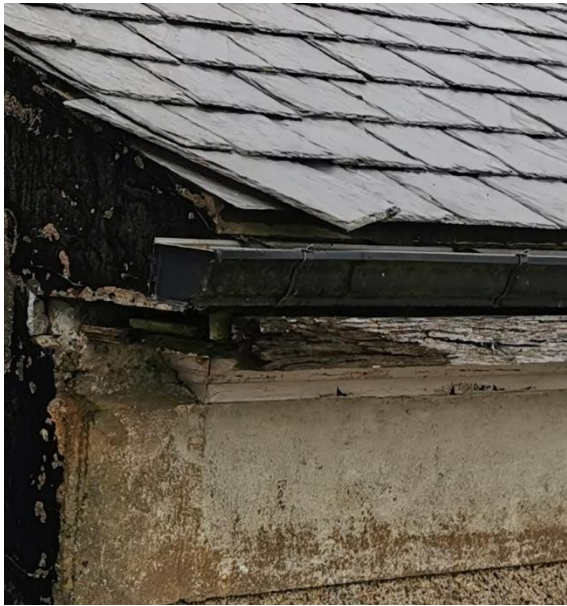
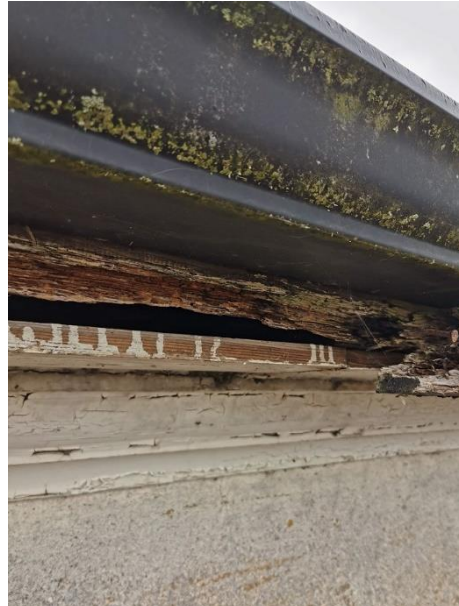
The extensive water damage to the interior of the main building originates at the junction between the eaves and the chimney stacks. Surface water runoff is entering the building at this point where the weathering detail has failed – possibly because it is inaccessible and therefore cannot be properly maintained.

**Photo 17
& 18.**
Eaves
details.

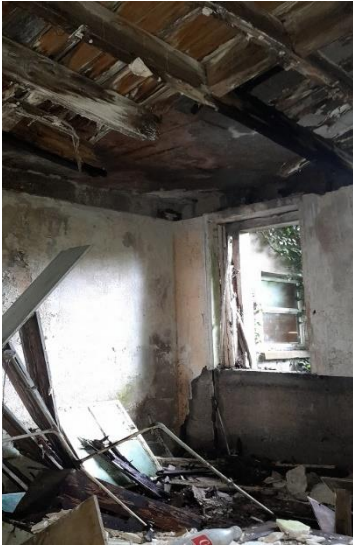
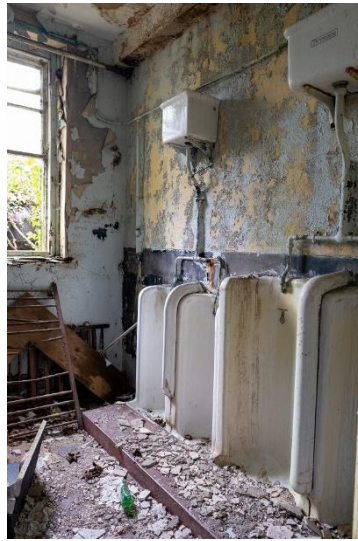
Presently the timber floors, suspended ceilings, and timber stairs have all collapsed. The roof timbers have also collapsed except for a small area over the stairs. Water ingress has damaged the walls and ground floor. The timber fenestration is no longer salvageable and has suffered from vandalism.

Thorough inspection of the annex was hampered by its state of collapse and the amount of debris on the ground which could also contain asbestos from the collapsed suspended ceiling. It is not possible to open internal doors as passage is blocked by debris and is unsafe. The presence of asbestos has previously been reported in the boiler room which is also now inaccessible.

Photo 19 & 20. The Annex interior

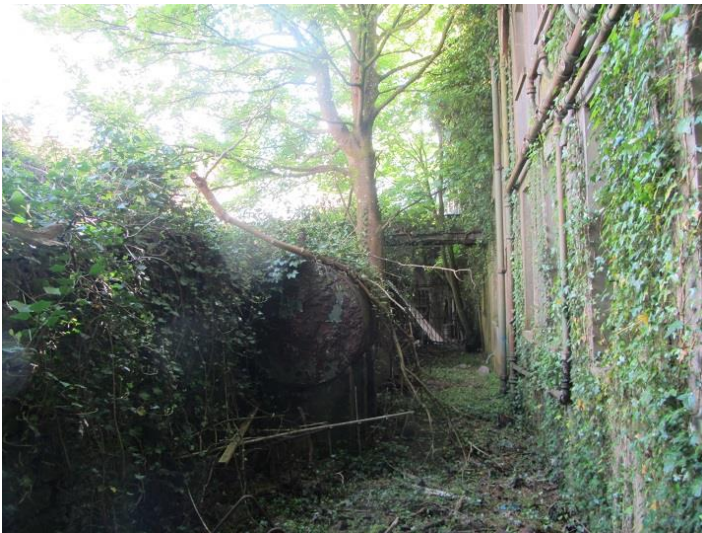
Photo 21. The Annex exterior and northern boundary wall.

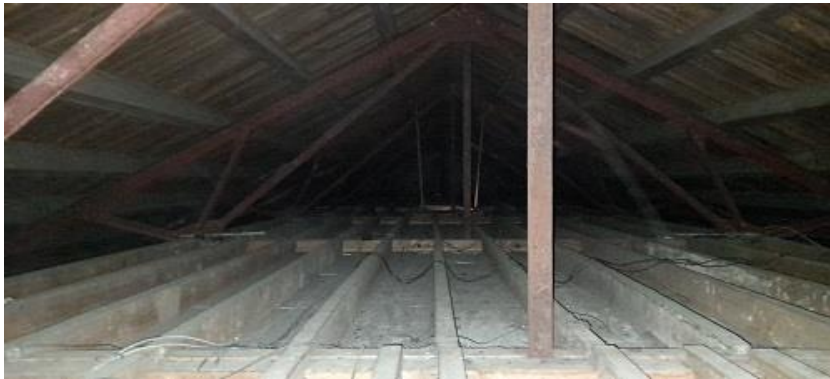
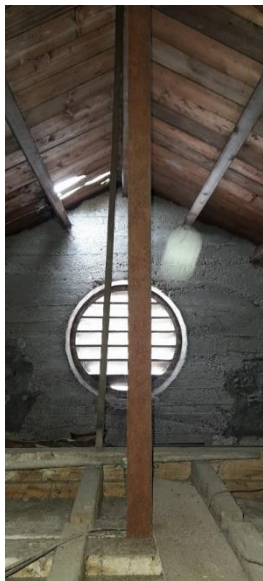
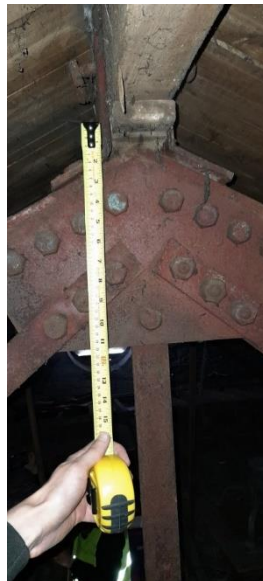
The roof construction is made up of slates on timber battens, on bitumastic felt on sarking boards, on timber purlins on a composite steel truss (see photos 22, 23 & 24 for roof construction). In the Architectural Conservation Report of May 2013 submitted with the Part 8 application of the same date, Gerry McManus states that

'These details would suggest the roof was recovered in the mid-20th century or later.' A large number of slates have slipped and there are at least 4 holes in the roof. Recent inspection would suggest that the slates are in good condition generally and a significant percentage should be salvageable. The bitumastic felt will have to be replaced along with the battens. The sarking board could be largely preservable. The steel trusses are in good condition generally.

Photo 22, 23 & 24. Rood construction & steel trusses

The roof repairs afford the opportunity to add insulation within the roof structure. The strategy will be to install insulation over the steel trusses, between the timber purlins. There will be a slight increase in the ridge level to accommodate a thin layer of insulation over the timbers as a thermal break.

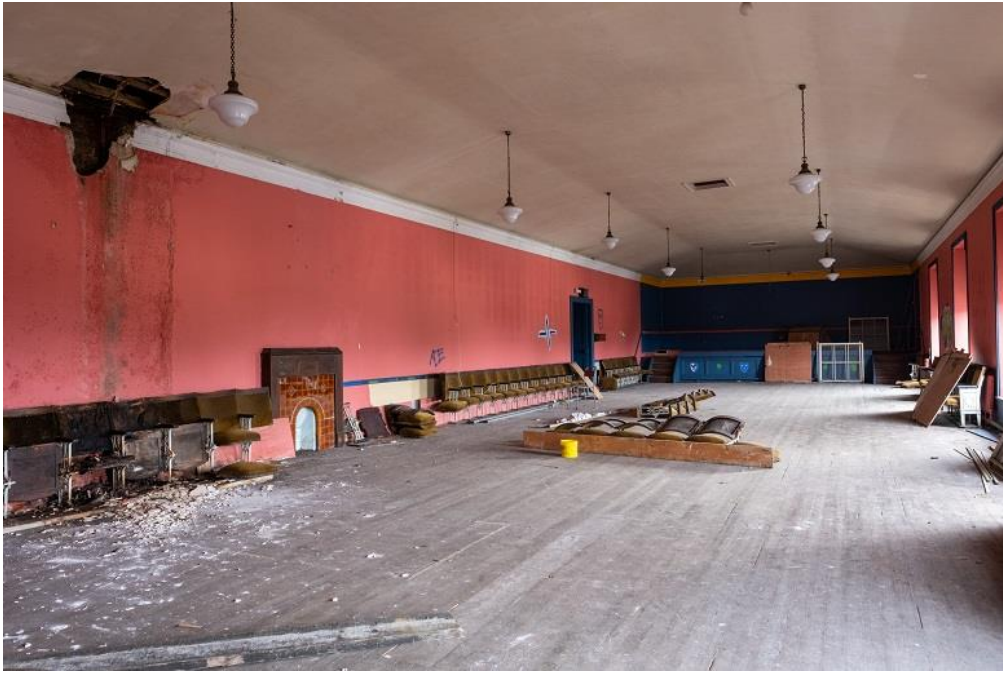
Photo 25. The Ballroom interior looking east (note water damage at ceiling)

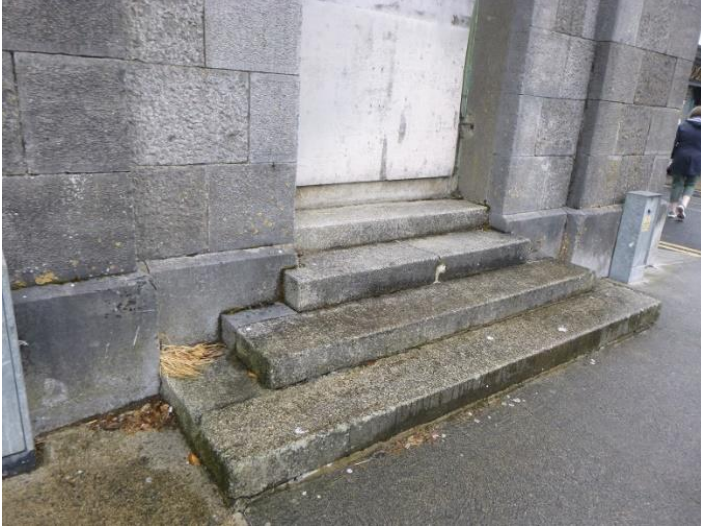
Photo 26. Stone steps at eastern entrance to be removed

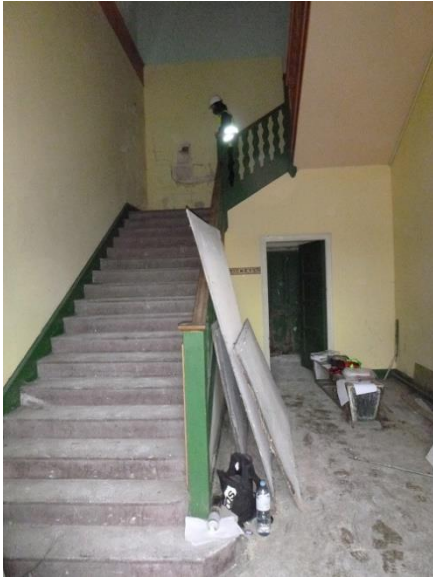
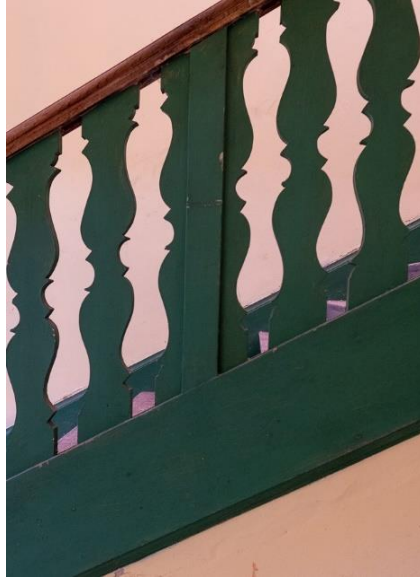
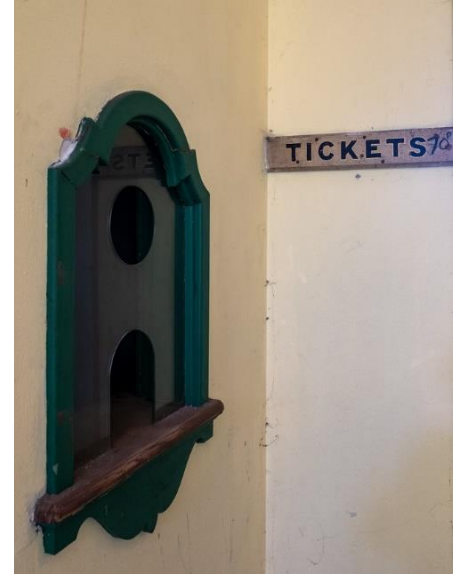
Photo 30, 31 & 32. Main stairs, balustrade detail, & ticketing hatch

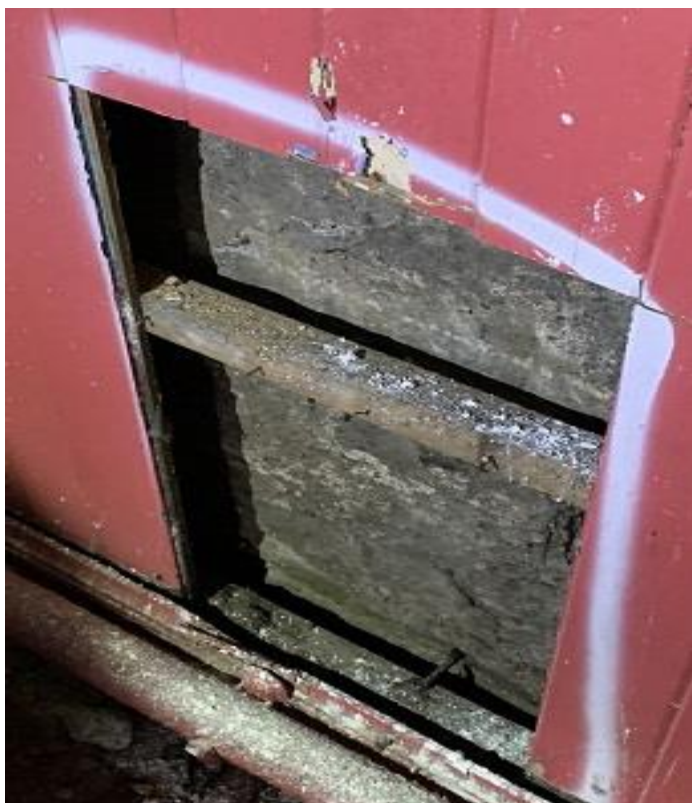
them and rendered over with a lime-based render (see photo 33). The metal pegs have suffered serious corrosion and as such the lining system is not repairable.

Photo 33. Dry-lining system with timber panelling

As part of the thermal upgrade of the external envelope, the existing dry-lining system will be removed to accommodate the installation of a vapour permeable insulation system supported on metal studs. Gerry McManus notes that: 'The dry-lining system is interesting as an example of construction of a particular era, but it is not of particular merit otherwise.' In addition to this, the steel pins, which are fixed into the rubble walls, and support the timber battens have corroded to a point where they are beyond repair.

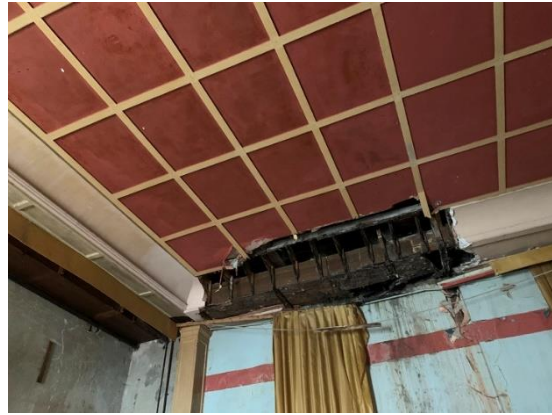
Photo 36. Cinema ceiling and water damage

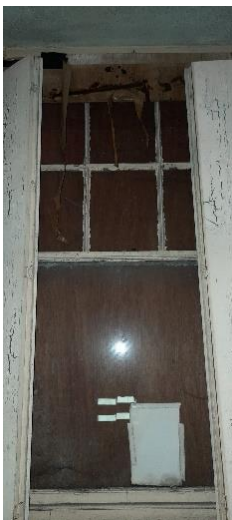
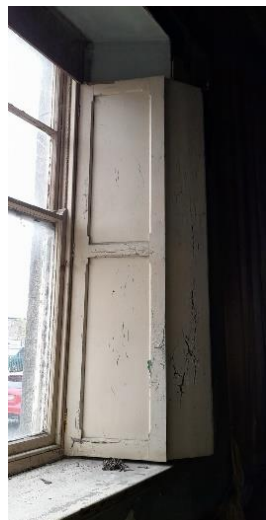
Photo 40. & 41. Ground floor windows

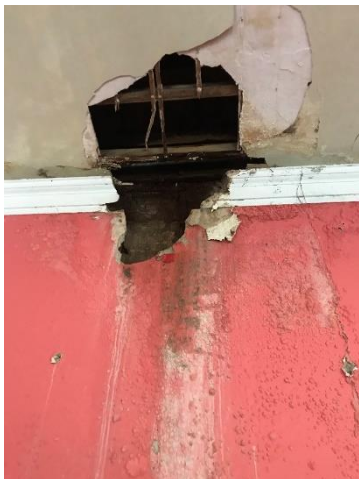
Photo 46. Ceiling and wall damage
