Galway County Council

February 2022

**PROPOSED HOUSING DEVELOPMENT
AT BALLYMOE, COUNTY GALWAY
Stage 1 Road Safety Audit**

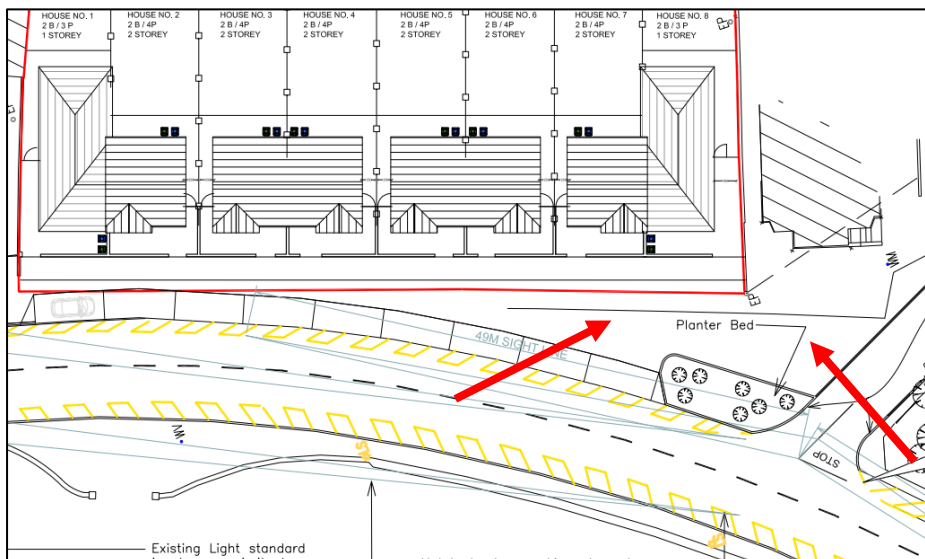
Figure 2.2: Widened Footway Area

It is understood that a new footway build-out is proposed along the R360, with a widened footway area at the south end of the scheme, between the proposed houses and recessed parking/planter box. This footway area could be accessed by vehicles for parking, via the recessed parking area and adjacent cul-de-sac local road. The existing east side footway is at-grade with the adjacent road carriageway. Inappropriate parking could result in material damage to footways and kerbs, and conflicts, impact collisions and injuries for pedestrians.

It is recommended that appropriate levels and measures should be provided to prevent inappropriate parking. Refer also to item 2.1 above.

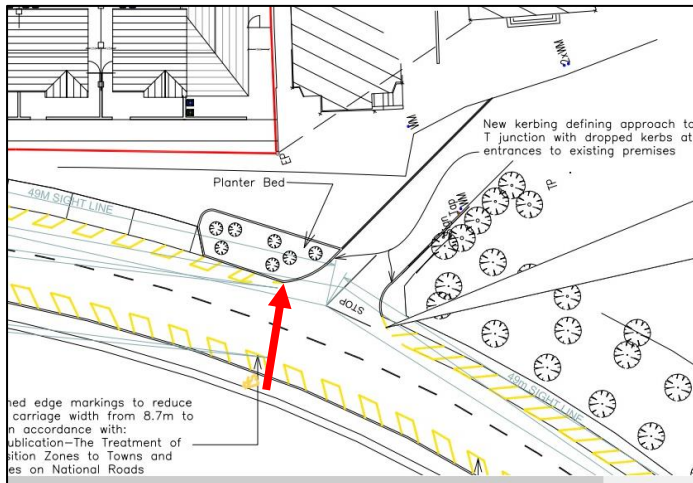
Figure 2.3: Planter Box Flush With Recessed Parking

It is proposed to provide a planter box with landscaping, on the north side of the cul-de-sac local road junction, immediately flush with the proposed recessed parking. The existing R360 east side footway is discontinued south of the local road junction. This could restrict pedestrian movements at this location, including pedestrians using the Suck Valley Way walking route and pedestrians generated between the proposed housing and south along the R360, resulting in potential conflicts, collisions, trips, falls and injuries.

It is recommended that pedestrian desire lines should be kept clear of restrictions, with appropriate footway treatments.

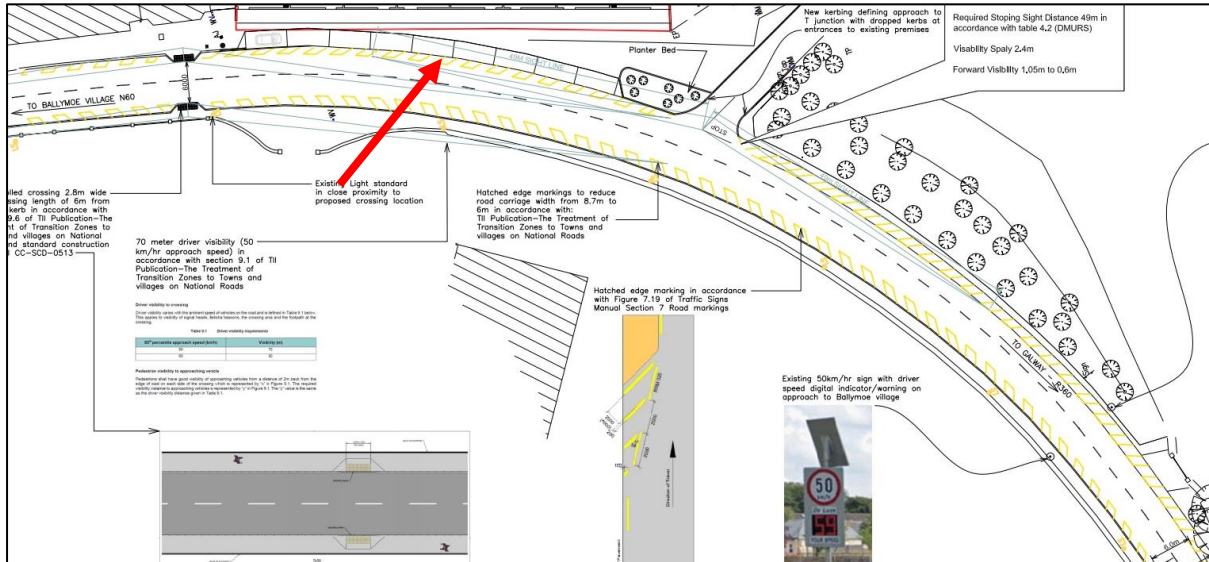
Figure 2.4: Hatched Road Markings

Although a Stage 2 item, the directional orientation of the proposed hatched road markings along the east side of the R360 are shown incorrect on the drawing provided for audit. It is recommended that the markings should be orientated correctly for the adjacent southbound traffic lane direction.

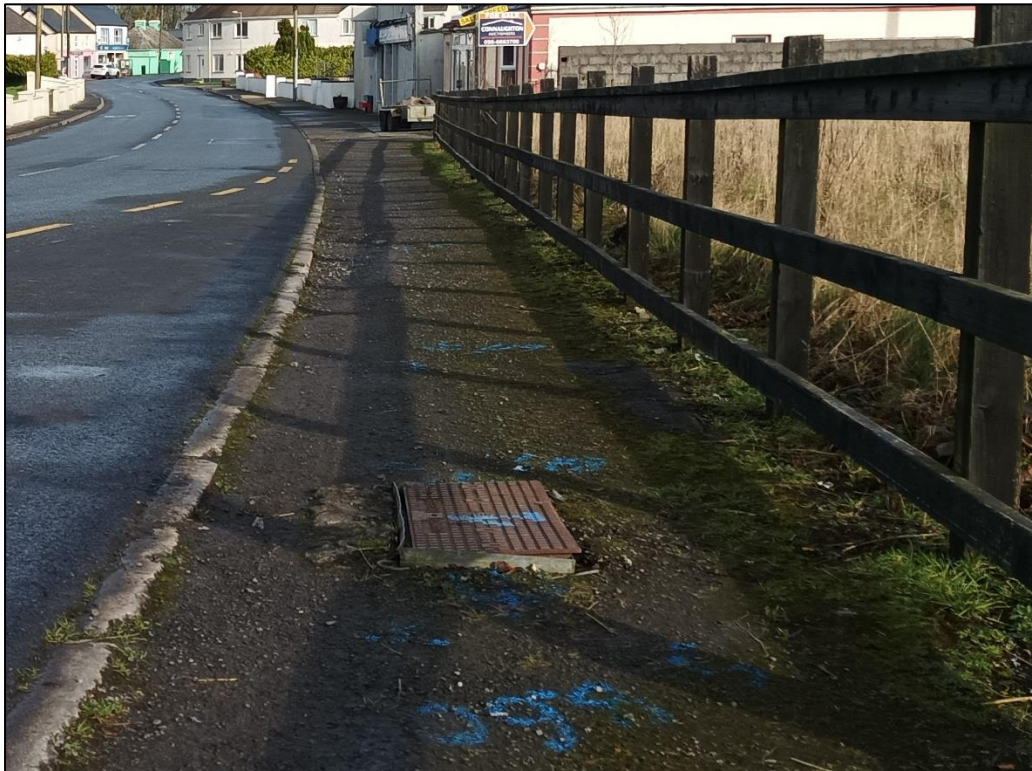
Photograph 2.6: Utility Manhole Cover on East Side Footway

There is an existing utility manhole with a loose cover and exposed frame located on the east side footway, within the extent of the proposed scheme. This is a potential trip hazard for pedestrians. It is recommended that the utility manhole should be reinstated appropriately as part of the proposed scheme works.
