Title: Stage 1&2 ROAD SAFETY AUDIT

St. Joseph's Housing Development, Ballinasloe, Co. Galway.

Client: Galway Co. Co.

Report reference: 1808R01

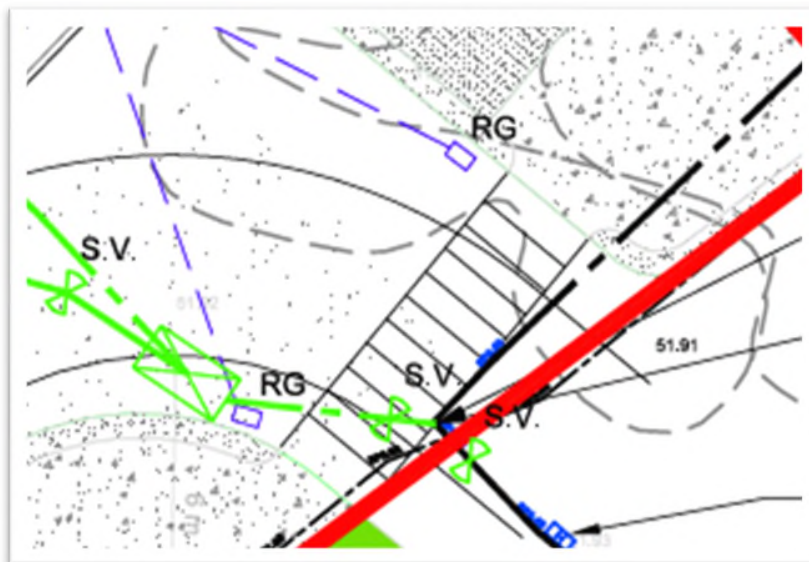
Drawing 22316/CE/001/PL Rev PL, Pedestrian crossing at St. Joseph's Place.

Zebra crossing type markings are shown on the drawings for the pedestrian crossing at St. Joseph's Place which links to the pedestrian link to the school. These markings, if installed, may give rise to confusion over priority. A pedestrian may think that they have priority akin to a zebra crossing but a driver may not assume so given the absence of beacons and other road markings. The confusion may lead to collisions with pedestrians.

It is recommended that at the detailed design stage that the striped road markings be omitted.

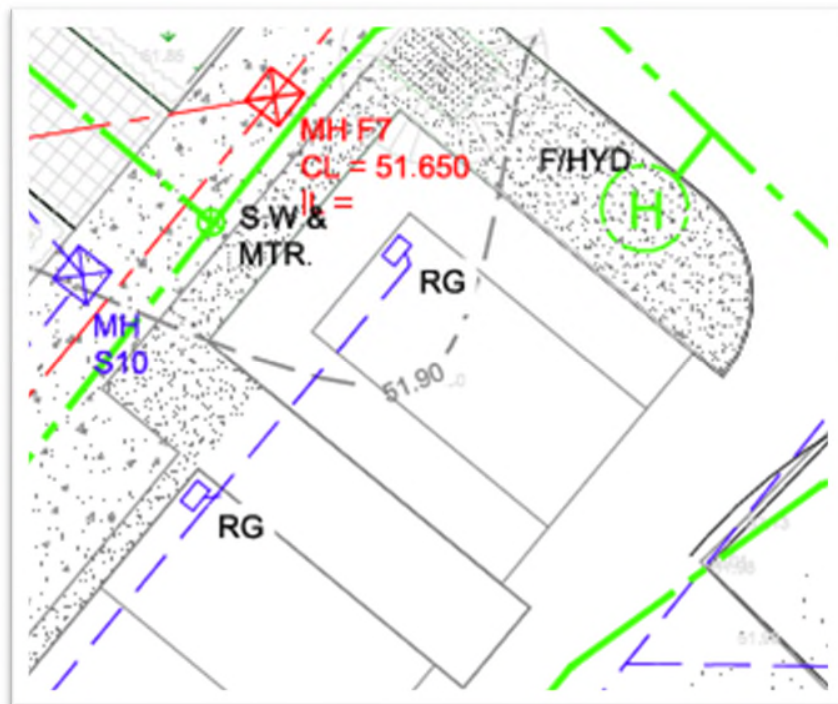
Drawing 22316/CE/001/PL Rev PL, Disabled parking bay.

It is proposed to provide a disabled parking bay adjacent to house no. 1. It is unclear if a dropped kerb is proposed to allow access from the bay to the footpath network. A lack of a dropped kerb could lead to inaccessibility for some and possible trips and falls.

It is recommended that at detailed design stage that a dropped kerb be provided to allow access to the footpath network.

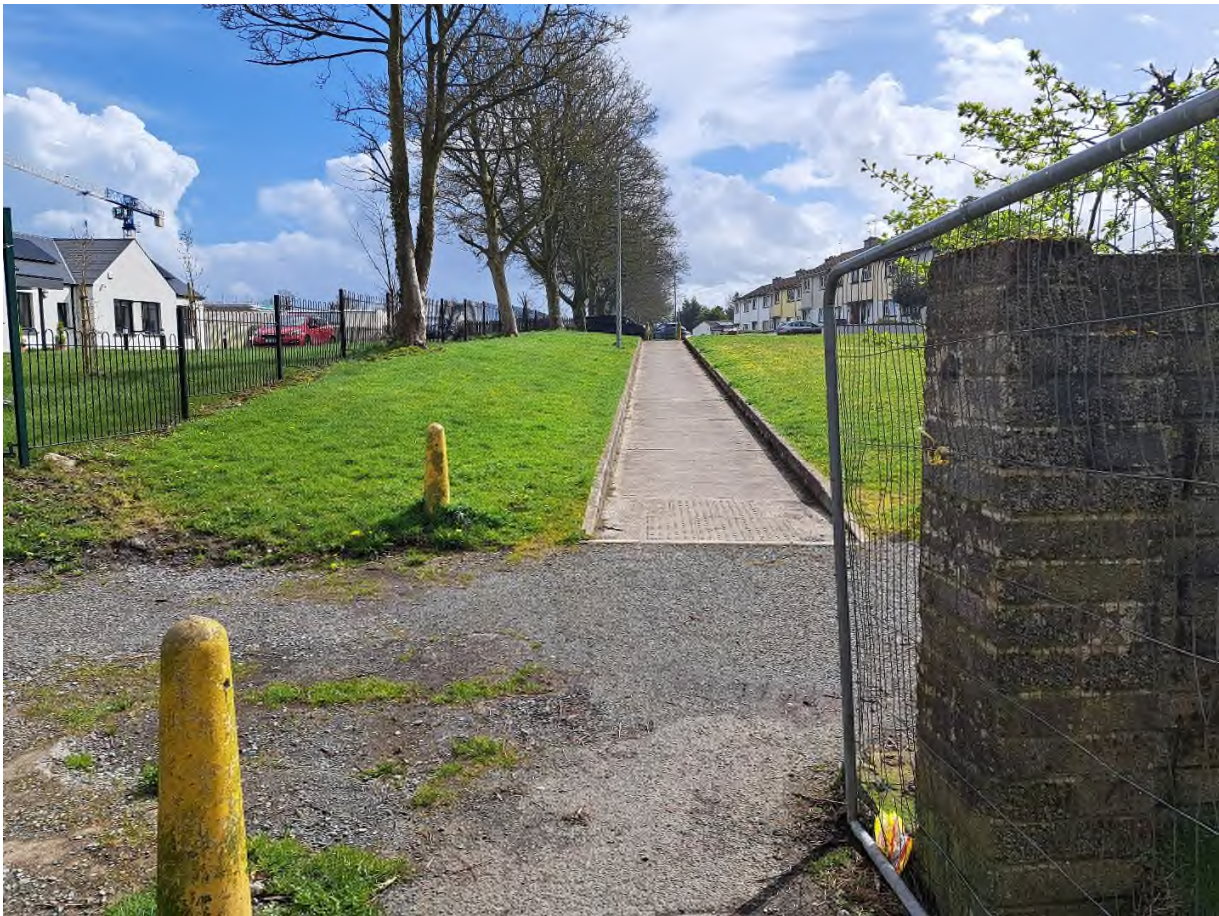
Drawing 22316/CE/001/PL Rev PL, Footpath leading to the school.

The existing footpath leading to the school has a downhill gradient towards the school. It may be difficult for some mobility impaired users to travel up given its length and gradient. This could lead to falls.

It is recommended that a relatively flat rest area be provided along the route for some mobility impaired users to take a break.

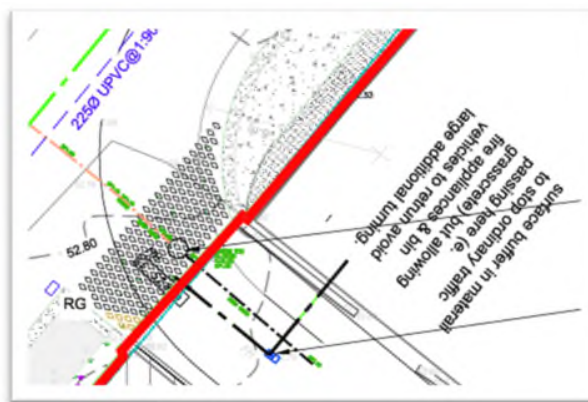
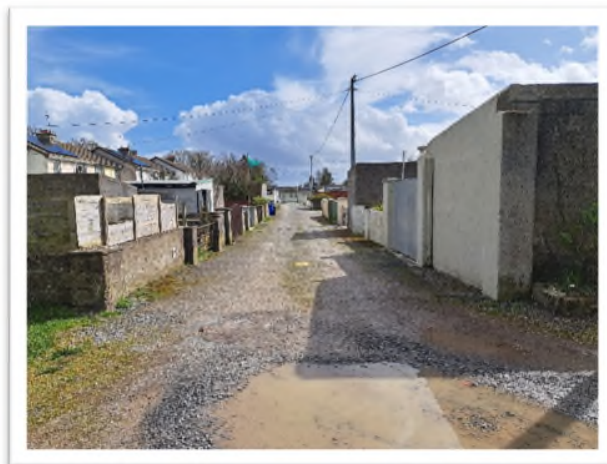
Drawing 22316/CE/001/PL Rev PL, Loop system for refuse vehicles.

It is proposed to have a one-way loop system for refuse vehicles and emergency vehicles. Grasscrete or similar is proposed to distinguish the surface. Given that the lane is surfaced and it provides a more direct link to the R446 it will most likely form the pedestrian desire line. An unsuitable surface for pedestrians could lead to slips and falls

It is recommended therefore that whatever surface is chosen at the detailed design stage that it is suitable for pedestrians to use.

It is assumed that the one-way system will be self-regulated by residents who will prohibit general traffic from using the route. Some signage and road markings may be required if this is not been adhered to.
