#### **Arboricultural impact Assessment**

**Galway County Council**

Farrannamartin, Tuam, Co. Galway

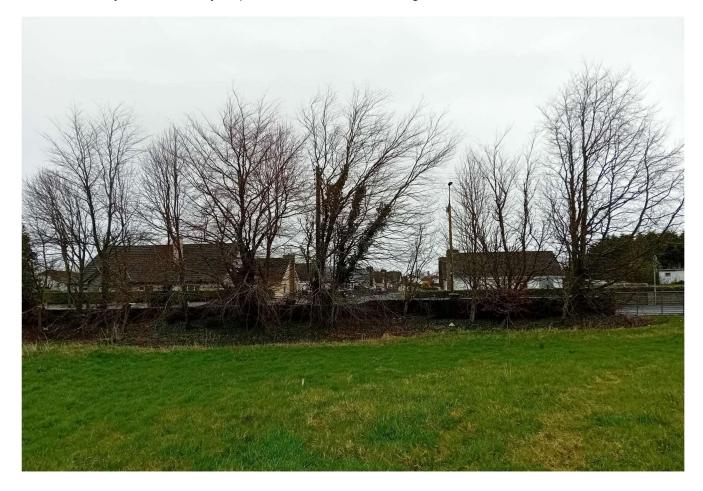
Front boundary trees that may require removal to allow for sightlines

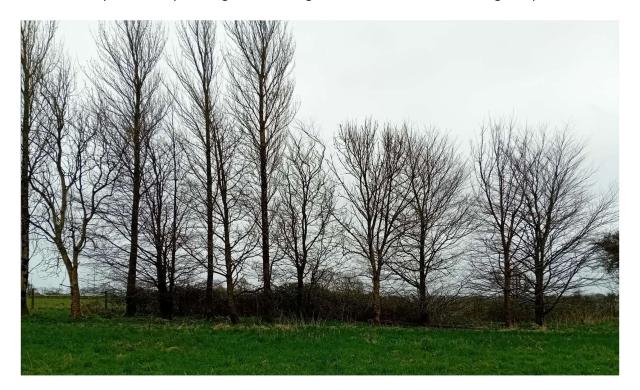
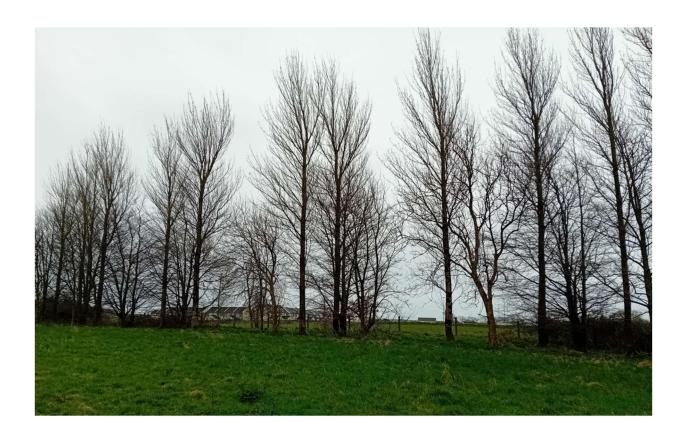
Rear boundary trees that provide good screening, it is advised to remove the larger Poplars trees

Tree line 2	Beech Poplar Ash Maple	М	280	16	N=2 S=2 E=2 W=2	1	Good	A mature tree line located along the rear boundary, it is recommended to remove the Poplar and retain the understorey of beech	Remove the Poplar and ash	Retain beech	B2	3.8m
Tree line 3	Sycamore  Beech Ash	M	250	10	N=3 S=3 E=3 W=3	2	Good	A mature mixed tree line displaying a good overall condition	Remove to facilitate a boundary wall	Remove	C2	
Tree line 4	Sycamore Beech Ash	M	250	8	N=3 N=3 S=3 E=3 W=3	1	Good	A mature mixed tree line displaying a good overall condition	Remove to facilitate a boundary wall	Remove	C2
