**Stage 1/2 Road Safety Audit
Proposed Residential Development
Cullairbaun, Athenry, Co. Galway**

Client:	Galway County Council
Document No:	242462-ORS-XX-XX-RP-TR-13g-001

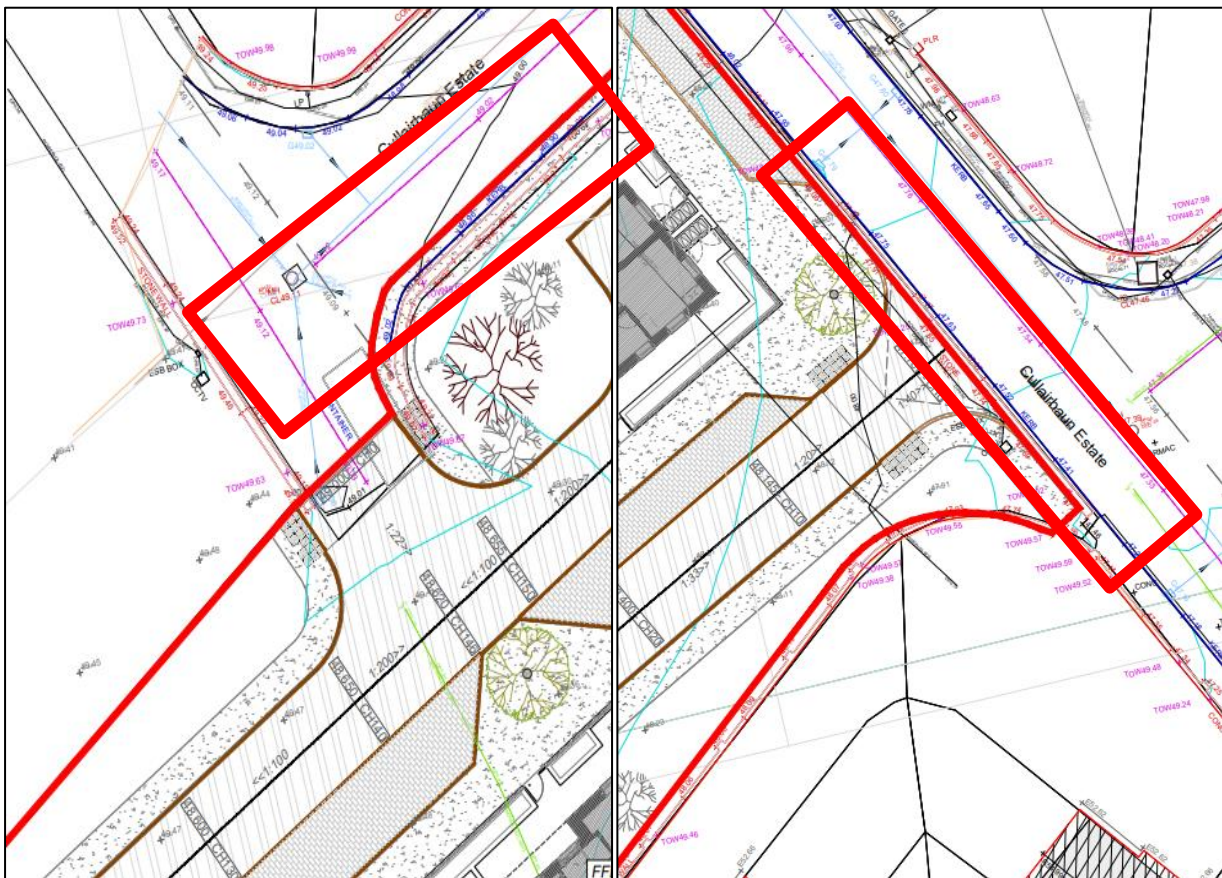
Problem No.01: Sightline Availability

Location: Proposed Development Entrances

The audit team note that there are no sightlines in the drawings provided to demonstrate that appropriate sightlines can be achieved when vehicles are exiting the development. The audit team is concerned that the appropriate sightlines cannot be achieved as boundary treatments and parked cars along the carriageway may obstruct visibility at the junctions. This could result in vehicles encroaching onto the main carriageway into the line of oncoming vehicles which could lead to sideswipe or side impact type collisions.

The design team should ensure that clear visibility is provided in both directions and that visibility envelopes are clear of any obstacles such as street furniture and boundary walls.

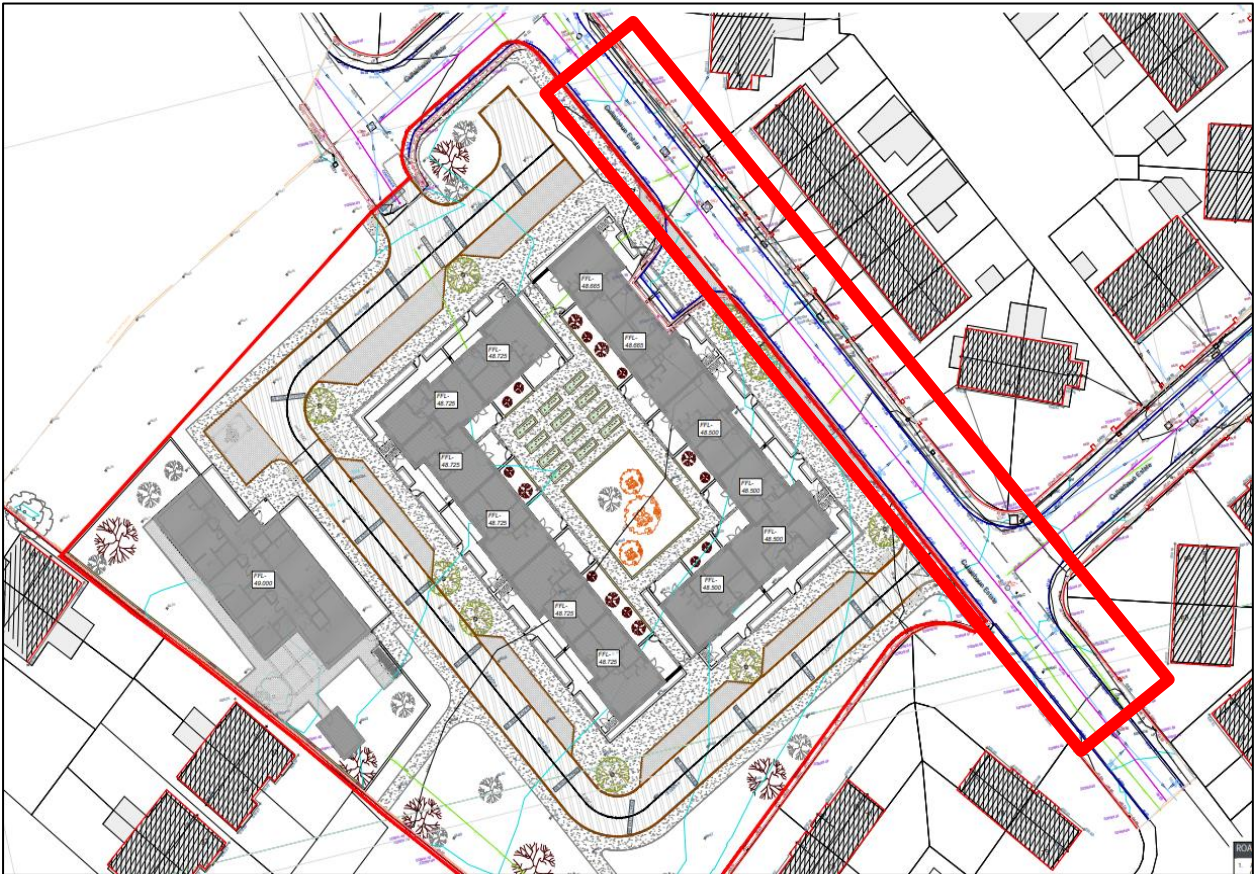
Problem No.02: Speed Control Measures

Location: Throughout the Scheme

The audit team note from the drawings provided, that there is a lack of speed control measures proposed within the scheme. The audit team are concerned that the layout as its currently presented could encourage higher speeds which could put vulnerable users within the development at risk. Should a collision occur there is a high risk of injury to the vulnerable user.

The design team should ensure that appropriate speed control measures are incorporated within the development to reduced vehicular speeds.

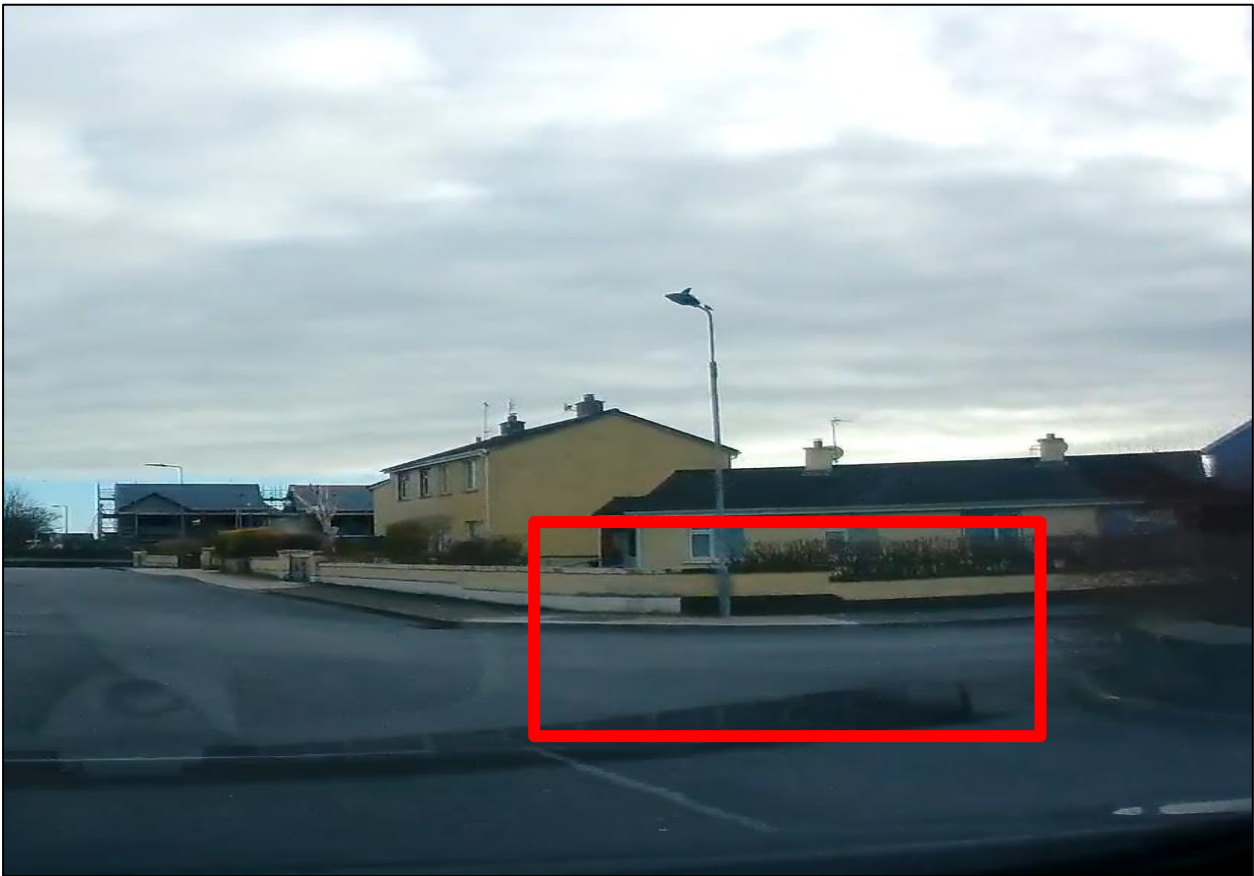
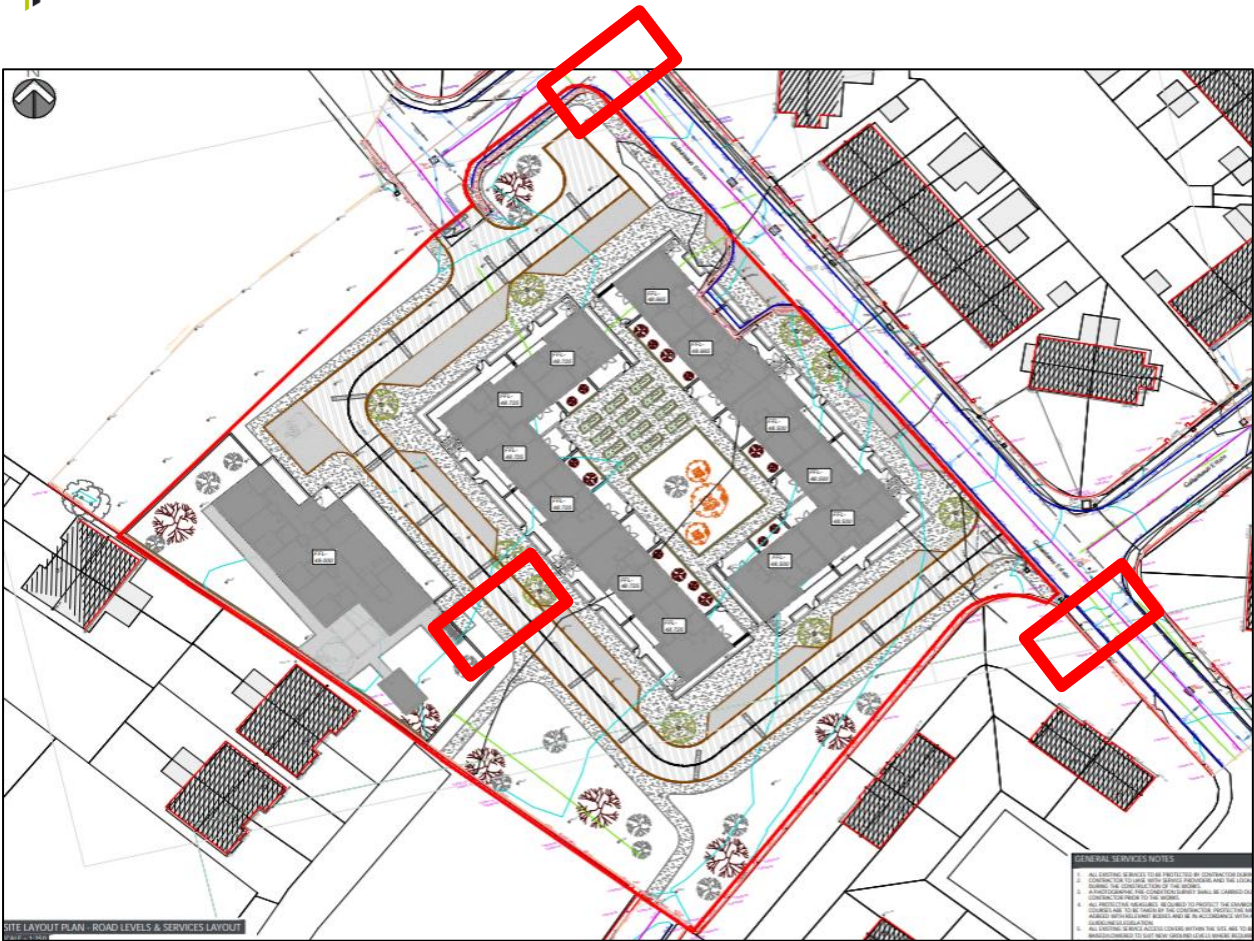
Problem No.03: Pedestrian Crossing and Desire Lines

Location: Internal Site Layout

The audit team have concerns regarding the location of the proposed pedestrian crossings within the development. Pedestrians are likely to cross the main road at the locations identified, as it aligns with their immediate crossing desire line. Also, the absence of a dedicated pedestrian crossings at these locations may present challenges for mobility-impaired individuals, potentially impeding their movement within the site. Furthermore, there's a risk of pedestrians making unsafe crossings, which could result in conflicts with vehicles or cyclists using the main road.

The design team should ensure that crossing points are provided along desire lines.

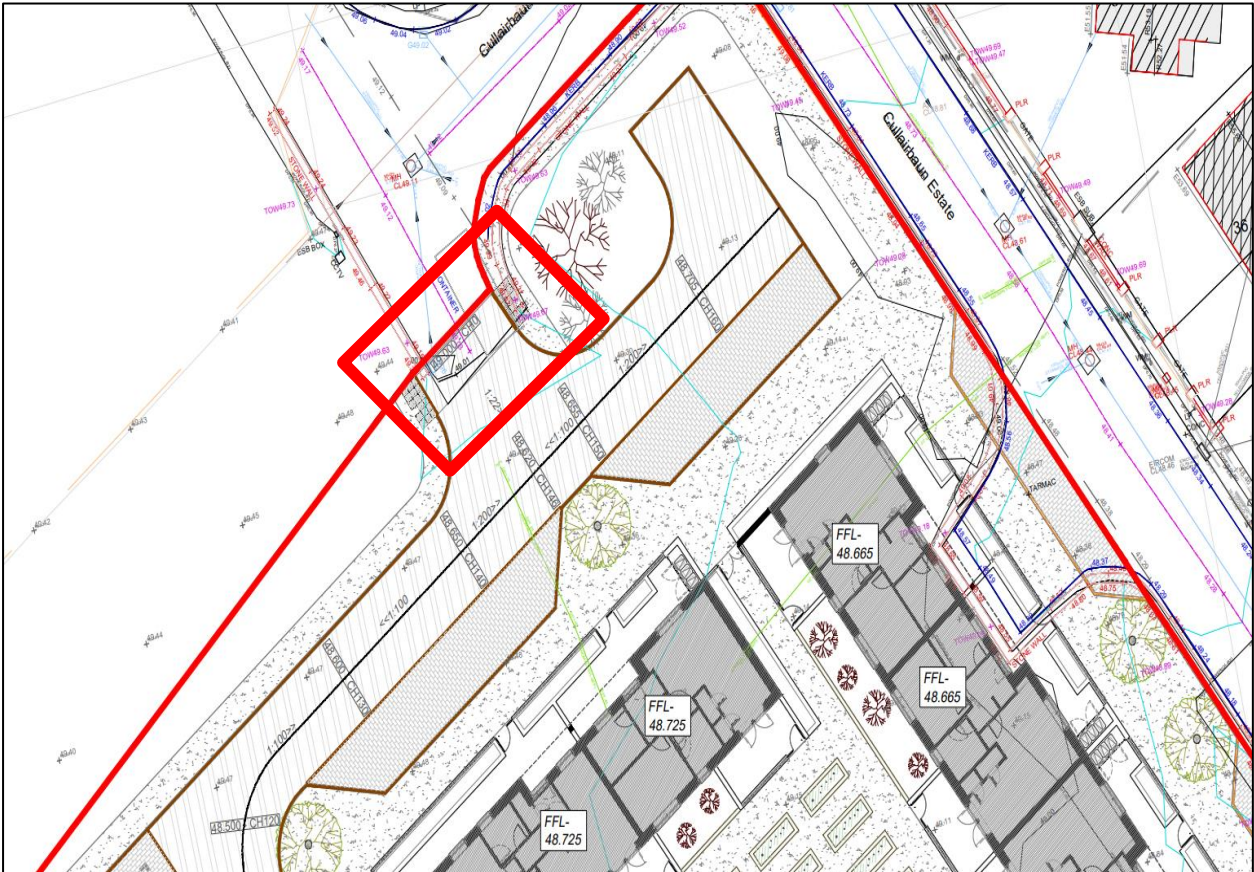
Problem No.04 Location of Uncontrolled Crossing

Location: Location Identified

The audit team note from the drawings provided that the proposed uncontrolled crossing appears to be on the sloped section of the raised table. This position of the crossing leads to an uneven surface particularly for mobility impaired pedestrians which could result in slips, trips and falls at the crossing location which could lead to injury.

The design team should provide the uncontrolled crossing at an appropriate location.

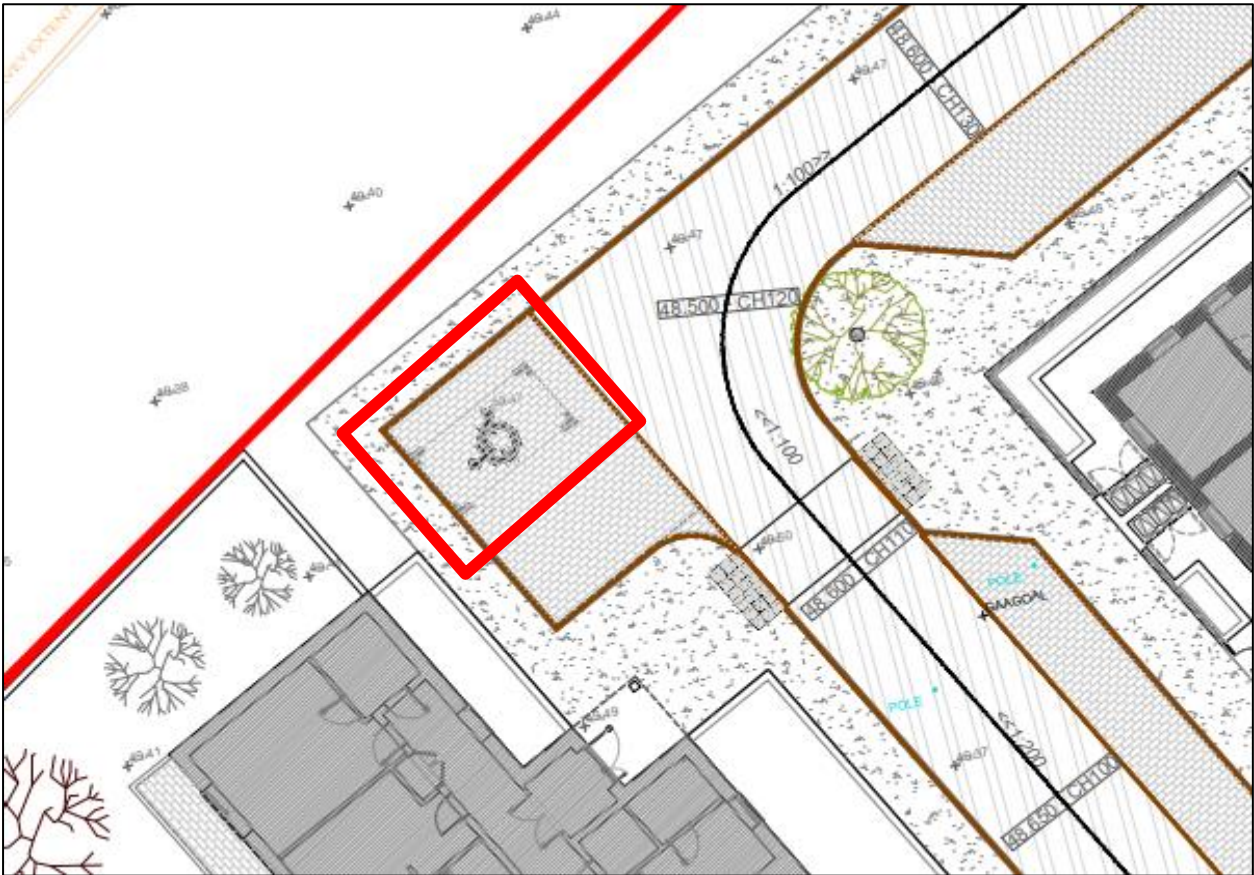
Problem No.05: Accessibility of Wheelchair Parking Space

Location: Disabled Parking Space Identified

The audit team note from the drawings provided, that there is a wheelchair accessible parking space provided within development. It is not clear from the drawings provided as to how users of this space will access the footpath and may have to use the roadway to access the nearest dropped kerb. Dropped kerbs should be provided at disabled parking spaces to allow accessibility for users.

The design team should provide details on the proposed access from the wheelchair accessible parking space to the footpath allowing for adequate level landings behind the dropped kerbing.

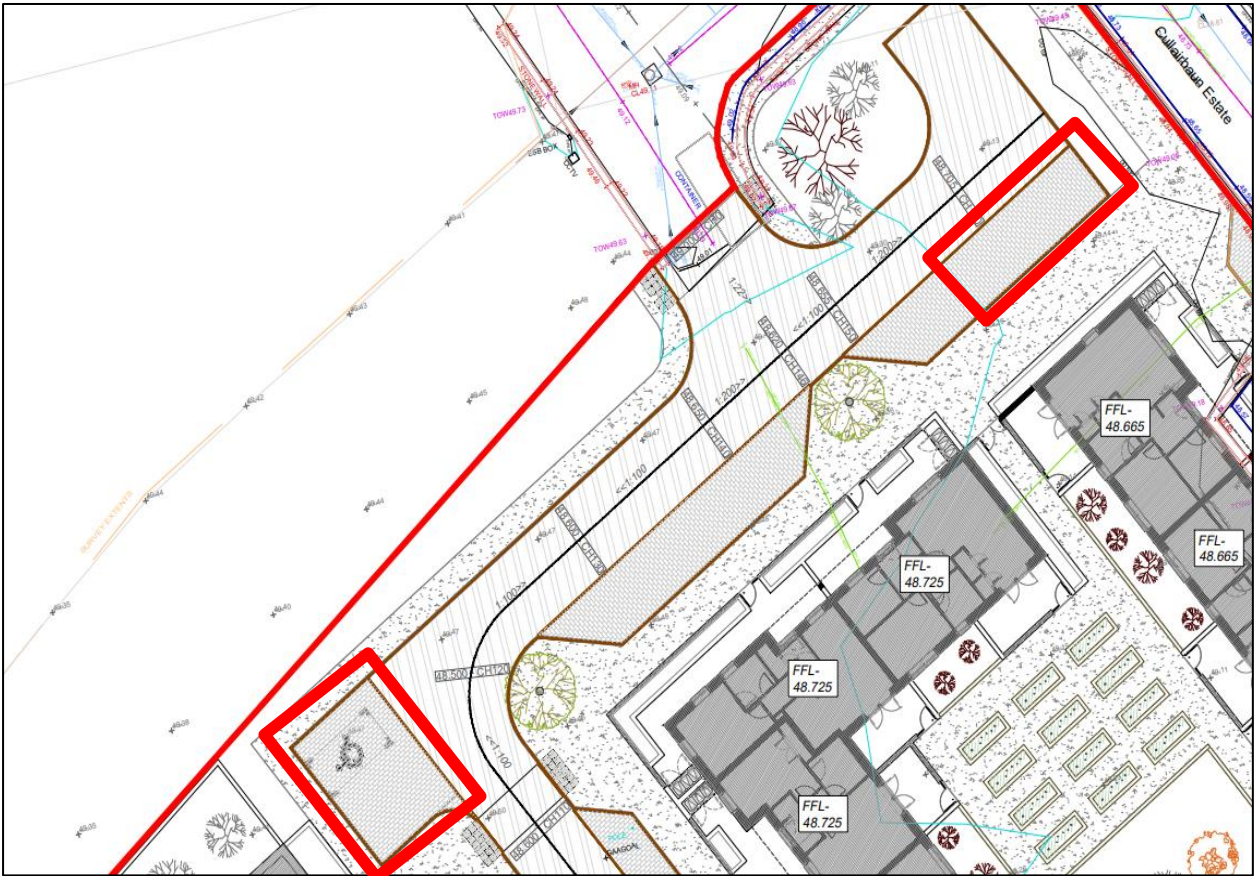
Problem No.06: Restricted Car Parking Spaces

Location: Location Identified

The audit team observes from the provided drawings that the parking spaces have limited manoeuvring space behind the bays, which may restrict vehicles from executing reverse manoeuvres effectively and turning onto the road. This constraint could increase the risk of conflicts between vehicles and vulnerable road users and vehicles entering the development, as drivers may need to reverse over extended distances to exit the spaces, thereby elevating the risk of collisions.

The design team should reassess the geometry of these parking spaces to address the identified safety risks and ensure that vehicles can safely manoeuvre in and out of the spaces.

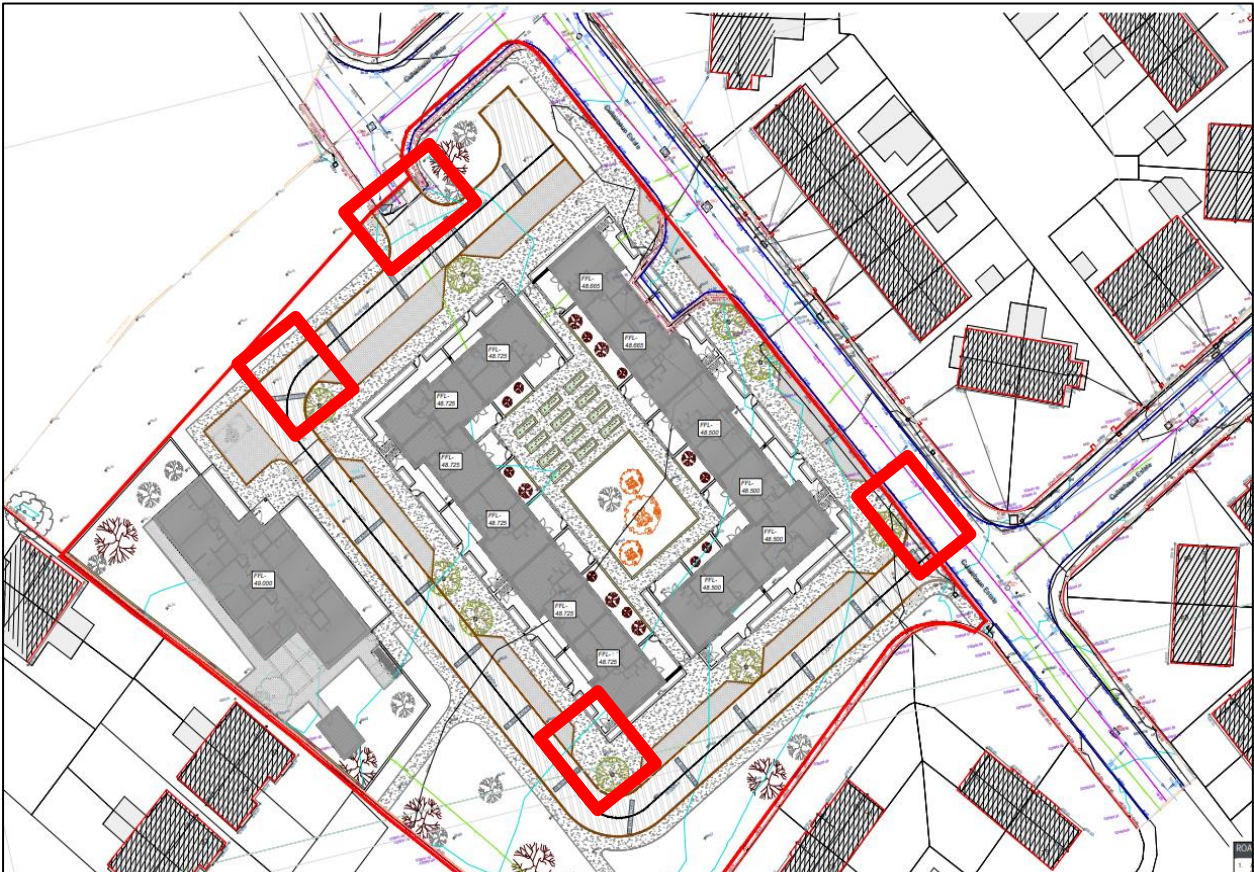
Problem No.07: Corner Radii within the Scheme

Location: Locations Identified

The audit team note from the drawings provided that the corner radii appear to be excessive which could increase the potential for higher vehicle speeds within the development. The audit team has concerns, that vehicles would not be encouraged to slow down and could result in collisions with vulnerable road users at the uncontrolled crossings.

The design team should ensure that the corner radii is appropriate for the design speed to slow vehicles down.

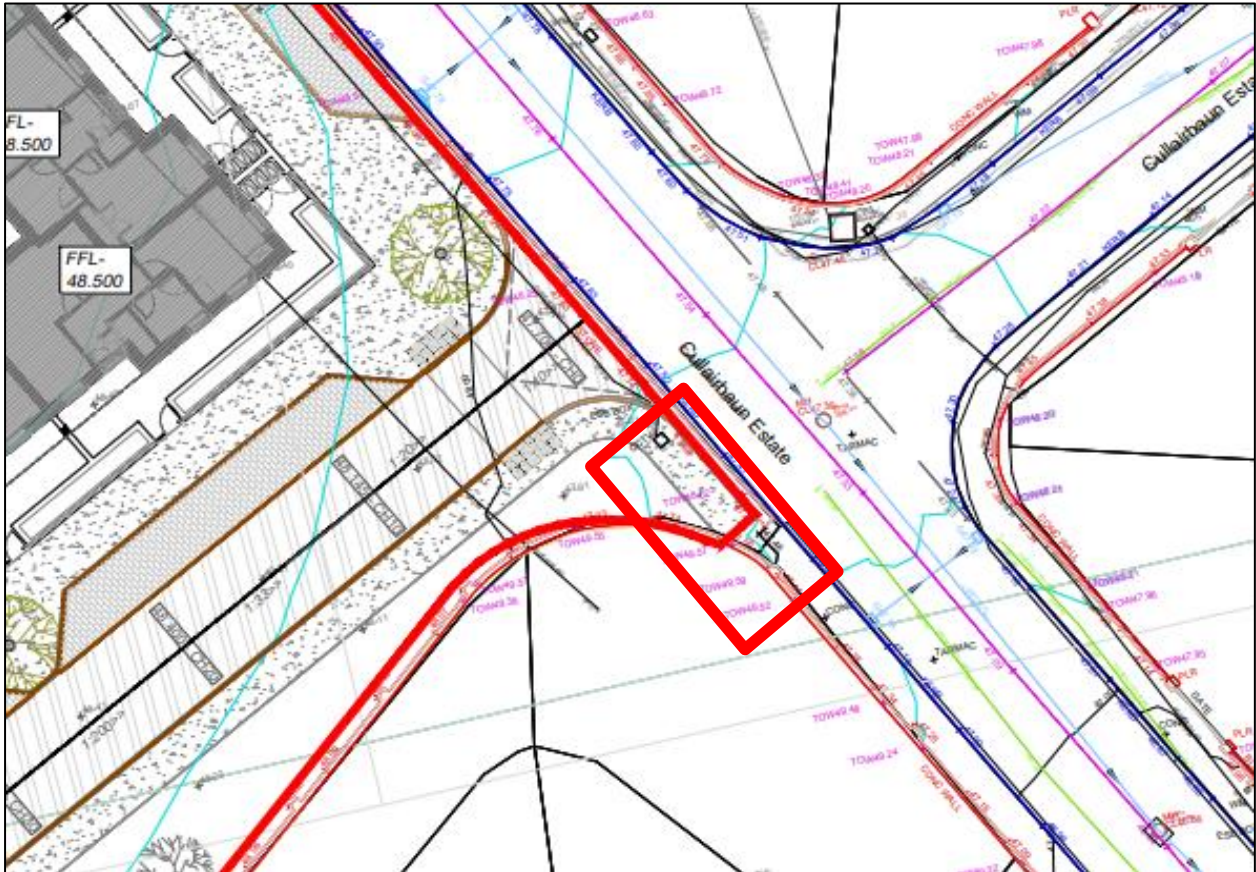
Problem No.08: Tie-in to Existing Footpath

Location: Site Entrance and Exit

The audit team note from the drawings provided that the existing footpath is narrower than the proposed. It is not clear how the existing and proposed footpaths are to tie in with each other. Lack of an appropriate tie-in to the existing footpath could lead to pedestrian confusion or trip and falls.

The design team should provide provision for appropriate tie-in to the existing footpaths.

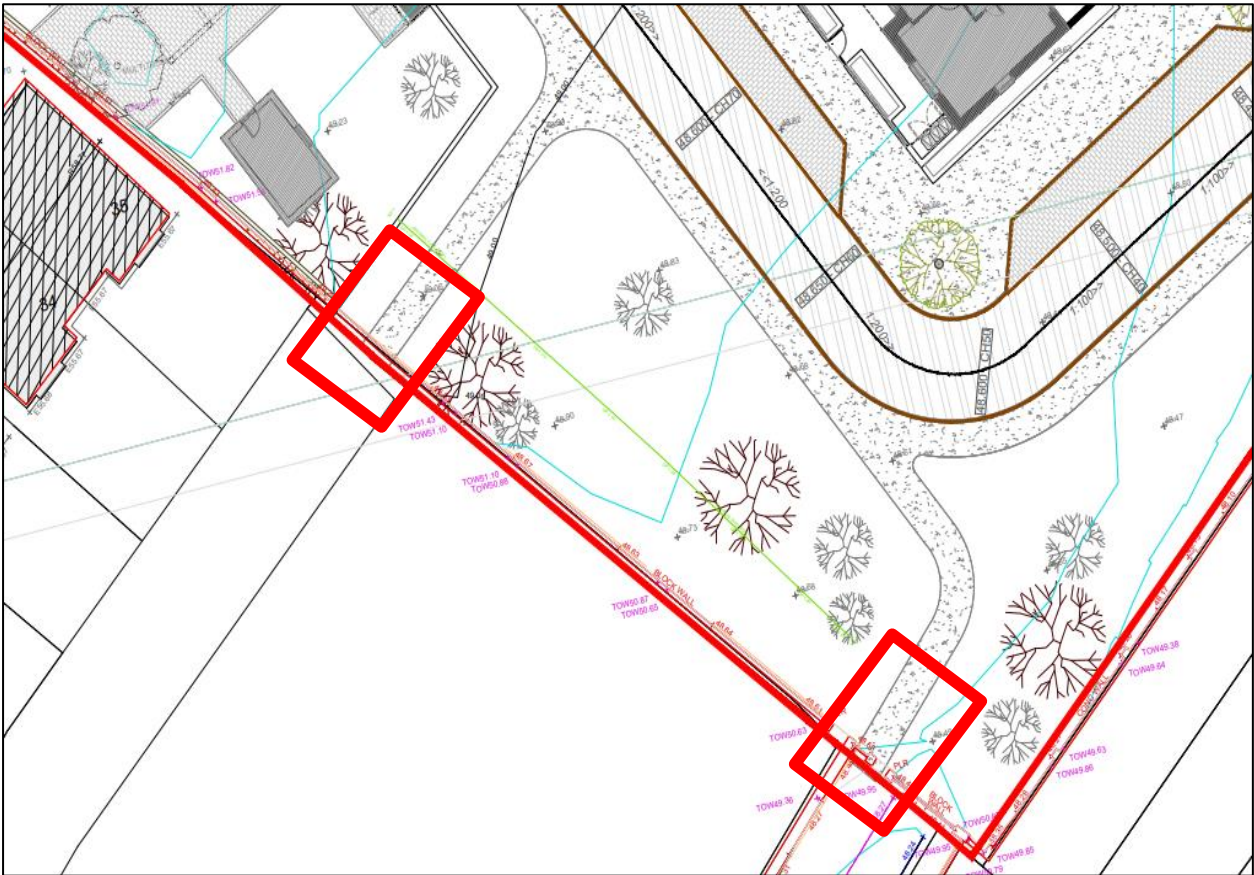
Problem No.09: Tie-in for New Footpath

Location: South of the Proposed Development

The audit team note from the drawings that the proposed footpaths terminate at the southern end of the site, however there is no existing footpath at these locations to tie into. Lack of tie-in to an existing footpath could lead to pedestrian confusion, who may enter the roadway to cross at a location without suitable pedestrian facilities. This has the potential to cause collisions between pedestrians and vehicles.

The design team should ensure that the proposed footpaths tie in with existing pedestrian infrastructure at these locations.

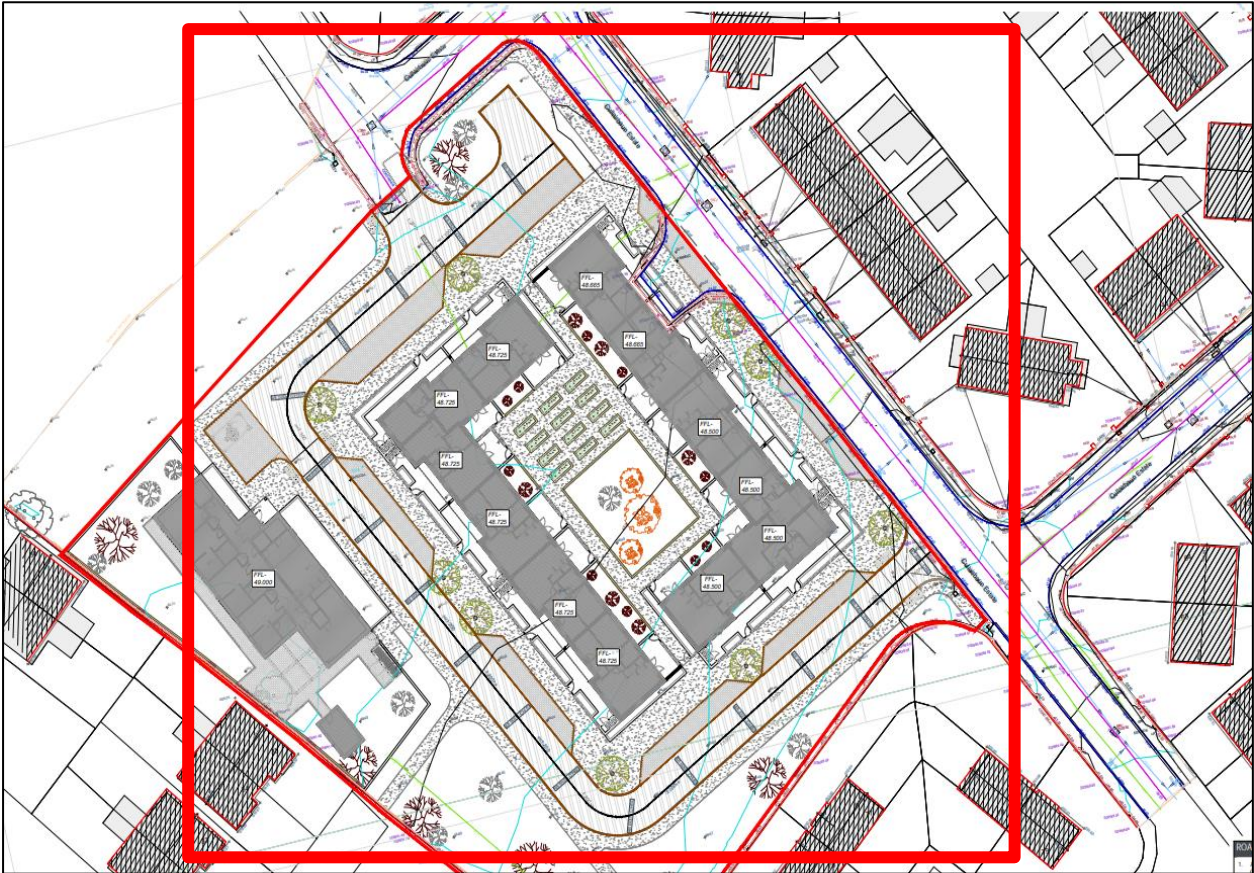
Problem No.10: Landscaping and Boundary Treatment

Location: Boundary of Scheme

The audit team note from the drawings provided, that there are parking spaces along the sides of the proposed development. If a vehicle must reverse out of these spaces and boundary treatments and landscaping if positioned incorrectly could hinder visibility. There could potentially be an increase in the number of collisions with pedestrians and/or side impact type vehicle collisions. This poses a significant risk of injury to pedestrians and vehicle occupants.

The design team should ensure that boundary treatments and landscaping do not hinder visibility for vehicles exiting these parking spaces. The design team should also ensure that landscaping does not restrict sightline availability at crossing points, junctions, and forward visibility for vehicles.
