Arboricultural impact Assessment

Galway County Council

Farrannamartin, Tuam, Co. Galway

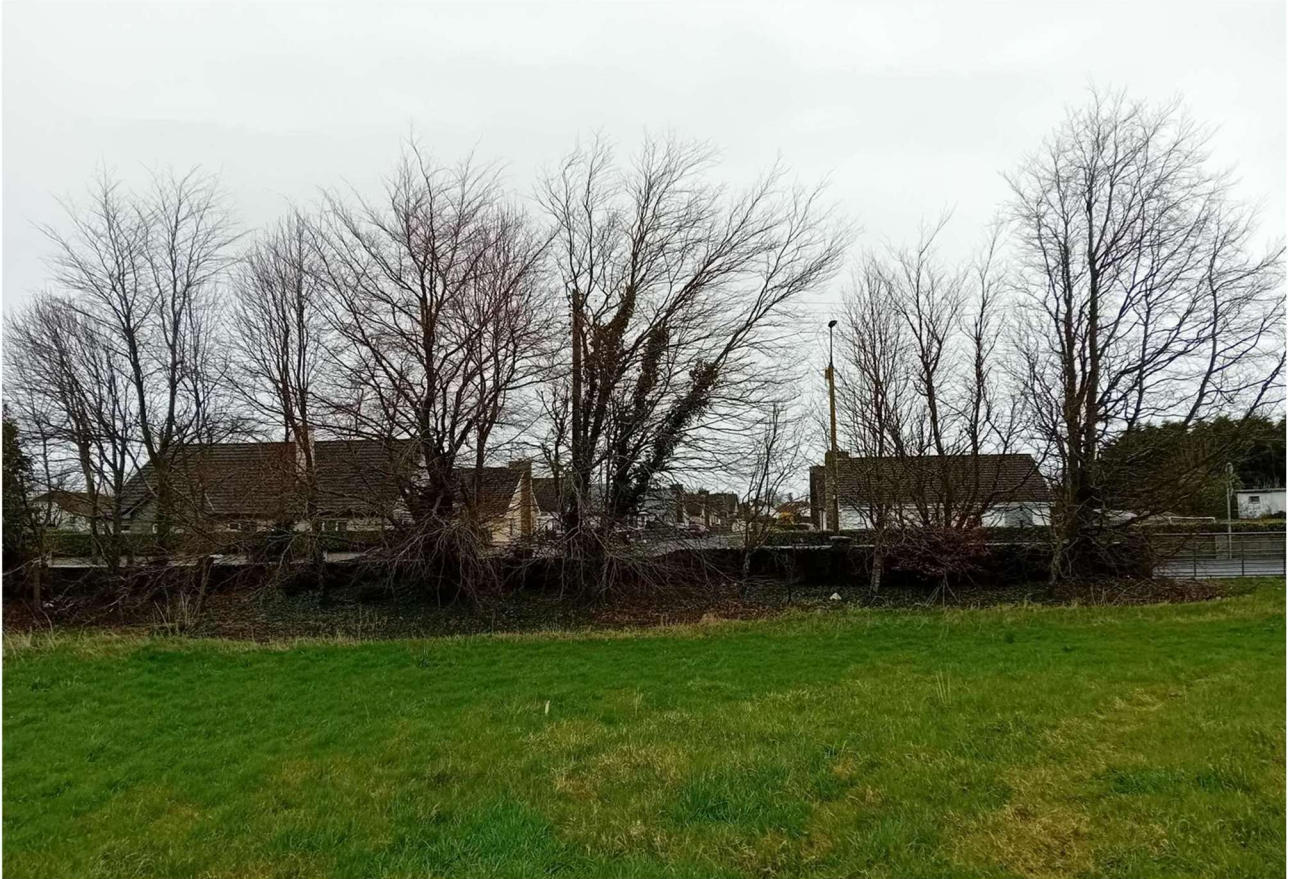
Front boundary trees that may require removal to allow for sightlines

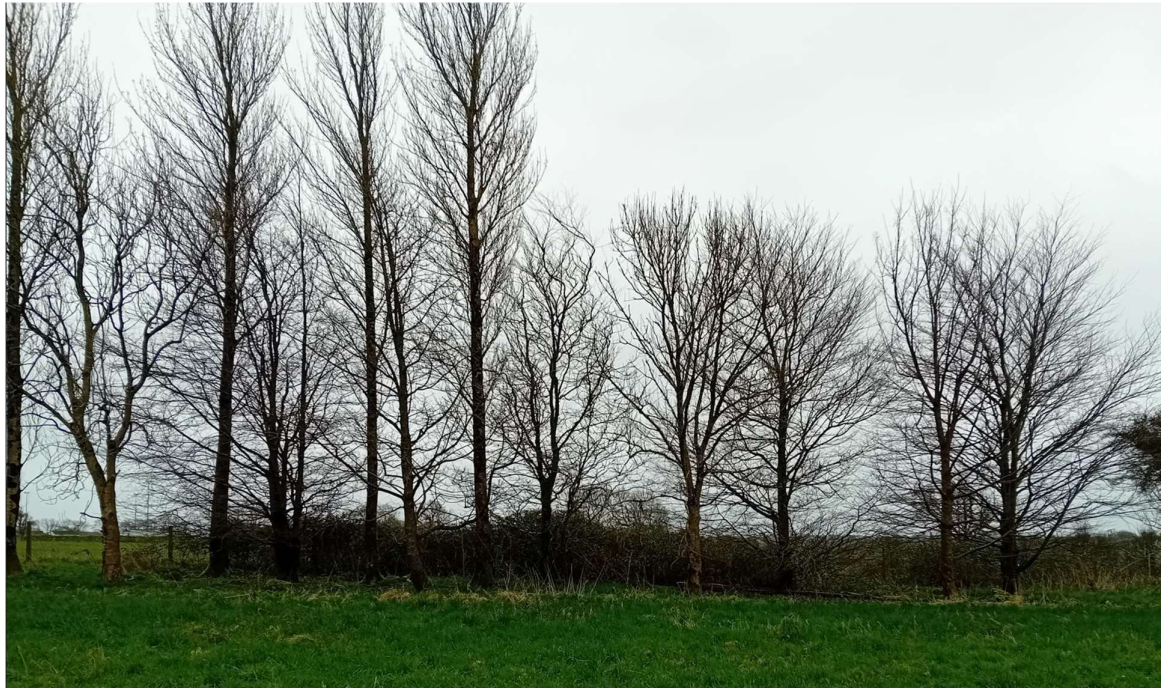
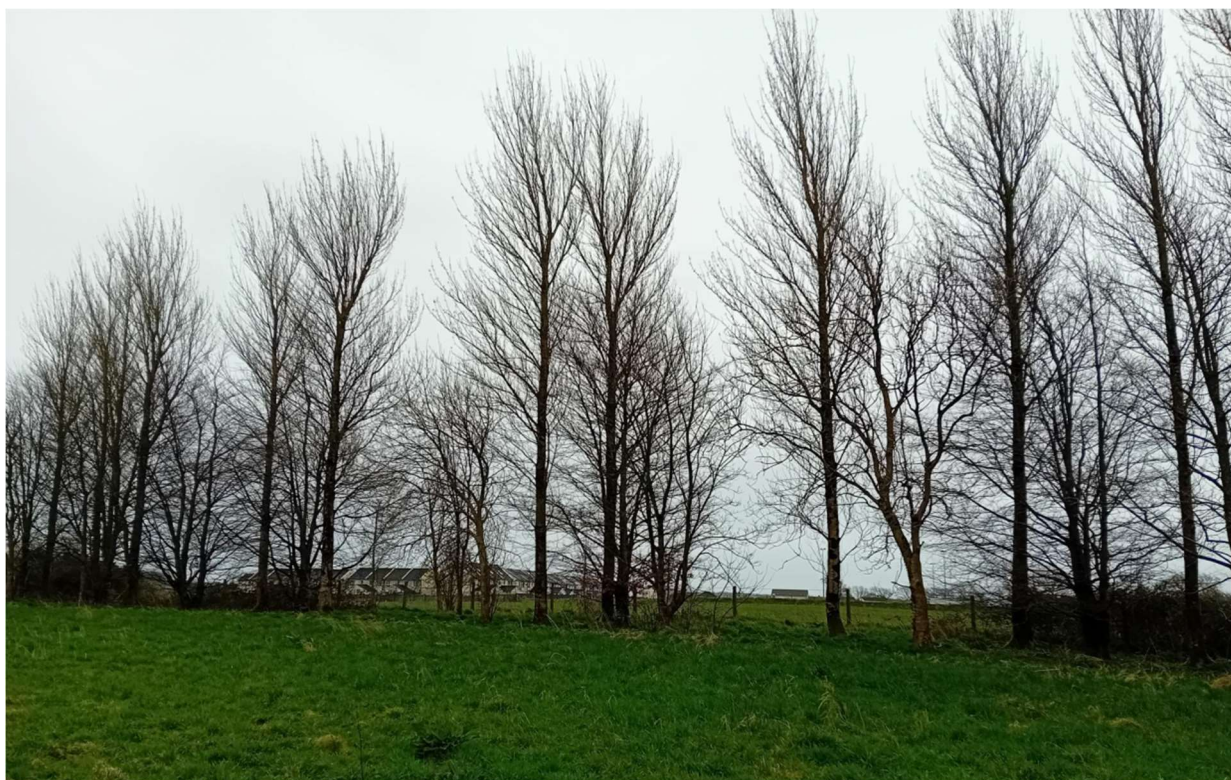
Rear boundary trees that provide good screening, it is advised to remove the larger Poplars trees

Tree line 2	Beech Poplar Ash Maple	M	280	16	N=2 S=2 E=2 W=2	1	Good	A mature tree line located along the rear boundary, it is recommended to remove the Poplar and retain the understorey of beech	Remove the Poplar and ash	Retain beech	B2	3.8m
Tree line 3	Sycamore Beech Ash	M	250	10	N=3 S=3 E=3 W=3	2	Good	A mature mixed tree line displaying a good overall condition	Remove to facilitate a boundary wall	Remove	C2	
Tree line 4	Sycamore Beech Ash	M	250	8	N=3 S=3 E=3 W=3	1	Good	A mature mixed tree line displaying a good overall condition	Remove to facilitate a boundary wall	Remove	C2
