## **TREE SURVEY**

**Mountain Road,  
Moycullen,  
Co Galway.**

**December 2020**

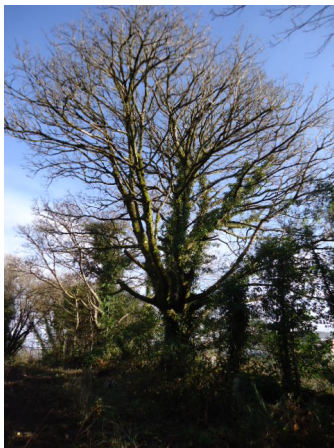
T555 – this tree appears to be in direct conflict with proposed new development.

| Tag | Species | Height (m) | Crown Spread (m) N/S/E/W | Dia' (mm)@ 1.5m | RPA circle radius (m) | Ht of lowest branch (m) & direction of growth | Life Stage | Estimated remaining contribution (years) | Physiological Condition | Structural Condition | Preliminary management recommendations | Category of retention + sub-category | Notes / GPS Location |
|---|---|---|---|---|---|---|---|---|---|---|---|---|---|
| 555 | Acer pseudoplatanus | 11 | 5/5/5/5 | 800 | 9.60 | 2m all | MA | 40+ | Good | Fair | Remove Ivy | A1 | |

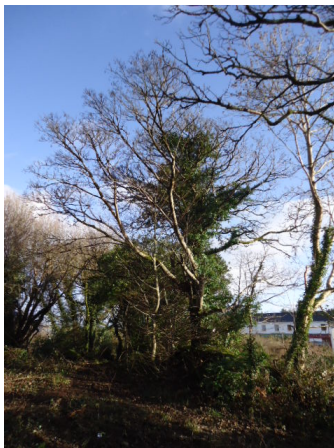
T557 – this tree appears to be in direct conflict with proposed new development.

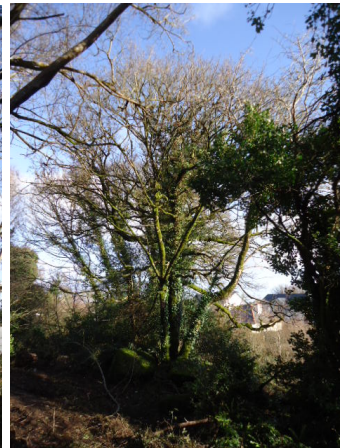
T558 – this tree appears to be in direct conflict with proposed new development.

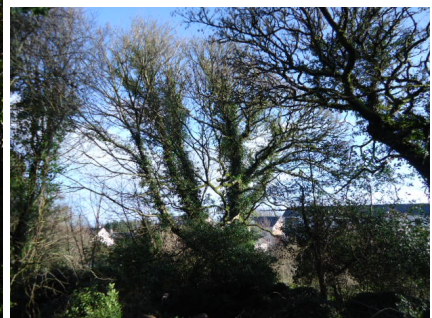
Particular care will be required around T559 the RPA of which extends into the site but area, however its retention is deemed possible as the majority will be within a planned greenspace. It is essential however that the area be protected as indicated on Tree Protection Dwg No 18401/T/103 Rev A.

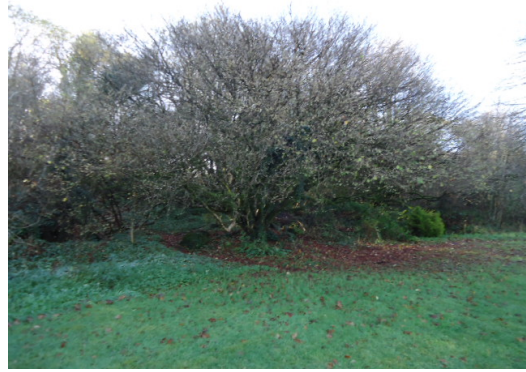
T562

| Tag | Species | Height (m) | Crown Spread (m) N/S/E/W | Dia' (mm)@ 1.5m | RPA circle radius (m) | Ht of lowest branch (m) & direction of growth | Life Stage | Estimated remaining contribution (years) | Physiological Condition | Structural Condition | Preliminary management recommendations | Category of retention + sub-category | Notes / GPS Location |
|---|---|---|---|---|---|---|---|---|---|---|---|---|---|
| 562 | Alnus glutinosa | 6 | 6/6/6/6 | 150x10 | 5.70 | 0m all | MA | 40+ | Good | Fair | | A1 | |

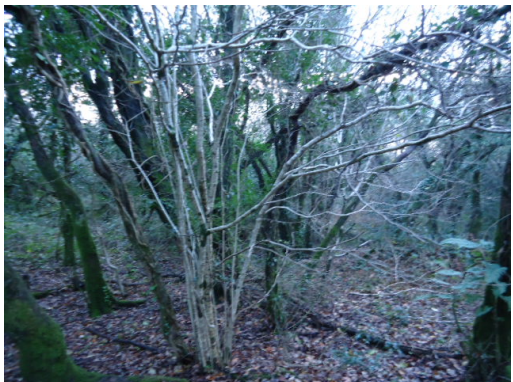
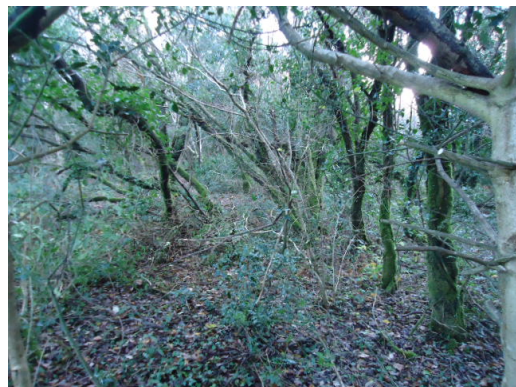
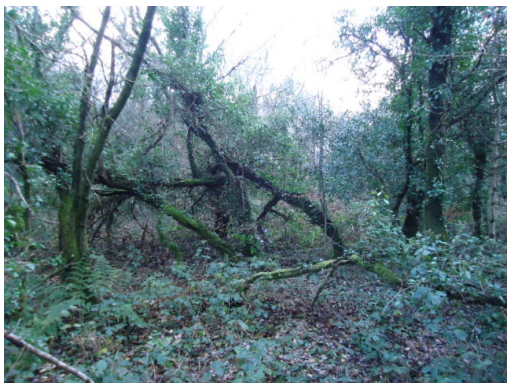
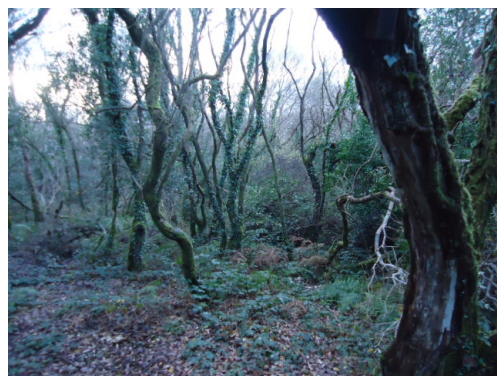
TG1 typical

Tree Group 1 – this group appears to be in direct conflict with proposed new development.
