Stage 1/2 Road Safety Audit

**Proposed Affordable Housing Development at
Raheen, Athenry**

On behalf of **Galway County Council**

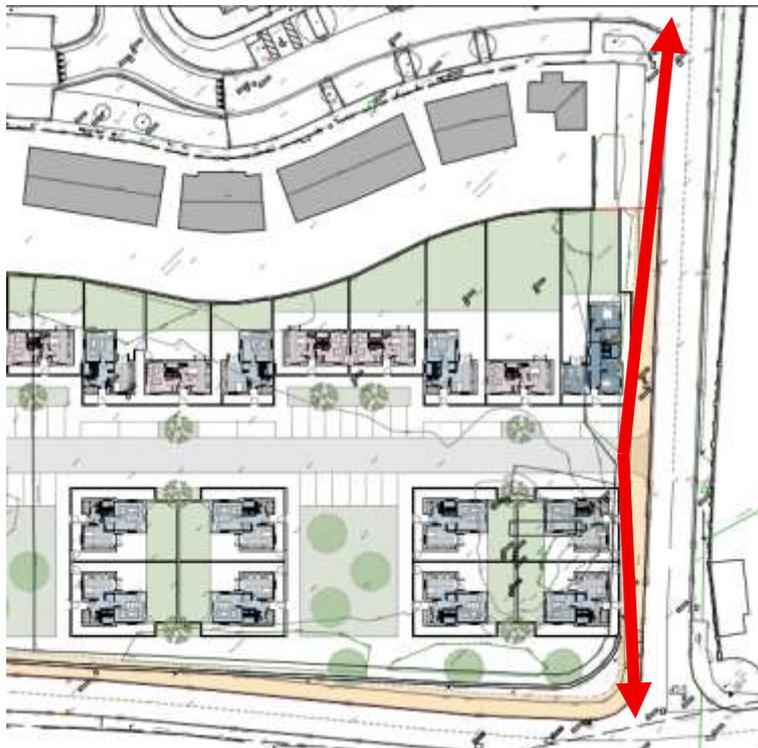
4.1.1 Development Junction (1)

Problem: The development junction is located between the L3103 and the existing Gort Mhaoilir residential development junction to the north-east. There is concern users may exit the development into the path of traffic who have just turned off the L3103.

Hazard: Vehicle / vehicle impacts may result.

Recommendation: The Design Team should ensure the junction visibility from the proposed junction in both directions is suitable for the approaching traffic speeds. Reference to DMURS should be made in this regard.

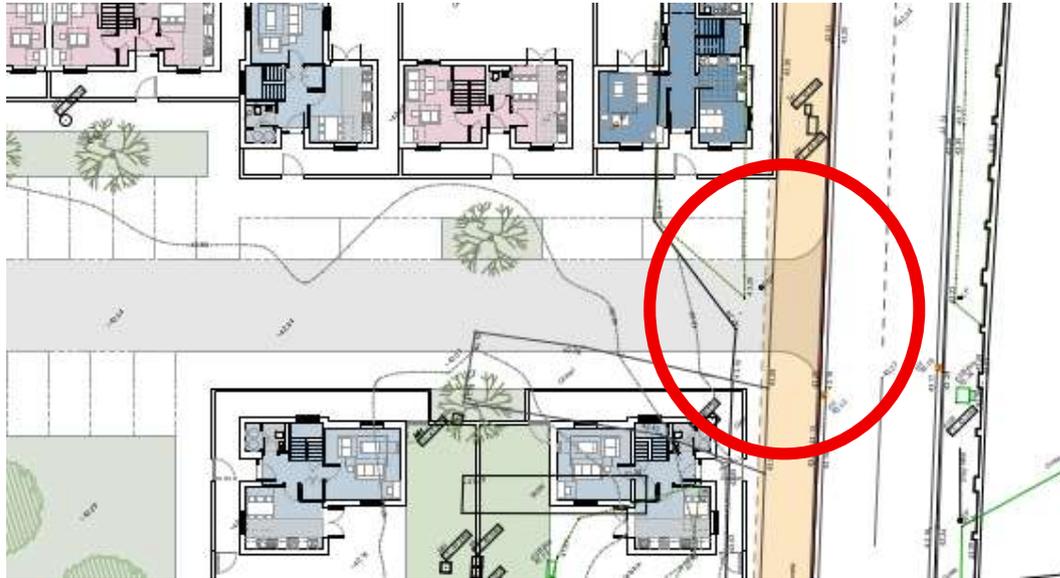
4.1.2 Development Junction (2)

Problem: The drawings indicate the footpath to the front of the development is to be widened, possibly for shared use by pedestrians and cyclists. At the same time the development access road crosses this path. It is not clear from the drawing which of these users is to be offered priority here.

Hazard: Development traffic may impact with crossing pedestrians and/or cyclists.

Recommendation: The Design Team should ensure suitable priority is clearly signed for one of the user groups, together with suitable junction visibility between motorists and non-motorised users.

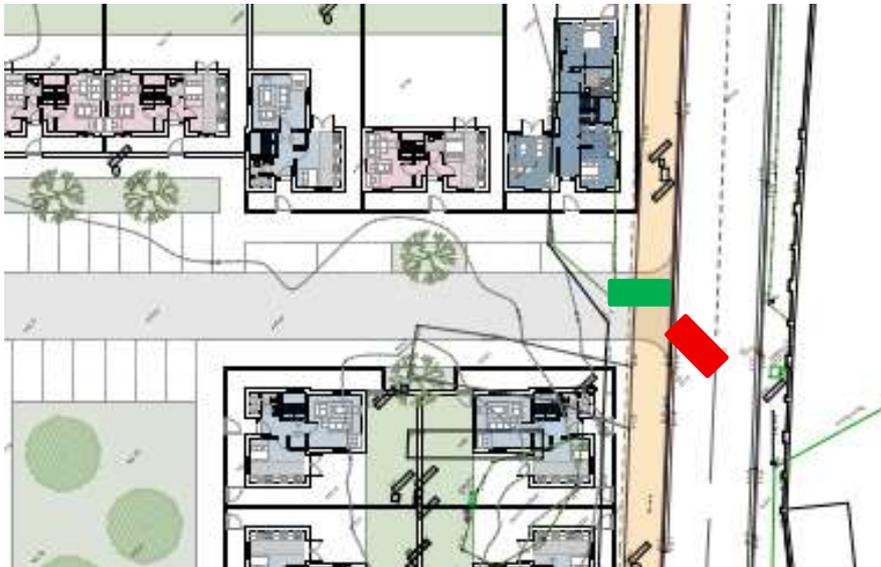
4.1.3 Entrance Junction – Swept Path

Problem: The development junction appears to be tight for entering vehicles turning left. There is concern these users may cross the centre of the development road.

Hazard: Impact with exiting traffic, possibly cyclists may result.

Recommendation: The Design Team should undertake swept path analysis and redesign the junction if required.

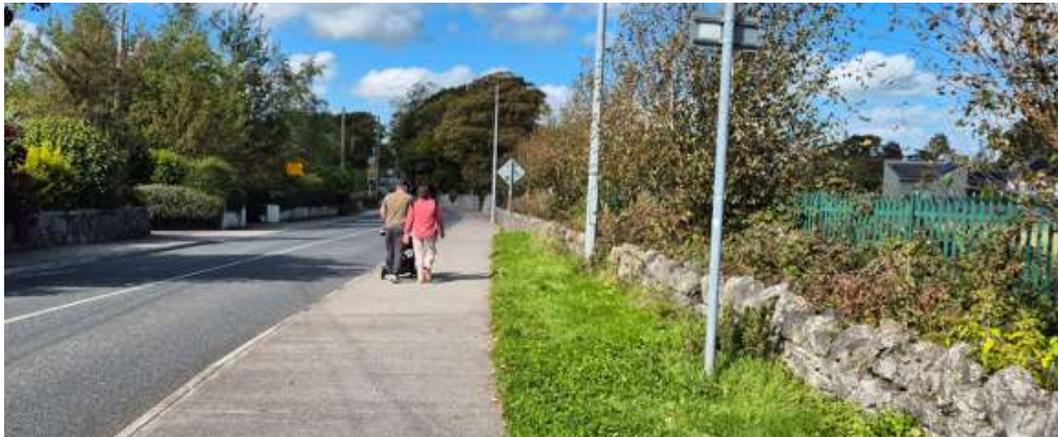
4.1.6 Shared Use Path

Problem: The proposals indicate widening of the existing footpath on the L3103. This may be intended to be used for sharing with cyclists. The path suddenly reduces in width and ties with the existing narrow footpath to the north-western end of the development lands.

Hazard: Cyclists may continue to cycle on the narrow footpath and impact with pedestrians.

Recommendation: The Design Team should provide a safe transition such that cyclists are guided to join the L3103 carriageway.

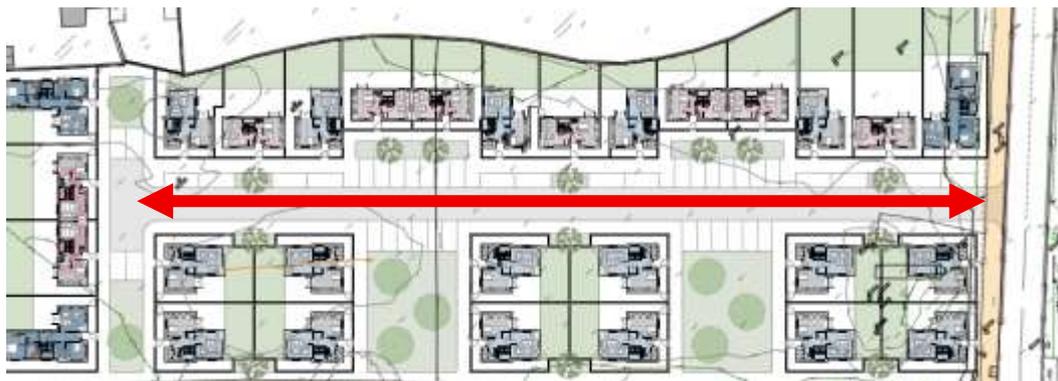
4.1.7 Development Road Alignment

Problem: The development includes a long and straight carriageway. Such carriageways have a poor record of high vehicle speeds.

Hazard: Crossing pedestrians may be subject to high-speed vehicle impacts.

Recommendation: The Design Team should provide physical features to ensure vehicle speeds are slow.

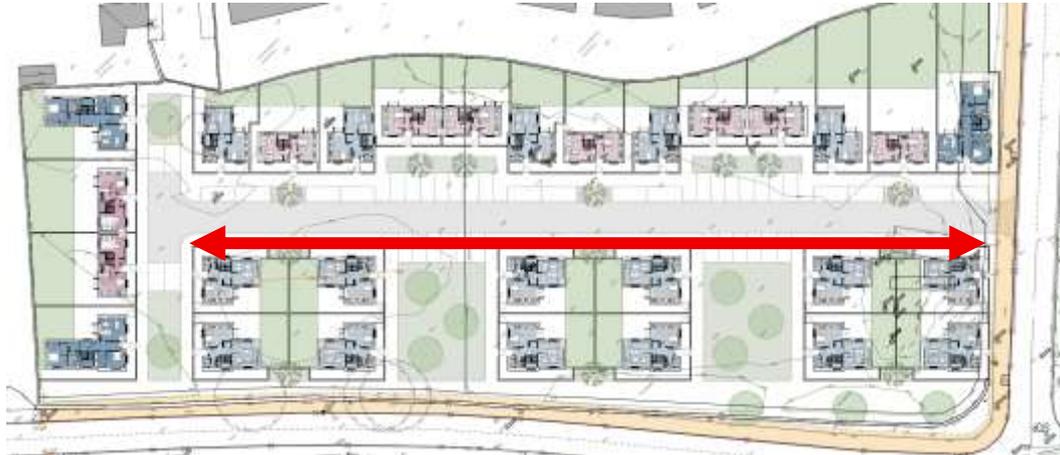
4.1.8 Pedestrian Desire Lines

Problem: Pedestrians walking from the development entrance through to the rear of the site have their desire line interrupted by vehicle parking bays and green areas. The pedestrian may decide to walk in the carriageway in order to take the shortest route to their desired destination.

Hazard: Pedestrian / vehicle impacts may result.

Recommendation: The Design Team should amend the layout in order to provide a direct yet safe route for these pedestrians.

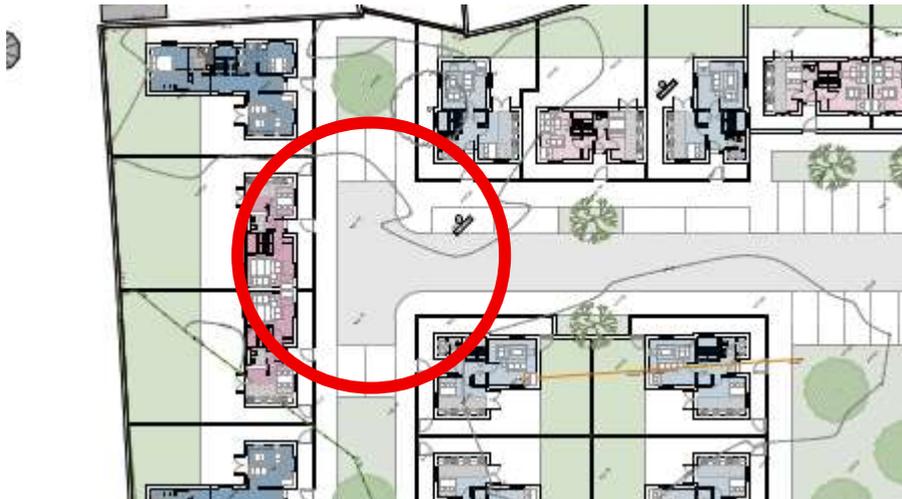
4.2.1 Turning Head

Problem: The turning head appears small. Large vehicles including the refuse collection vehicle may have difficulty in turning within the space provided. The vehicle may be required to reverse back to the nearest road junction.

Hazard: Impact with other road users or crossing pedestrians may result.

Recommendation: The Design Team should ensure the turning head is of sufficient size for turning of all anticipated vehicles.
