Report to Accompany ABP Application (177AE)

River Maintenance Works at Rossaveel Sports Grounds

Sept 2023

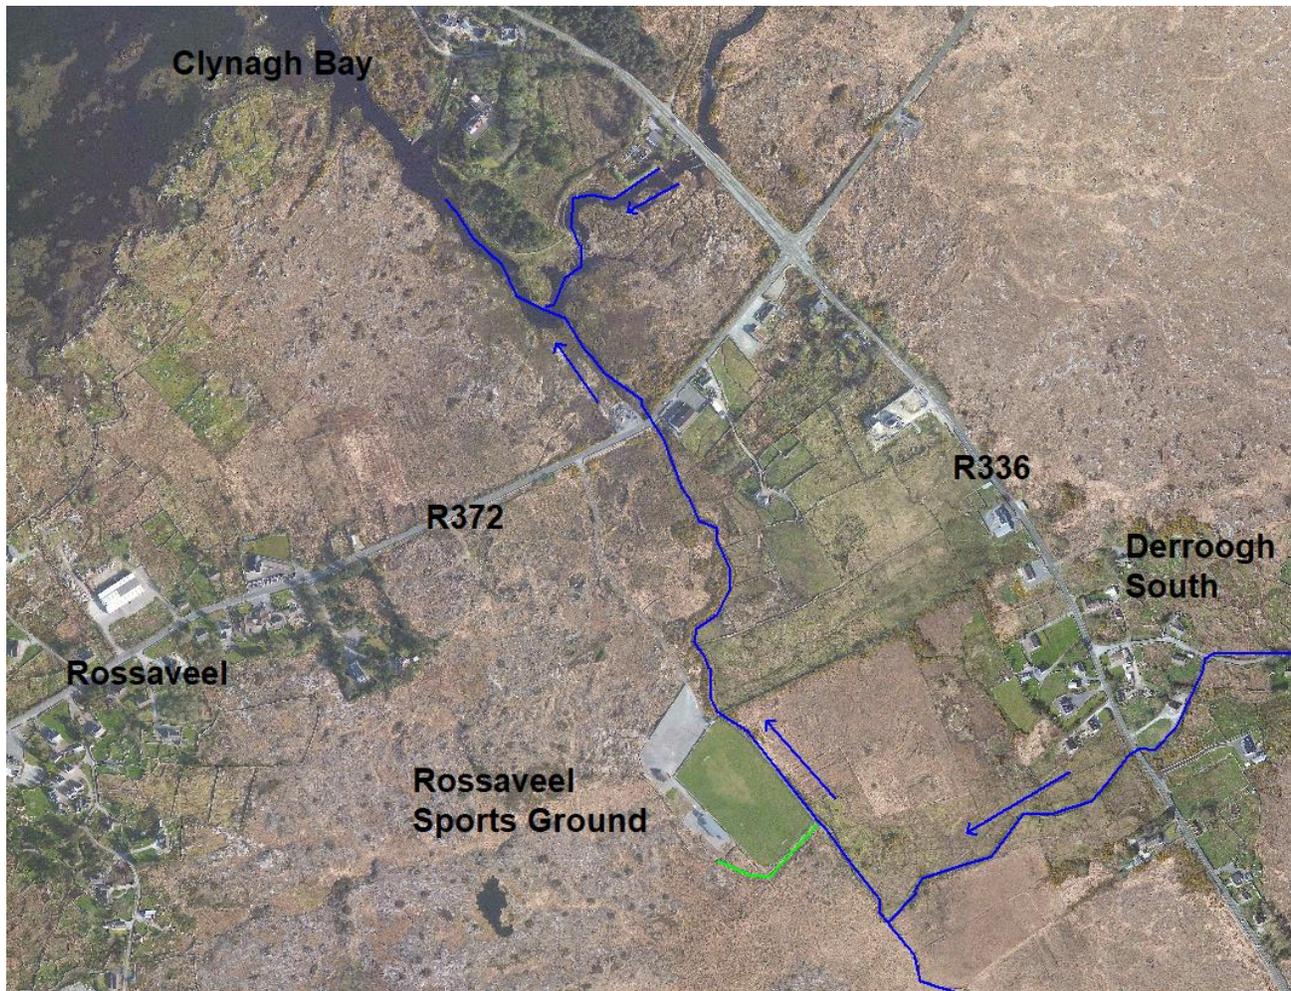
Fig 2 Site Layout Plan

Two rivers, from Derroogh South and Loch an Iolra merge 150m upstream of the sports ground travel along the pitch to Clynagh Bay approximately 500m away to the highwater mark. A section of the stream has become completely overgrown downstream of the pitch resulting in water backing up in the stream, flooding the pitch and damaging it. Existing open drains have been constructed around the pitch to ensure it is dry and playable.

- Existing rivers and streams
- Existing open drain

The stream passes under the Rossaveel Bridge on the R372 on its way to the bay which has a 2.4m span and 2.2m high arch and is of sufficient capacity for the volumes of water in the stream. This report includes photos of the flooding at the location and details of proposed mitigation works. Fig 2 shows the location of the Sports Ground close to the village of Rossaveel.

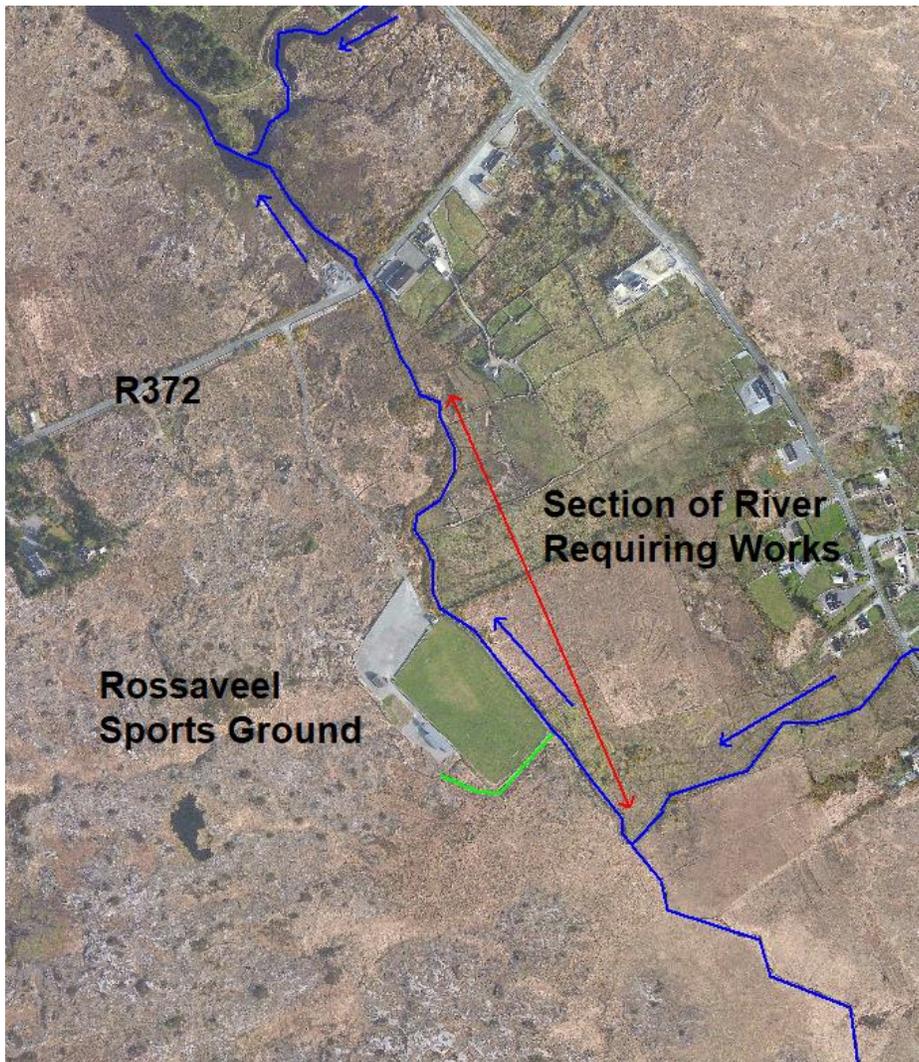
Fig 3 Extent of Works

The works are to include the removal of vegetation and blockages from the river from the point where the two rivers merge to a point downstream of the sports ground, a total distance of approximately 550m, as shown in Fig 3 below. From there the river is clear and is in a straight line to the sea. The land is soft bog with rock outcrops and some regrading and removal of rock will be required to ensure a constant unrestricted fall away from the sports ground.

Works are to be carried out by a mini digger and operatives with chainsaws and in strictly in accordance with the OPW Environment Management Protocols and Standard Operating Procedures. The mitigation measures outlined in the enclosed Natura Impact Statement (NIS) are to be adhered to also.

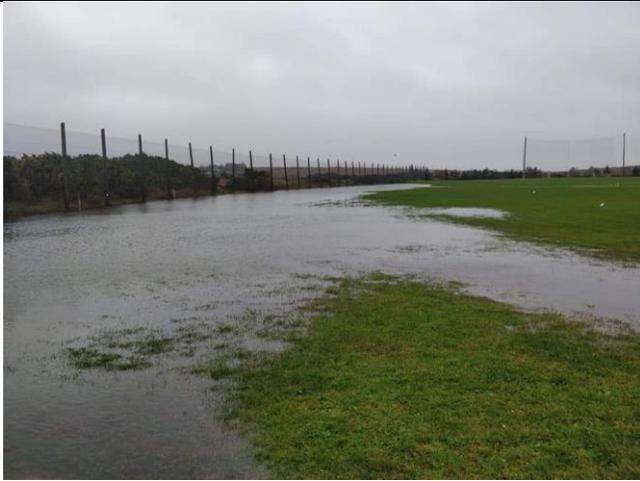
Flooding at the Sports Field in Rossaveel. The stream requiring works runs along the pitch, approximately 5m outside the fenceline shown.

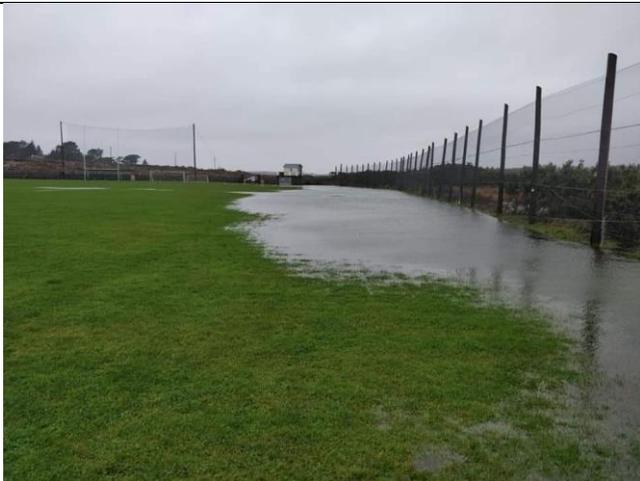
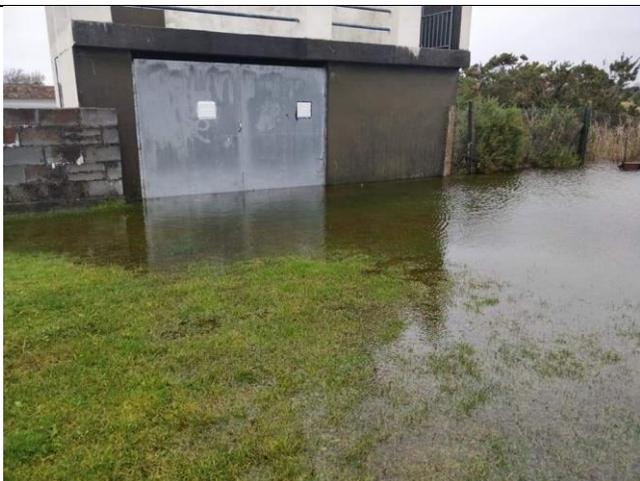
Flooding of the storage shed at the Sports Field in Rossaveel.

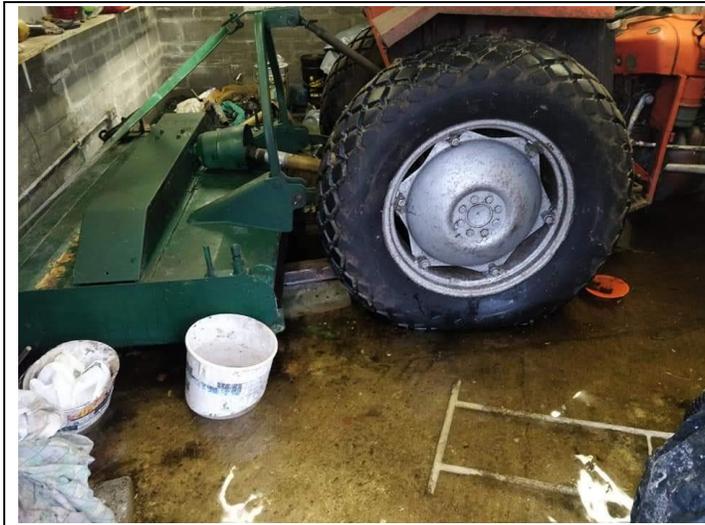
Flooding of the storage shed at the Sports Field in Rossaveel damaging equipment.

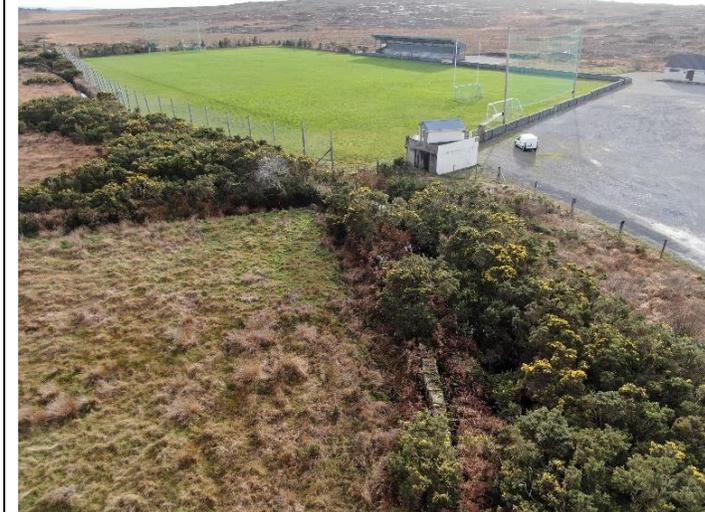
View of the Sports Field showing the area of the stream requiring cleaning works in the foreground.

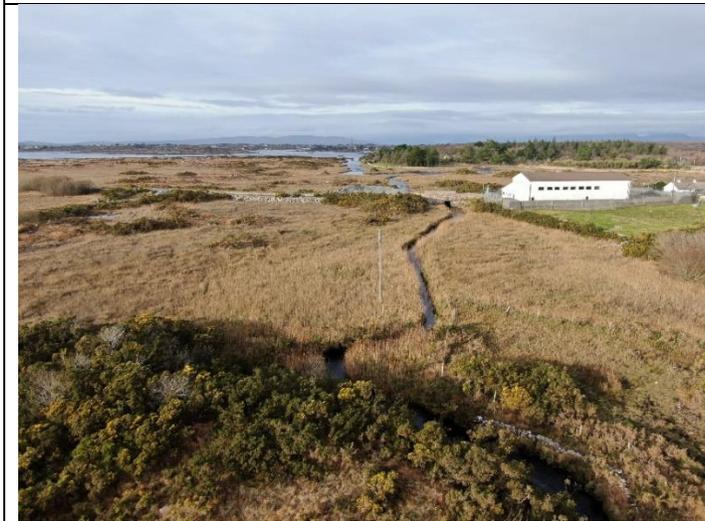
Downstream view of the river to Rossaveel Bridge and the bay showing no works being required.

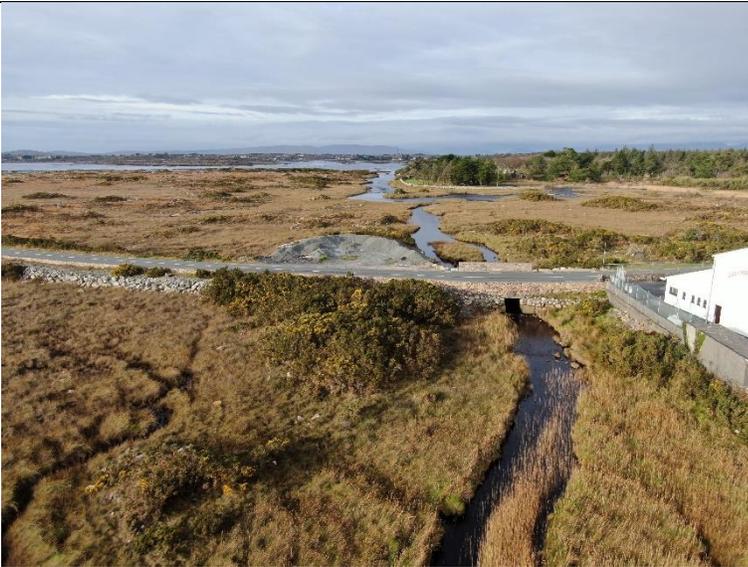
Downstream view of the river to Rossaveel Bridge and the bay showing no works being required.

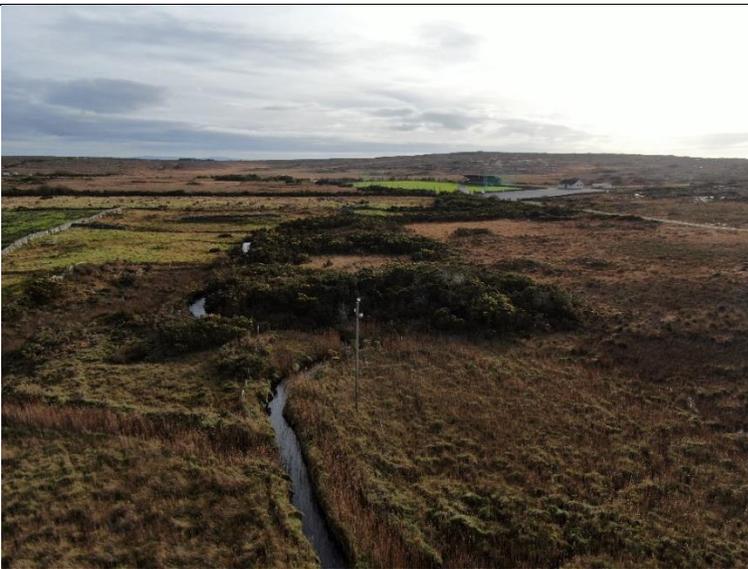
Upstream view of the river from the R372 to the sports ground

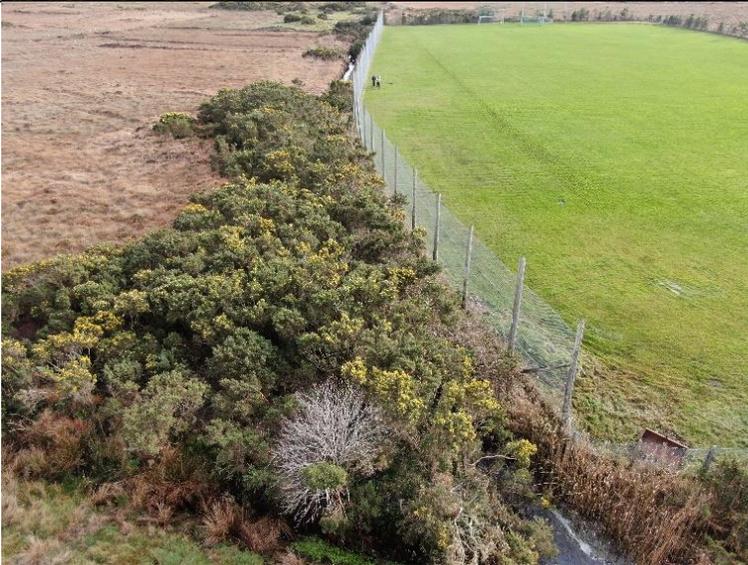
Upstream view of the river running along the pitch requiring cleaning works.
