*Bat Inspection Survey*

*“It is proposed to construct 4 no. new housing units at Moylough. 2 no. 3 bed X 2-storey terrace units and 2 no. 2 bed apartment units. It is proposed to demolish the existing structure with the exception of the street front (North) façade. Moylough is 5 km northwest of Mountbellew and 50 km from Galway. It is located on the N63 national secondary road and is also served by the R328 and R364 regional roads. This proposal represents an ideal infill opportunity within the village confines of the 50 kph speed limit zones whilst the land benefits from direct access onto the R360.”*

*Moylough, Co. Galway*

*Galway County Council*

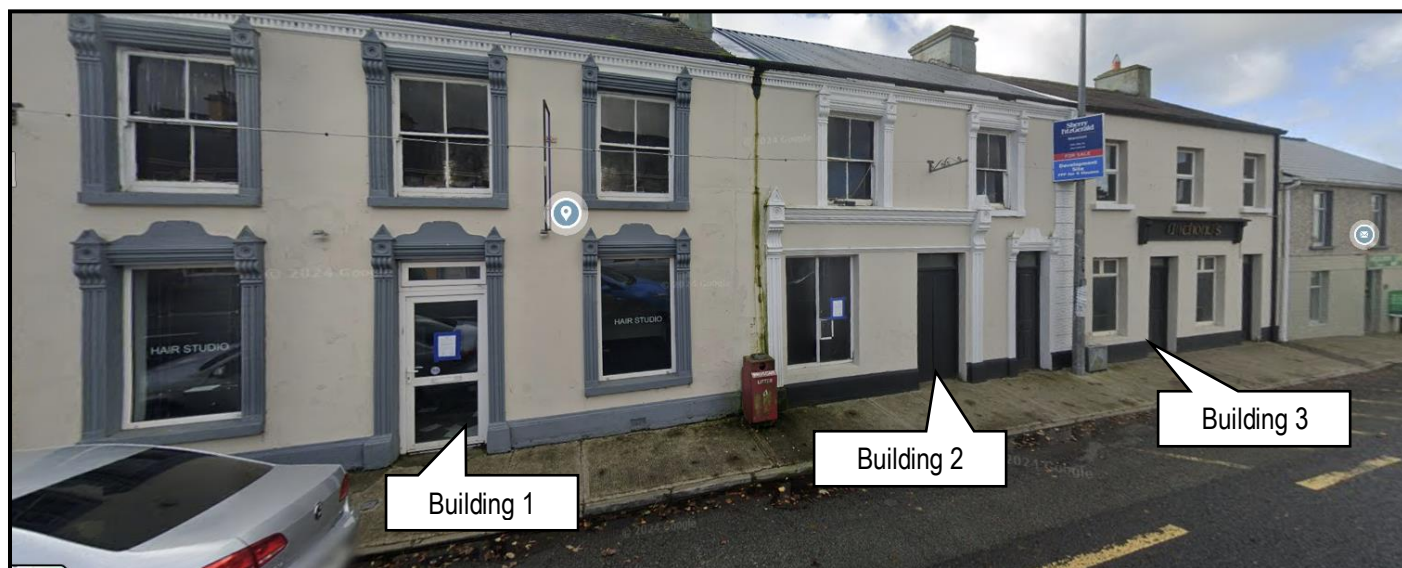
Figure 6.0- 3 no. Buildings on site

The application site currently is composed of 3 buildings which are all in varying states of disrepair. For ease and clarity, the buildings will be referred to as buildings 1, 2 and 3. Figure 6.1 below indicates the buildings numbers.

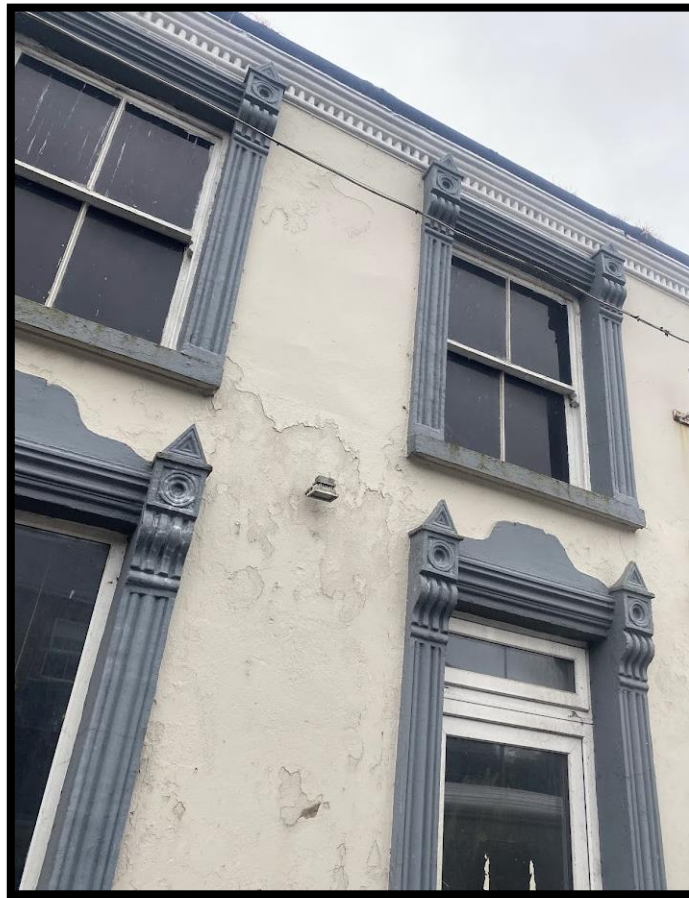
**Figure 6.1-** Front of Building 1

**Building 1-** This building has been the building used most recently. There is a large main room with a small hallway to the rear of the building. There was a hole in the floor above. This building had a lack of suitable cracks/crevices for bats to roost in. The first floor of the building cannot be accessed through this building and is assessed as part of building 2.

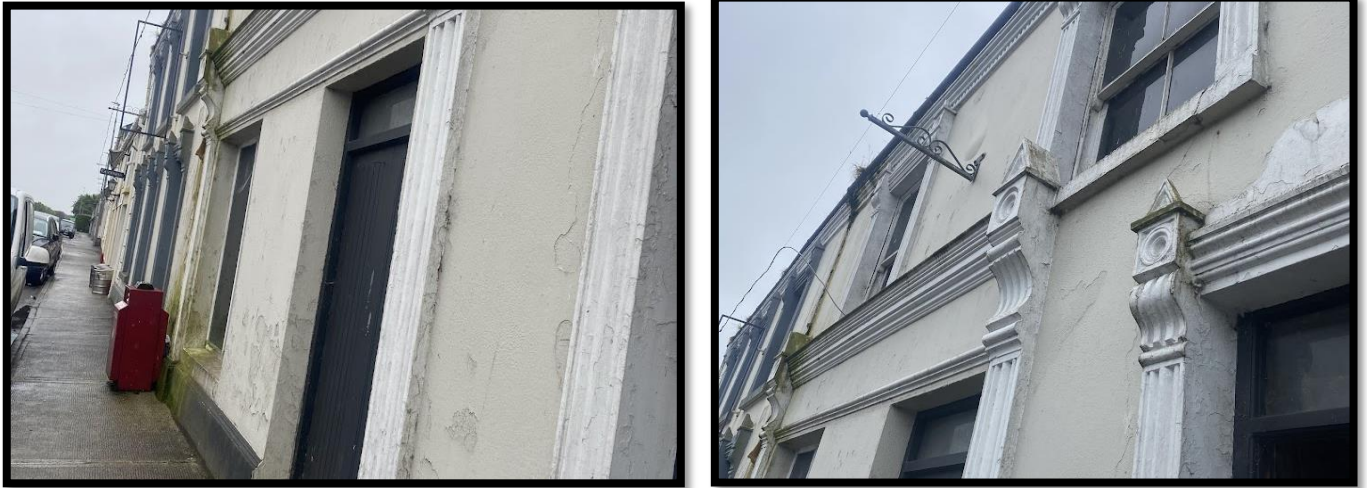
**Figure 6.3-** Exterior of Building 2

Building 1 was previously used as a hairdresser, this building is two storeys, however it could not be access due to health and safety. Building 2, is a two-storey building, there is a number of holes in the roof. Also, access could not be obtained to the first floor, due to health and safety concerns. Building 3 has no first floor, as the building has been cleared internally. All windows and door to the front of the buildings are intact. To the rear of the buildings there is a number of broken windows and doors. There are areas of the buildings where there is no roof.

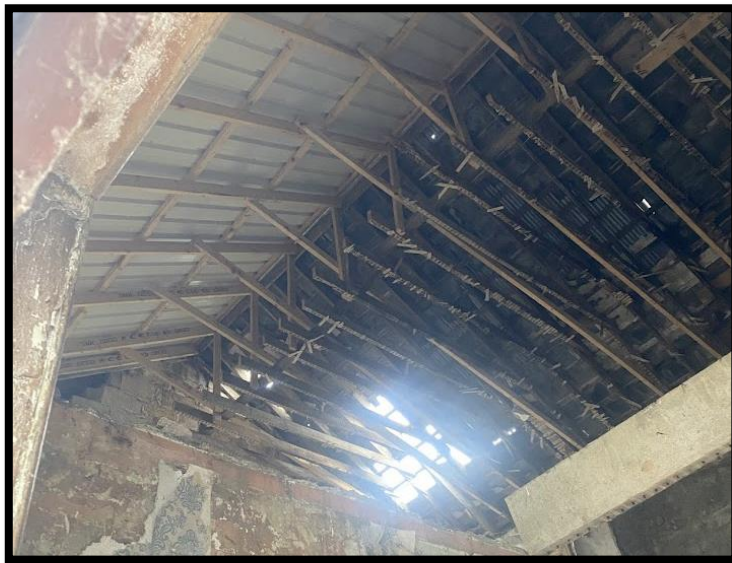
**Figure 6.4-** Roof of Building 2

**Building 2-** The hallway of this building leads to an adjoining large room, with a small room, containing mostly rubble and there is a chimney. The first floor could not be accessed as the stairs have been damaged. The interior notes there is a hole in the roof.

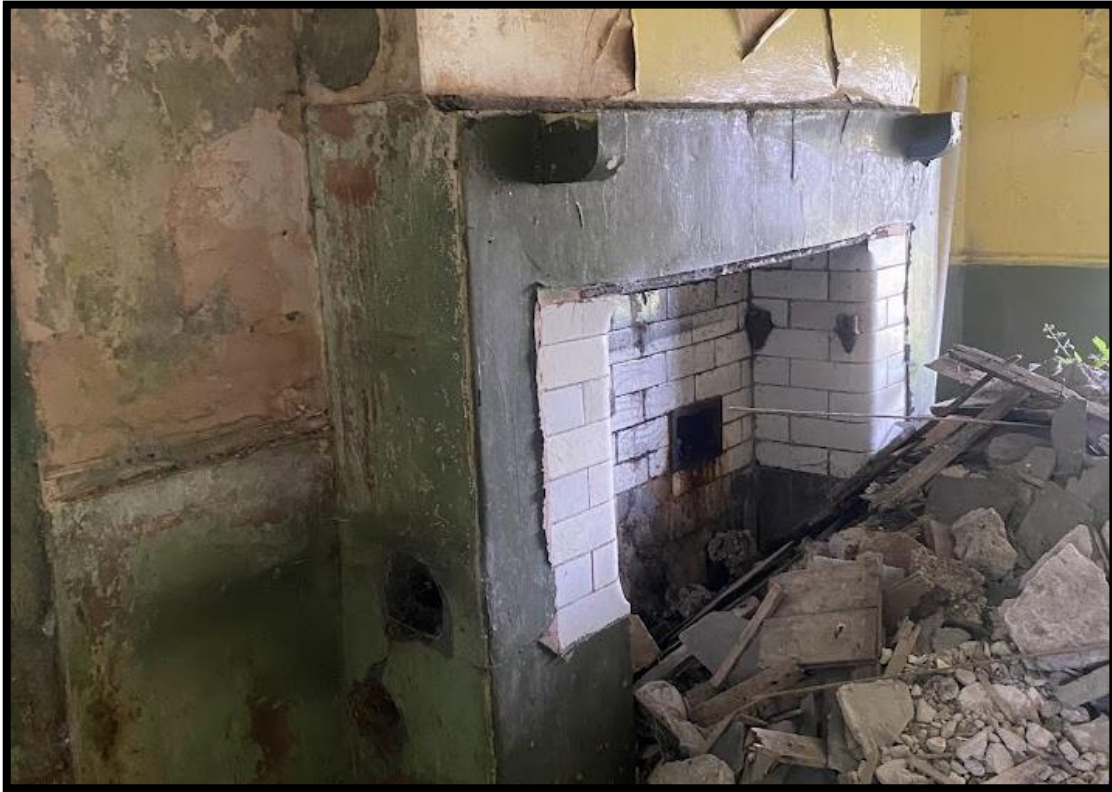
**Figure 6.8-** Chimney and rubble to the rear of building 2

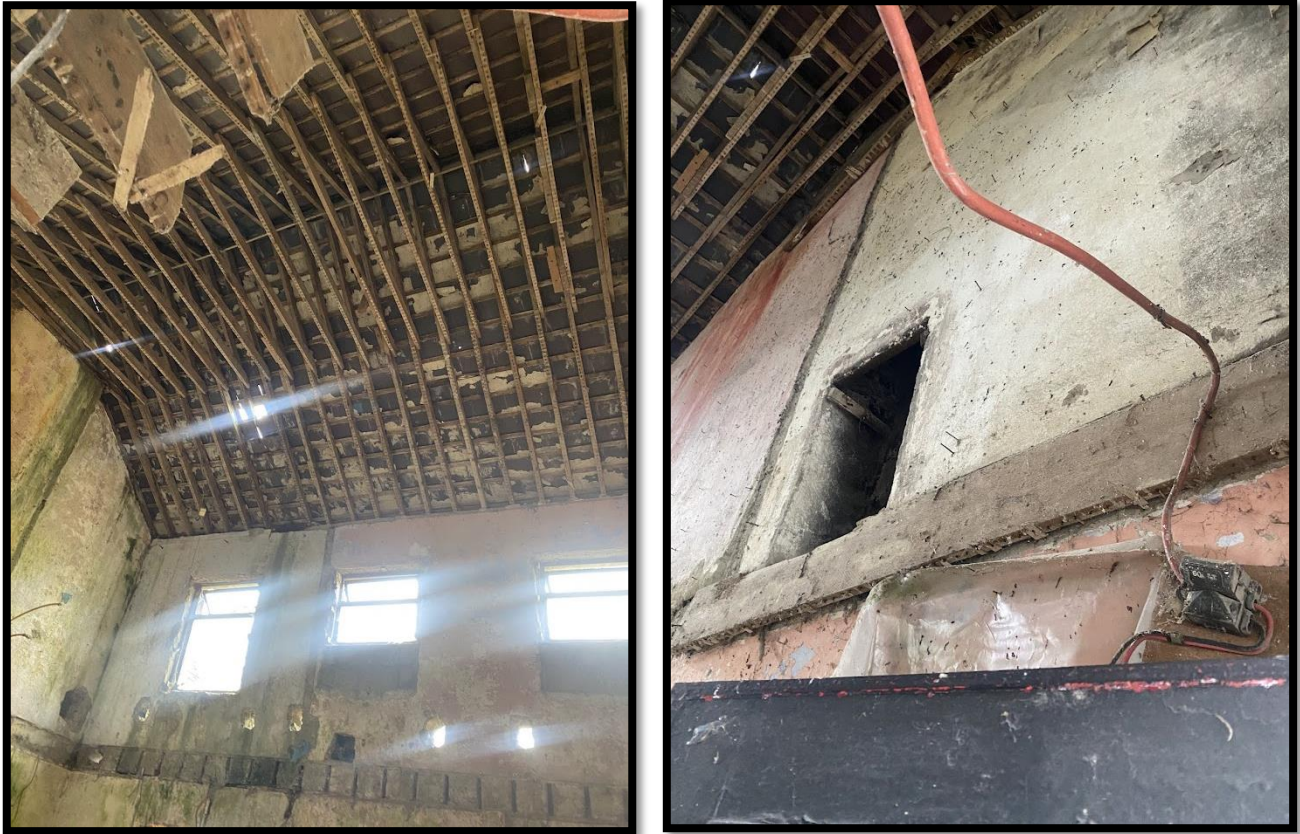
Figure 6.10- Interior of Building 3

**Building 3-** This building is composed of one large room and a small room with a chimney to the rear of the building. There is no roof on the small room to the rear. Vegetation has been to grow in the building. A number of chimneys are within the building, many have twigs likely for nesting birds. This building has a moderate roost potential.
