**24151-01-001**

# **HOUSING DEVELOPMENT AT COSMONA, LOUGHREA, CO. GALWAY**

Road Safety Audit Stage 1/2

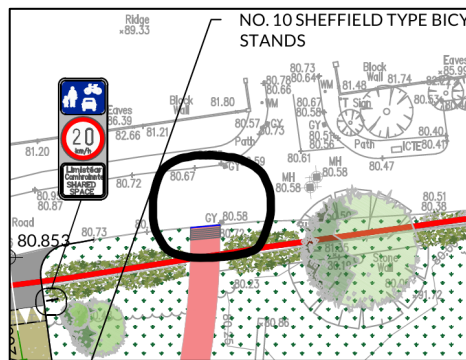
### 2.1 **Problem:** Cyclists Entering the Carriageway

**Location:** Hazelwood Estate

The design drawings show that the shared footpath/cycletrack ends suddenly at the main access road of the adjacent Hazelwood estate. Cyclists and pedestrians at the end of the track may have limited visibility to the east due to overgrown vegetation. Drivers in the Hazelwood estate may not anticipate cyclists and pedestrians emerging onto the roadway. It is also noted that no dropped kerb and tactile paving is provided opposite the crossing to enable pedestrians cross over to the opposing footpath. This situation could increase the risk of collisions involving pedestrians and cyclists.

#### **Recommendation:**

Ensure sight lines comply with design standards and that motorists are warned of the presence of pedestrians and cyclists. Provide appropriate dropped kerbs and tactile paving in the footpath opposite.

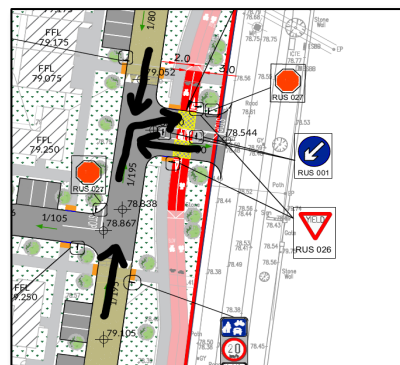
### 2.2 **Problem:** Right of Way

**Location:** Entrance Avenue

The design drawings indicate a relatively long and straight access road adjacent to the entrance. It is unclear who has right of way at this junction. A lack of clarity may lead to side swipe vehicle collisions at this location.

#### **Recommendation:**

Ensure adequate guidance is provided to motorists relating to the right of way at this location.

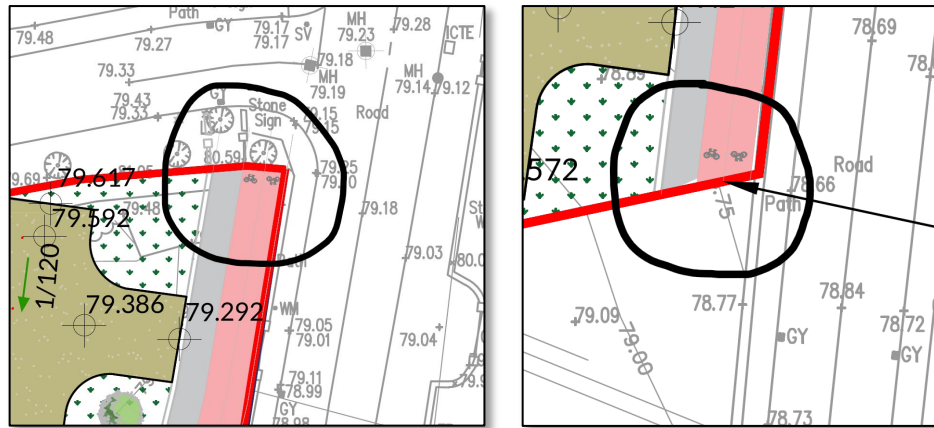
**2.5 Problem:** Termination for Cyclists from Cycle Track**Location:** Northern & Southern end of the Site

The drawings show a designated cyclist path, but it finishes suddenly at both ends without any details regarding its termination. The absence of features to help cyclists integrate with existing traffic and pedestrian facilities may heighten the risk of collisions involving cyclists

**Recommendation:**

Ensure adequate features are designed and constructed to guide cyclists on and off the cycle track.

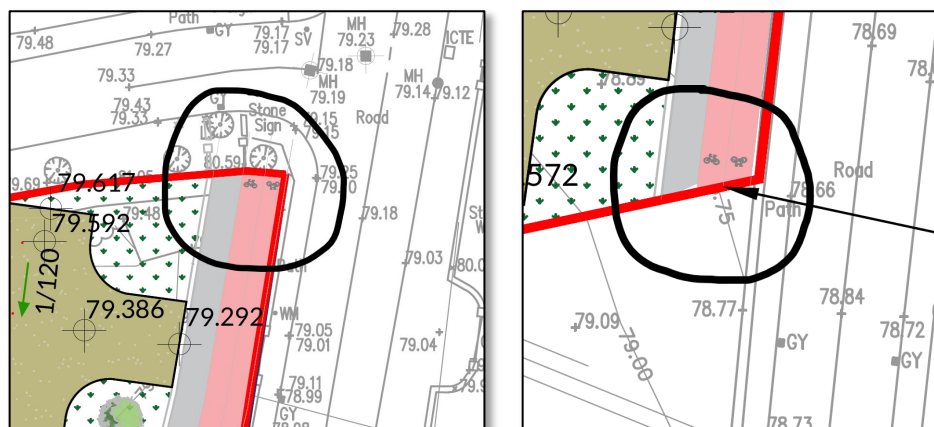
**2.6 Problem:** Termination for pedestrians from footpath**Location:** Northern & Southern end of the Site

The drawings show a new footpath within the proposed development, but it finishes suddenly at both ends without any details regarding its tie-in to the existing footpaths. The absence of connections to the existing footpaths may increase the risk of collisions involving pedestrians.

**Recommendation:**

Provide appropriate footpath connections to the existing footpaths.

| Paragraph No. in Safety Audit Report | To Be Completed By Designer | | | To Be Completed by Audit Team Leader |
|---|---|---|---|---|
| 2.6 | Yes | No | The footpath to the north will be extended to tie create an uncontrolled crossing. Lidl are developing the lands to the south which will provide connectivity to the south | Yes |

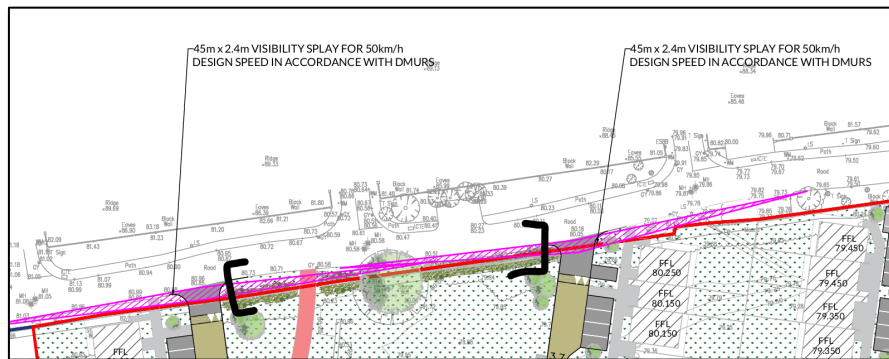
## 2.7 **Problem:** Visibility Splays

**Location:** Exiting into Hazelwood Estate

Visibility splays are indicated for both exits into the Hazelwood estate from the Cosmona Development. These visibility splays extend across existing vegetation and shrubbed areas. Over time, excessive growth coupled with a lack of ownership/maintenance may result in visibility splays being reduced. This may contribute to collisions when vehicles are exiting the junctions.

### **Recommendation:**

Ensure adequate visibility splays are provided and maintained. Remove trees & shrubbed areas within the extents of the visibility splays.

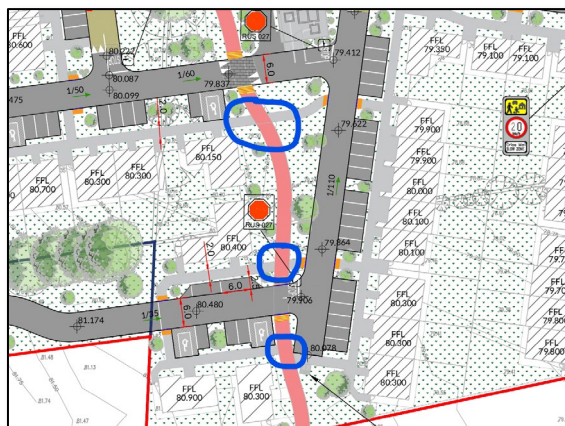
## 2.8 **Problem:** Pedestrians Entering the Shared footpath/cycletrack

**Location:** Multiple Locations

Pedestrians may not expect to encounter cyclists on the shared footpath/cycletrack and may not make room for cyclists to pass. This may be a particular issue for visually impaired persons, who may enter the shared surface unbeknown to them, resulting in collisions between cyclists and pedestrians.

### **Recommendation:**

Provide appropriate warning for pedestrians where the footpaths meet the shared footpath/cycletrack.

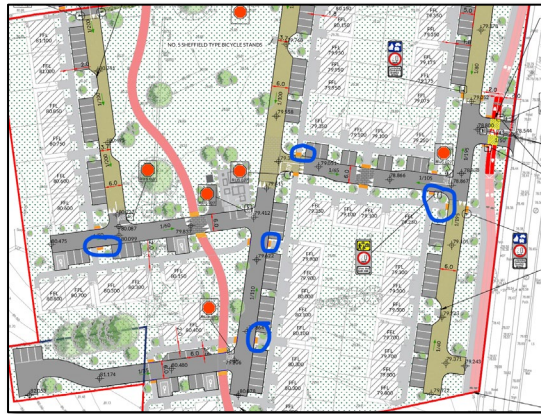
2.9 **Problem:** Inadequate Visibility  
**Location:** Uncontrolled Pedestrian Crossings

A number of uncontrolled pedestrian crossings are proposed throughout the development. However, it is unclear whether adequate inter-visibility is provided between drivers of vehicles approaching the crossings and pedestrians stopped waiting to cross. Obstructions to intervisibility may include planting, refuse bins and parked vehicles adjacent to pedestrian crossings.

**Recommendation:**

Ensure adequate intervisibility between motorists & pedestrians is provided at uncontrolled crossings.

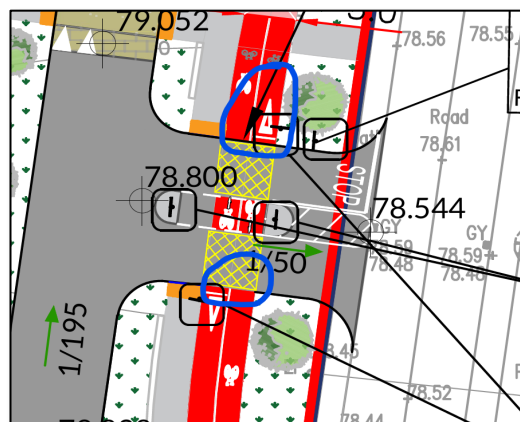
2.10 **Problem:** Cyclist Access to Cycle Surface  
**Location:** Development Access Point

It appears there is a full height kerb between the carriageway and the cycle lane. While a drop kerb is indicated for pedestrians, no height for the kerb at the cycle lane is indicated on the drawings. TL404 indicates that kerbs are not recommended in the path of cyclists at the edge of the road. Cyclists may lose control when attempting to mount a kerb.

**Recommendation:**

Provide a suitable and level transition from the carriageway to the cycle track in accordance with the new Cycle Design Manual.

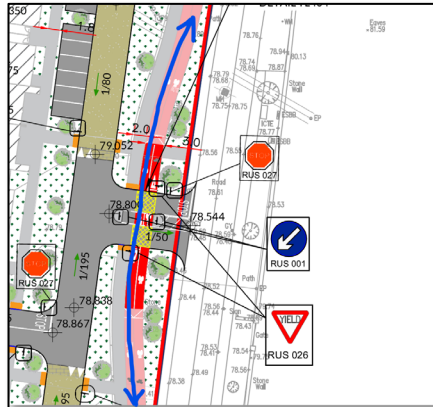
2.11 **Problem:** Cyclist Speed  
**Location:** Main Entrance Crossing

The design drawings indicate a gentle swept path for cyclists as they approach the crossing point. Cyclists approaching at speed may have difficulty stopping to give right of way to vehicles entering/exiting the development. This may result in side-swipe collisions between vehicles and cyclists.

**Recommendation:**

Ensure the approach to the crossing for cyclists incorporates a suitable alignment that promotes cyclists to slow down in advance of the crossing, as outlined in TL404.

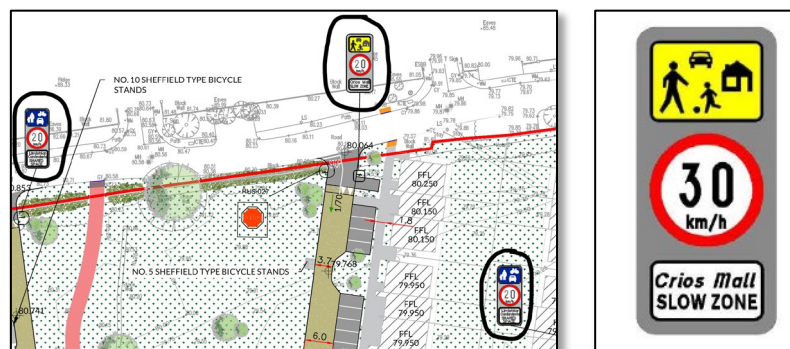
2.12 **Problem:** Slow Zone Signage  
**Location:** Throughout

The design drawings indicate Slow Signage and other speed signage throughout. The Traffic Signs Manual indicates that Slow Zone signage for built up areas is 30km/h, however differing speeds are indicated on the design drawings. Confusion regarding the exact speed limit may cause drivers to ignore the actual speed limit, thus increasing the likelihood of accidents and collisions.

**Recommendation:**

Ensure speed limits throughout the development are as per the applicable legislation and the relative design standards.

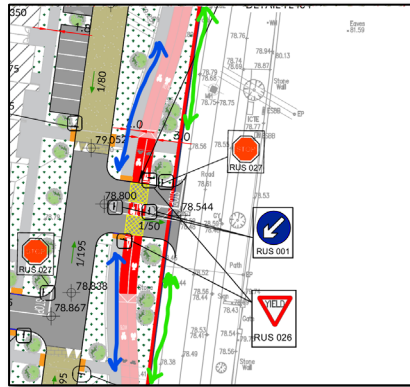
### 2.13 Problem: Driver Confusion

**Location:** Main Entrance

The design drawings indicate a new pedestrian footpath and crossing within the development. The drawings do not indicate what is proposed for the existing footpath that is between the boundary wall and the R350. Multiple crossing points in close proximity may cause confusion for motorists resulting in an increased likelihood of vehicle & pedestrian collisions.

**Recommendation:**

Remove the existing footpath to limit pedestrians crossing at multiple locations.

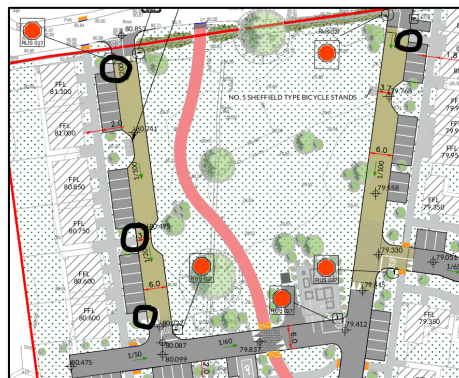
## 2.14 Problem: Pedestrian Delineation

**Location:** Shared Surfaces

Footpaths and shared surfaces are planned within the development. However, it may not be clear to visually impaired pedestrians where the dedicated footpaths ends, and the shared surfaces begin. Consequently, they might inadvertently step onto the shared surface without realizing it, which could increase the risk of being struck by a passing vehicle.

**Recommendation:**

Provide appropriate tactile warning at the interfaces of footpaths and shared surface.

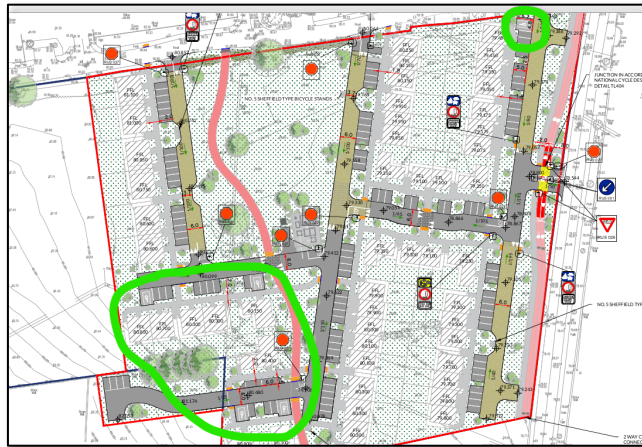
**2.15 Problem:** Disabled Parking**Location:** Throughout

There are five disabled parking spaces, with four located in the southwest corner of the development. However, there are significant areas within the development that lack any disabled parking. Once parked, individuals with disabilities may need to navigate several road crossings to reach their destination, raising the risk of collisions between pedestrians and vehicles

**Recommendation:**

Provide a more even distribution of disabled parking across the site.

| Paragraph No. in Safety Audit Report | To Be Completed By Designer | | | To Be Completed by Audit Team Leader |
|---|---|---|---|---|
| 2.15 | No | No | Accessible parking has been located in close proximity to the single storey units where council tenants are most likely to require accessible parking. | Yes |

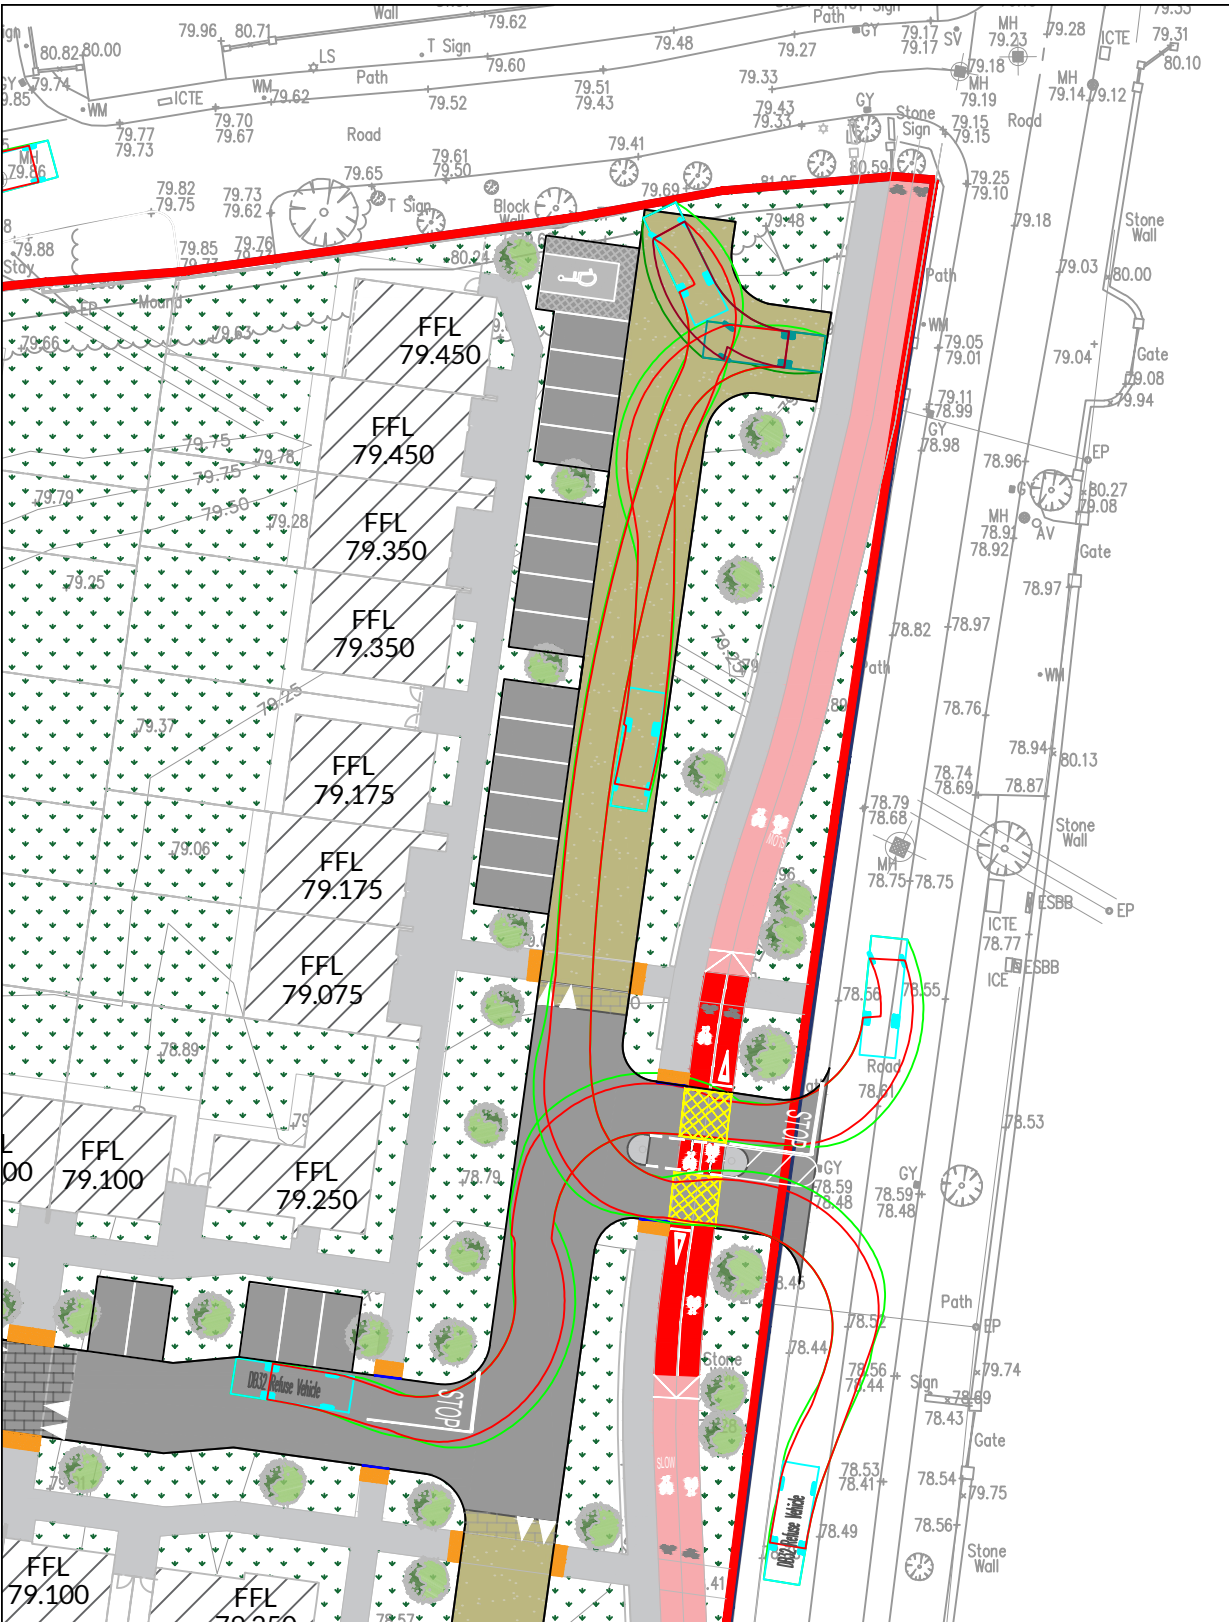
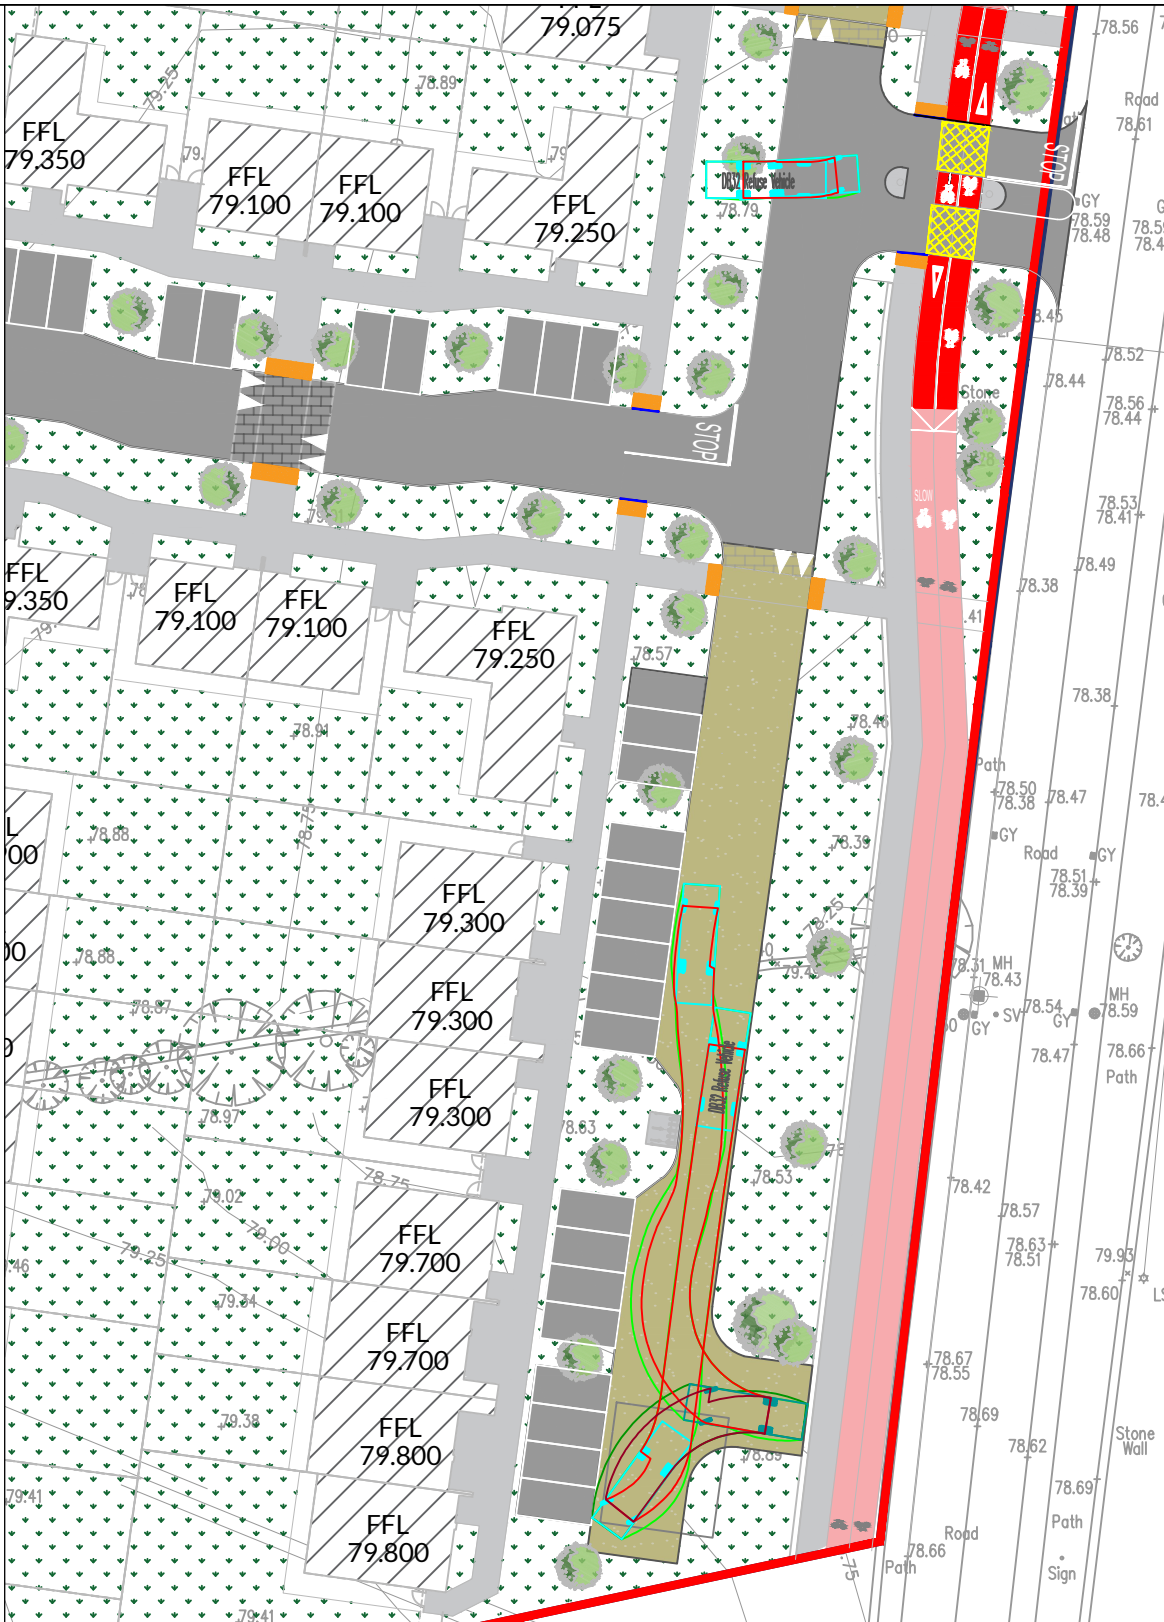
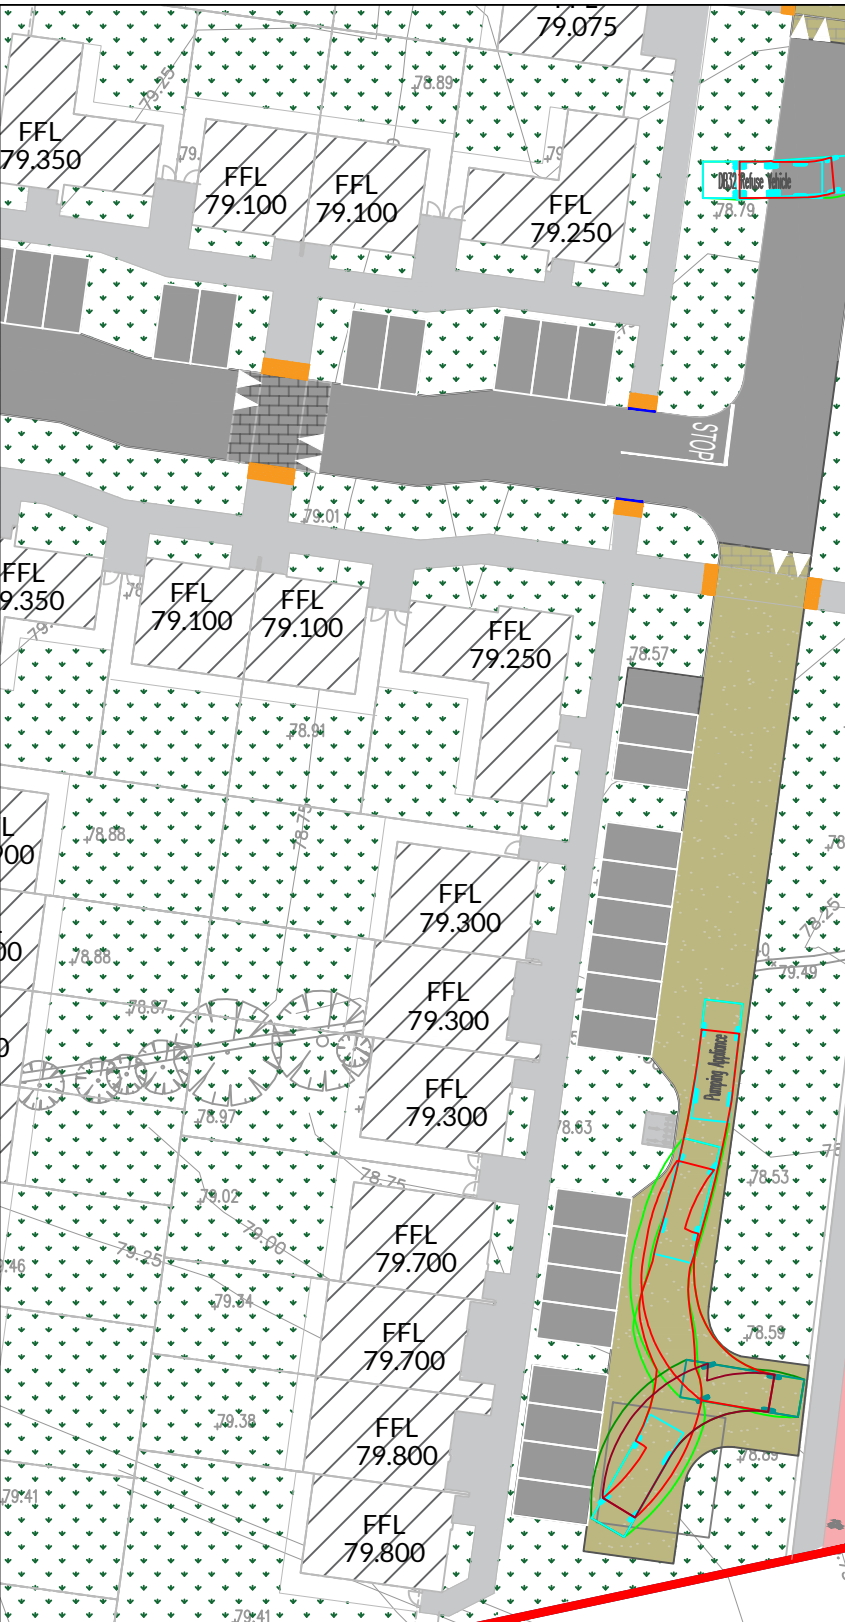
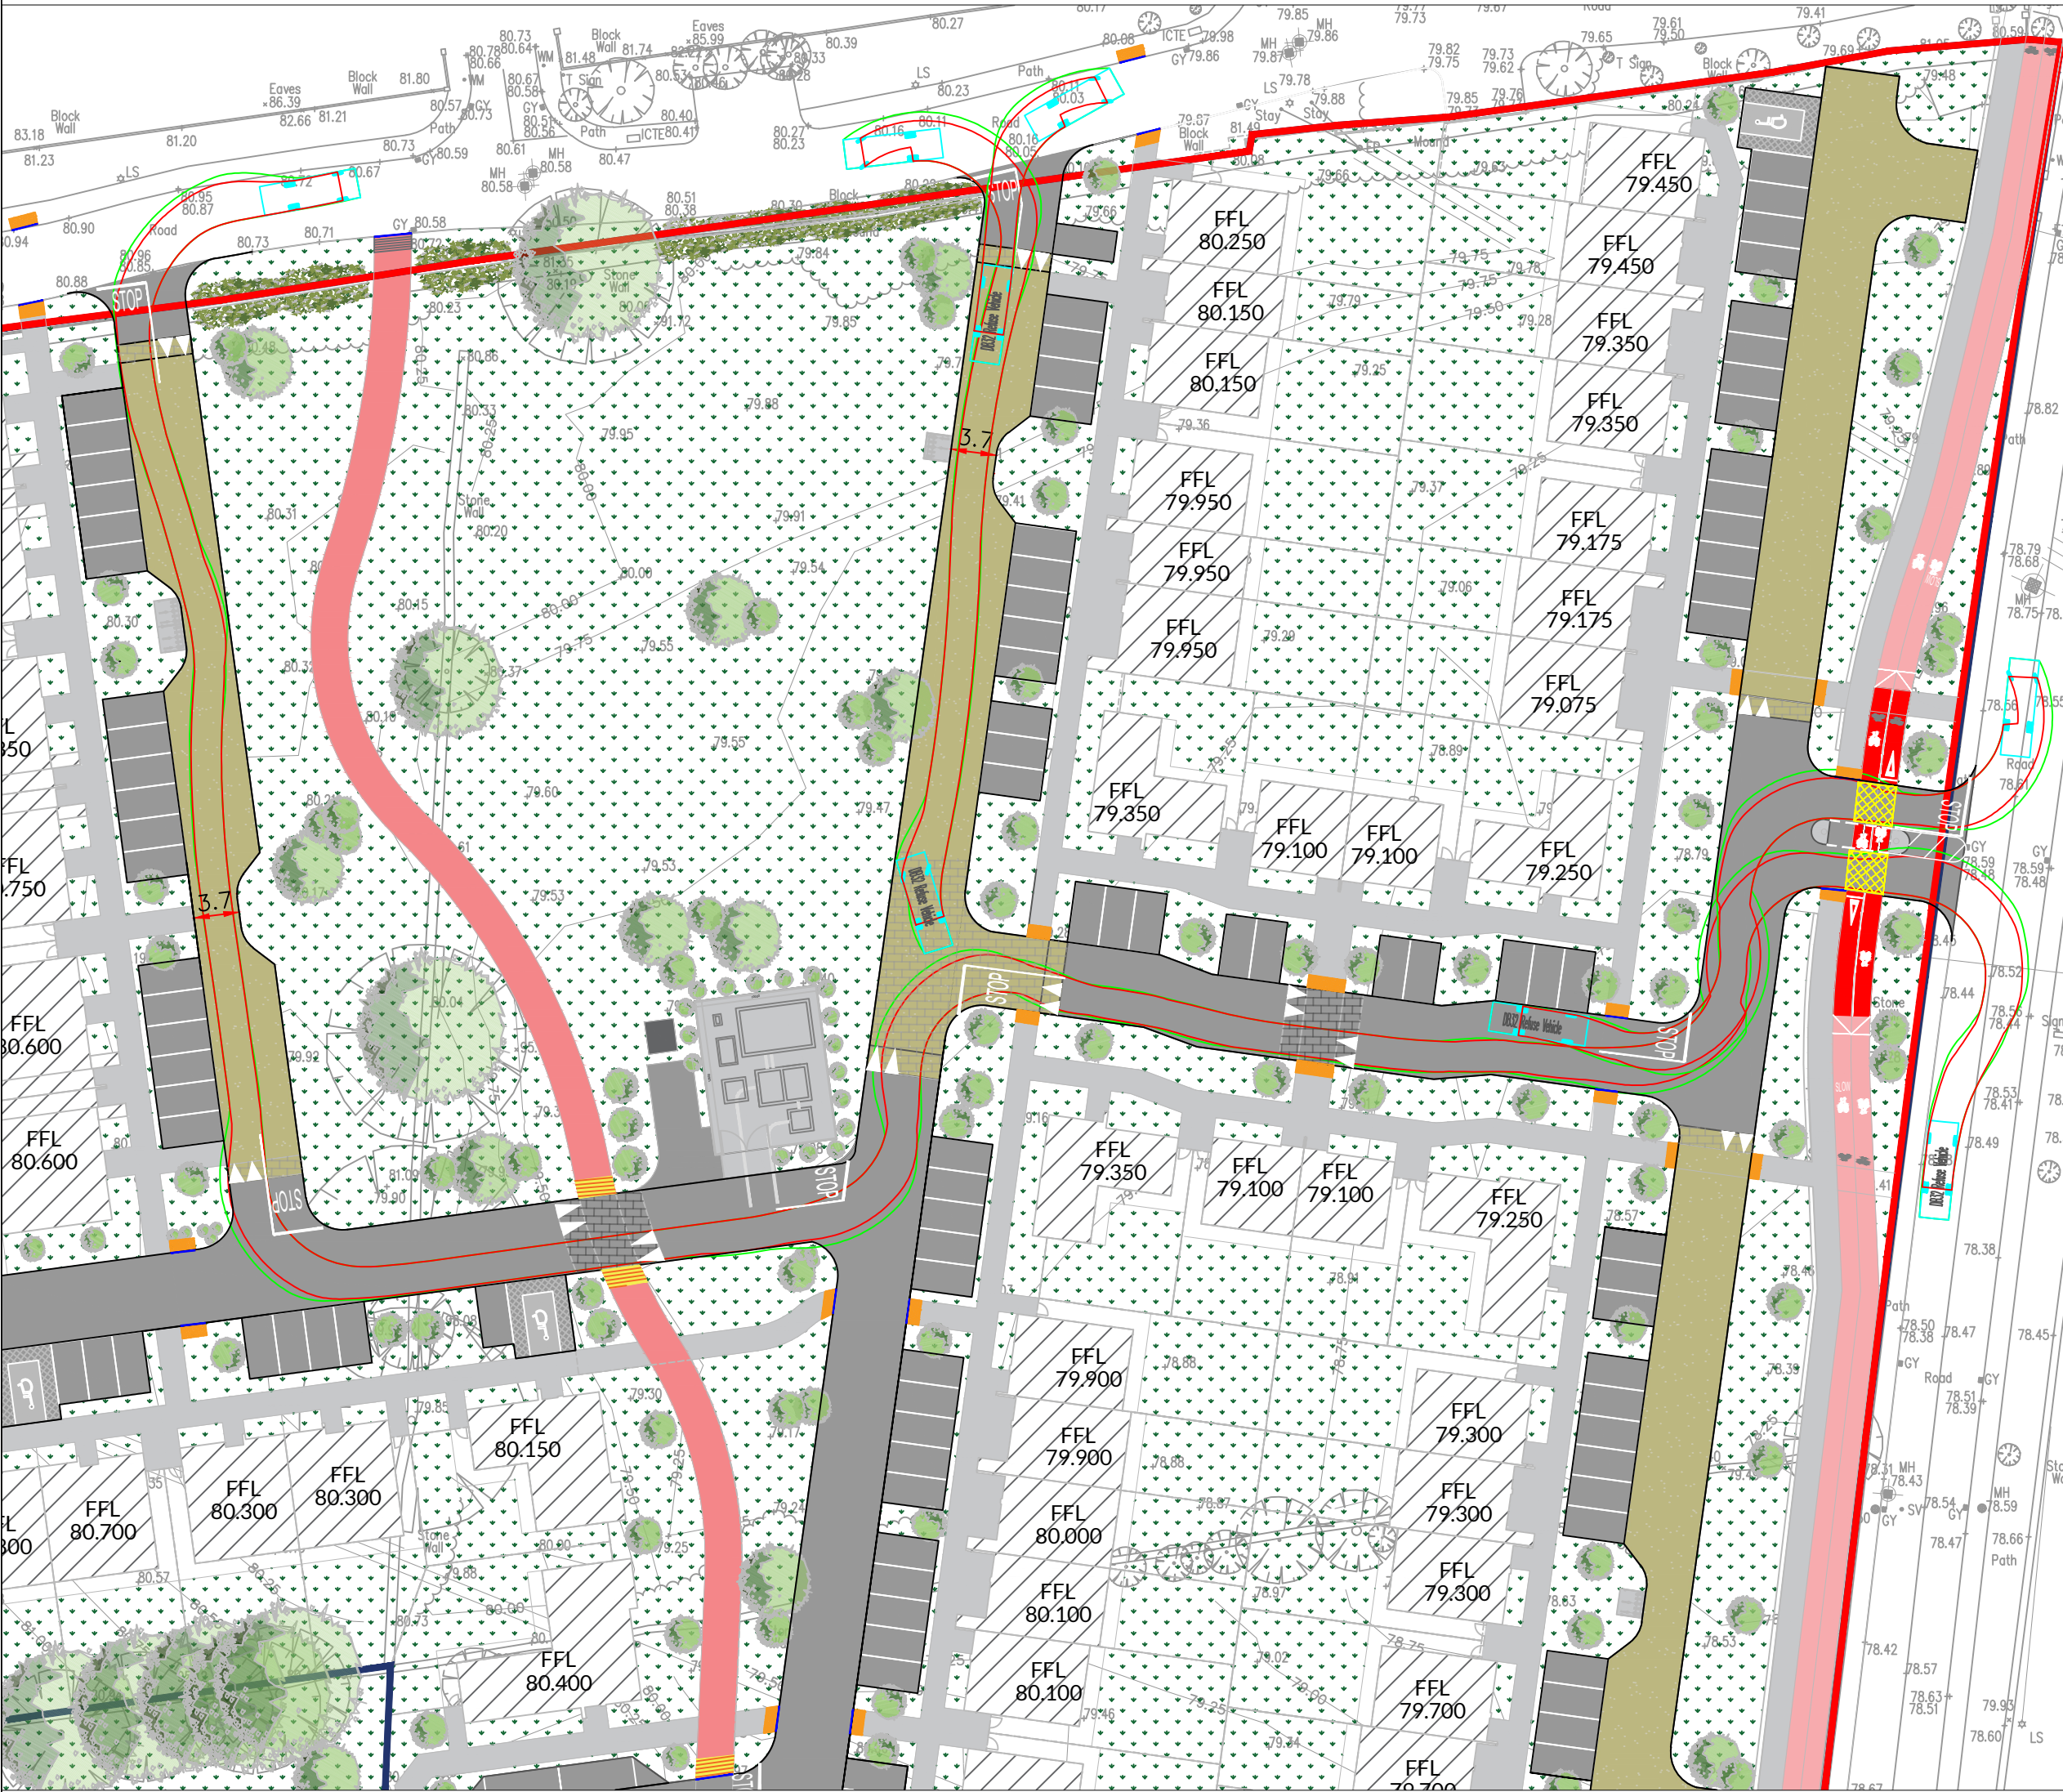
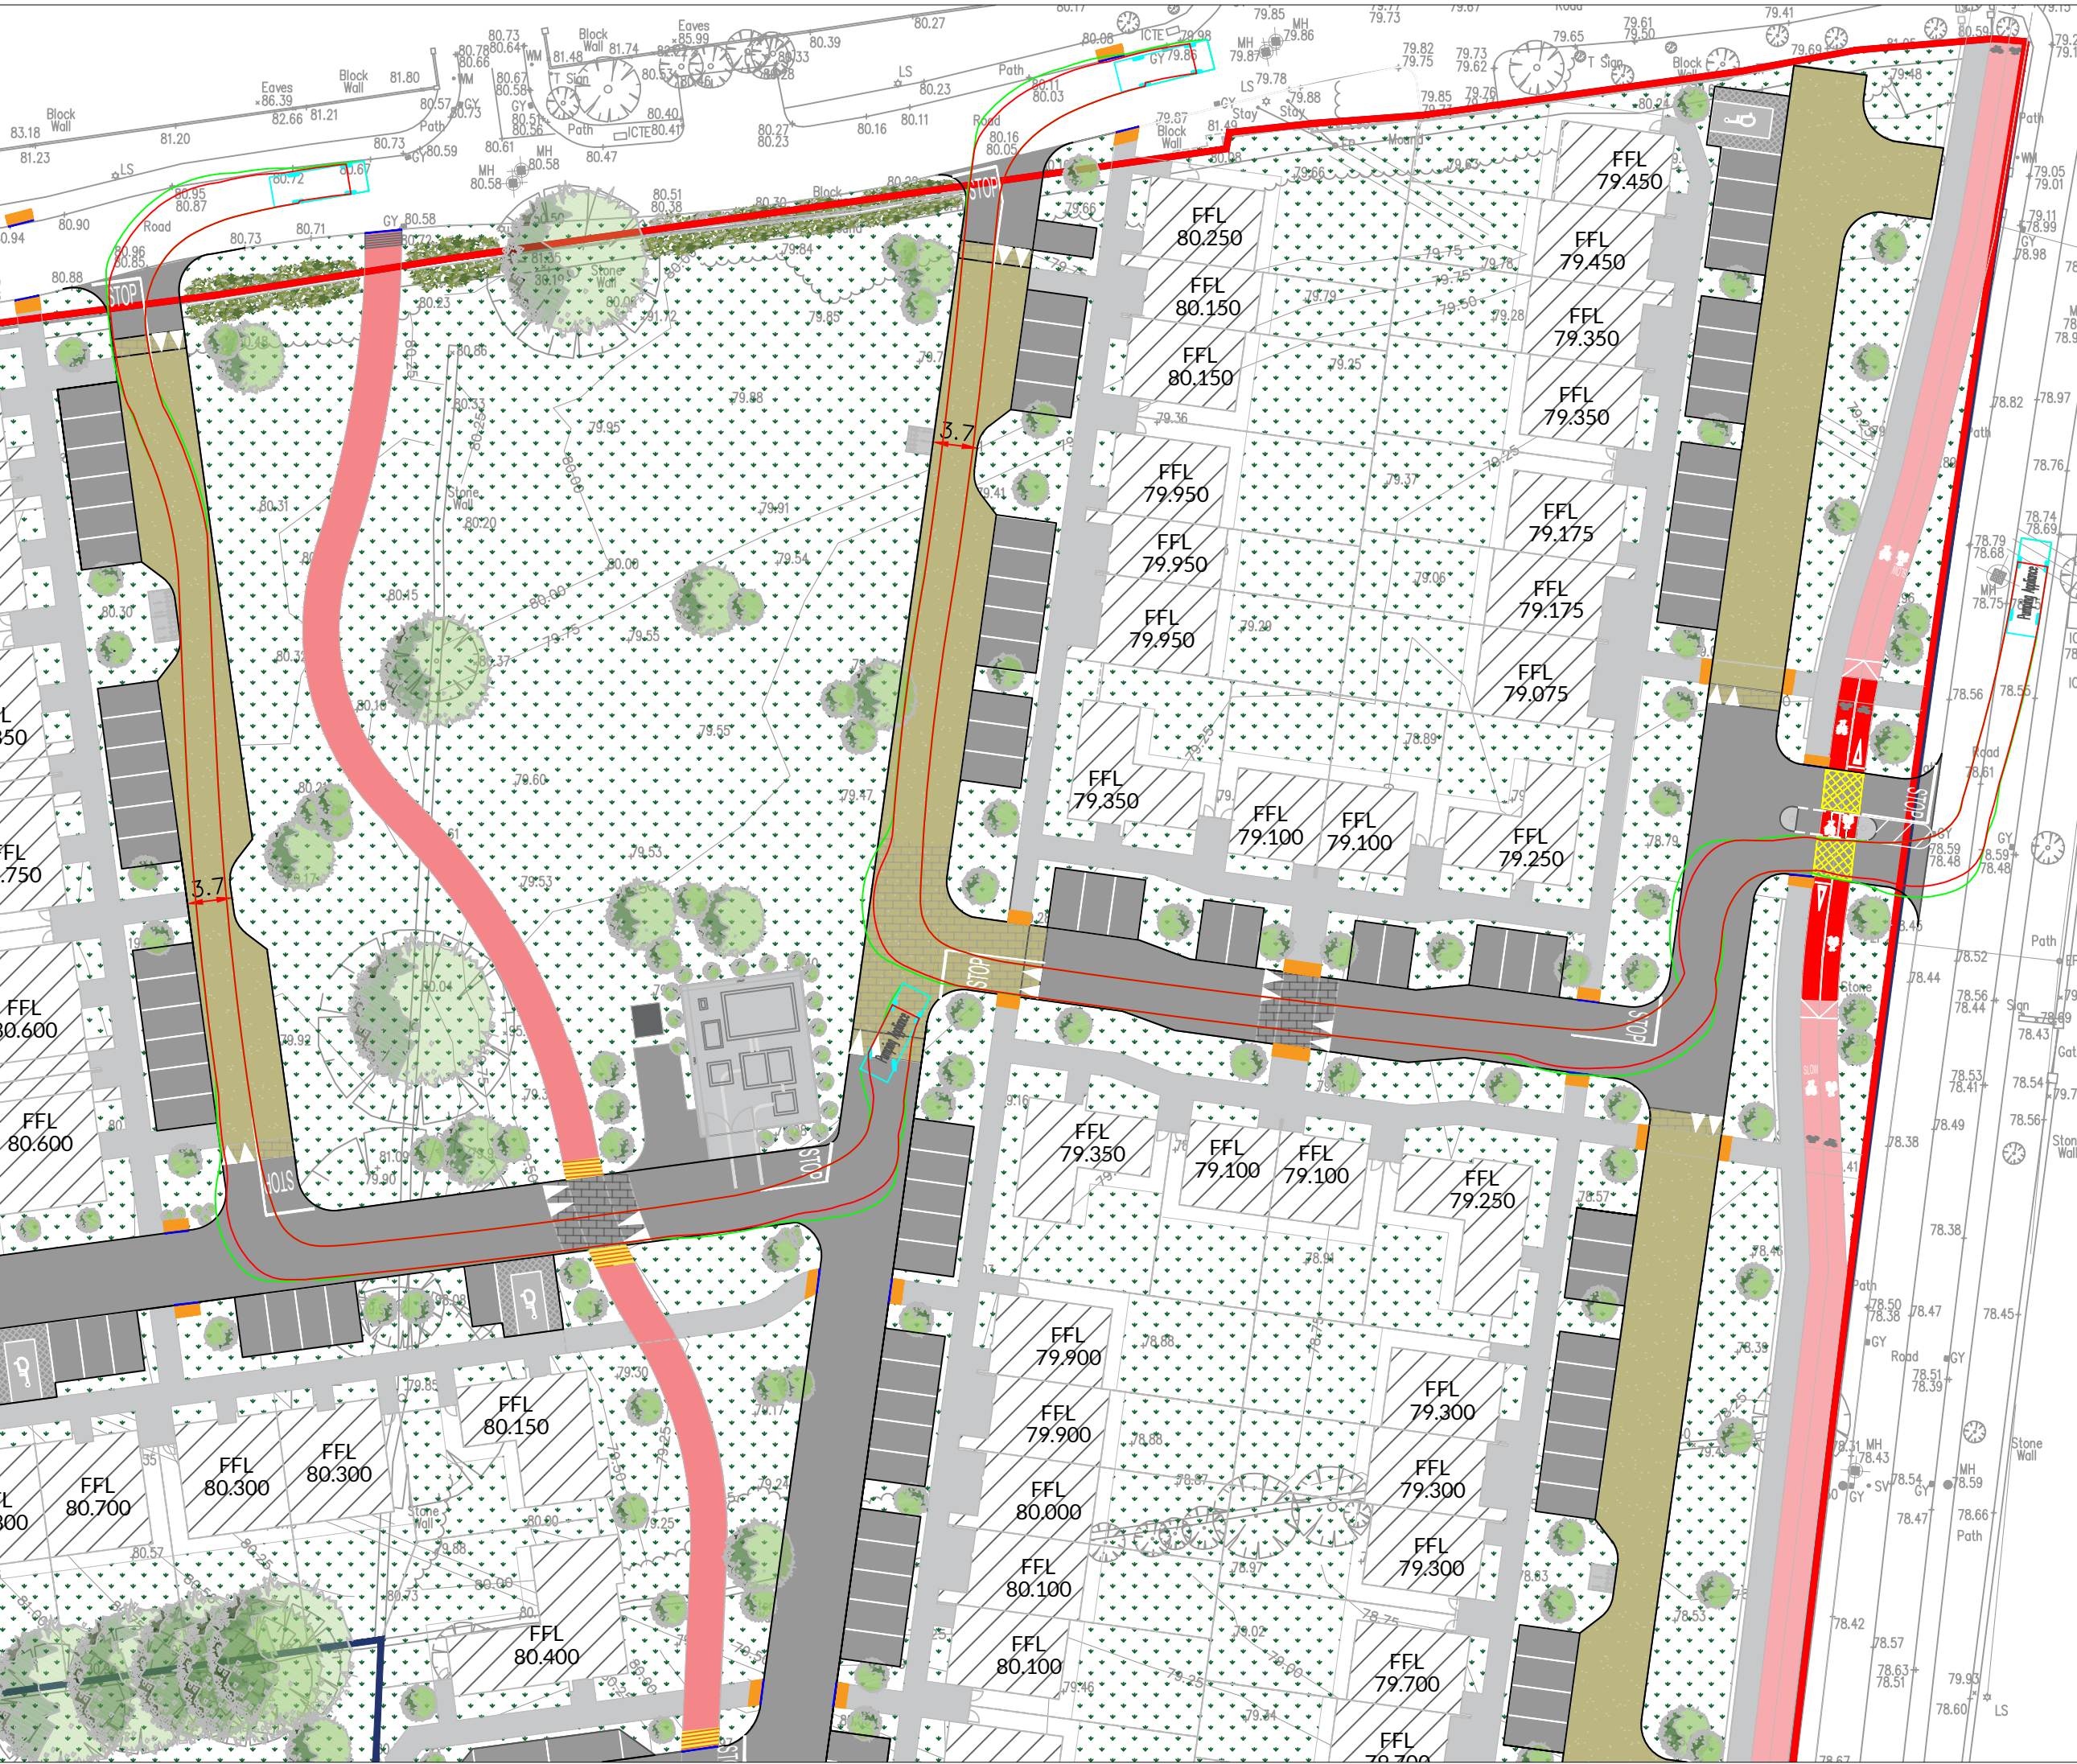
SWEPT PATH ANALYSIS - REFUSE VEHICLE  
SCALE 1:500

Overall Length: 7.900m  
Overall Width: 2.400m  
Overall Body Height: 3.183m  
Min Body Ground Clearance: 0.588m  
Max Track Width: 2.400m  
Lock-to-lock time: 6.00s  
Curb to curb Turning Radius: 9.625m
