Farranamartin, Tuam  
Co. Galway  
Stage 1  
Road Safety Audit

This report describes the Stage 1 Road Safety Audit carried out on an entrance to a proposed housing estate in Farranamartin, Tuam, Co. Galway. The proposed scheme is located within the jurisdictional boundary of Galway County Council seen in Figure 1-1.

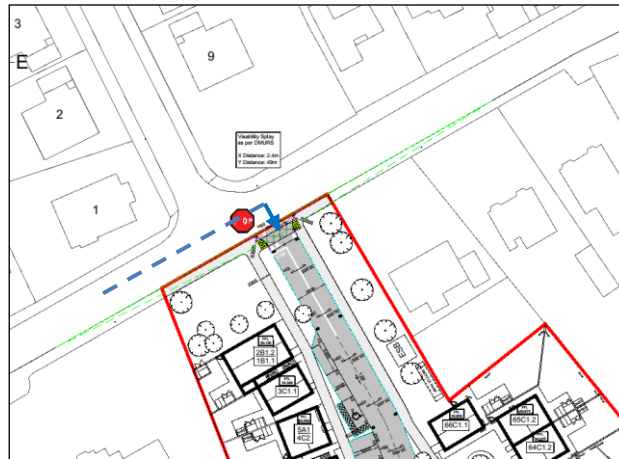
Figure 2-1 Right Turn Movement

The Audit Team observed onsite the existing environment along the R393 (Galway Road). The Audit Team are concerned about volume of traffic potentially turning right into the proposed estate. It may result in rear end collision(s) with stationary traffic wanting to turn right with approaching traffic.

The design team should ensure the planned traffic volumes don't require a queueing lane.

| To be Completed by Designer | | | | To Be Completed by Audit Team Leader |
|---|---|---|---|---|
| 2.1 | YES | NO | TTA is being completed for the site. In receipt of the TTA, discussions will be had with GCC in relation to this. | |

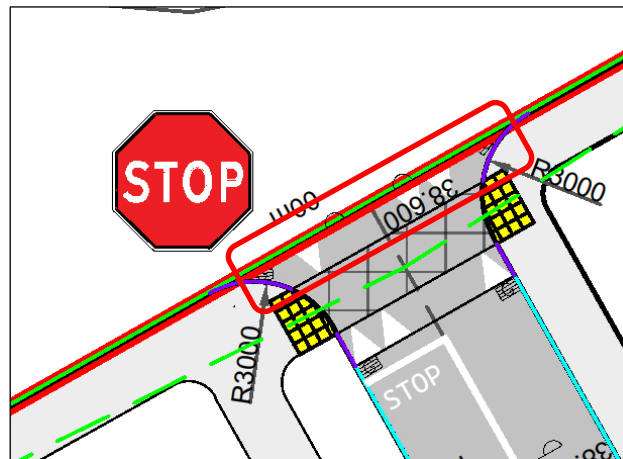
Figure 2-2 Ramp Details

The Audit Team noted on the design drawings the proposed raised table crossing and kerbing detail. The Audit Team are concerned that the proposed ramp will commence out on the carriageway, due to required kerb and gradient standard. This may result in road users striking the ramp edge and directing them towards other vehicles resulting in a head on collision

The design team should ensure the proposed raised table crossing meet the required standards.

| To be Completed by Designer | | | | To Be Completed by Audit Team Leader |
|---|---|---|---|---|
| 2.2 | YES | NO | Alternatively, a standard pedestrian crossing is to be put in here at the junction in accordance with CC-SCD-05123. | |

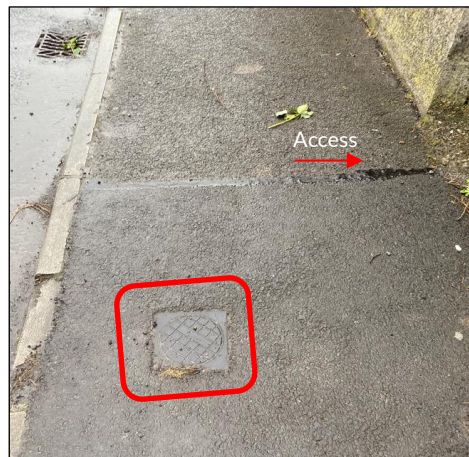
Figure 2-3 Underground Utility

The Audit Team observed onsite existing utility/water metre in the footpath of the proposed access. The Audit Team is concerned that the underground utility/water metre hasn't been accounted for in the design teams proposed design. This may result in the utility cover becoming a trip hazard if not flush with the pavement resulting in potential slips or trips by Vulnerable Road Users.

The design team should ensure all utilities are flush with the proposed works.

| To be Completed by Designer | | | | To Be Completed by Audit Team Leader |
|---|---|---|---|---|
| 2.3 | YES | YES | | |

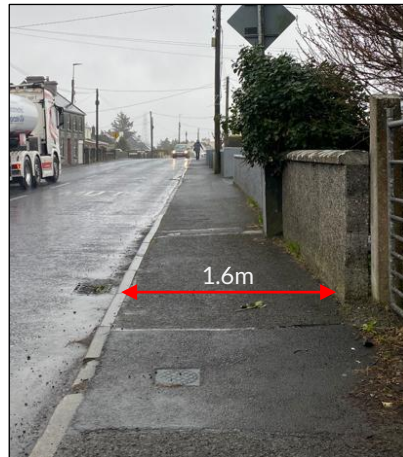
Figure 2-4 Footpath Width

The Audit Team observed onsite the exiting footway width is approximately 1.6m. The Audit Team are concerned that the footpath is insufficient in width to allow vulnerable road users to pass two abreast. This may result in vulnerable road users entering the carriageway in order to pass one another. This may result in a collision between a vulnerable road users and a vehicle.

The design team should ensure the footway width is as per standard.

| To be Completed by Designer | | | | To Be Completed by Audit Team Leader |
|---|---|---|---|---|
| 2.4 | YES | NO | Footpath within the site, along the Galway Road will be 2.0m wide. GCC have been informed and made aware of the slimer footpath provision outside of the site boundary. | |

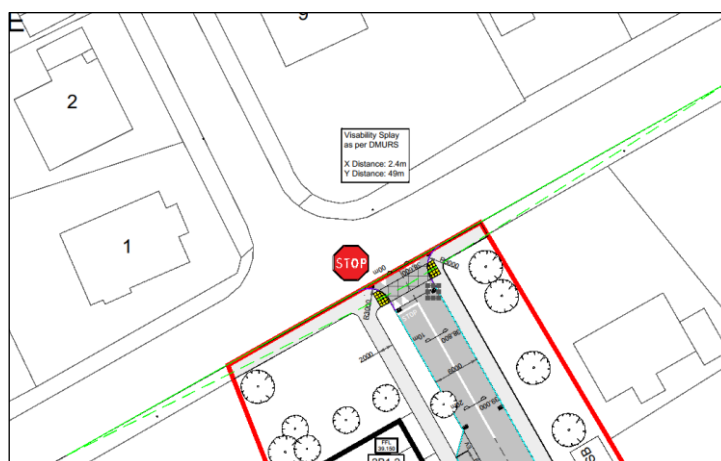
Figure 2-5 Visibility Splay

The Audit Team noted on the design drawings the visibility splay, at the proposed access. The Audit Team is concerned that the visibility splay shown are for vehicles on the pedestrian crossing, not at the STOP line. Inadequate visibility may result in vehicles entering the carriageway with oncoming vehicles, which may result in a side swipe type collision .

The design team should ensure visibility splay is provided as per standard.

| To be Completed by Designer | | | | To Be Completed by Audit Team Leader |
|---|---|---|---|---|
| 2.5.1 | YES | YES | | |

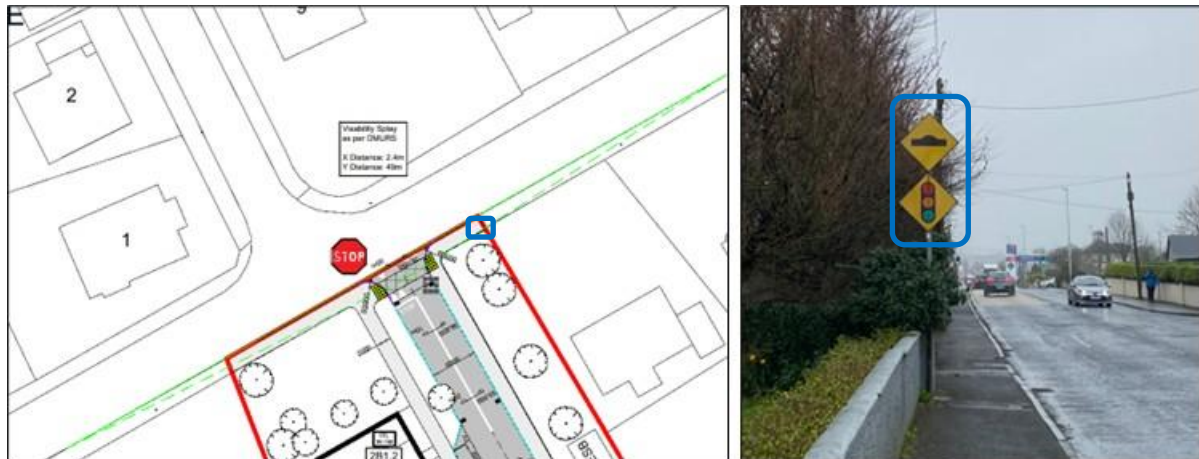
Figure 2-6 Visibility Envelope - Warning Signage

The Audit Team observed onsite the location of the existing warning signage. The Audit Team are concerned that the high sided vehicles will have their visibility obstructed by the signage when exiting. Inadequate visibility may result in vehicles edging out into the carriageway, which may result in a side swipe type collision with approaching vehicles.

The design team should ensure the visibility envelope is clear form any obstructions.

| To be Completed by Designer | | | | To Be Completed by Audit Team Leader |
|---|---|---|---|---|
| 2.5.2 | YES | YES | | |

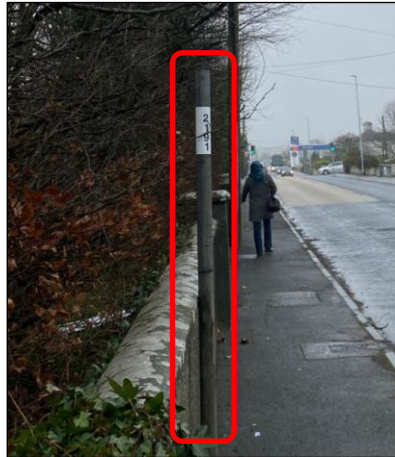
Figure 3-1 Signpost

The Audit Team observed onsite a redundant post at the back of the footpath.

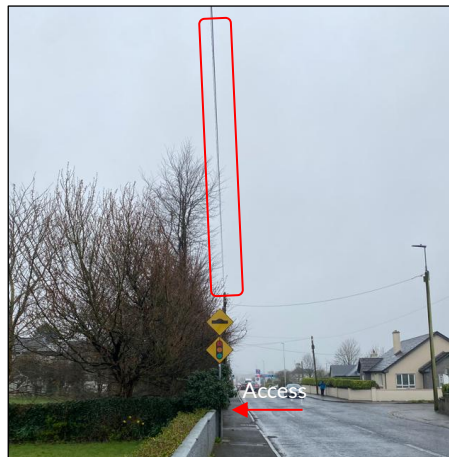
Figure 3-2 Overhead Utility

The Audit Team observed onsite the overhead utility wires at the existing field access.
