Bat Survey & Mitigation Measures
For the Demolition of a Derelict Dwelling
at
Williamstown
Co. Galway

Doherty Environmental Consultants Ltd.

July 2021

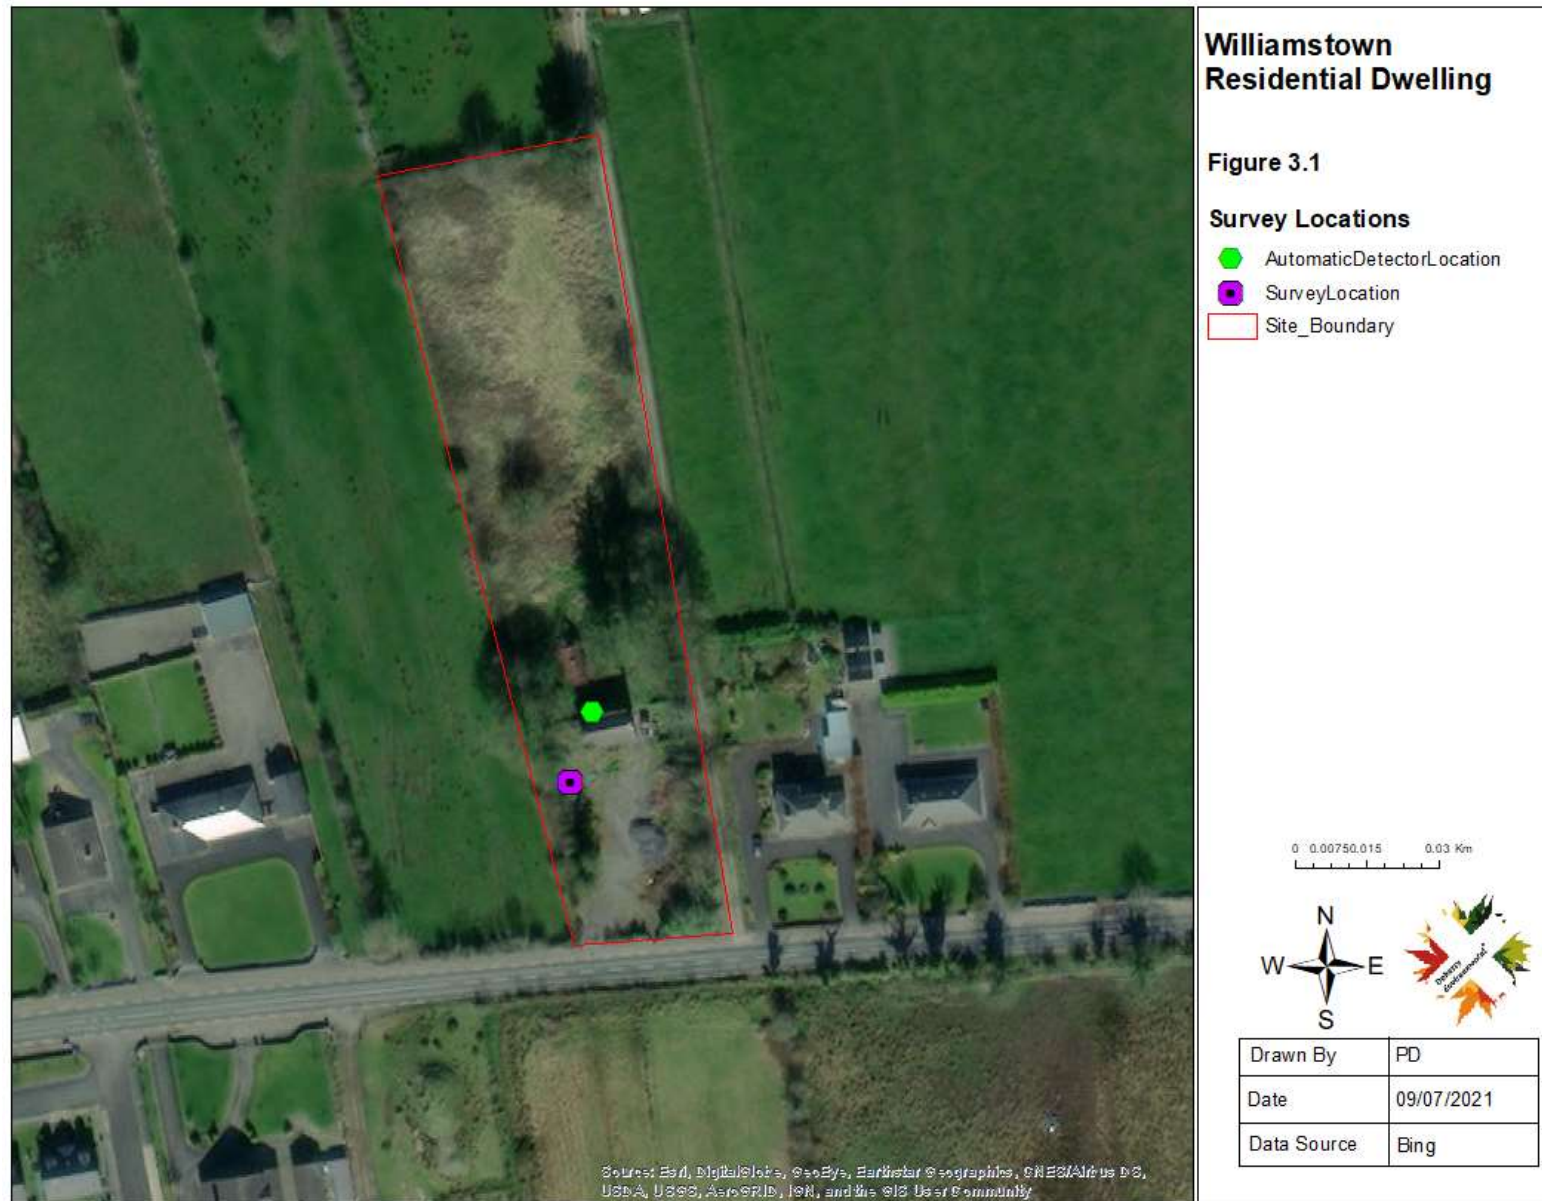
A position was taken up to the southwest of the derelict dwelling to complete the manual survey. that afforded a view of the south-facing side of the pitched roof, the open window voids at the south-facing side and the shed to the north of the dwelling. The location is shown on Figure 3.1.

The automated bat detector, an SM4 Bat Full Spectrum bat detector, was installed on the north side of the dwelling between the dwelling and the shed. Appendix 1 Plate 3 shows the automatic detector in position. The location is shown on Figure 3.1. The automatic detector was set to

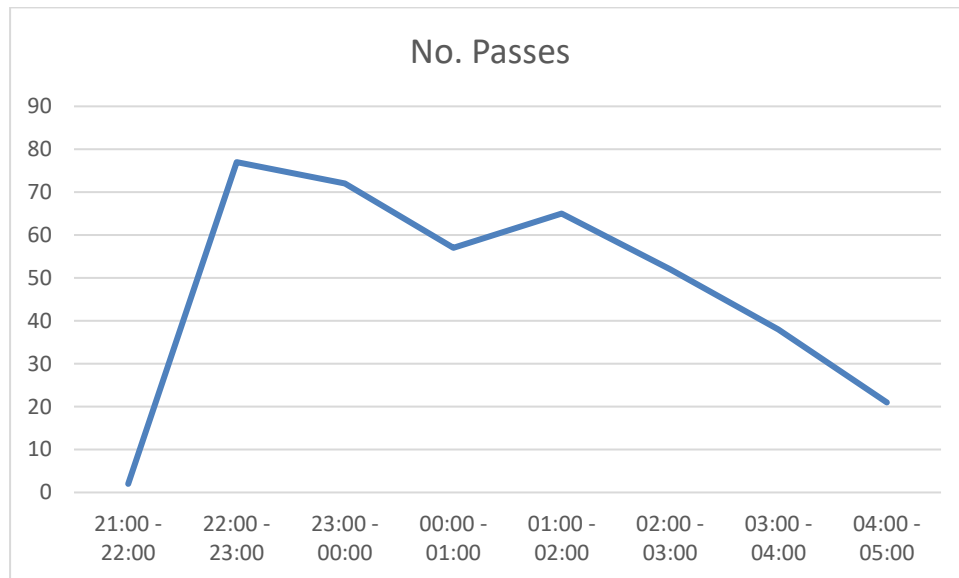
The activity was concentrated in the hours between 22:00 and 03:00 and declined thereafter. Graph 1 below displays the levels of activity, based on the number of bat passes recorded per hour, by the automatic bat detector.

Activity between 22:00 and 00:00 was observed during the manual emergence survey and consisted of a low number of bats (no more than 3 observed at any one time), predominantly Soprano pipistrelle foraging in the sheltered area to the north of the dwelling.

Low numbers of bat calls were recorded between 04:00 and 05:00, during the time that coincides with re-entry to roost sites. The low numbers are indicative of an absence of swarming and are consistent with the findings of the emergence survey, indicating the use of the structure as a roost site by low numbers of bats. Based on the results of the emergence survey, combined with the low levels of activity recorded during the re-entry time it is likely that the derelict dwelling functions as a day roost for a low number of Soprano pipistrelle bats.

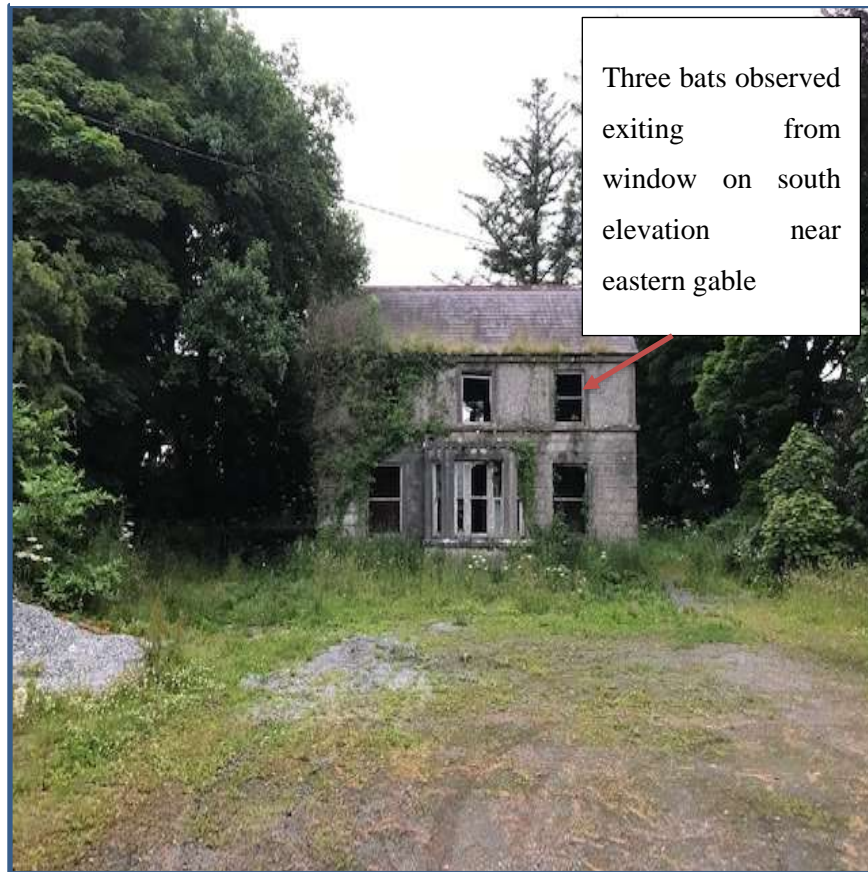
Three individual Soprano pipistrelle bat were visually observed emerging from the upper northeast window void on the southern elevation between 22:11 and 22:15, approximately 20 minutes after sunset. All three bats were observed flying inside the upper room prior to emerging from the window void.

Plate 1: View of southern elevation and open window where bats were observed exiting the structure

Alternative roosting opportunities will be provided in the new structure. A bat brick will provide access to an area of internal loft space at the eastern gable end of the structure. A loft space of 2m x 2m surrounding the bat brick entrance will be provided. The loft space will be enclosed in a timber stub frame with marine ply used as the side-walls and floor. The timber rafters will be exposed within the cavity space to provide roosting opportunities. This cavity space that will be provide roost opportunities for bats will be positioned at the eastern gable end of the structure as that is the side of the building that bats were observed emerging from during the bat survey.

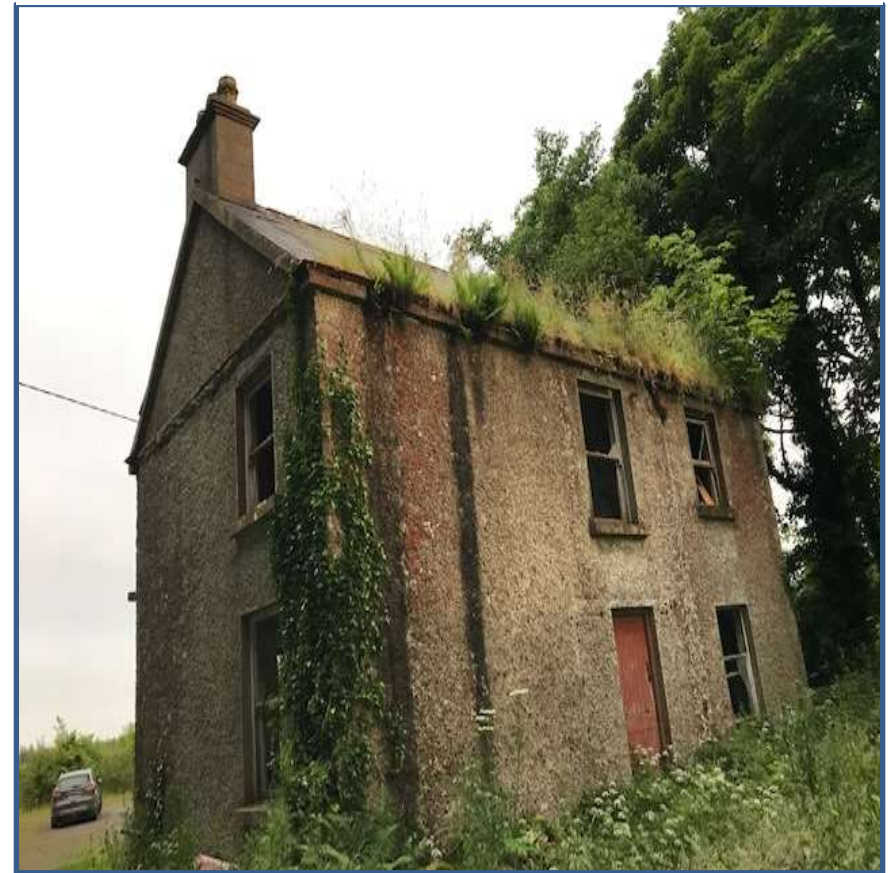
Plate 2: View of the northern elevation and eastern gable end from the northeast

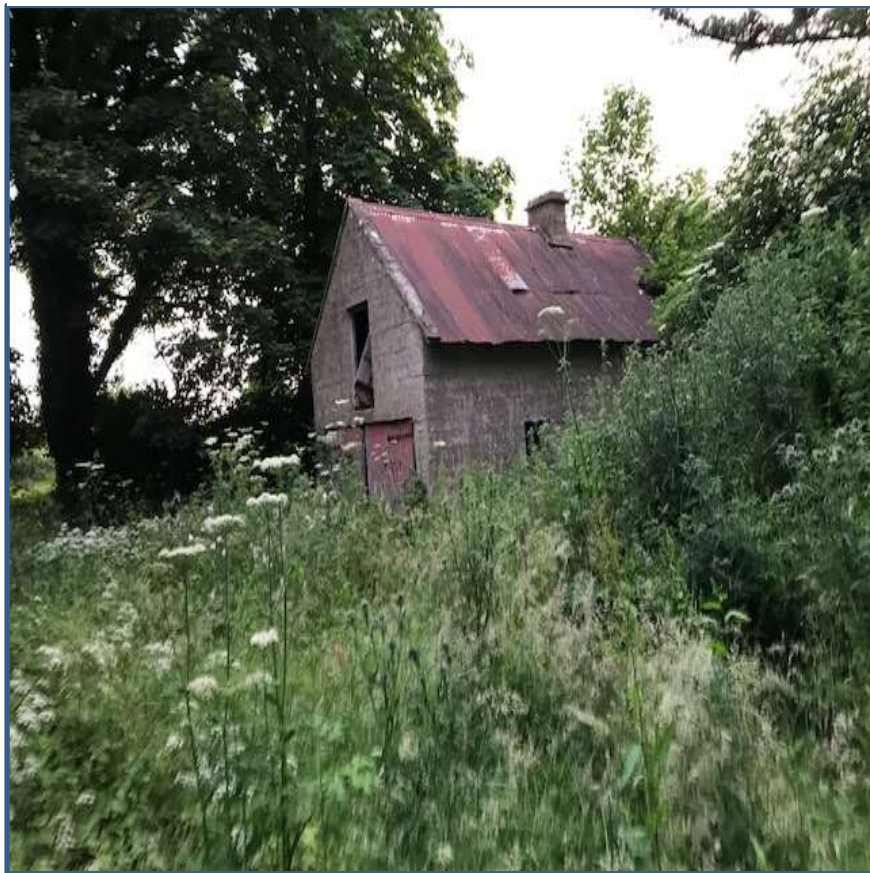
The shed to the rear of the dwelling is of low roost potential owing to the corrugated sheeting that forms the roof of this structure.

Plate 3: View of corrugated roofed shed to the rear/north of dwelling

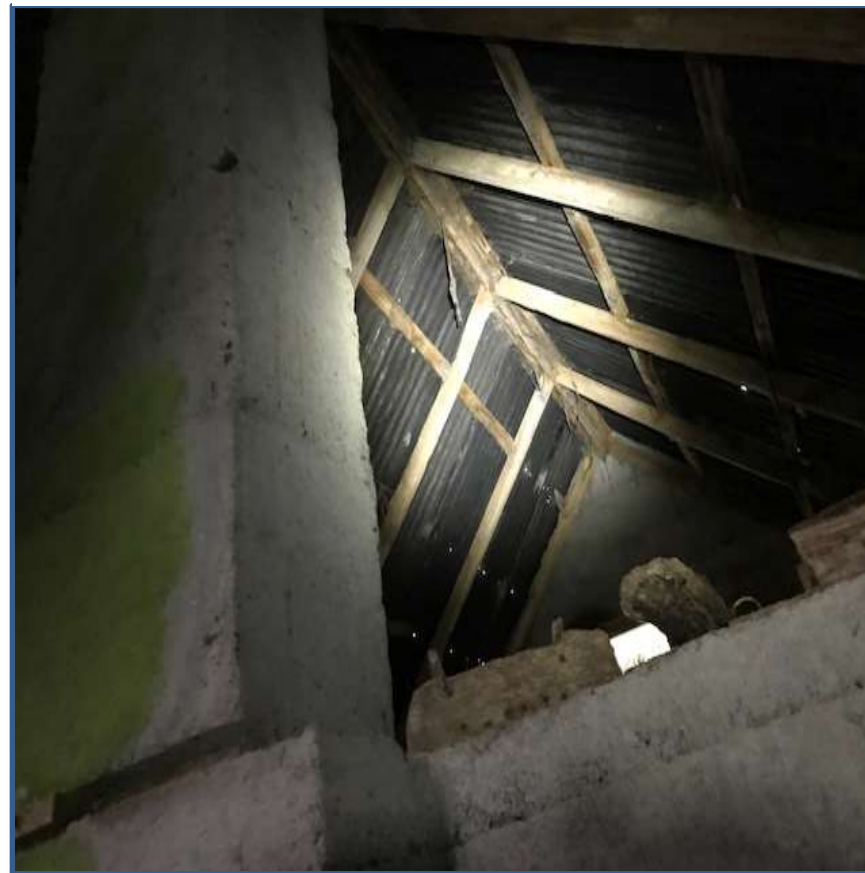
The corrugated roofed shed to the rear of the derelict dwelling does not support any roosting bats. No field signs or bats themselves were observed in the shed during daytime inspections and no bats were observed emerging from or entering the shed during any of the roost surveys completed at the site.

Plate 4: Internal view of the shed to the north of the dwelling
