1. INTRODUCTION

The following report was compiled at the request of John Britton Consulting Engineers on behalf of Galway County Council. It concerns an archaeological assessment of the existing Town Hall building in Loughrea, County Galway. Planning permission is being sought for the refurbishment of the town hall and conversion for use as a heritage/tourism facility and incubator offices. The archaeological assessment involved a desk based survey and site visit to assess the archaeological significance of the area in general and the specifically the site of the proposed development. It should be stressed that this is an assessment of the archaeological potential of the site. Conservation architect Ms Geraldine McManus is compiling a separate report on the architectural significance of the building.

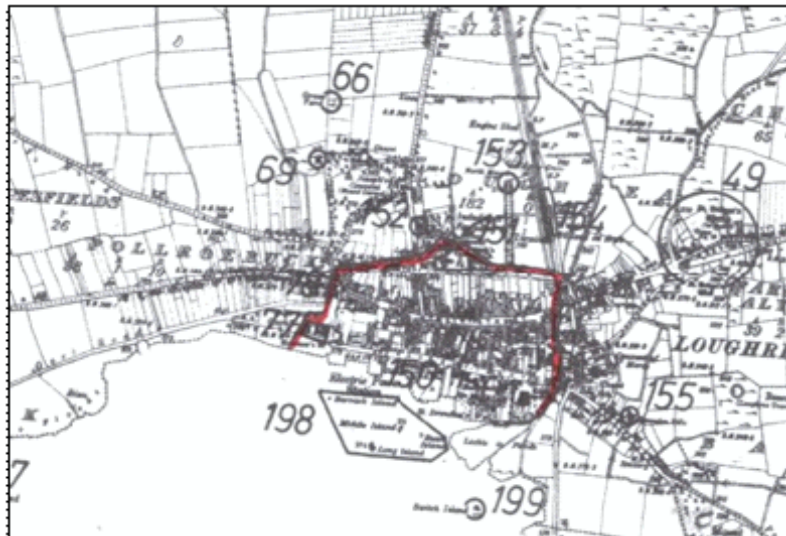
Figure 3 depicts the zone of archaeological potential around the town of Loughrea. It is clear from this map that the town hall building is located within this zone of archaeological potential. The existing building is located immediately N of the medieval street layout and in the general vicinity of where the original castle may have been located. While the proposed planning application is concerned only with refurbishment of the existing structure **any disturbance to ground level inside or outside the building should be monitored by a suitably qualified archaeologist.**

Fig. 3: Extract from Sites and Monuments Map, Sheet 105 indicating the zone of archaeological potential (highlighted in red).

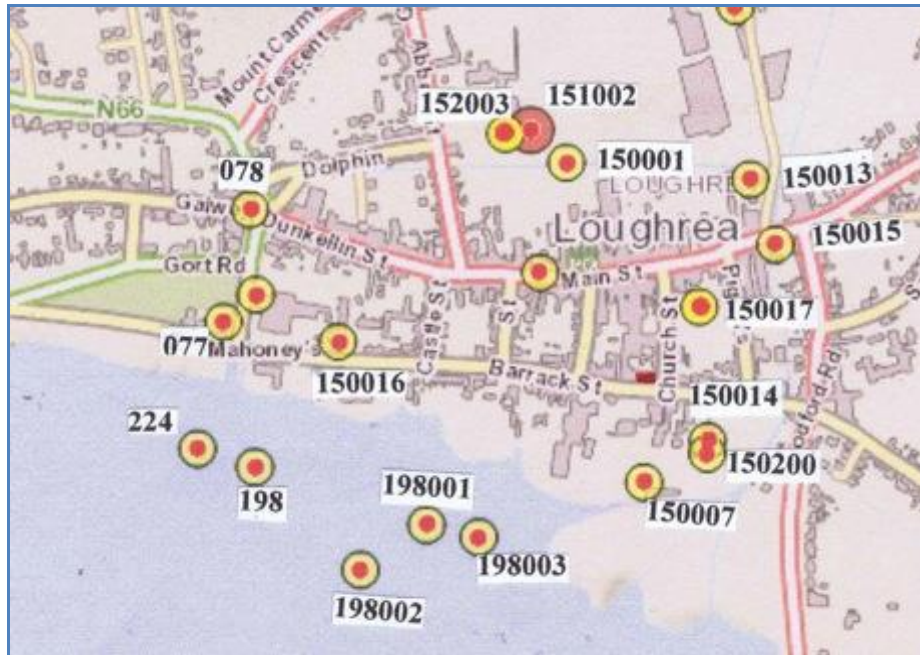
The following map (Fig. 4) and table (Fig. 5) highlight the recorded archaeological monuments in the area of the proposed development. It should be emphasised that none of these monuments will be directly impacted by the development. The development site is located on the N side of Barrack Street at the intersection between Barrack Street and Church Street. Located within the medieval town of Loughrea (GA105:150), as detailed in Section 3, there are a number of monuments in the general environs. South of the development site, in the N fringes of the lake there are five lake dwellings or Crannogs (GA105:19800-198003, GA105:224). The tradition of building these lake dwellings dates back to the Neolithic and they are defined as predominantly wooden enclosures, constructed on natural or artificial islands. Brushwood, peat and stone were used in their construction and they functioned as habitation sites of permanent or seasonal use. Ecclesiastical features/sites in the area include St. Brendan's Cathedral (GA105:150014) to the SE, a church and graveslab (105:150017) to the N and a church (GA105:150013) further N. A holy well (GA105:150007) is indicated c. 130m to the S while a cross (GA105:152003) is located 400m to the NW. A mill (GA105:015) located 250m to the NE is the only Industrial site in the vicinity.

Fig. 4: Map indicating recorded archaeological monuments in the area.

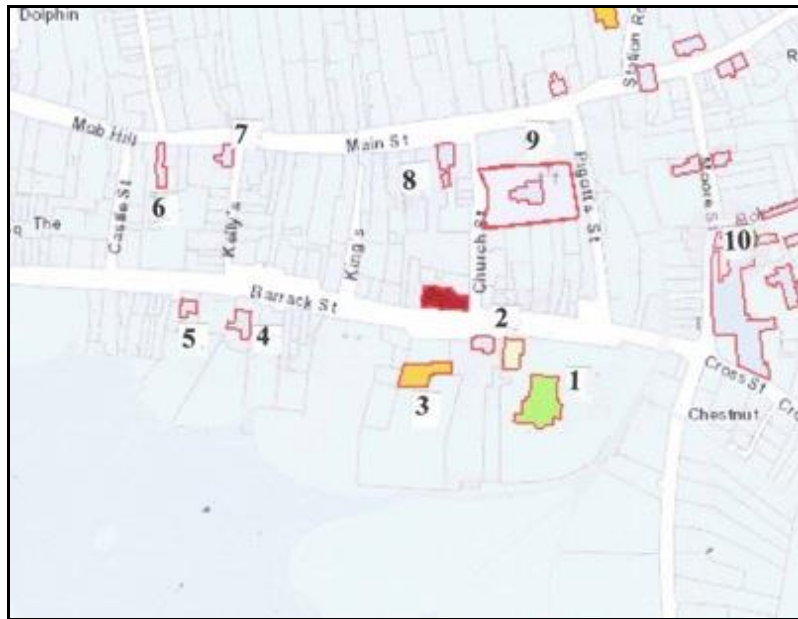
The National Inventory of Architectural Heritage was consulted to evaluate the number of sites in the area that were considered to be of architectural significance. Figures 6 and 7 highlight the results of this search. The majority of recorded buildings in the area are houses dating from to the 19th and 20th centuries.

Fig. 6: Recorded Architectural sites in the area.

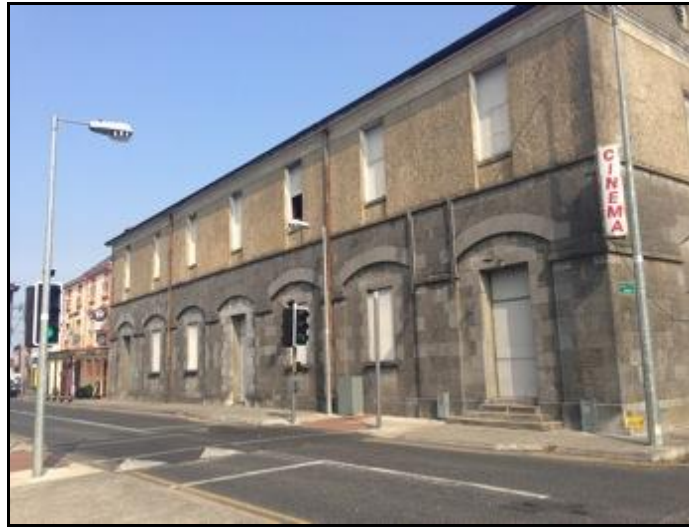
The site of the proposed development is located within the medieval town of Loughrea, situated at the junction of Barrack Street and Church Street and adjoining a public house to the W. The National Inventory of Architectural Heritage records the building as being of Regional importance (Reg. 30337027) while the building is listed as a protected structure by Galway County Council (Reg. 315). The building comprises of an attached two-storey seven-bay structure with a pitched roof and overhanging eaves with arcade details on the lower floor (Plate 1). Built as a town hall in c. 1860 the building was subsequently a cinema and ballroom and is currently unused and falling into disrepair. The dressed limestone walls of the ground floor have a dressed limestone plinth course and there is a render string coursing between floors. The first floor has roughcast rendered walls. There are square headed window openings throughout with the ground floor doorway openings also squared and set in segmental-arched recesses. All of doorway and window openings are presently boarded up and entrance is only gained off Church Street where an iron gateway gives access via a narrow passageway to the building (Fig. 9). The ground floor level consists of one large rectangular room which was used as a cinema with a ticket booth and lobby at the E end, two rooms along the N wall (one

Plate 1: View of building from the SE.

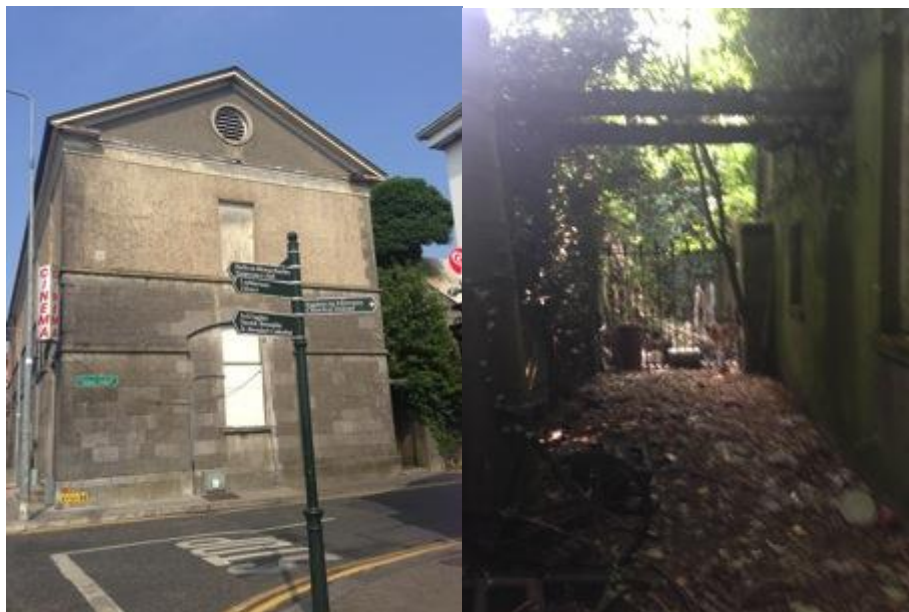
Plates 2 & 3: E elevation and yard in N of building.

The first floor plan is similar to that of the ground floor with one large room, that functioned in the last century as a ball room, a stage at the E end and a number of rooms and toilet facilities in the NE. The building retains the furniture and fittings dating to its use as a cinema and ballroom. The six-over-six pane timber sliding slash windows to the front elevation have been removed and are lying against the S wall of the interior. A narrow yard in the N of the building (Fig. 9, Plate 3) has an iron gate in the E
