ARCHAEOLOGICAL IMPACT ASSESSMENT ASSOSIATED WITH THE PROPOSED MULTI-USE COMMUNITY BUILDING AT BURKES LANE, ATHENRY, COUNTY GALWAY.

PART 8-PLANNING APPLICATION

Martin Fitzpatrick, M.A. February 2023

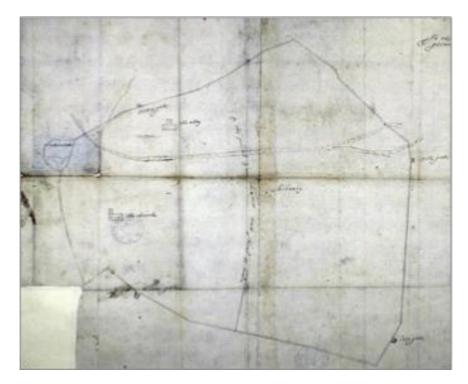
Fig. 4: 'Plat of Athenry' 1583, J. Browne (PRO SP63/104/34)

One single late-medieval/early modern map survives for Athenry. That map was created in 1583 by John Browne and is entitled 'The Plat of Athenry'. It contains little detail apart from the location of the internal wall referred to by Sidney in 1576, which essentially cut the town in half.

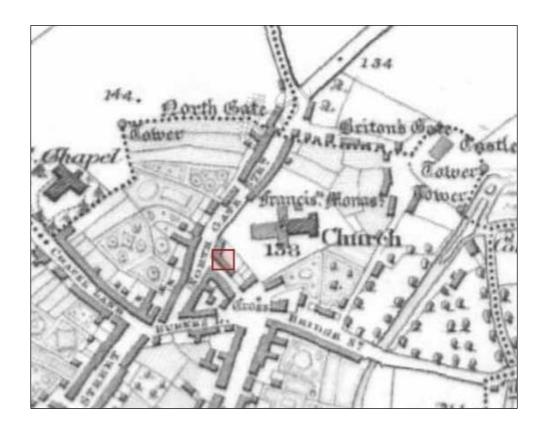
Fig. 5: Extract from 1st edition O.S. Map (After OSI).

An examination of the various ordnance survey maps provided an opportunity to trace the development of the area from the 19th century. The existing street pattern is evident on the first edition maps and has changed little. The first edition map (1838) indicates a building at the site fronting onto Burke Lane with garden space at the rear.

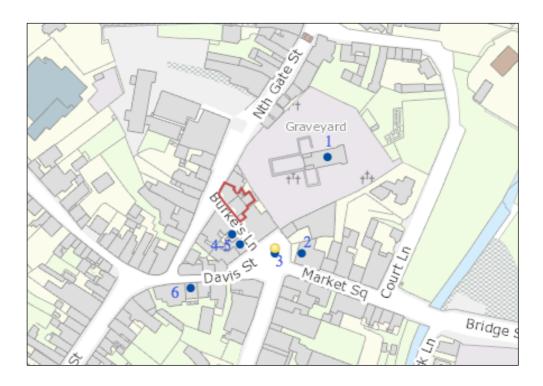
Fig. 7: Recorded Protected Structures and structures recorded in NIAH located in vicinity of the site.

Known architectural heritage assets in Burke Lane and area surrounding it are listed below and shown in Figure 7. The proposed works are located within the Town Centre Architectural Conservation Area. A total of 6 structures in the vicinity of Burke Lane/North Gates Street are recorded in the National Inventory of Architectural Heritage, one of which is also a Recorded Protected Structure.

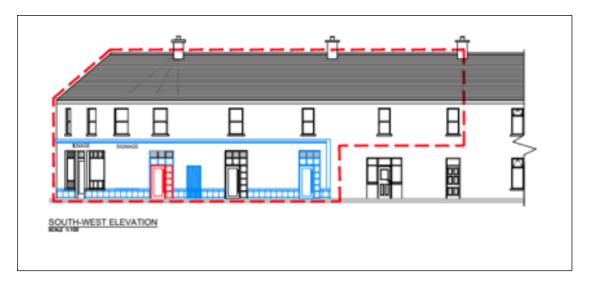
Fig. 8: Existing elevation.

The site was visited on Friday 10th of February 2023. The existing building is a two storey premises with a modern slate roof, three chimneys and modern facia and gutters. The building faces onto both Burke Lane and Northgate Street in the centre of Athenry town. The recently painted building is attached to a two storey dwelling house on North Gate Street and a commercial building with residence overhead facing onto both Burke Lane and Market Square.

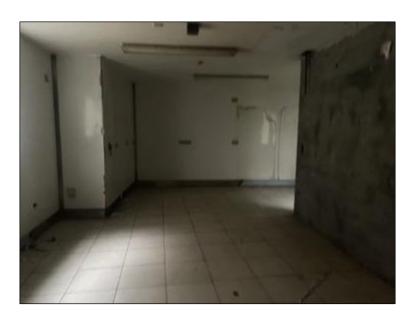
Plate 5: Former kitchen/food preparation area. Taken from S.

A modern wooden panel door in the E wall leads to a two modern toilet facilities with tiled floors and modern sinks. A composite door in the N wall leads to the very small overgrown yard area that has a concrete covering. A second doorway in the E wall leads to a large roughly rectangular area lit by a window in the W wall. With tiled floor and modern fixtures and fittings this room functioned as the kitchen/food preparation area. A gap at N end of E wall leads to a N-S running hallway with a composite door in N wall that leads to a narrow outside space and a similar doorway in S wall that leads to Burke's Lane. A modern toilet is accessed via a wooden door in W wall of hallway.

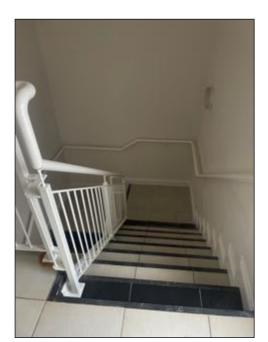
$\textbf{Plates 7 \& 8:} \ \ \textbf{Modern stairs and window on landing at first floor level}.$

A metal stairway accessed from a composite doorway from Burke Lane leads to the first floor level of the building. The hallway, steps and first floor landing have tiled floors and modern fixtures and fittings. The first floor landing is lit by a large window looking onto Burke Lane. The first floor level of the building, like that below, has primarily got plasterboard covering the original walls and has modern fixtures and fittings throughout. Floor coverings are carpet, tiles and vinyl while window frames are composite or wood all of which have been inserted in the last 20 years.

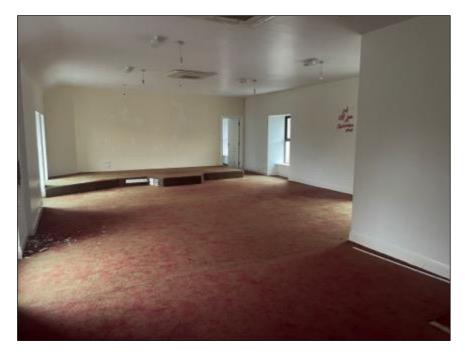
Plate 9: View of main room at first floor level. Taken from the W

The main ground floor area is a large room lit by two windows overlooking Burke Lane and three looking onto St. Marys Church (GA084-00015). The original walls are covered by painted plasterboard and carpet covers the floor. There are modern fixtures and fittings throughout. The E end of the room has a raised floor level. A doorway, off centre to S in E wall leads to a very small chamber lit by a window looking onto Burke Lane. A doorway in the W wall of the room leads to a hallway that in the S leads to the stairs and a room that overlooks the intersection between Burke's Lane and North Gate Street and in the W leads to further toilets and two further rooms overlooking North Gate Street.

The proposed development will see the removal of the existing plasterboard to facilitate a breathable membrane to be placed against the original walls. The removal of the plasterboard will afford the opportunity to record the original features of the building and it is recommended that these features are recorded throughout the building. Any features of architectural significance noted should be reported and provisions made to incorporate them into the new design. The County Council Architectural Conservation officer should be consulted to advise on how best to proceed in relation to any features from the original building being incorporated into the new design.
