Bat Survey Report

Renovation of Somers House

at Burkes Lane, Athenry, Co. Galway

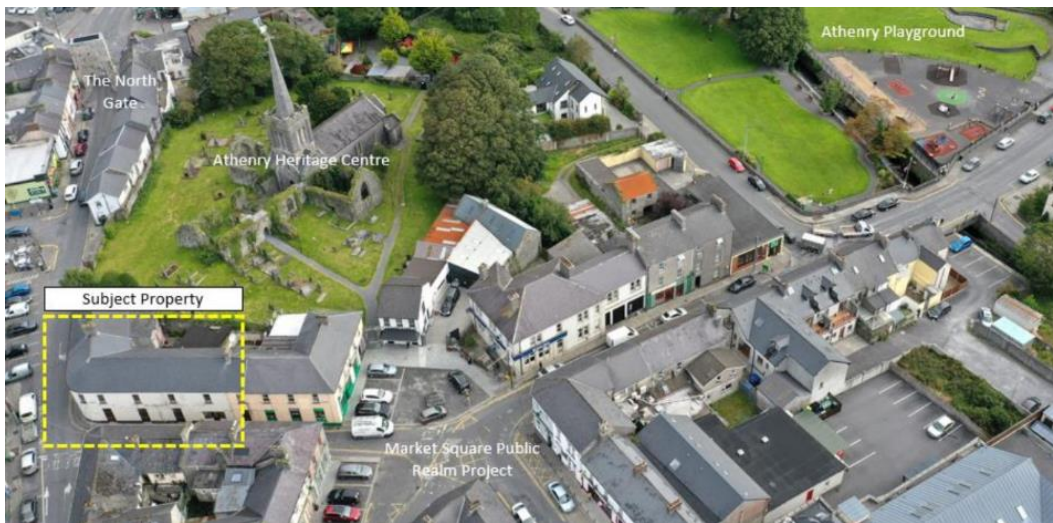
Plate 3-1: Aerial view of building

The site in question consists of an existing building situated within the town of Athenry. The site is located to a former church and graveyard now used as a heritage building. This neighbouring site has potential for roosting and feeding bats although several lamp-posts were noted which if turned on frequently would lower the potential for bat usage (plate 3-1).

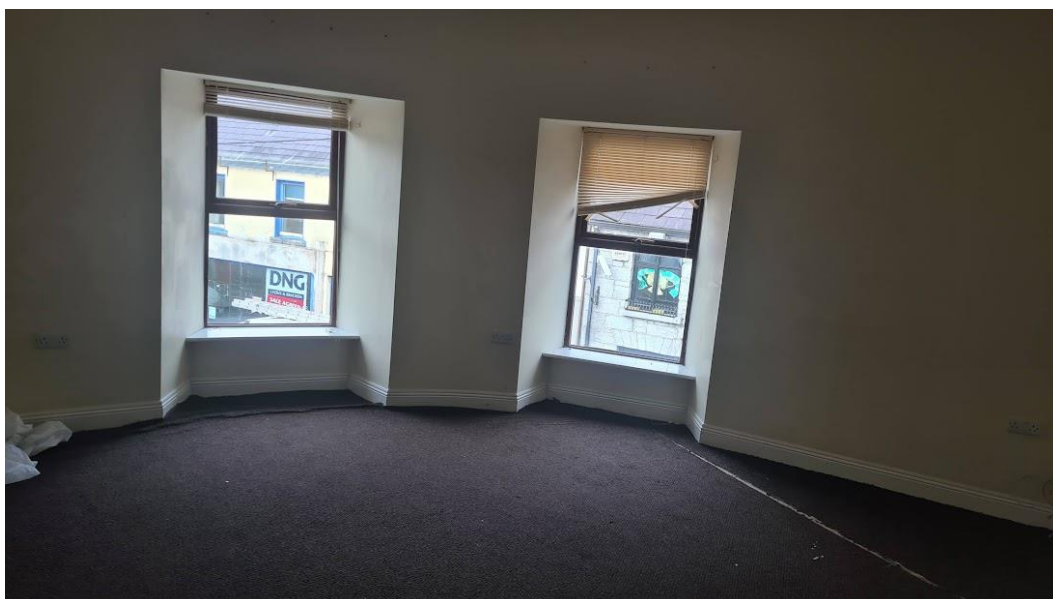
Plate 3-2 Upstairs in building

All rooms were examined for evidence of bats. Soft furnishings such as curtains were examined as wintering bats can hibernate in them. No evidence of bats were found. Upstairs consists of multiple rooms, each with double glazed windows. Windows were checked for access points, no evidence of bats or droppings found (plate 3-2).

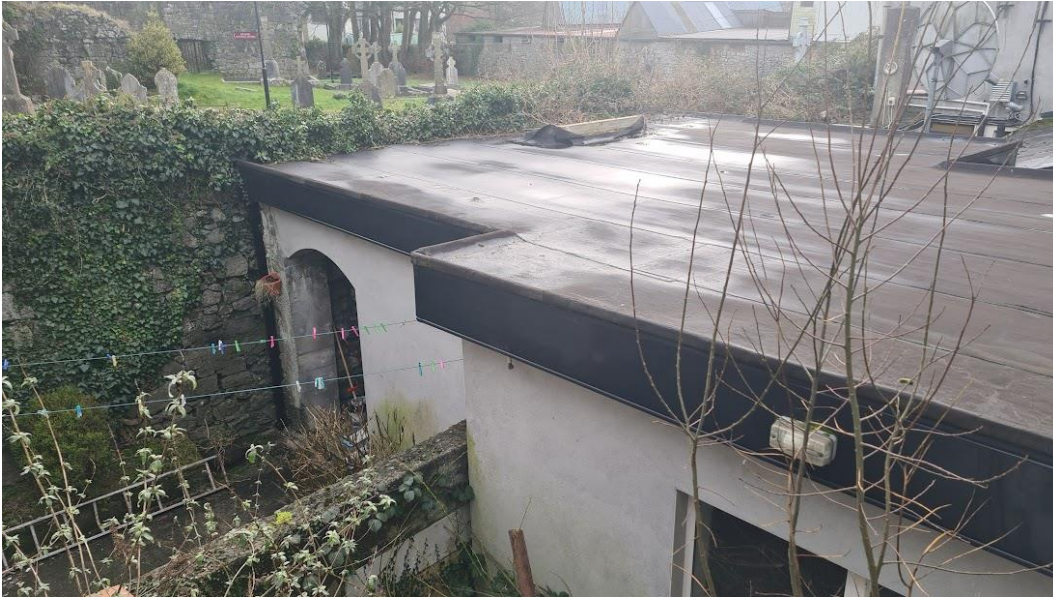
The subject two-storey building is in good condition, both externally and internally. Externally the building has a plaster render and slated roof with minimal potential access points suitable for bats. A flat roof section to the rear is partially within the site boundary. The roof of this section consists of bitumen. A portion outside the boundary of the building has a skylight type split in the bitumen that could provide access (plate 3-3). This was not examined as it lay outside the boundary of the site. A single external cavity was recorded under a bitumen lip to the rear of the building (plate 3-8). No sign of bats was found here.

Plate 3-3 Bitumen felt roof with potential access

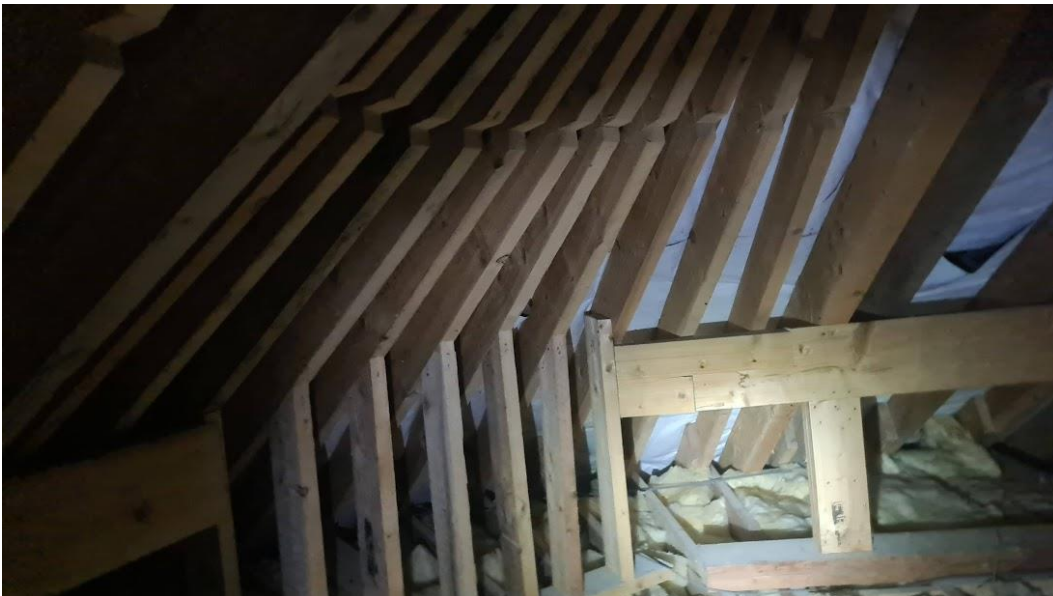
The attic was also examined. The roof is in good condition and was previously renovated (plate 3-4). No gaps found along main section and it is lined with breather membrane. Both gable walls were examined. The southern wall consists of stone (plate 3-6). Some gaps can be found towards the adjoining attic space (internal wall) however the wall was completely covered in cobwebs with no bat droppings. The North-east wall (brick) was similarly covered in cobwebs

Plate 3-4 Attic space

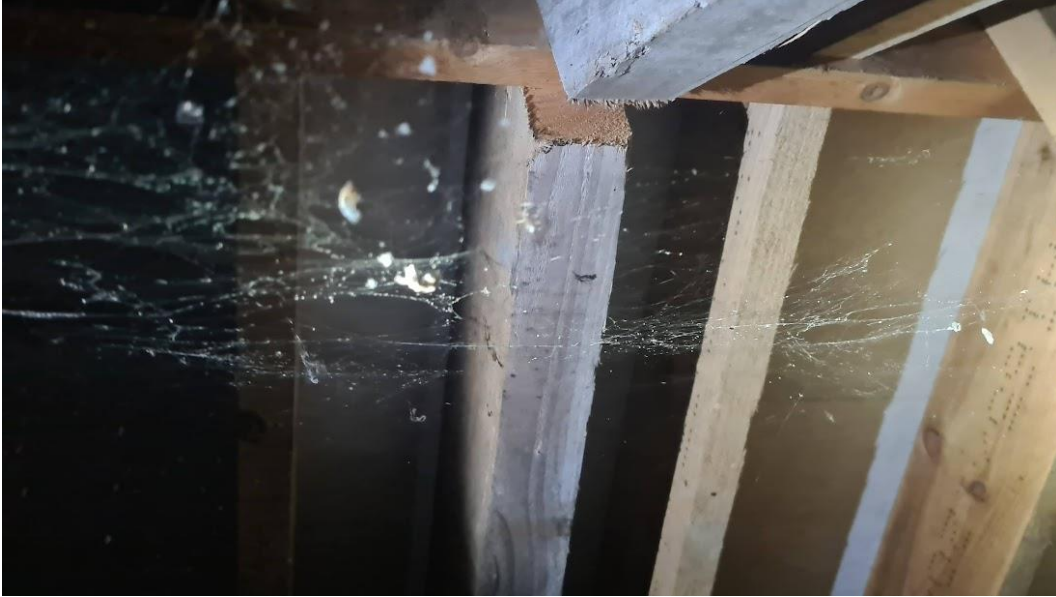
with no cavities present (plate 3-7). There was also an accumulation of cobwebs along the top edge of ridge beam (plate 3-5). This is the area most likely to host void dwelling bats such as Brown Long-eared. The accumulations of cobwebs here is a negative indicator for these types of bats.

Plate 3-5 Accumulation of cobwebs in attic space

No evidence of bats using the building were found during the daylight building assessment. A thorough search was conducted throughout the building and no signs of bats was found. An accumulation of cobwebs in the attic space is a good indication that no flying species use the space. No signs of bat droppings, or staining were found.

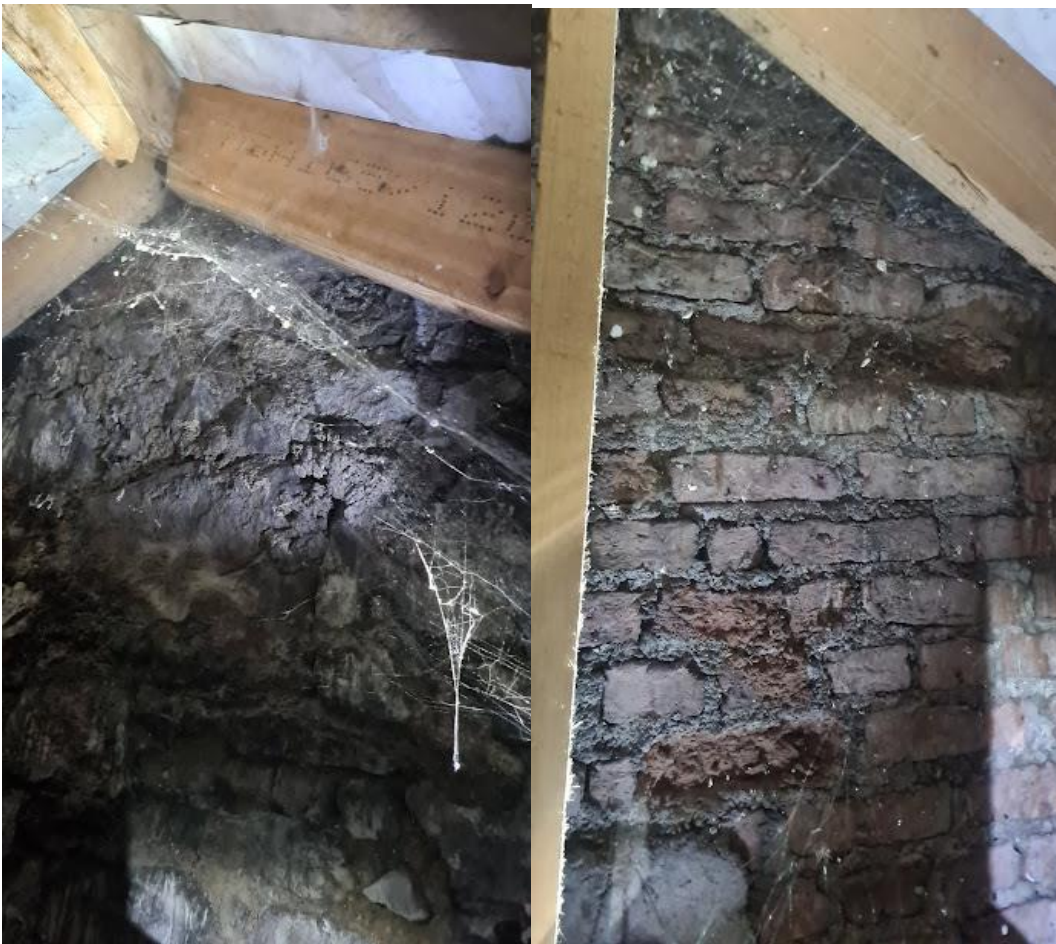
Plate 3-6 Southern gable wall

Plate 3-7 NE gable wall

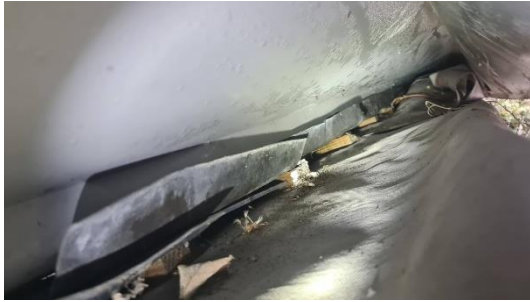
Plate 3-8 view under bitumen

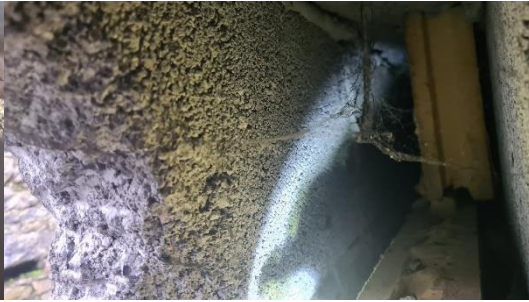
In the downstairs flat roofed extension, a ducting pipe has been removed providing potential access externally, thorough an insulation filled cavity wall. This was examined however no evidence of bats was found (plate 3-9 to 3-11).

Plate 3-9 Inside cavity wall

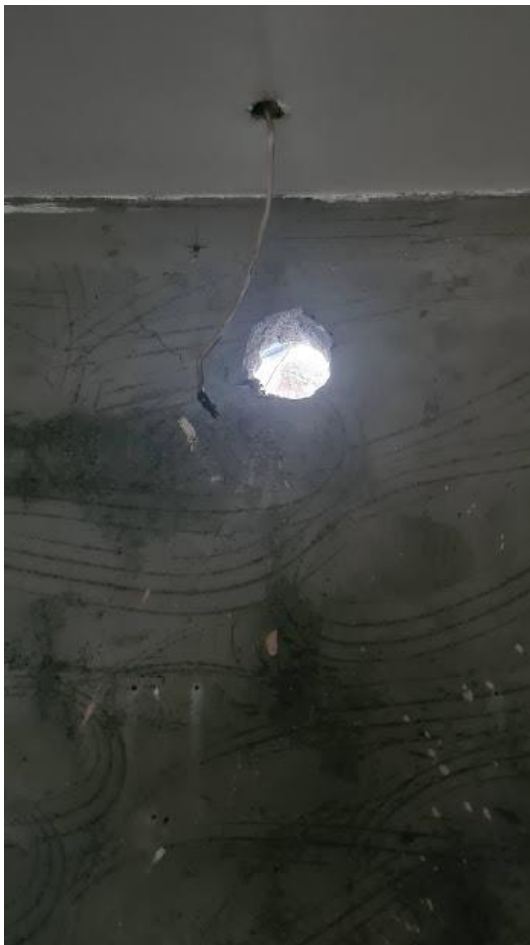
Plate 3-10 large opening to rear of building

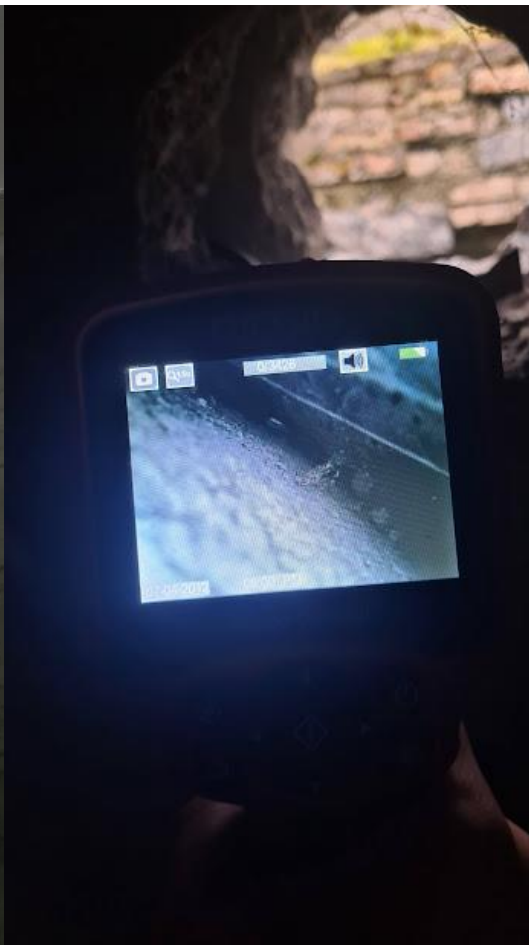
Plate 3-11 Inside wall cavity
