Claregalway, Co Galway

Archaeological Impact Assessment

Client: Galway County Council

Report Date: 4th August 2021

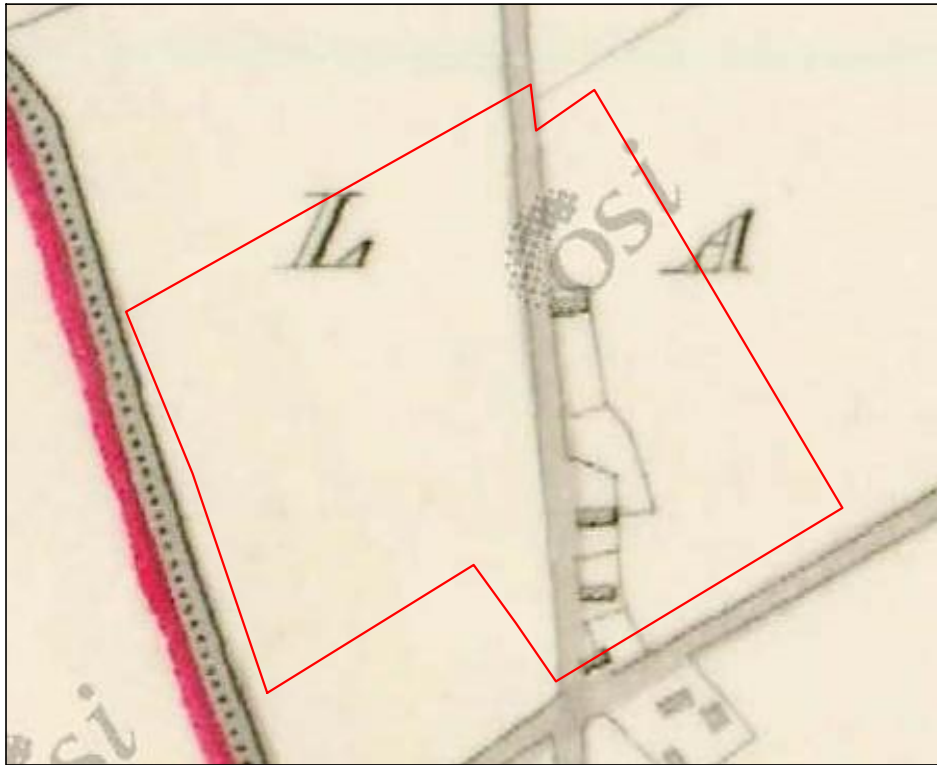
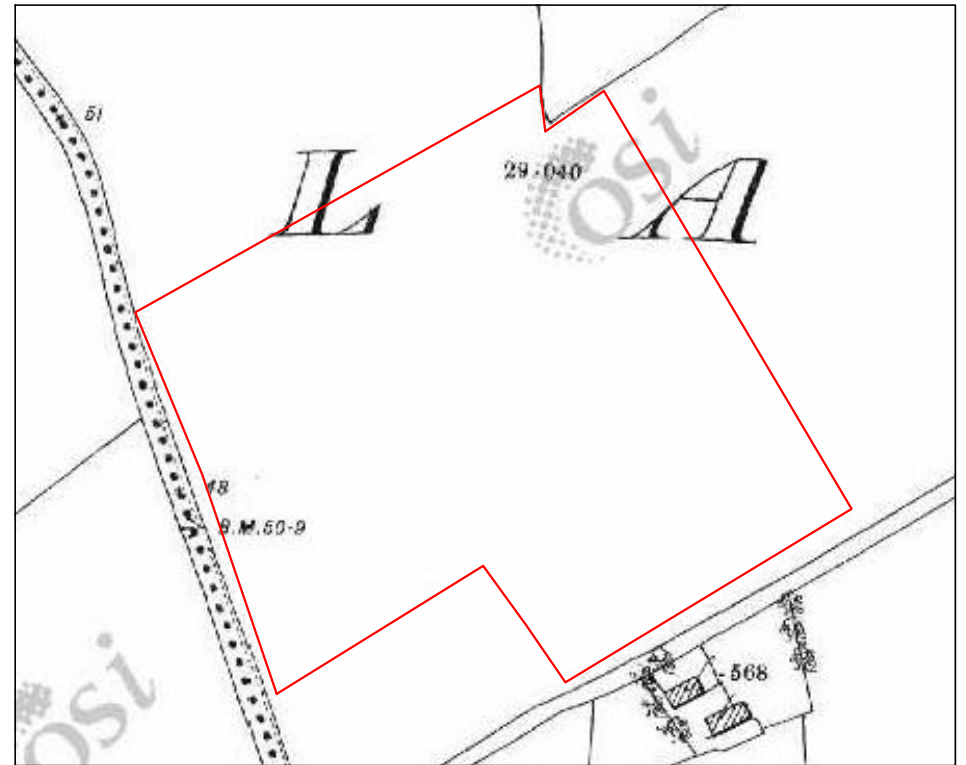
Figure 3: Extracts from Historical Mapping

In the 1st Edition OS Map (1837) a roadway aligned N/S bisected the subject site and was lined on the eastern side by houses and their associated gardens. The houses, gardens and road were absent in the 1888-1913 OS map There were no additional features of archaeological potential noted in the subject area.

(l) 1st Edition OS Map (1837)

(r) 2nd Edition OS Map (1888-1913)

- The 1st Edition OS Map (1837) depicts a roadway aligned N/S which bisected the subject site. It was lined on the eastern side by houses and their associated gardens. The houses, gardens and road were absent in the 1888-1913 OS map.

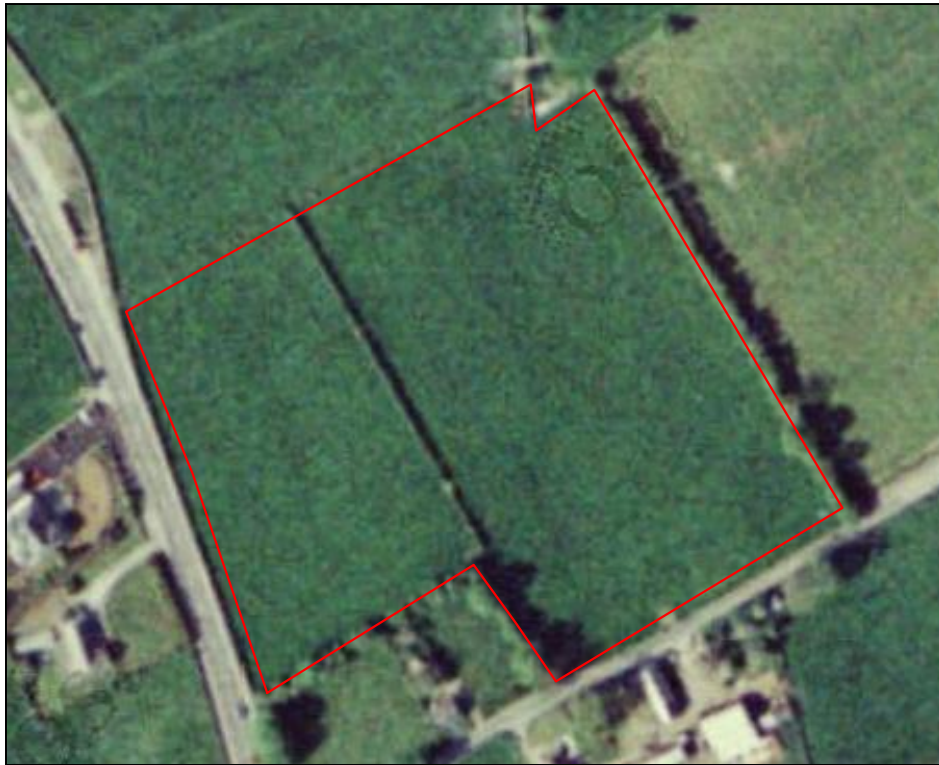
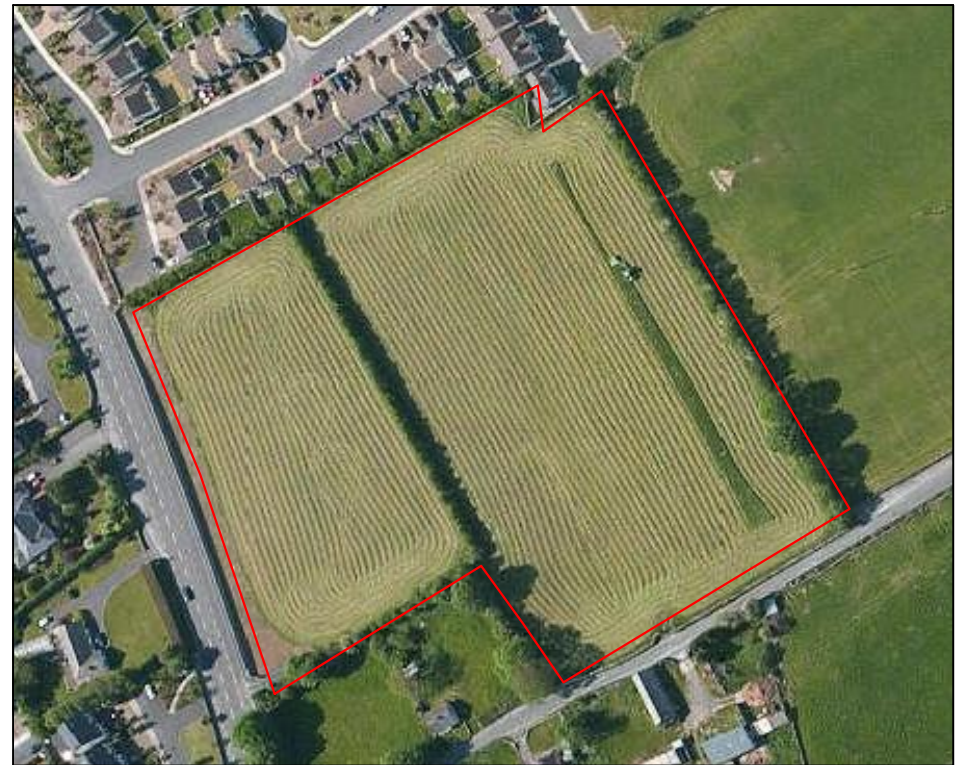
Figure 4: Extracts from Aerial Photography

The 2005 & 2005-2012 OSi Aerial Photographs and 2020 Google Maps Aerial Photograph clearly show the line of the pre-1840s N/S roadway and associated houses located in the eastern field (Figure 4). This roadway was depicted on the 1837 OS map. It bisected the subject site and was lined on the eastern side by houses and their associated garden. The houses, gardens and road were absent in the 1888-1913 OS map There were no additional features of archaeological potential noted in the subject area. See Table 2 below for details.

(l) OS Aerial Photograph (2000)

(r) Digital Globe (2013)

- The pre-1840s roadway and associated houses are visible as crop marks on aerial photography.
- There were no additional features of archaeological potential noted in the subject area during analysis of historical mapping or aerial photography.

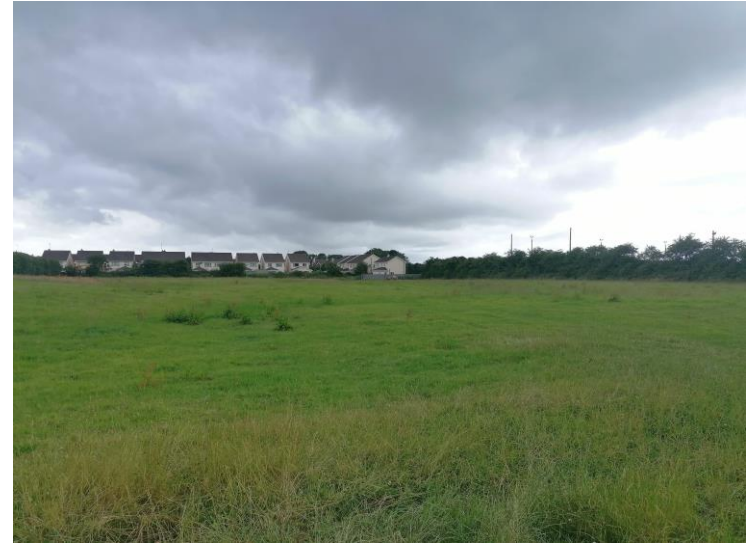
Towards the southern end of the eastern field was a gentle, shallow linear hollow, identifiable by reeds at its base. To the east of this shallow hollow area were numerous low lumps and bumps suggestive of underground features; possibly the remains of a roadway that once crosses that field in a N/S direction as recorded on the 1st Edition OS map (1837) (Figure 3, Plate 2 & 3). This hollow linear can be followed through the field to the south of the subject site, also corresponding to the location of the road on the map. The lumps and bumps lining the east of the linear hollow within the subject site are likely to be the remains of the houses and gardens depicted on the 1st Edition OS map. These houses and the road were demolished by the 2nd Edition OS map (1888-1913) (Figure 3).

Plate 2: S corner of E field, note the reeds, Facing N

It is recommended that the site be subject to further assessment namely geophysical survey of the subject site followed by test trenching of same.

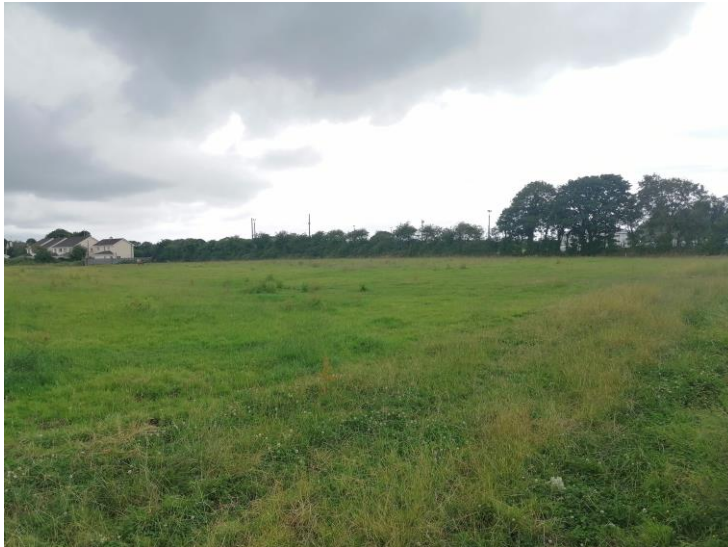
Low lumps and bumps and a shallow linear hollow were noted in the southern end of the easternmost field. These correspond to a pre-1840s roadway and associated houses which were

noted on the 1st Edition OS map. There were no additional features of archaeological potential noted in the development area.

Plate 3: S corner of E field, note low lumps and bumps, Facing NE

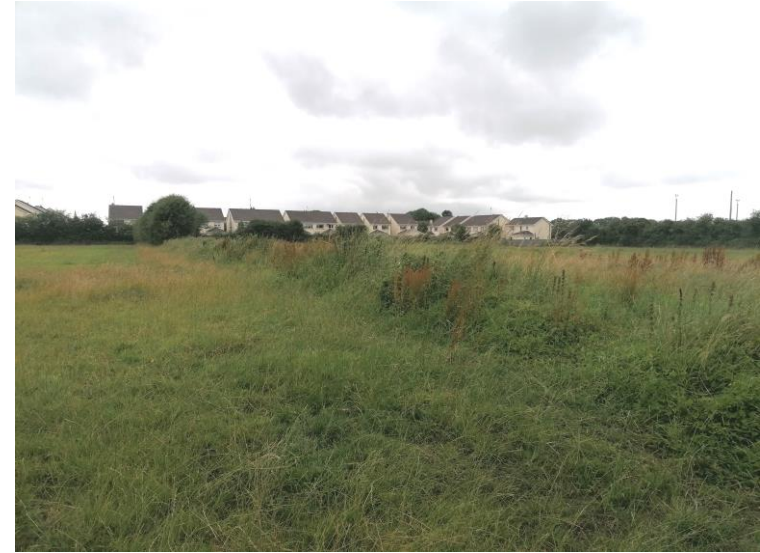
The site was visited by Maeve McCormick of Archer Heritage Planning Ltd on 30th July 2021 in drizzly conditions (Plate 1-8). The development site comprised two grassy fields currently in use as horse grazing pasture. The fields are surrounded by a modern stone wall (Plate 8). The two fields are divided by a hedge aligned NNE/SSW, there is a gap to the south of the hedge allowing easy access to both fields (Figure 4, Plate 6).

Plate 6: E corner of W field, showing dividing hedge row, Facing N

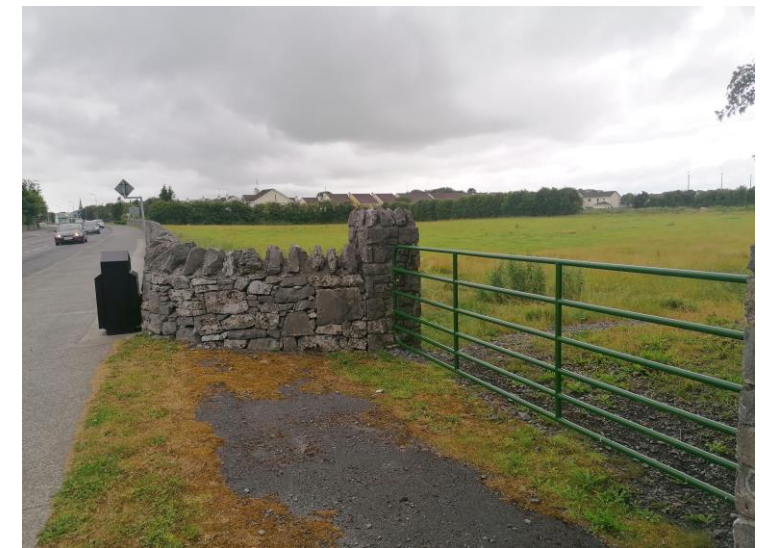
The proposed site is located on a 2.8Ha of open pastureland c.0.5km south of Claregalway village, on the eastern side of the R381 road. It is bordered by the R381 on the west, Lakeview Road to the south, a small disused cottage and its boundary hedges in the SW corner, Housing Estate 'Cuir na hAbhann' to the north and Claregalway Community college greens and football pitch to the east. It is currently in use as horse grazing land. The subject area is bisected through the centre by a NW/SE hedgerow. This divides the land into two separate rectangular fields. The subject area is enclosed by a modern limestone wall which lines the footpaths.

Plate 8: Modern stone wall enclosing subject site
