An Spidéal Pedestrian Crossing

Stage 1 Road Safety Audit

Comhairle Chontae na Gallimhe

September 2025

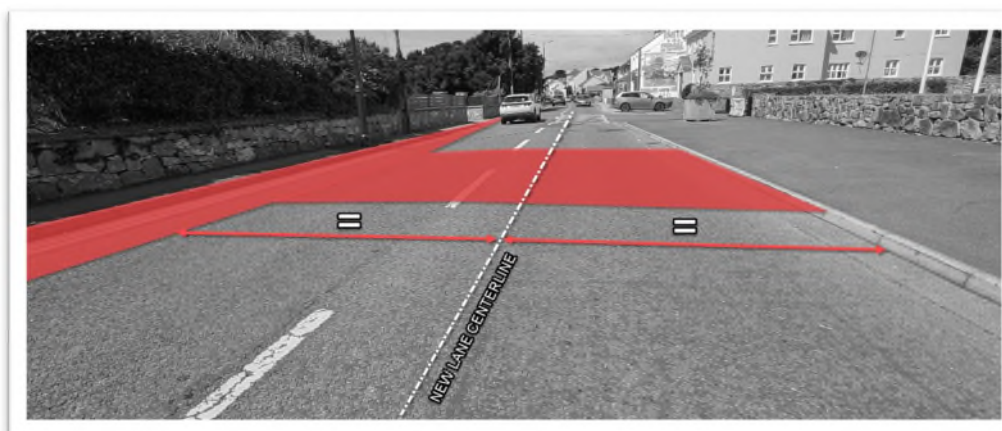
Figure 2.2 – Footpath Widening Will Require Adjustment to Centreline Road Markings

2.2 Problem: Tie-In to Existing Centre Line Road Markings

Location: Road Markings Serving R336 In Proximity to New Crossing

Failing to adjust the existing centreline road markings and yellow box marking to account for the footpath widening could lead to unequal lane allocation, resulting in driver confusion, kerb strikes and head-on type vehicle conflicts.

Recommendation

The existing centre line markings and yellow box markings outside the school entrance should be modified appropriately to ensure a seamless tie-in to the new crossing works.
