## DEMOLITION & REPLACEMENT OF EXISTING COTTAGE AT: CHURCH STREET, LOUGHREA, CO. GALWAY

Architectural Heritage Impact Assessment 30/07/2026

**aughey o' flaherty architects**

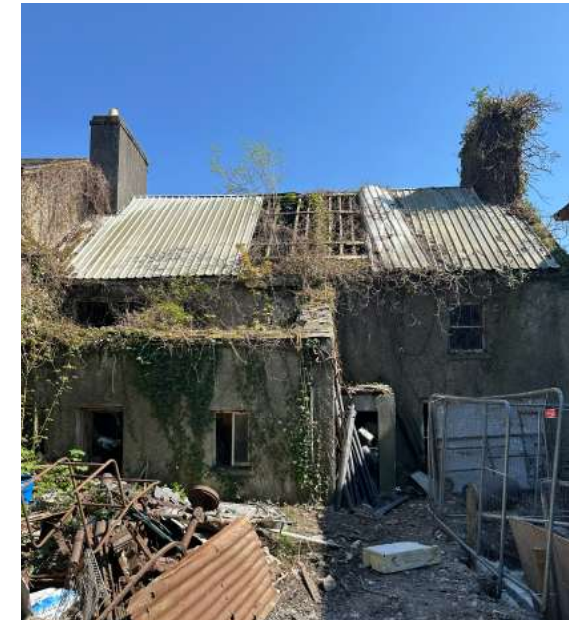
Fig.18: View from Rear

It is not clear when the roof has collapsed, but the current condition is partly due to extensive water ingress to all parts of the interior through the missing roof. The entirety of the slates are missing from the roof and the condition of the primary roof timbers is beyond repair.

The interior of the building is heavily saturated and floor joists on the upper floors are partially extant and partially collapsed, and likely to be significantly weakened through rot. Most of the floorboards at first floor level appear to have been removed. The plaster and lath ceilings at both first floor and ground floor level have, for the most part, collapsed into the ground floor rooms. The timber floorboards at ground floor level are saturated and soft through rot, with gaps where the floorboards have collapsed into the floor void below.

The structural cross walls and chimney breasts are intact and are contributing to stability of the structure. The external plaster to the Church street facade appears in poor but stable condition, while all architectural features and external joinery are missing. Established wild ivy and creepers have taken over the side and rear facades in a number of locations.

From visual inspection, we estimate that the loss of the roof covering and associated heavy water ingress took place within the last twenty years. It is possible that a single incident such as major storm damage or the theft of lead from the roof may have accelerated this deterioration. The damage to the building is considerable, and much of the architectural fabric is irretrievable. The building has received a temporary roof cover made of corrugated metal, of which a significant portion is missing at the rear, which we believe has caused further damage.

- 'Bellying' of the front masonry wall as structural elements have decayed and failed.
- First floor structural timber joists and internal masonry 'tie walls' have separated from the external walls.
- Leaning of the southern gable and chimney towards the town hall.
- Collapse of first floor timbers.
- Collapse of the timber staircase and landings.
- Decay and collapse of timber lintels.
- Failure and collapse of roof structure of both the cottage and lean-to extension.
- Deterioration of timber roof trusses has resulted in decay of roof covering fixings.
