**Structural Condition  
and  
Remedial Intervention Report  
to  
Church Street, Loughrea**

Report Ref: CORA-26110-RP-01

Date: 27th April, 2026

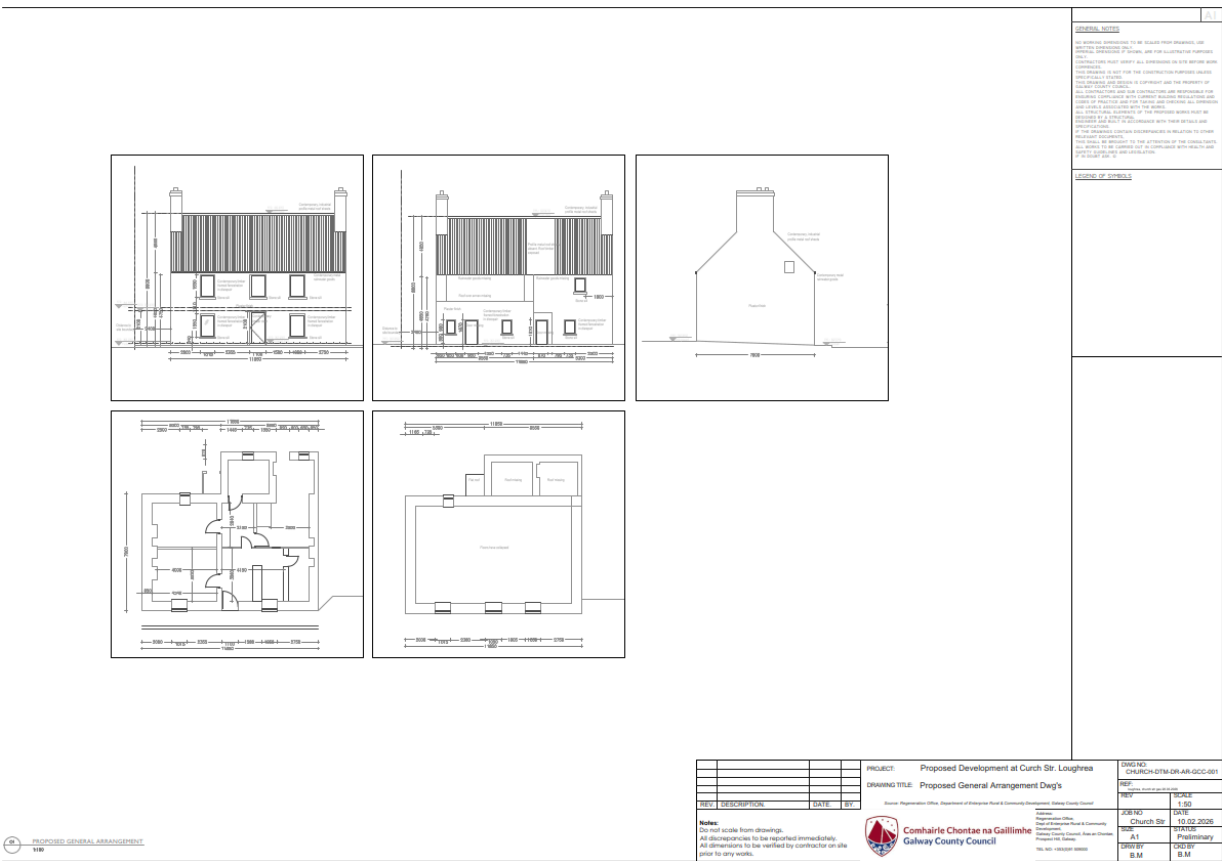
Drawing 2 - General Arrangement - Galway County Council

The load-bearing walls are unreinforced random rubble stone of varying thicknesses. The front elevation is finished with render, while the southern gable consists of exposed stone.

The internal floors comprised timber joists. The main roof is a pitched timber structure with profiled metal sheeting. The roof of the rear lean-to extension has collapsed.
