**BAT AND SWIFT SURVEYS AT DUNLO HILL
TERRACE, DOOLEY'S PUB AND ADJOINING
PROPERTY, BALLINASLOE, CO. GALWAY**

Structure: Dunlo Hill Terrace, Dooley's Pub + Adjoining 3 storey house

Proposed Works: Renovation to residential units

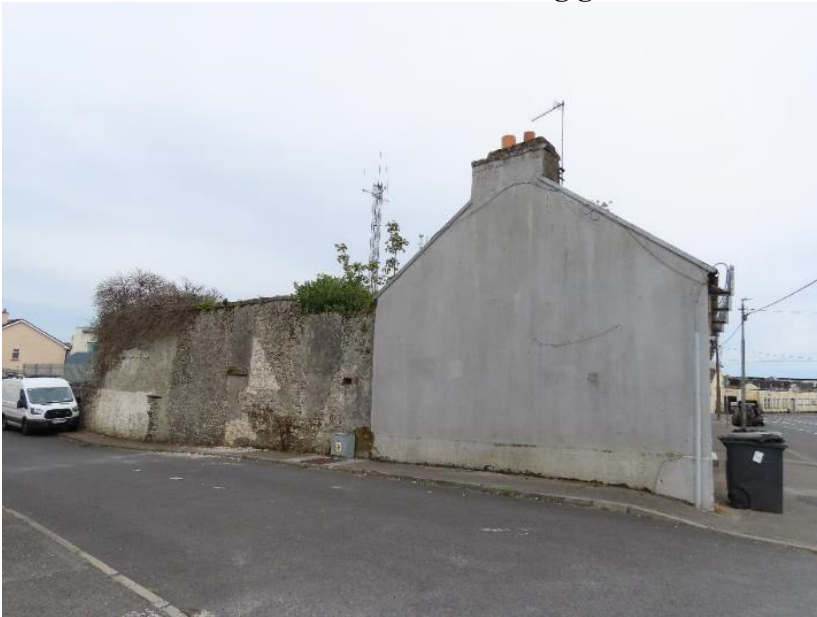
Photo 1 – western end of Dunlo Hill terrace – western gable and stone wall to rear

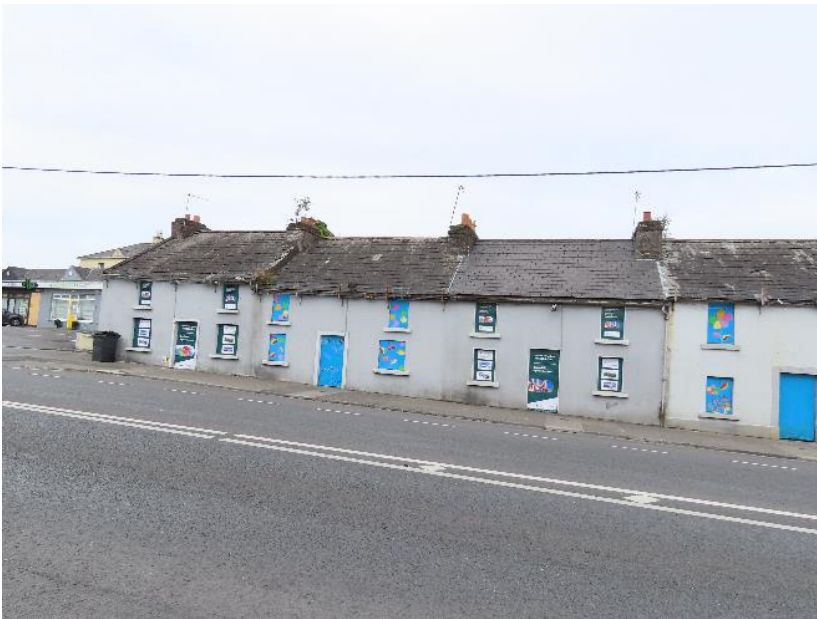
Photo 2 - Properties 1- 4 at western end of Dunlo Hill terrace

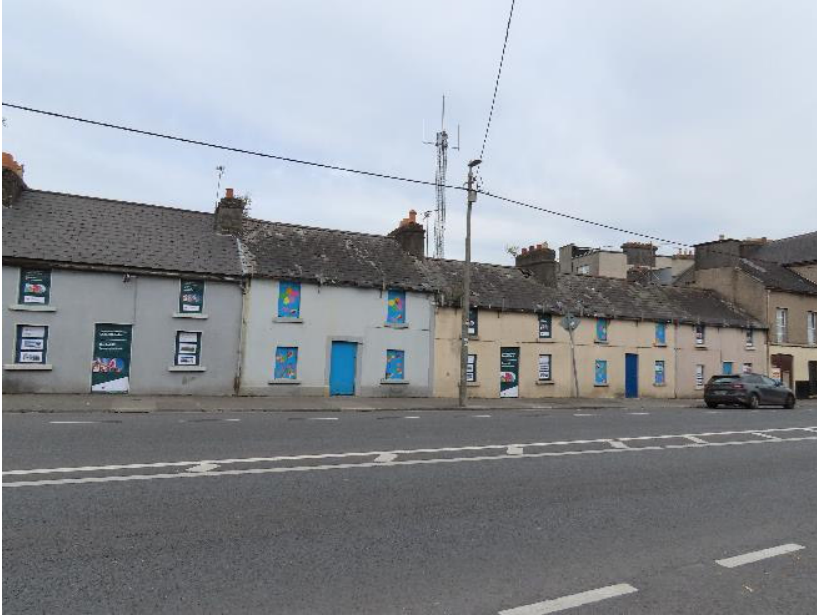
Photo 3 - Properties 3 - 7 in Dunlo Hill terrace – front elevation

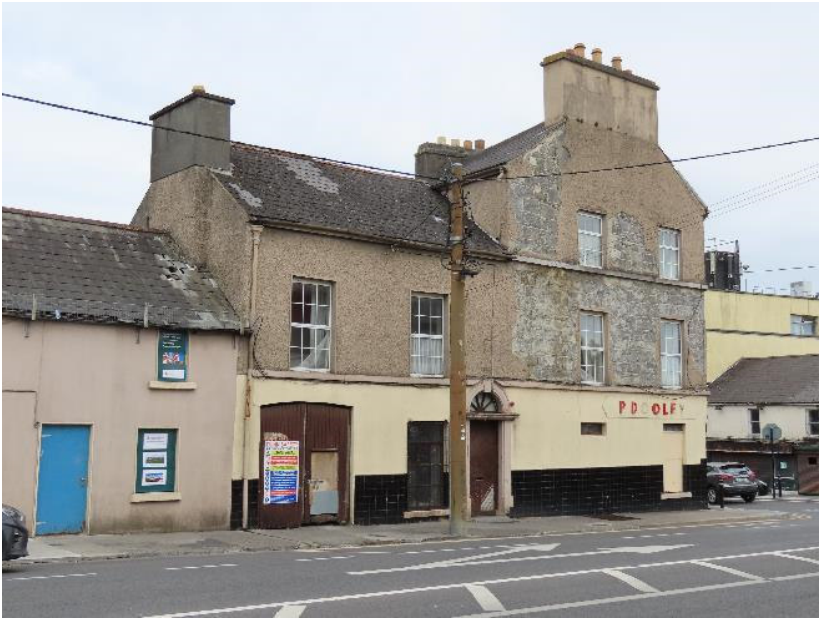
Photo 6 - southern elevation of P. Dooleys pub which is attached to Dunlo Hill terrace

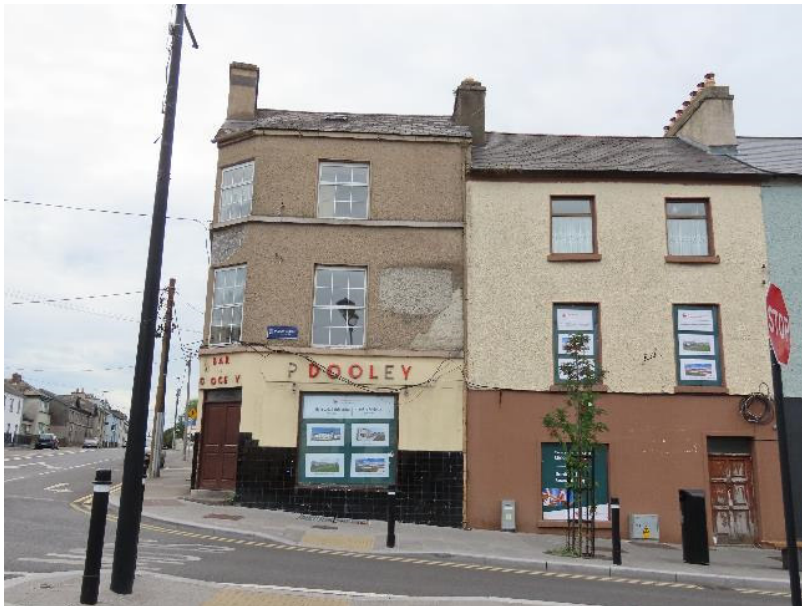
Photo 7 - Eastern elevation of Dooley's pub on corner and adjoining 3 storey property (Property No. 9)

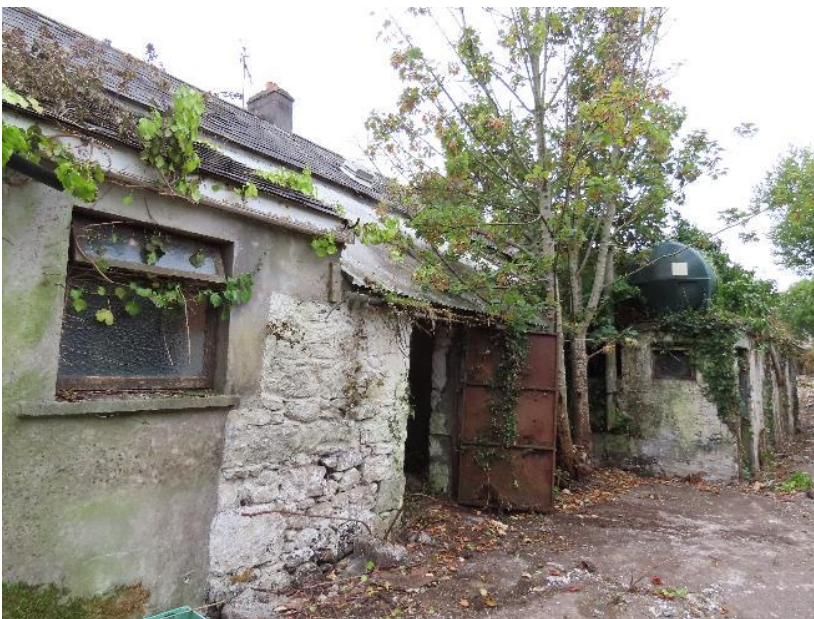
There are numerous small outbuildings to the rear of the terrace cottages. These buildings served as outdoor toilets. Two larger two storey stone outbuildings are situated to the rear of P. Dooley's pub. There is also a range of high stone outbuildings to the rear of the house on Dunlo Street. No evidence of bat usage was found in any of the outbuildings.

Photo 11 - Stone outbuildings to rear of Dooley's pub

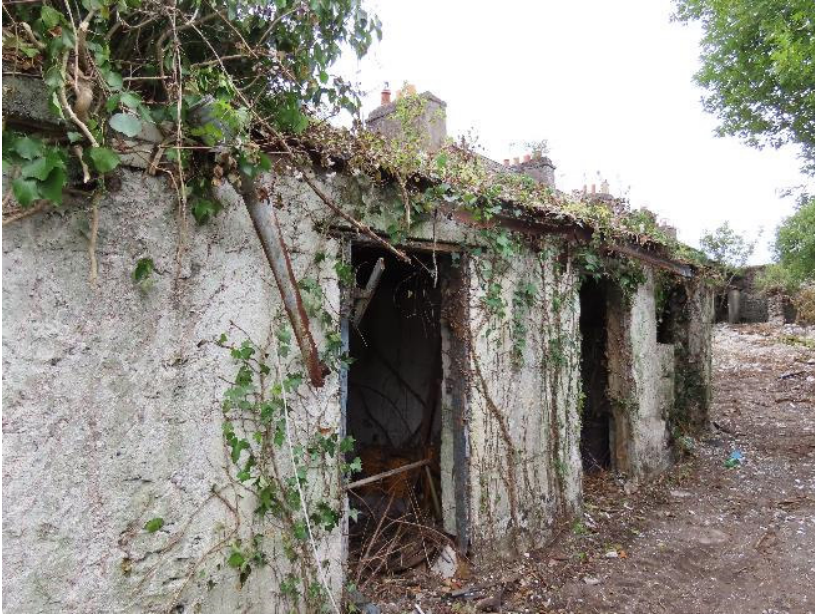
Photo 12 - Stone outbuildings to rear of Dooley's pub

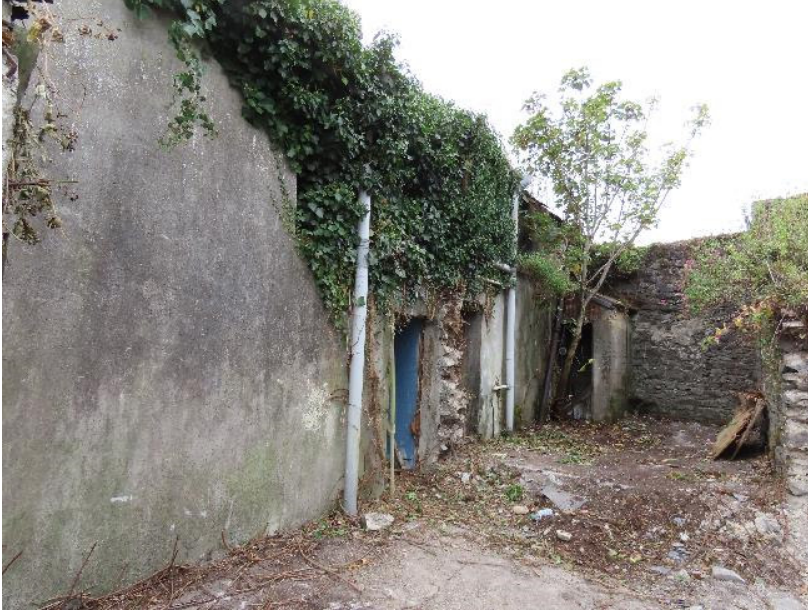
Photo 14 - Rear of Dunlo Terrace – westernmost section. Access to each unit was via the rear door

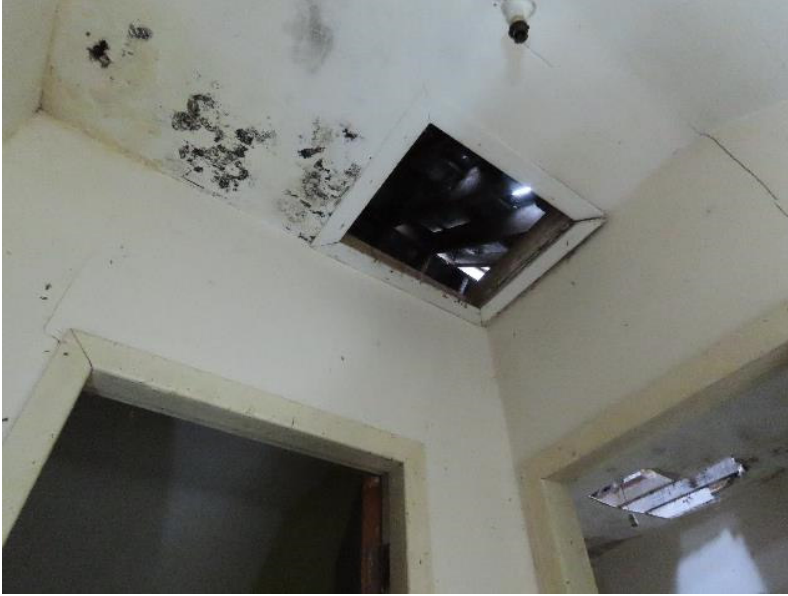
Photo 20 - Access to attic space of Property 1 via trapdoor in upstairs ceiling

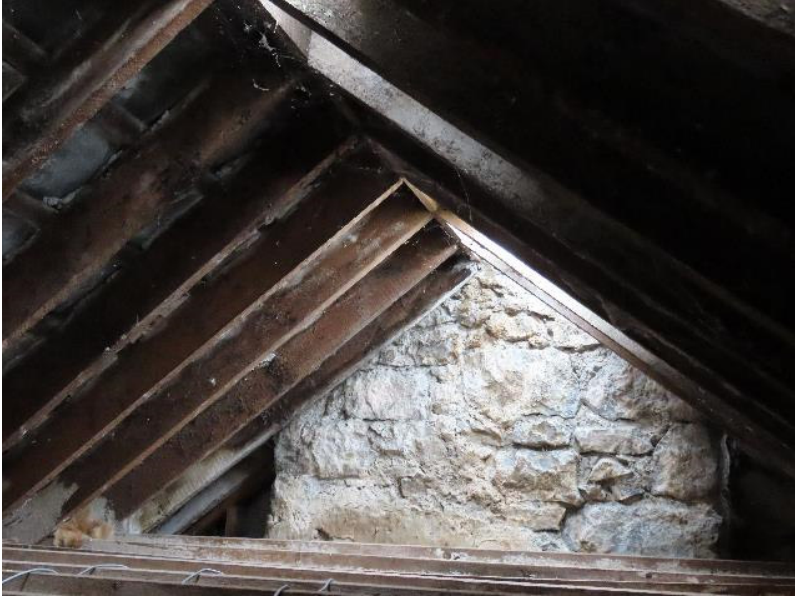
Photo 22 - Attic space of Property 1

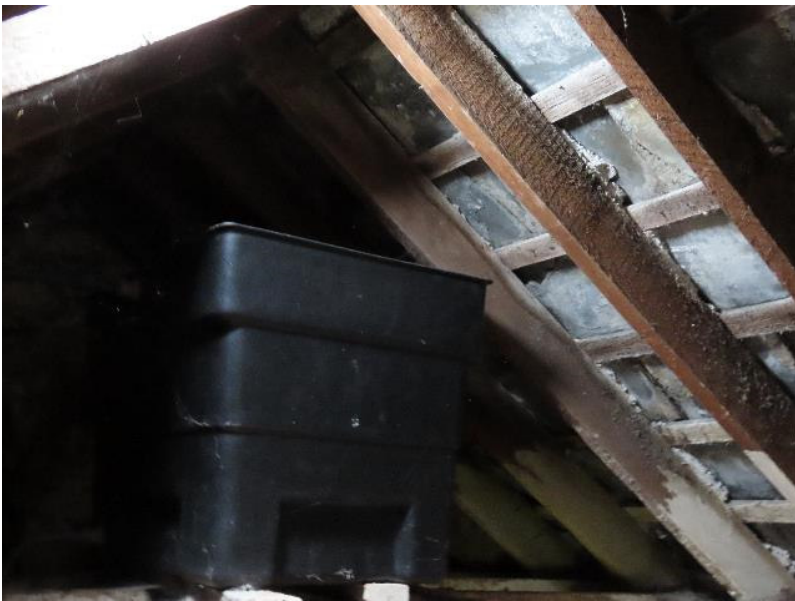
Photo 23 - Attic space of Property 1 showing original slates

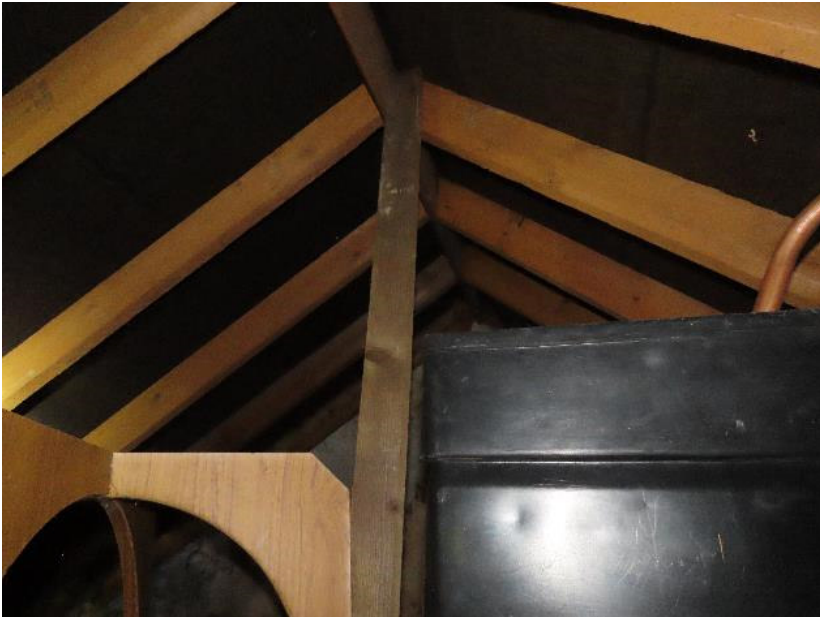
Photo 28 - Attic space of Property 3 showing bitumen lining on inside of slates

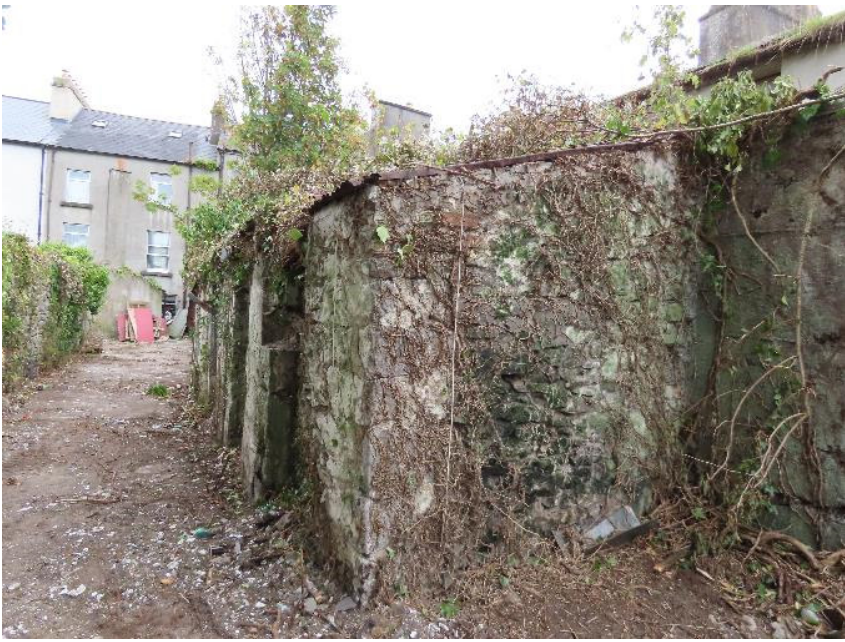
Photo 42 - Sheds to rear of Property 5, 6 & 7

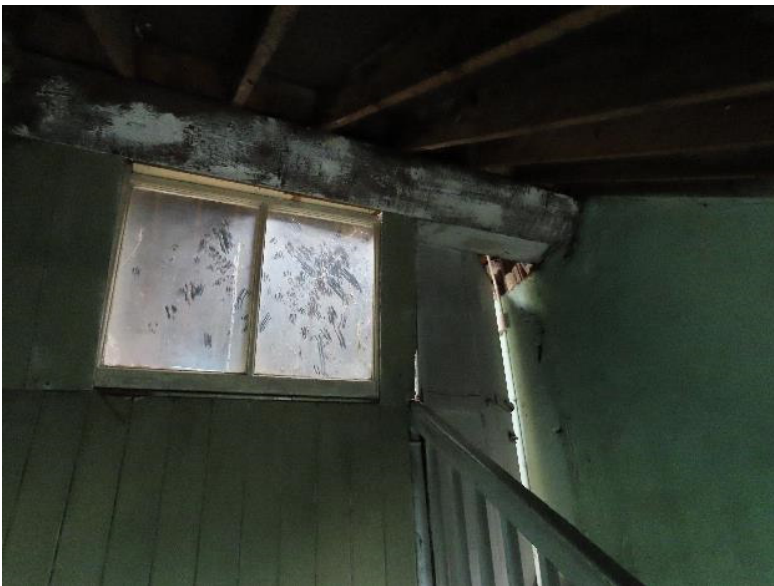
Photo 58 – stairs to attic space

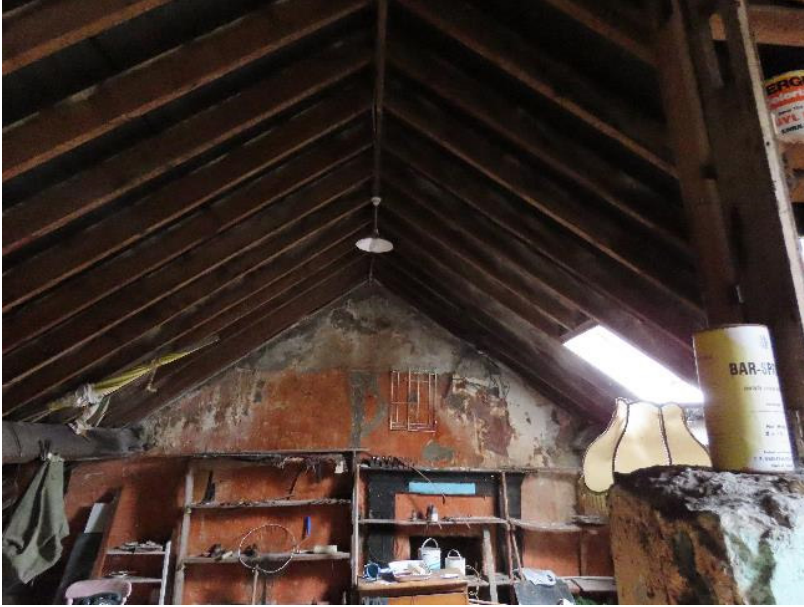
Photo 59 – attic space being used as work space/ storage space

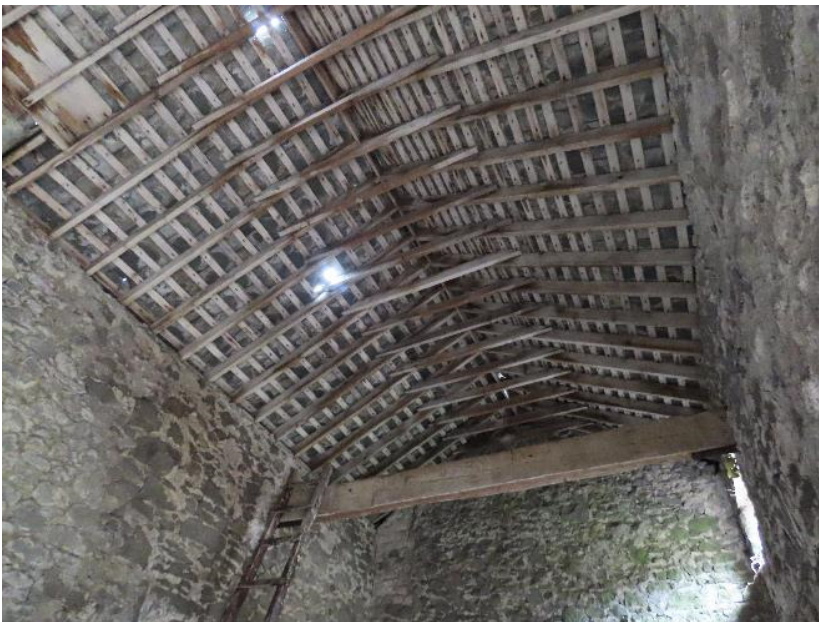
Photo 62 – exposed roof timbers in outbuilding

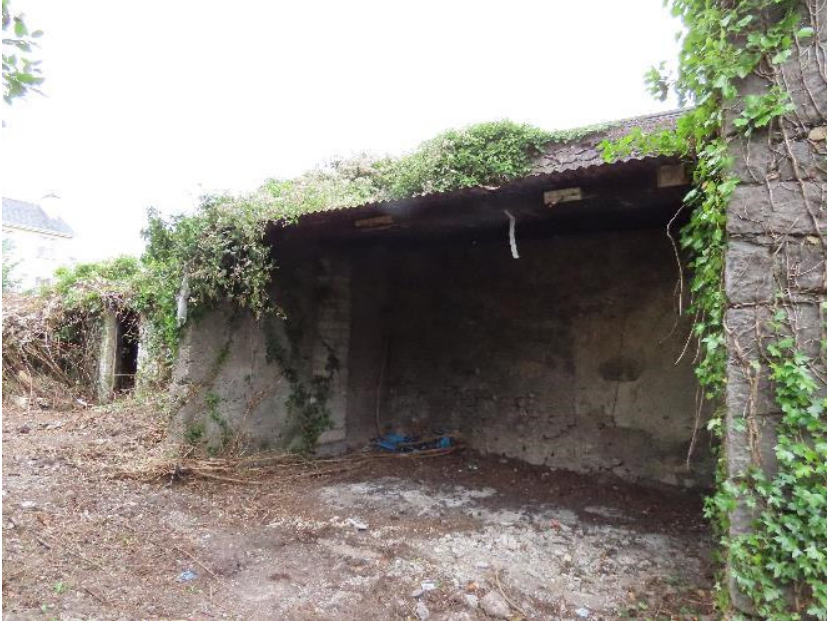
Photo 63 – lean-to building attached to stone outbuilding

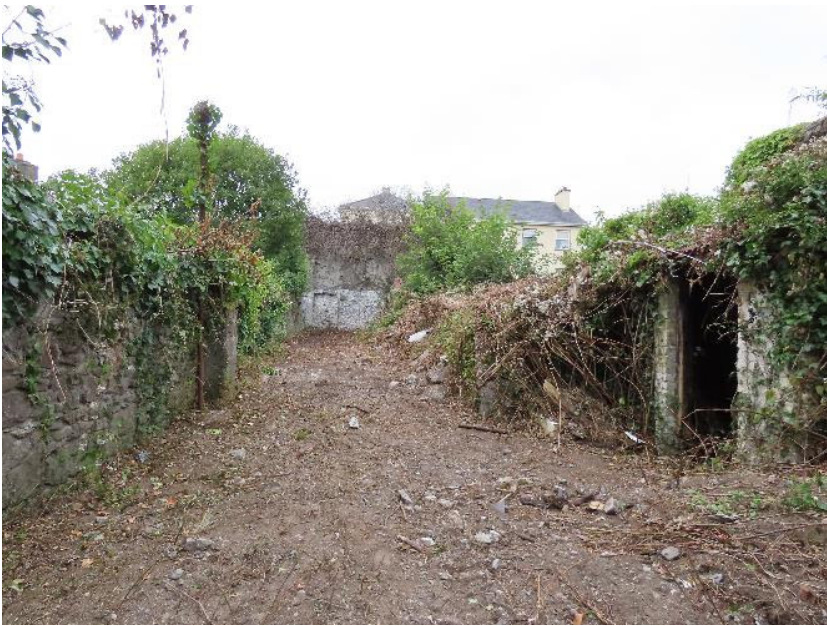
Photo 64 – looking west towards rear boundary wall

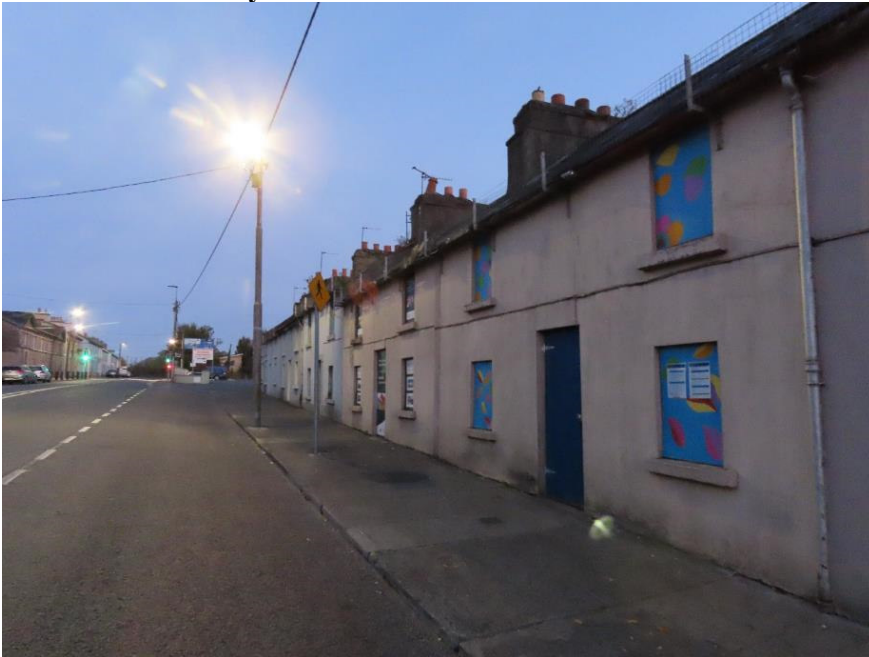
Photo 65 – dusk bat detector survey conducted to front of terrace on Dunlo Hill

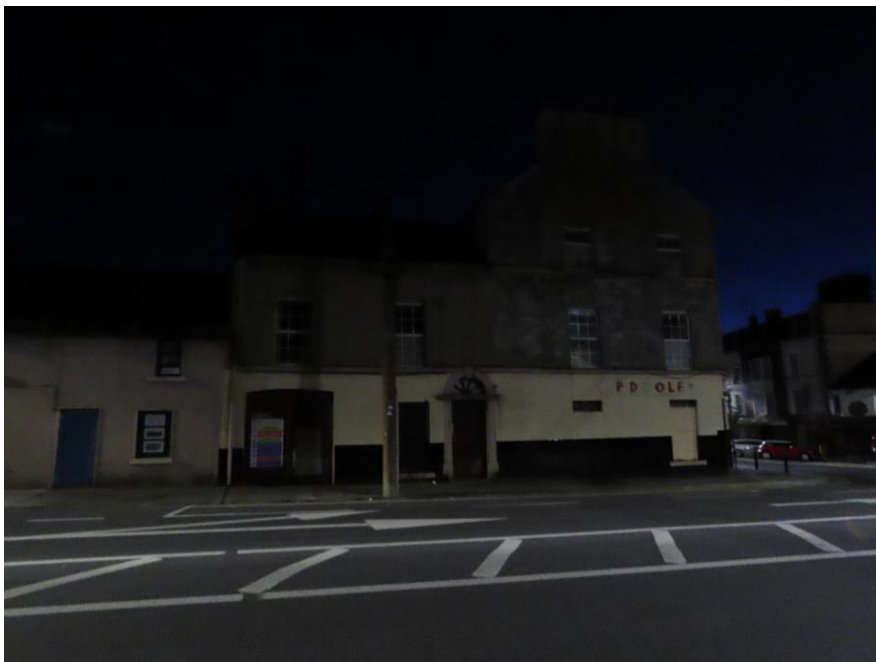
Photo 66 – dusk bat detector survey conducted to south and east of Dooley's pub and adjoining building

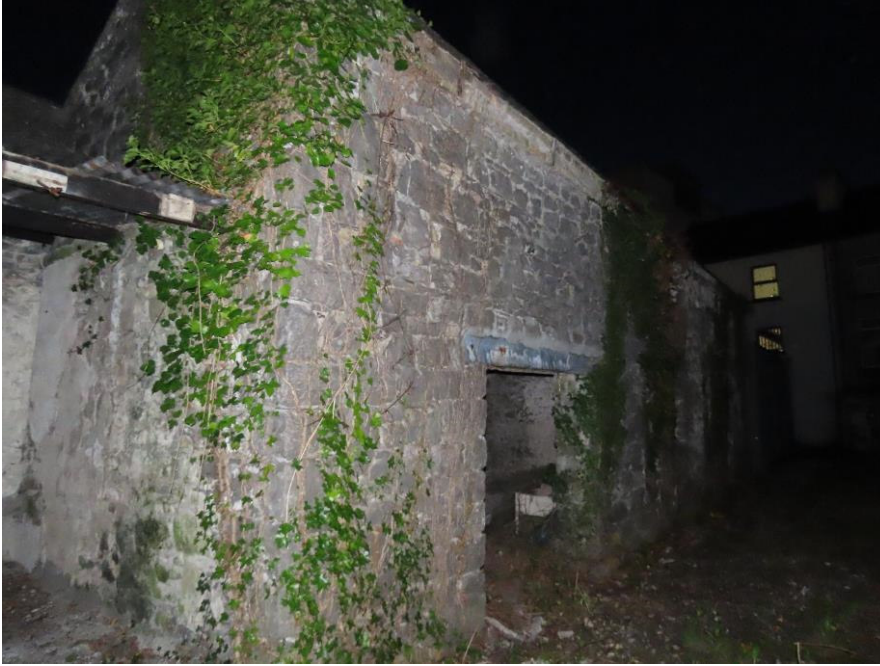
Photo 67 – dusk survey conducted at stone outbuildings to rear of Property 9

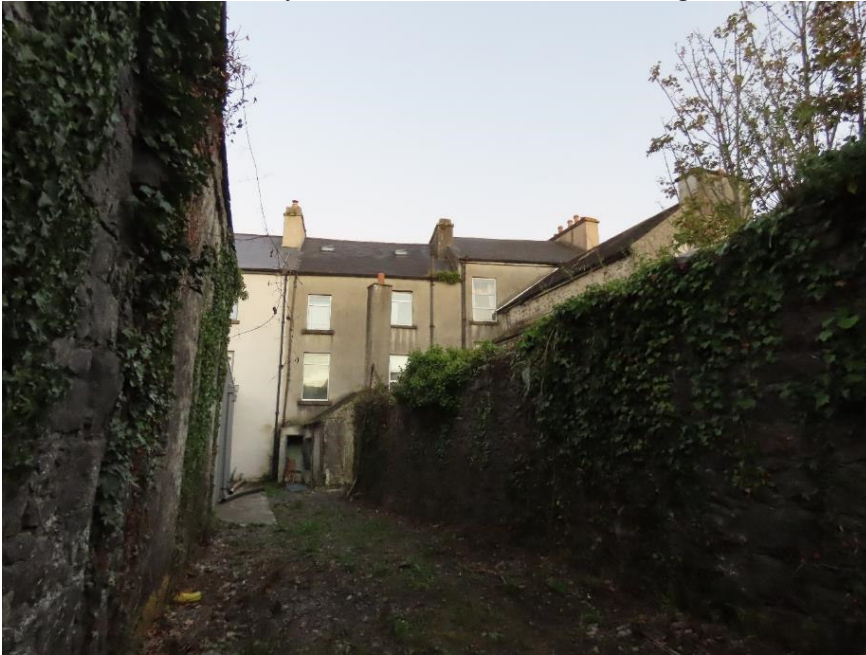
Photo 68 – dawn survey conducted at stone outbuildings to rear of Dooley's and Property 9
