Title: **Stage 1&2 ROAD SAFETY AUDIT**
For;
Dunlo Hill Development, Ballinasloe, Co. Galway.

Client: **Galway Co. Co.**

Date: **May 2023**

Report reference: **1846R01**

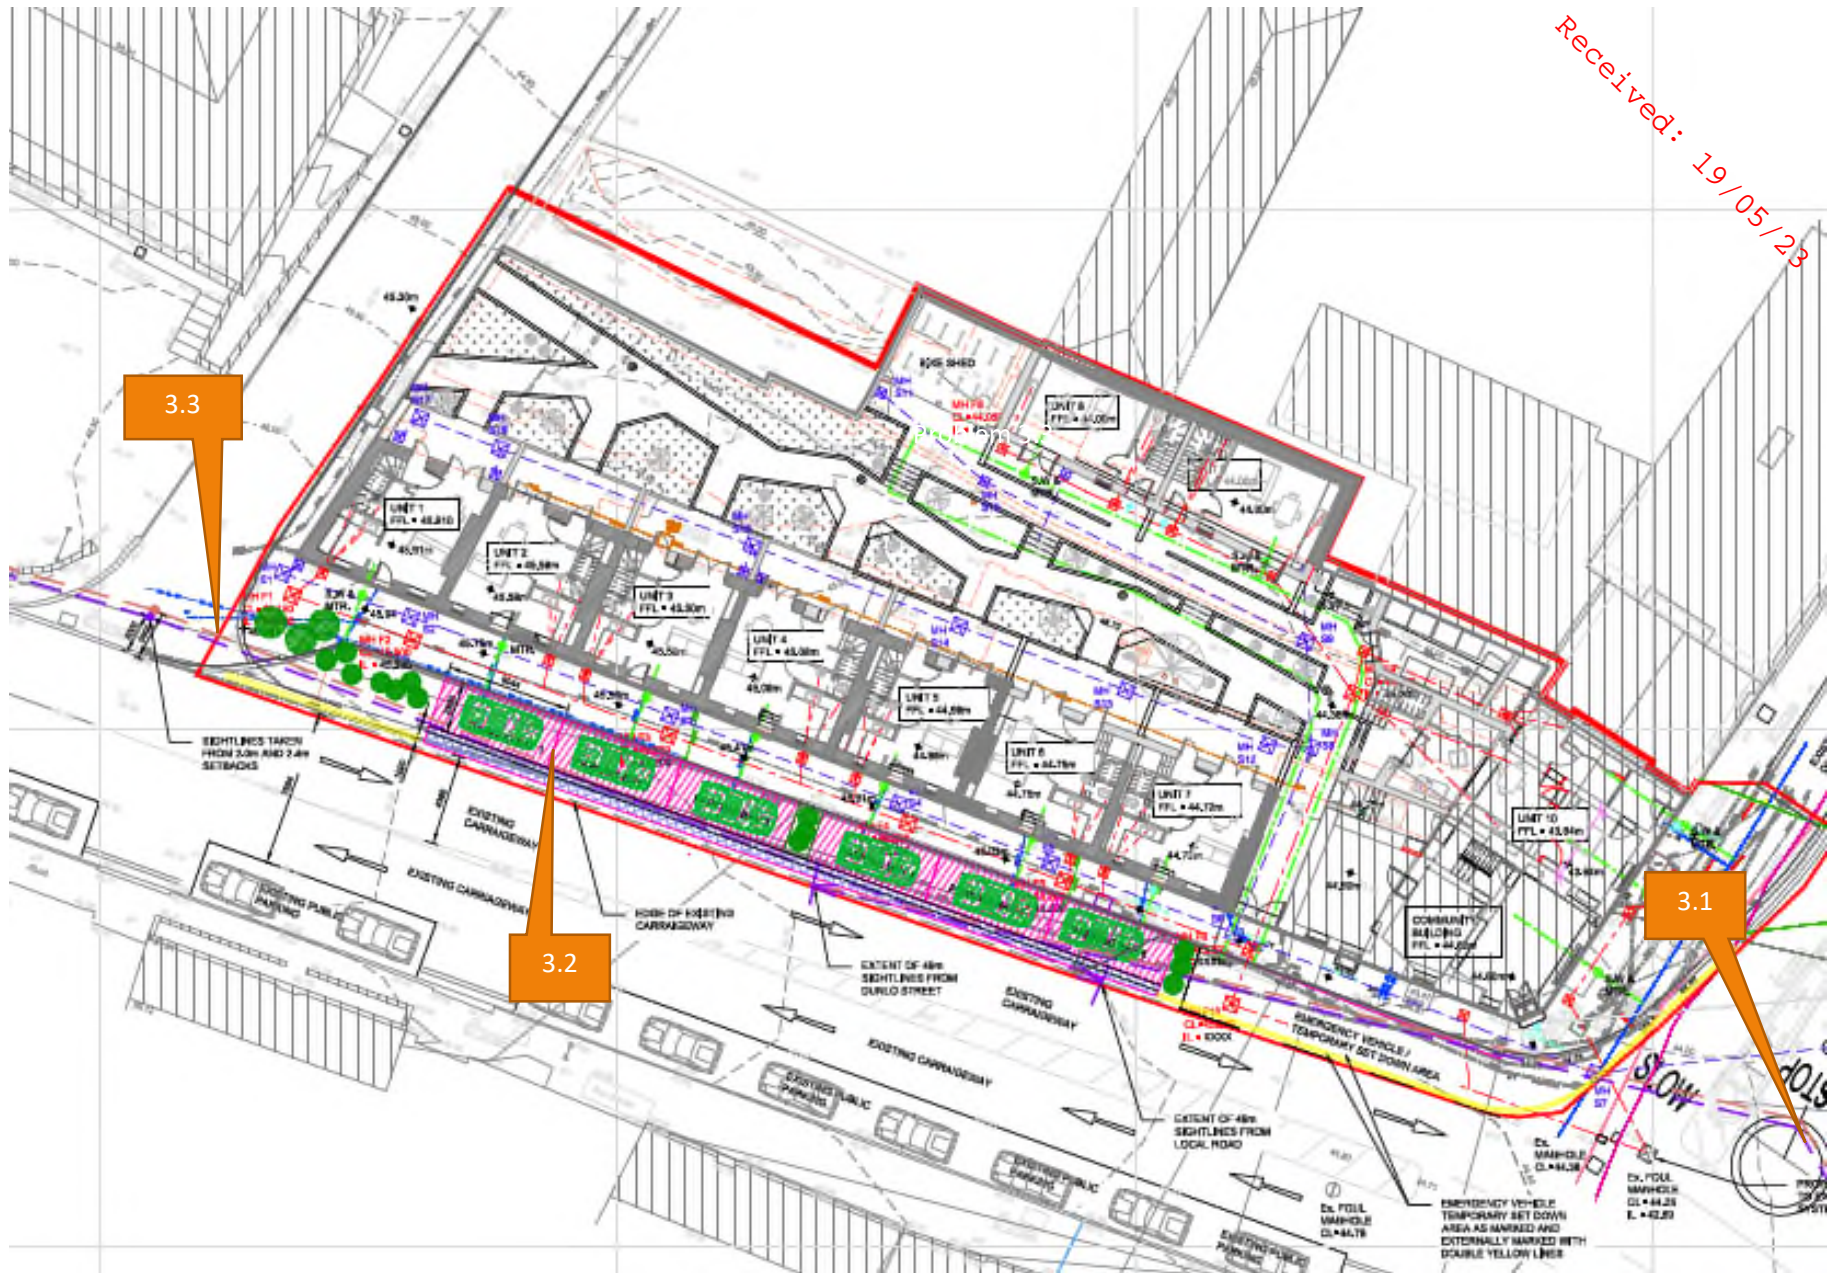
Problem Location Plan.

The stop line is set very far behind the edge of the R446 through route. This makes the visibility to the left for drivers exiting Dunlo Street appear worse than it actually is. The stop line may be ignored by drivers who are familiar with the area leading to a less formal yield control junction.

It is unclear where the bus stop on the R446 will be relocated to. Without a suitable stopping place the mobility impaired may not be able to access the bus.

Pedestrians crossing the Dunlo Hill access road to the west of the site may not have suitable crossing facilities which could lead to trips and falls.

It is recommended that the stop line be brought forward to close top the edge of the through carriageway/new double yellow line.

Ensure that alternative arrangements are provided for bus users.

Ensure that suitable dropped kerbs and tactile paving is provided.
