## **Building Conservation Assessment**

Barkhill, Woodford, Co. Galway (**Planning Ref: Part 8 LA01/24**)

**Client:** Galway County Council

**Date:** 28<sup>th</sup> of June 2024

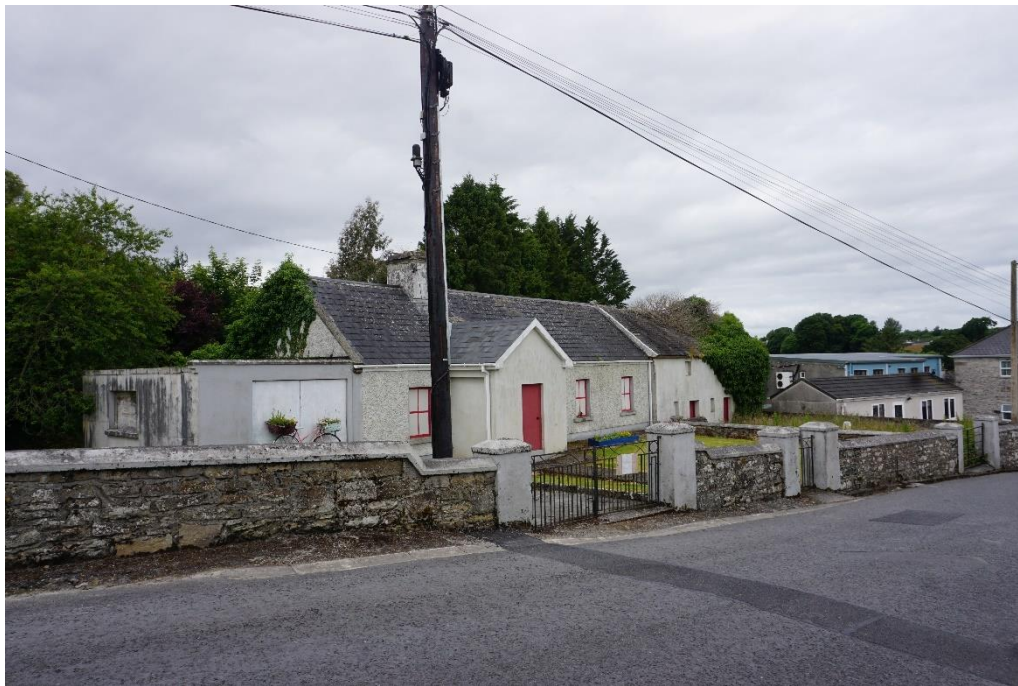
**Photograph 1 - Main Entrance and Front Elevation**

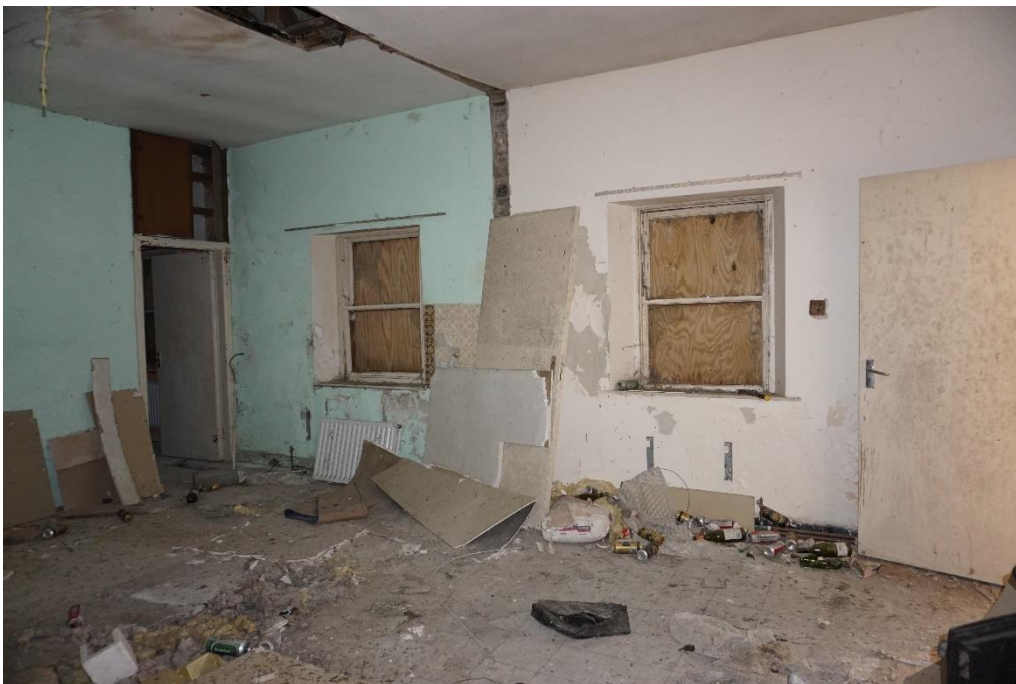
There is a modern concrete floor throughout the dwelling.

**Photograph 8 - Main Living Room with Concrete Floor**

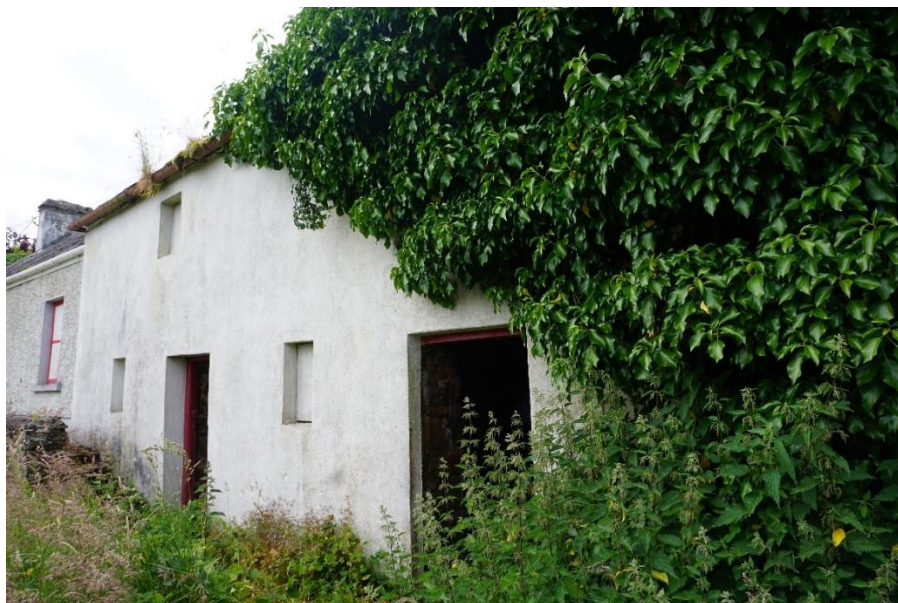
There are 3 No. traditional timber plank doors present on the outbuilding, 2 No. to the front elevation and 1 No. to the rear elevation.

**Photograph 10 – Exterior Outbuilding Traditional Timber Plank Doors**

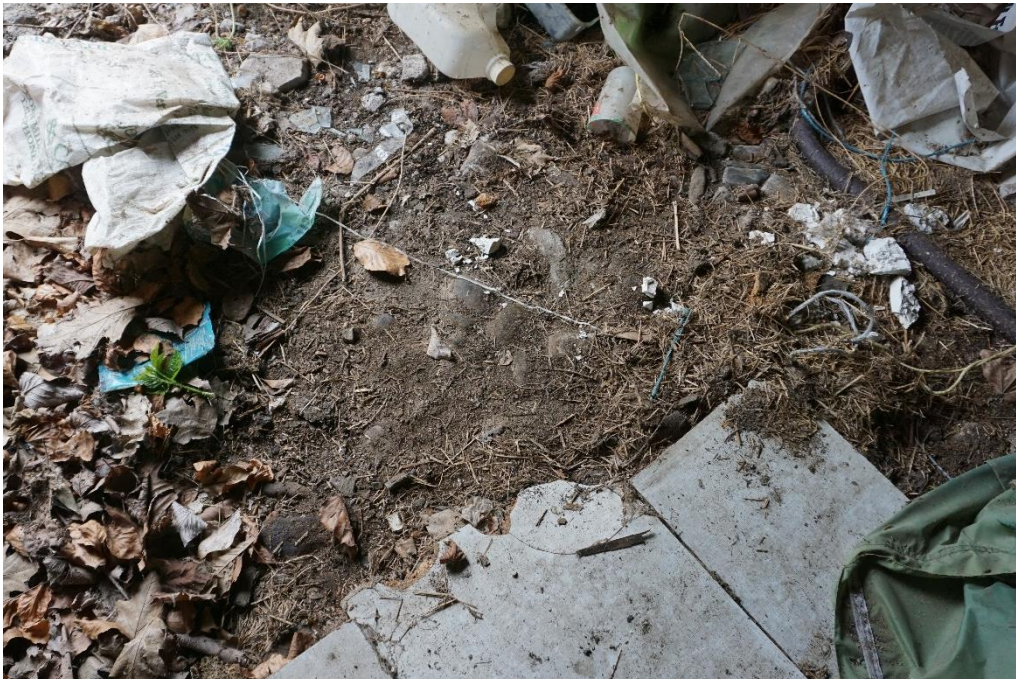
The ground floor is largely obstructed by debris, however there is evidence of the presence of original cobblestones.

**Photograph 13 - Cobblestones**

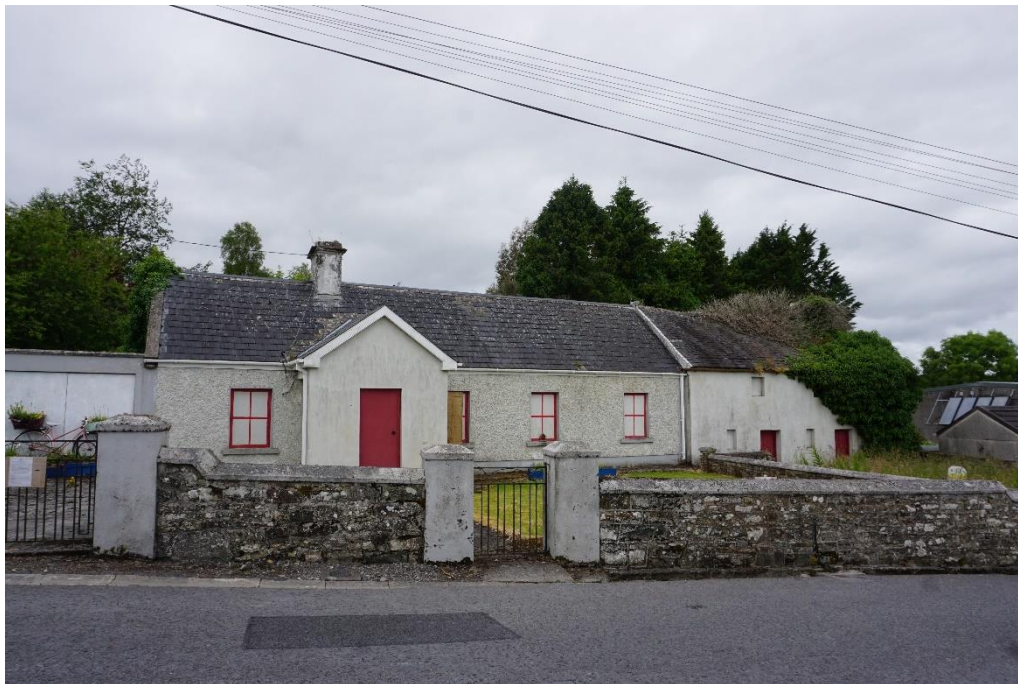
There is a limited portion of the south-western boundary visible which is a modern cast-in-situ concrete wall.

The line of the northern boundary wall is present on the 2<sup>nd</sup> edition Ordnance Survey Ireland map, however the original random course stone wall has been modified to increase the height with concrete.

**Photograph 12 – Stone Boundary Wall and Modern Gate on Eastern Side of Site**

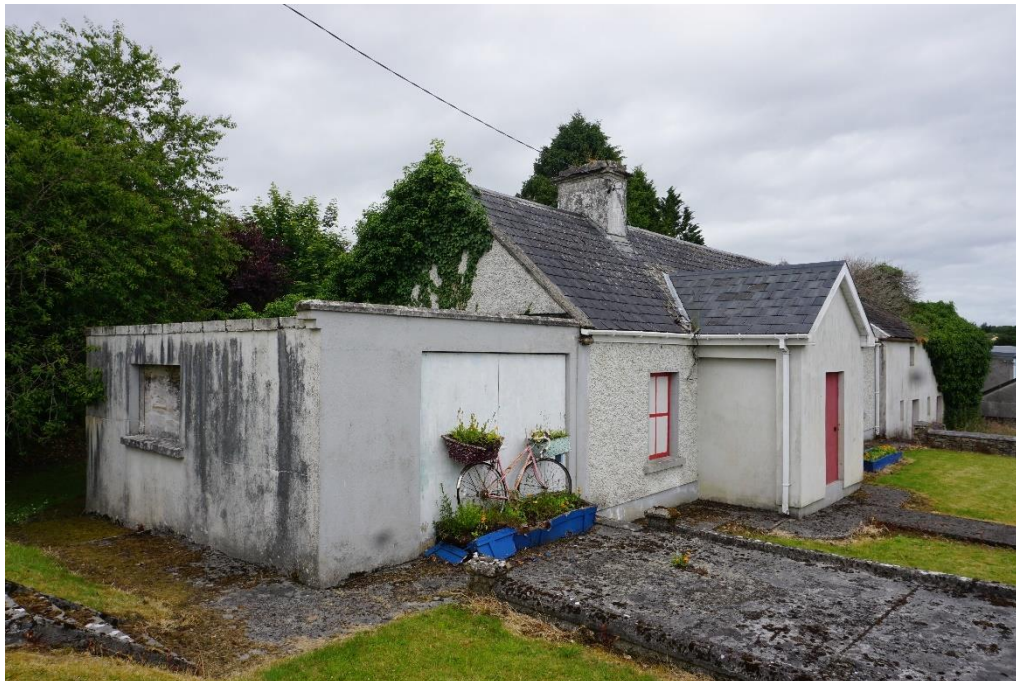
The exterior surface in front of the dwelling is primarily grass with a concrete driveway and footpaths. 2 No. stone dwarf walls line the driveway from the gates to the garage. There are concrete steps leading to the raised grass area to the south of the dwelling. The exterior surfaces are all modern late-20<sup>th</sup> century interventions.

The remainder of the property is heavily overgrown.

**Photograph 13 – Exterior Surfaces Around Dwelling**
